DUTCH
SAFETY BOARD

Mid-air collision during air display training

The Hague, October 2018

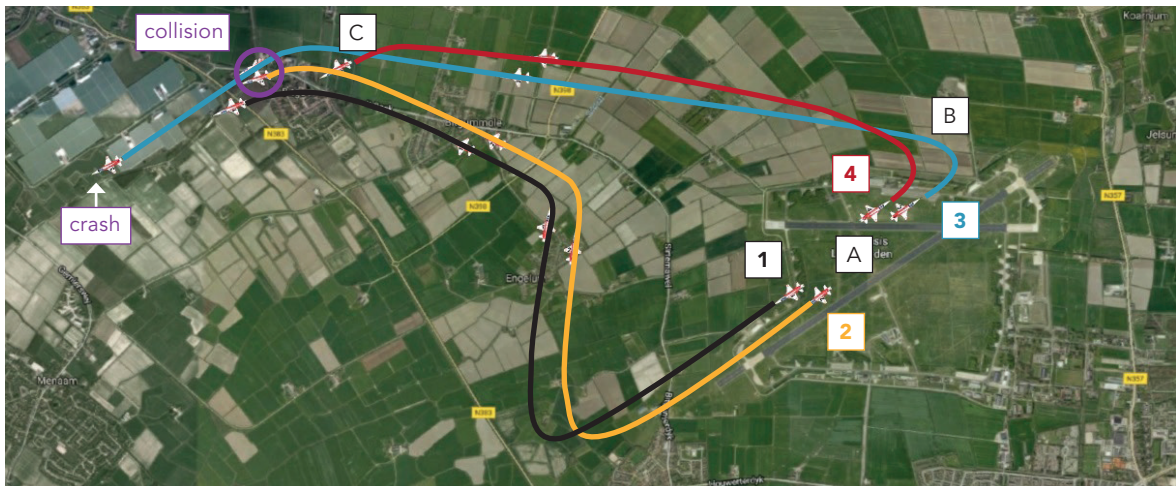
After the opposite pass (A) numbers 3 and 4 turned to the north-west (B) to perform a left-hand turn to the west to re-join the other two aircraft. During the left turn, before forming the Diamond formation, number 3 flew under number 4 and overtook the other aircraft (C).

Figure 1: Tracks flown by the four aircraft of the formation and the place of collision. The black line depicts the track of number 1, the yellow line is number 2, the blue line is number 3 and the red line is number 4. (Source: Dutch Safety Board)

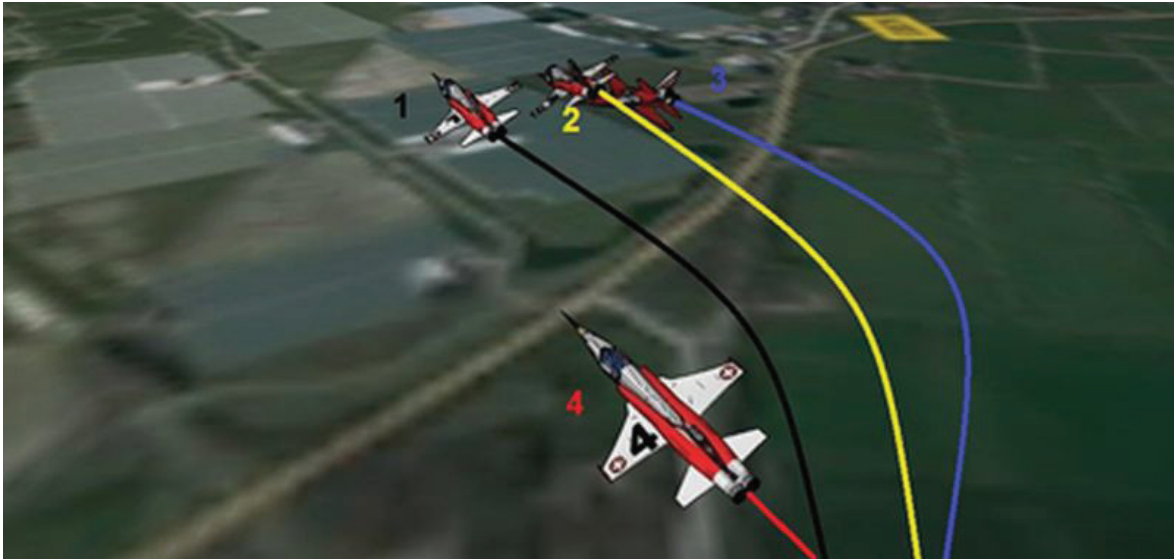
Realising he was out of position, flying faster than the other aircraft in the formation, pilot number 3 reduced power and banked to the right in order to fly underneath the formation. According to the pilot, this is a common procedure to reduce speed and position himself back in the vicinity of the other aircraft. While doing so, he lost sight of aircraft number 2. Pilot number 2, flying in formation with, and focussing on the position of number 1, did not see aircraft number 3. The decrease in speed of aircraft number 3,

while the pilot of this aircraft lost sight of the other aircraft in the formation, resulted in aircraft numbers 2 and 3 colliding with each other. During the collision, number 3 aircraft hit number 2 with its left main wing, thereby damaging the right-hand wing including the flap and cutting half of the right-hand elevator of aircraft number 2.

Figure 2: Close up of the situation during the collision. (Source: Dutch Safety Board)

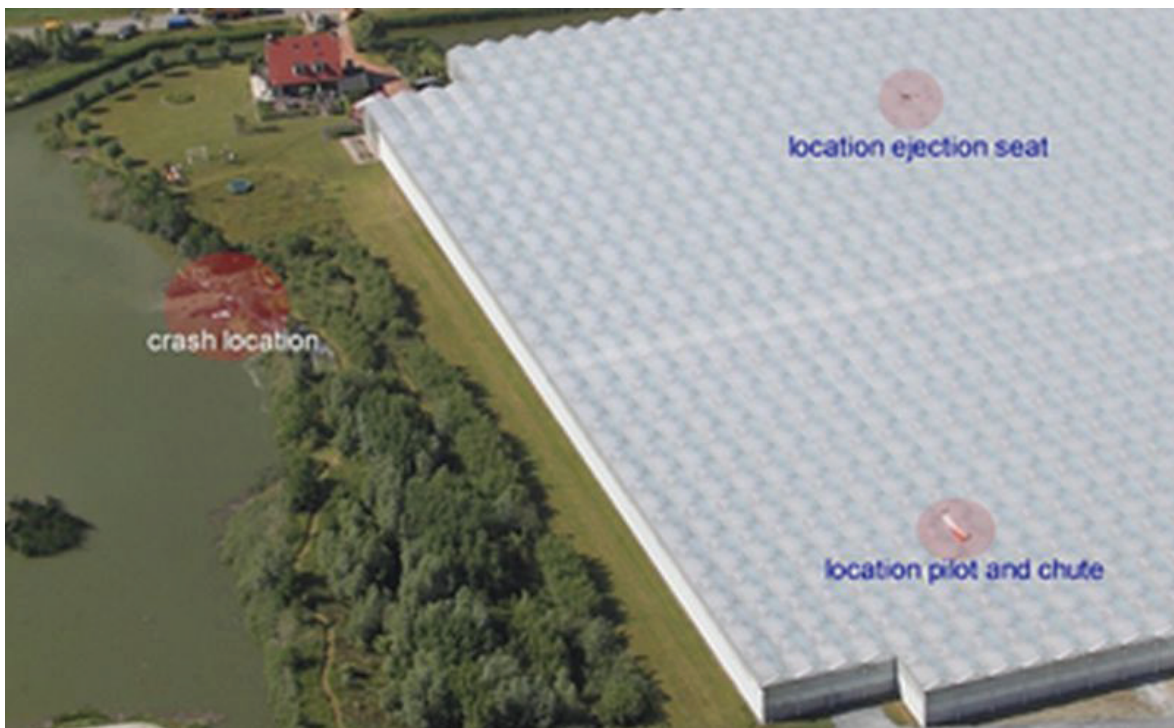
Number 3 aircraft was damaged to such an extent that the aircraft became uncontrollable and tumbled around the longitudinal axis. After realising the aircraft was uncontrollable, the pilot ejected after the aircraft had turned more or less upright. The pilot, his ejection seat and the parachute fell through the glass roof of a greenhouse and hit the ground. The pilot sustained minor injuries. The aircraft crashed on the edge of a pond next to the farmhouse belonging to the greenhouse and came to rest under water.

Figure 3: Impact location of accident aircraft. (Source: National Police)

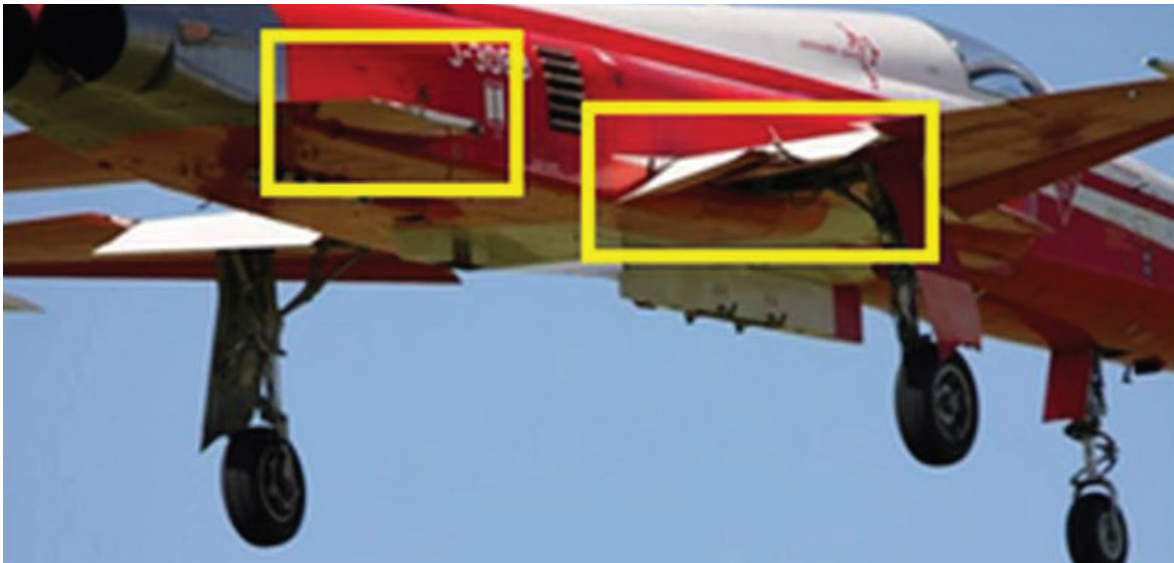
The pilot of number 2 aircraft initially steered the aircraft in the direction of the sea and performed some controllability checks. After he was convinced that his aircraft was still flyable despite the damage sustained, he was able to return to Leeuwarden air base and made a normal landing several minutes later.

Figure 4: Damage to aircraft number 2 just prior to landing at Leeuwarden air base. (Source: Royal Netherlands Air Force)

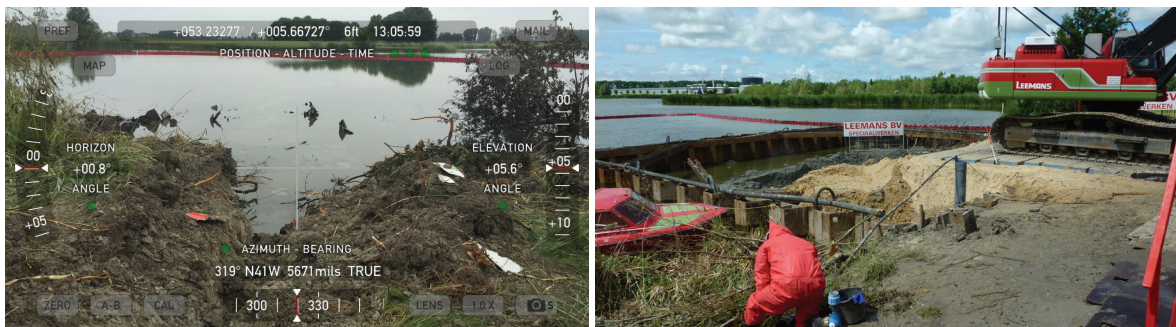
Number 3 aircraft crashed on the edge of a small pond behind greenhouses. After hitting the ground the aircraft went into the pond and, apart from some small debris, most of the aircraft went under water. Several days after the accident it was decided to salvage the aircraft from the pond as evidence to the safety and criminal investigation.

Figure 6: Impact area of aircraft number 3 and salvage operation. (Source: Dutch Safety Board)

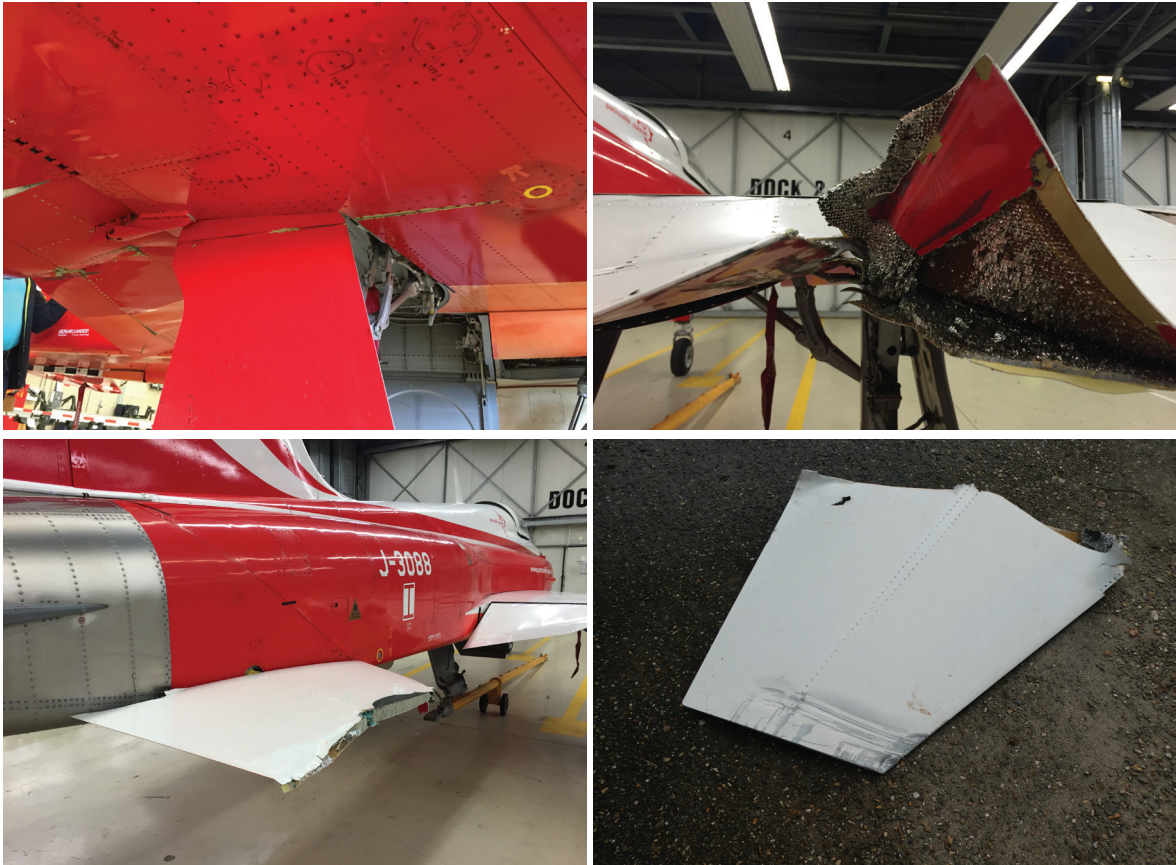
- A scratch on the underside on the leading edge flap.
- A continuous scratch, starting in the middle on the underside, over the gear door, to the right-hand trailing edge flap.
- A scratch ending in an upward bended crack in the right-hand trailing edge flap.

- Cut off around the middle.
- Bended at inboard edge.

Some months after the accident, part of the right-hand stabiliser that was cut off was found on the roof of a building in the neighbourhood around 1,300 metres northeast of the impact area of aircraft number 3.

Figure 7: Damage of number 2 aircraft - underside right-hand wing (top left); right-hand trailing edge flap (top right); right-hand horizontal stabiliser (bottom left); found part of right-hand horizontal stabiliser (bottom right). (Source: Dutch Safety Board)

The scratches on the underside of the right wing of number 2 indicate that some part of number 3 hit the underside of the wing. Because it was a single, small scratch, this part must have had a relatively small surface. This and the fact that the right-hand horizontal stabiliser of number 2 was cut off sharply, indicates that both aircraft had a relative bank, where number 2 had a bank to the left and number 3 had a bank to the right. This analysis corresponds with the statement of the pilots. The angles of the banks remain unknown.

The beginning of the scratch under the wing of number 2 was small and ended in the upward bended cut in the right-hand trailing edge flap. Because both aircraft flew almost in the same direction, this was an indication that some part of aircraft number 3 moved from the front to the back along the wing. This can only be explained by the fact that there was a relative movement between both aircraft, where number 2 flew faster than number 3. This is in line with the statement of the number 3 pilot that he slowed down to regain sight of the other aircraft.

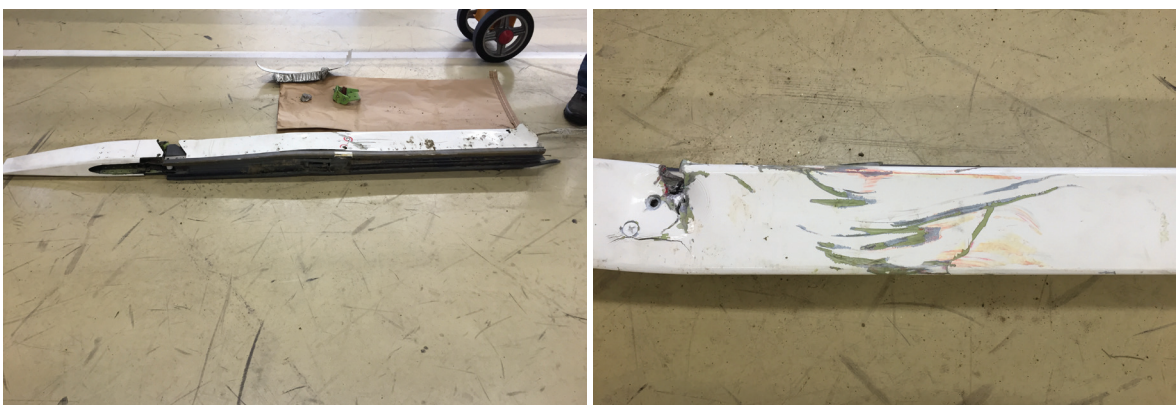
The aircraft was totally destroyed. A white coloured, left-hand missile launching rail of the aircraft was found in a field near the place of collision. The launching rail was scratched and had some traces of red paint on its surface.

Figure 8: The number 3 aircraft left-hand missile launching rail. (Source: Dutch Safety Board)

With reference to the scratches and red paint on the left-hand missile launching rail of number 3, it is likely that this part of the aircraft caused the scratches underneath aircraft number 2's right-hand wing. Since the right-hand horizontal stabiliser of number 2 was cut off sharply, this must be caused by an aircraft part with a relative small surface. The most probable part, with reference to the damage, was the trailing edge of the left-hand wing of number 3, especially the part with the aileron that was found during the salvage. Because of the cut in the aileron with prolongation to the wing and traces of red paint on that place, it is likely that the right-hand horizontal stabiliser was hit by the left-hand wing at the height of the aileron of number 3.

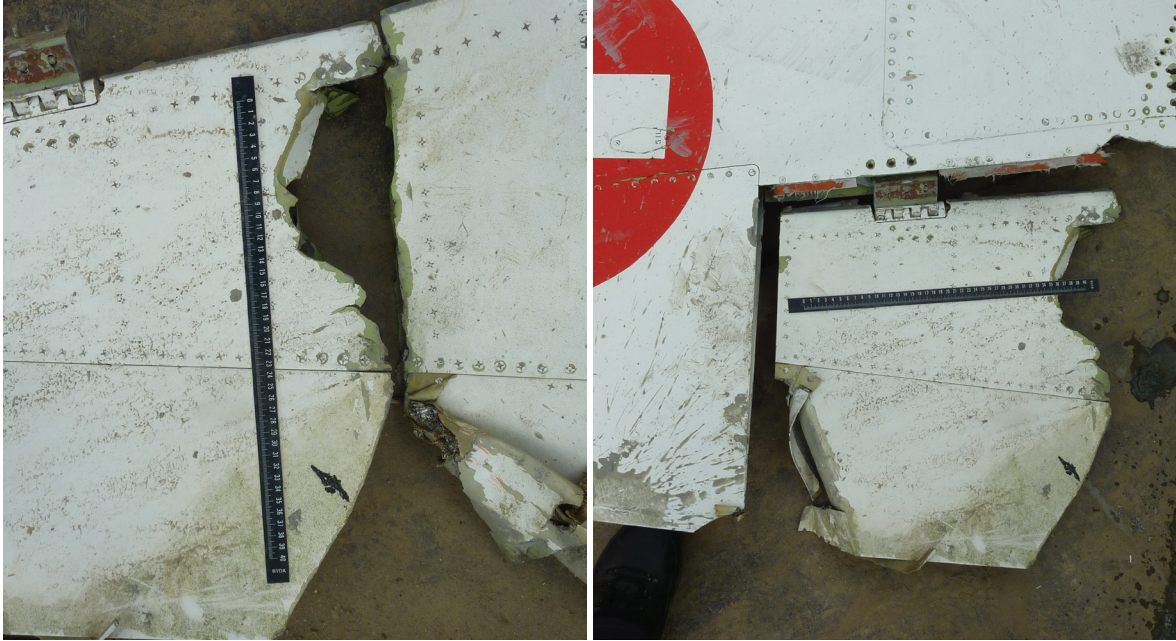
During the salvage several aircraft parts, large and small, of aircraft number 3 were found and secured for investigation. Among these parts were a part of the left-hand wing and aileron. Originally, these parts were joined together but were now cut off. The aileron was cut through and this cut was prolonged into the wing. The edge of the left part of the aileron was bent and had some red paint on it.

Figure 9: Two pieces of the left-hand aileron (left) and the left piece situated near its original place on the wing (right). (Source: Dutch Safety Board)

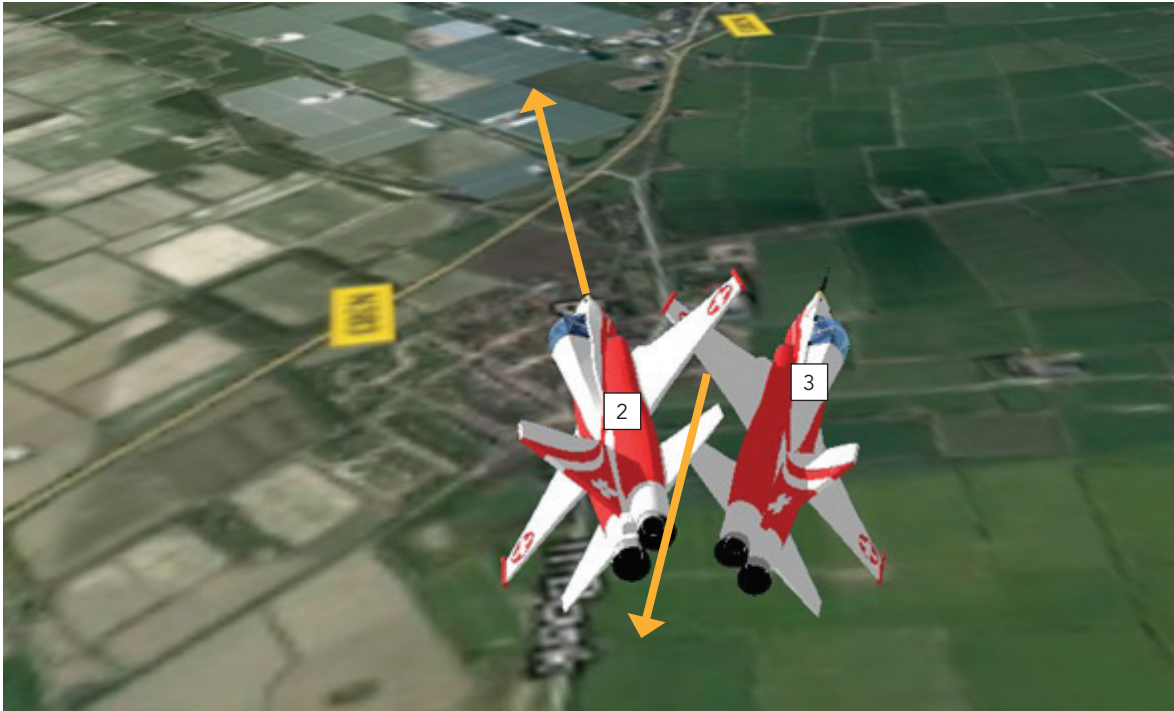
Figure 12: Estimated position and relative motion of aircraft numbers 2 and 3 at the time of the collision.
(Source: Dutch Safety Board)

Because number 2 aircraft flew faster than number 3 aircraft, there was a relative movement between both aircraft. Parts of the number 3 aircraft's left wing hit the number 2 aircraft's right wing underside and right-hand horizontal stabiliser from the front to the back.
