**FINAL REPORT OF SERIOUS INCIDENT
INVOLVING
M/s JET AIRWAYS ATR 72-500 AIRCRAFT
VT-JCL
AT BANGALORE
ON 15/06/2016**

FINAL REPORT OF SERIOUS INCIDENT INVOLVING M/s JETAIRWAYS
ATR 72-500 AIRCRAFT VT-JCL AT BANGALORE ON 15/06/2016

| 14. Type of incident | : Air Turn Back due to Smoke in Cabin and Engine fire |

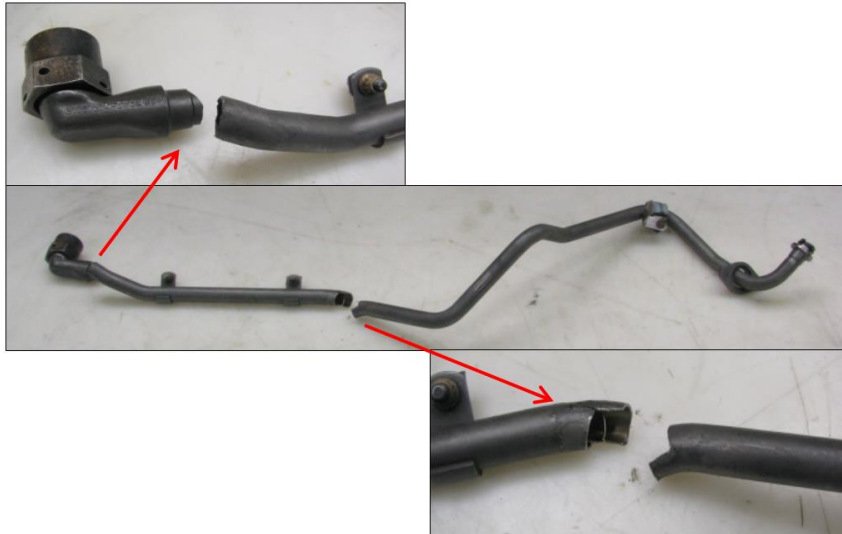
Fig 1

- (i) No 6 and 7 bearing vent tube were cracked.

- SEM examination of the fracture surfaces of No 6 and No 7 bearing vent tube of as indicated in Fig 01, revealed a flat surface with evidence of beach marks and river lines indicative of fatigue. SEM magnification of the fracture surface suggests the fatigue origins were located along the tube outer diameter and propagated likely by high cycle fatigue towards the inner diameter. The exact fracture origins due to rubbing could not be further characterised. No evidence of material anomalies was observed.

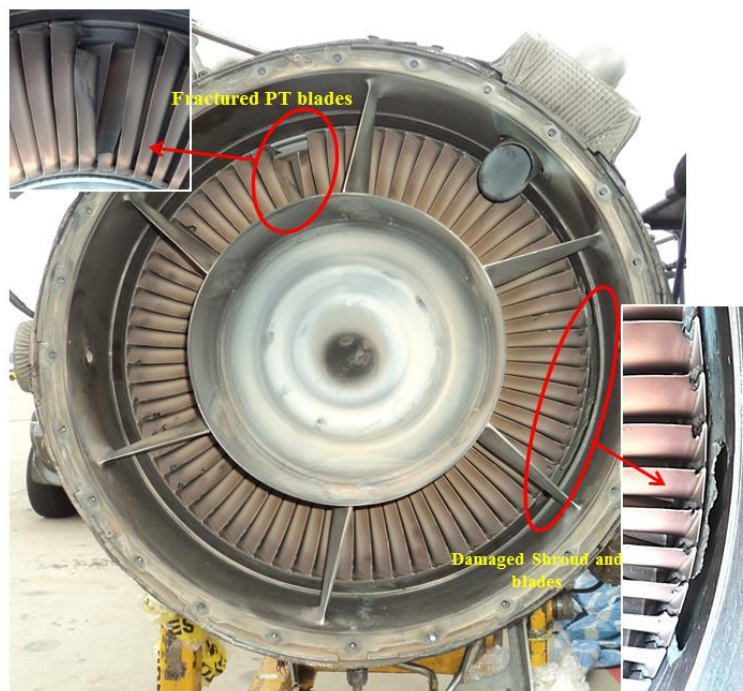
Fig 2

- (ii) One blade of the 2nd stage power turbine was found fractured at the base.
- (iii) Another blade of the 2nd stage power turbine was found fractured close to the middle.
- (iv) Nick marks and damage were noticed on many other Power Turbine blades.
- (v) The power turbine shroud housing showed impact damage
- (vi) Shroud had some material missing from it.

fracture region near the leading edge indicative of fatigue. The other fractured PT2 blade was fractured near the shroud tip and showed a fracture morphology indicative of tensile overload. (Fig 02)

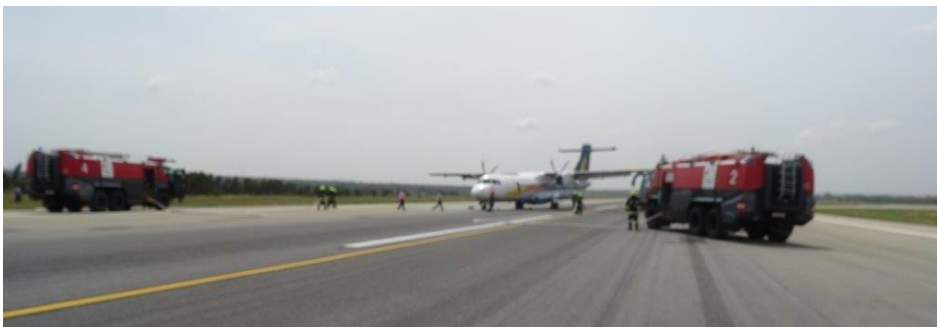
Fig 07

Fire was reported on the No 2 Engine during flight at an altitude of approximately 1200 Feet. The fire warning continued in the cockpit even after 02 squib discharges and stopped just close to landing.

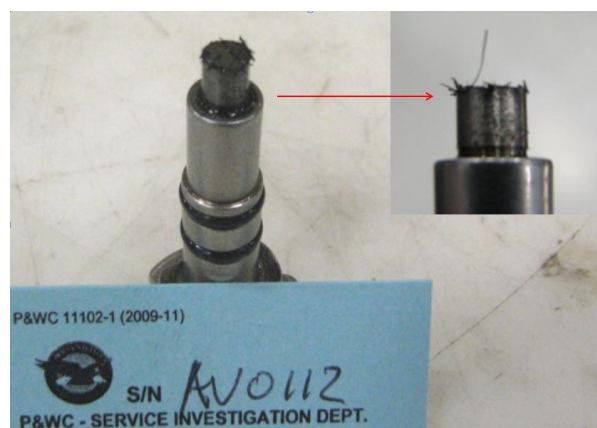
Fig. 08

- The engine externals showed no evidence of high temperature exposure
- The high pressure turbine (HPT) and low pressure turbine (LPT) could be rotated freely. The power turbine (PT) could be rotated only partially before it would bind.
- The turbo machinery magnetic chip detector (MCD) showed some metallic slivers (Fig 08).The reduction gearbox (RGB) MCD was clean.

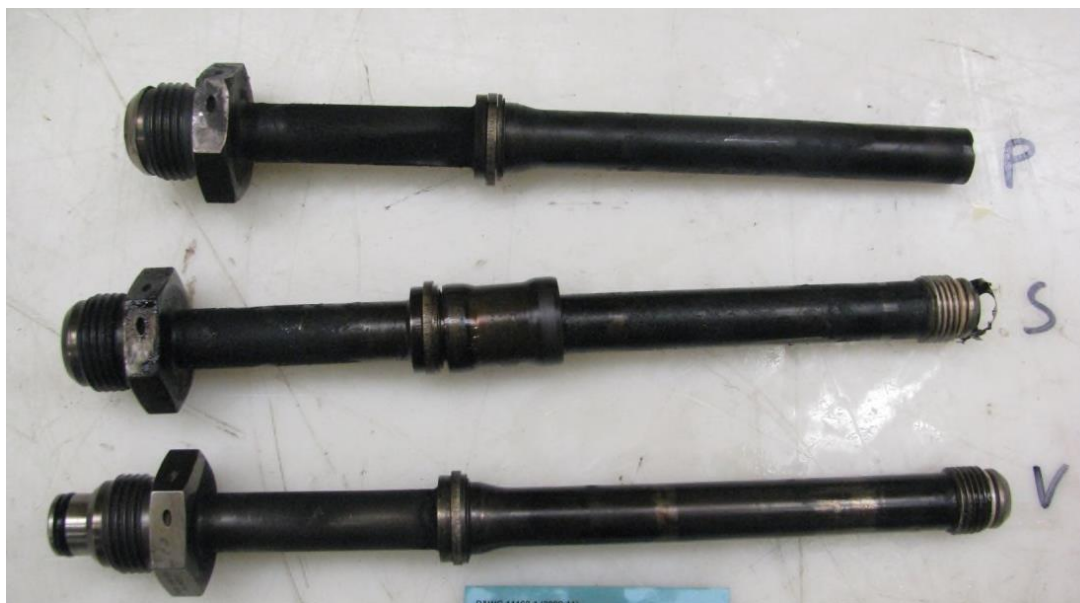
Fig 09

- The Nos. 6 and 7 bearings oil scavenge and vent transfer tubes were found loosened with the metal tip seal gasket on the scavenge tube end significantly worn

(Fig 09). The Nos. 6 and 7 bearings oil pressure transfer tube was fractured showing a flat fracture surface morphology indicative of fracture by fatigue.

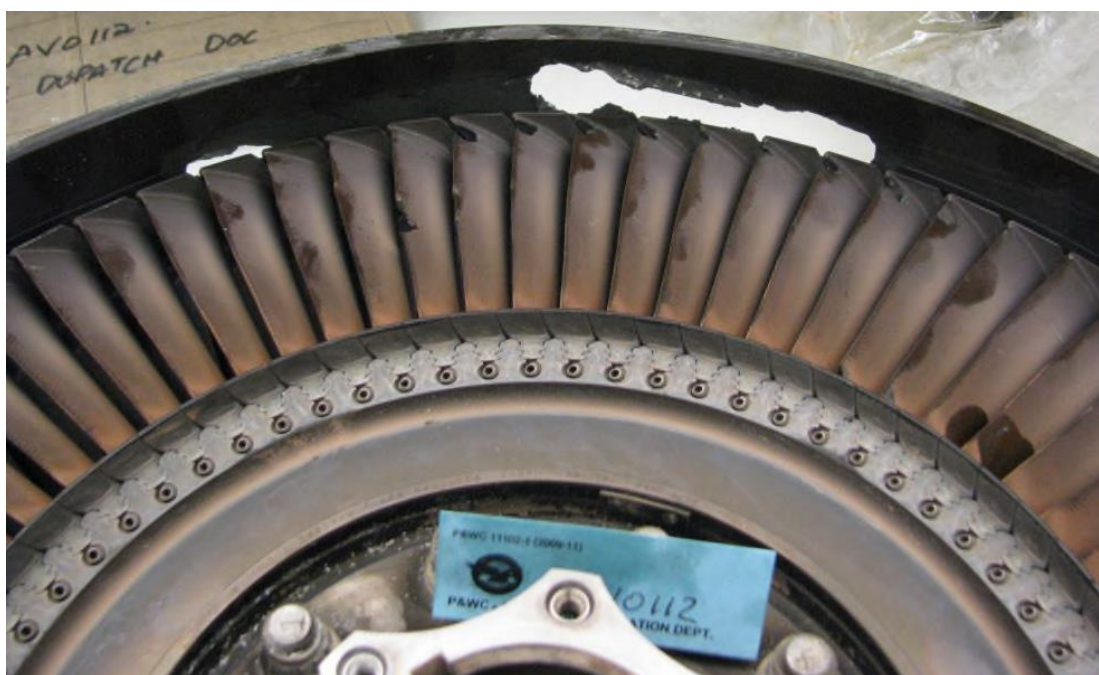
Fig 10

- The PT stator shroud housing showed impact damages with material loss (Fig 10).

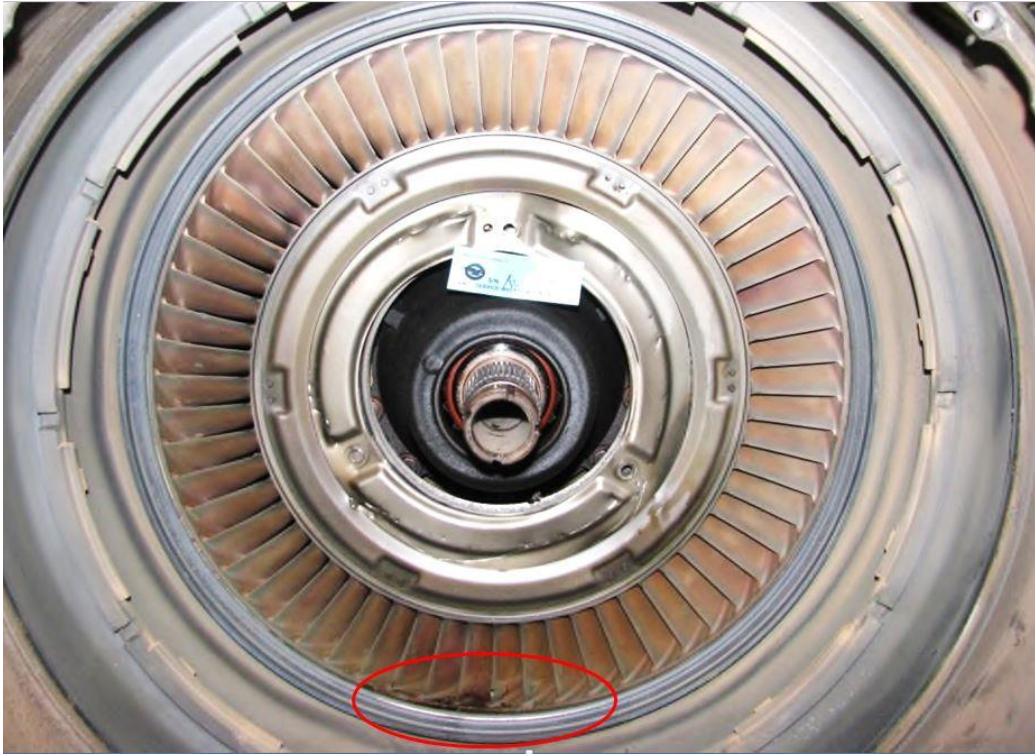
Fig 11

- The first stage PT blades and stator showed no distress. However, the 1st stage stator showed “cooked” oil residue discoloration in the 6 o’clock region (circled) and the inner baffle bolts (arrows) were all fractured (Fig 11).
- The Nos. 6 and 7 bearing housing inner turbine duct (ITD) retaining bolts were all fractured (Fig 12). The Nos. 6 and 7 roller bearings showed a darkened colour but no distress. The No. 6 and 7 bearing housing air /oil seals showed significant wear of the knife edges and the release of metallic slivers due to the wear (Fig 13).

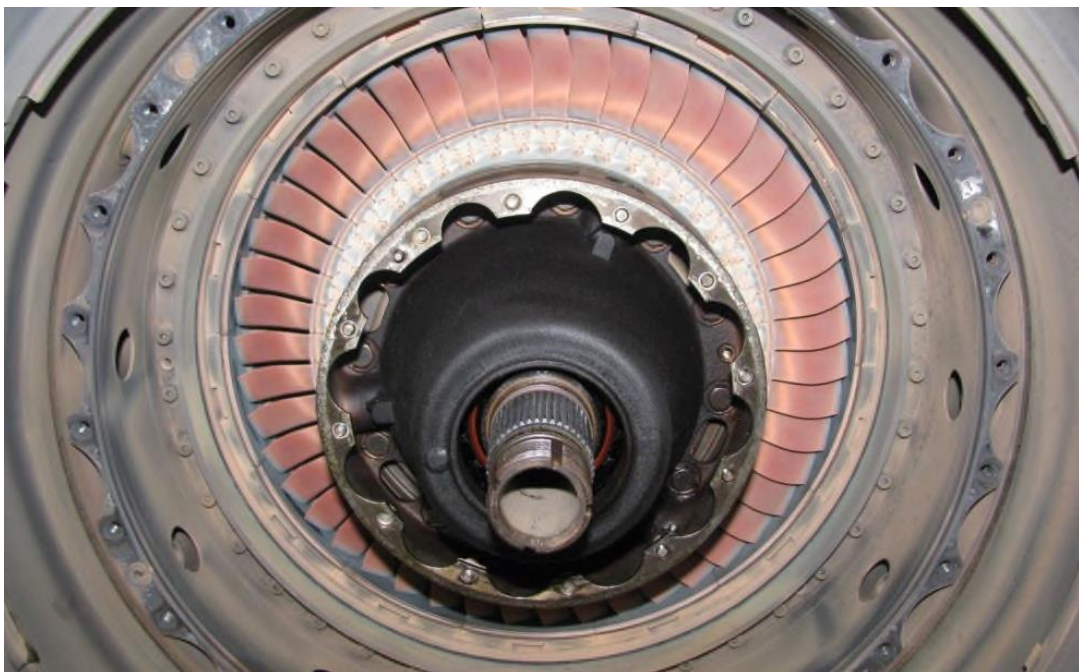
Fig 12

- The Nos. 6 and 7 bearing housing inner turbine duct (ITD) retaining bolts were all fractured (**Fig 12**). The Nos. 6 and 7 roller bearings showed a darkened colour but no distress. The No. 6 and 7 bearing housing air /oil seals showed significant wear of the knife edges and the release of metallic slivers due to the wear (Fig 13).

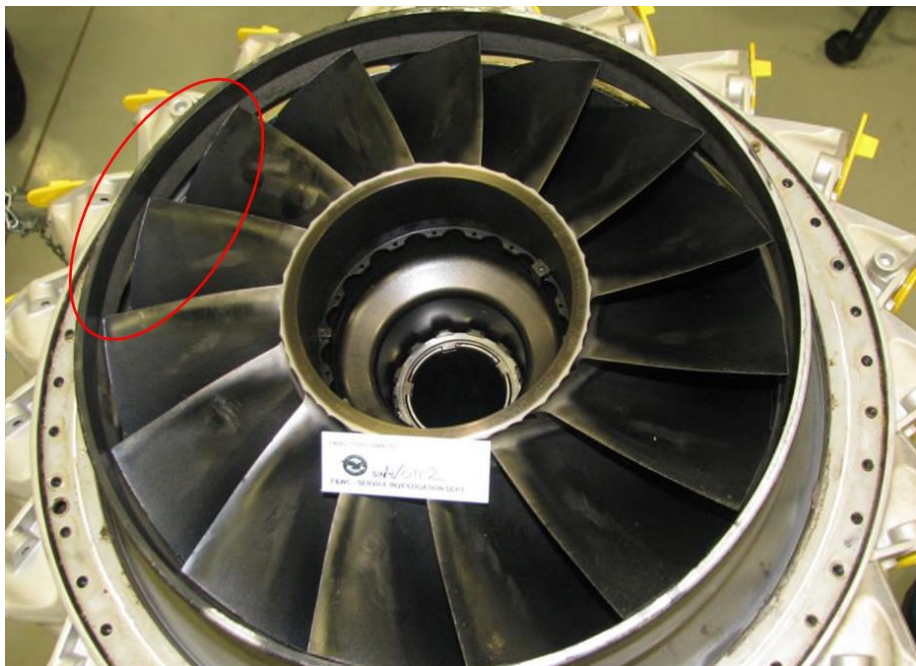
Fig 14

- The LPT blades and stator showed no distress.
- The HPT blades, the HPT stator and combustion liners showed only operational wear.
- The PT shaft showed no intershaft rubbing.
- The LP impeller was oil wetted and showed no evidence of FOD. However airfoil rubbing contact was observed resulting in the raised edges of the impeller airfoils (circled, Fig 14).

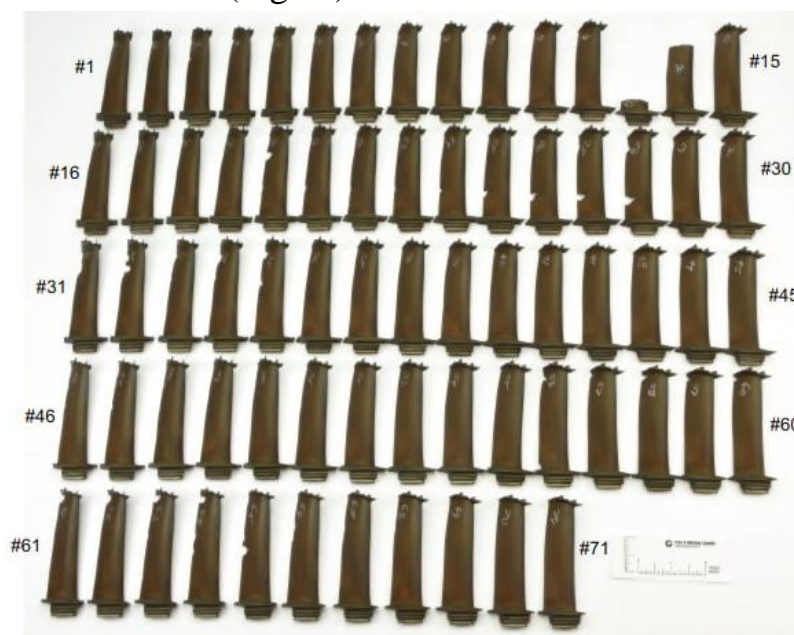
- Two of the 2nd stage PT blades were fractured. One of the fractured PT2 blades (P/N 3118204-01) was fractured near the platform and exhibited a small flat

- The fractured blade indicated as blade No. 13 in Fig 15 showed a fractured airfoil at approximately 0.4 inches above the platform on the leading edge (L/E) side. A relatively flat topography with evidence of beach marks and river lines indicative of fatigue cracking was observed at the L/E region. The fatigue region was also observed to occupy a relatively small surface area compared to the overload fracture (Fig 16).

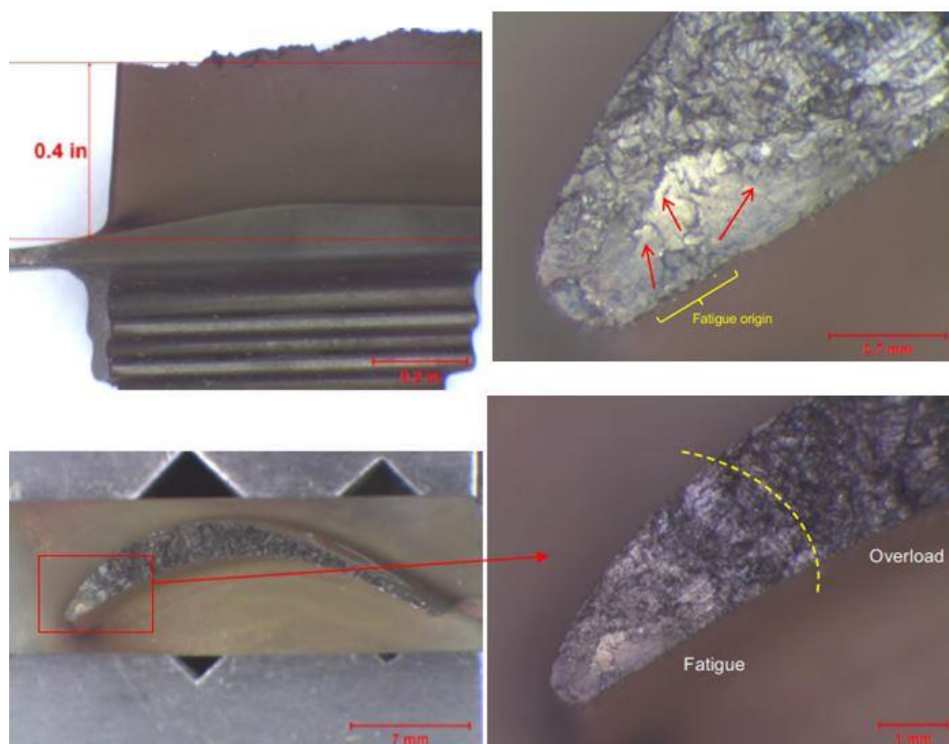
Fig 16

- The fatigue origin initiated along the leading edge on the pressure side of the airfoil propagating towards the suction side and trailing edge (Fig 16)
- Scanning electron microscope examination of the fracture origin region showed an oxidised surface along the pressure side surface (bracket) as well as the leading edge (Fig 17).

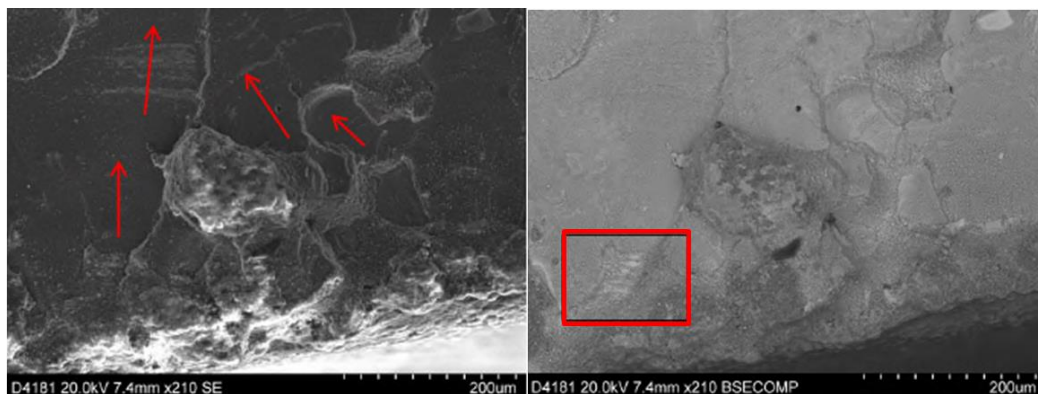
Fig 18

- SEM examination at higher magnification showed the crack propagation (arrows) was emanating from an oxidised region. SEM backscattered electron - energy dispersive spectroscopy (EDS) within the oxidised origin region revealed the presence of a Niobium rich phase.(Fig 18)

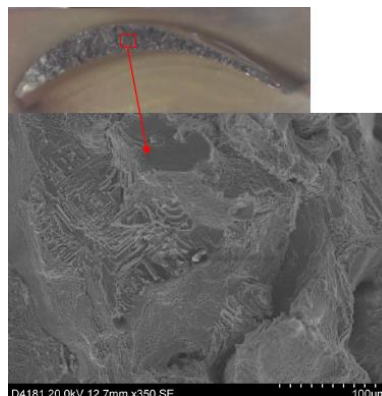
Fig 19

- SEM examination of the fracture surface away from the fatigue propagation exhibited features consistent with fracture by overload (Fig 19).

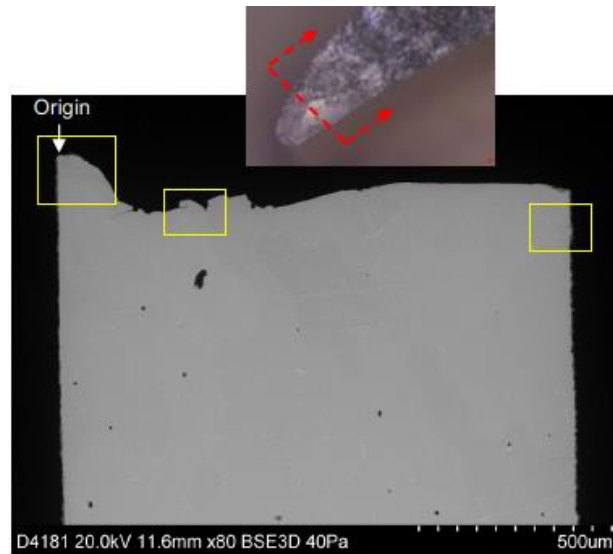
Fig 20

- A metallographic transverse cross-section through the origin area as indicated by the inset in Photo No. 35 was examined by SEM (Fig 20).

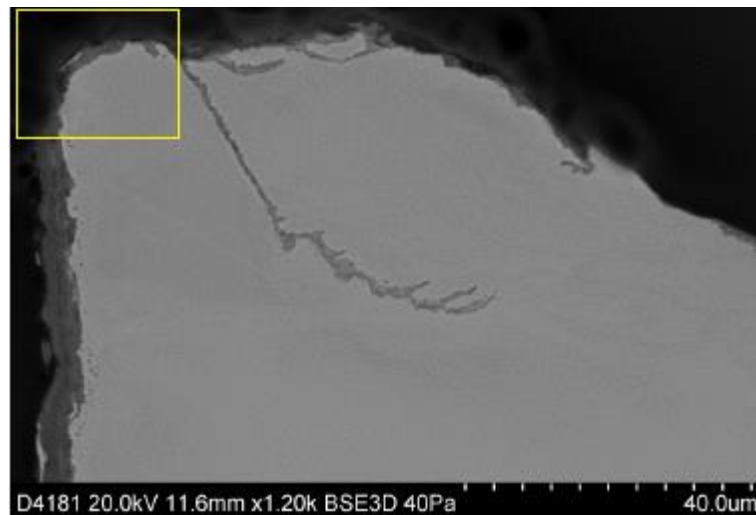
Fig 21

- SEM examination at higher magnification of the boxed region at the origin in Fig20 showed the presence of an oxidized layer / corrosion along the leading edge and on the fatigue origin region of the fracture surface (Fig 21). A secondary oxidized crack connected to the fracture surface was also observed in the region of the fracture origin.

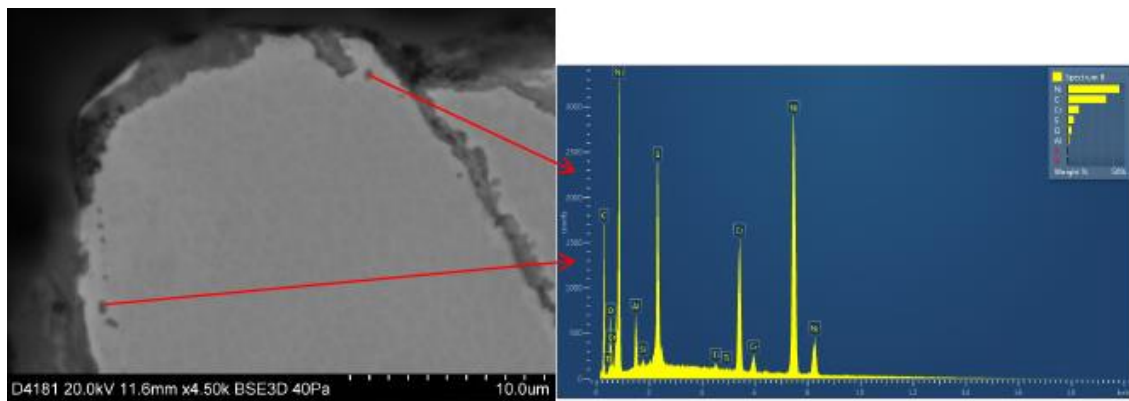
Fig 22

- SEM examination at higher magnification of the boxed region at the origin in Photo No. 36 showed the presence of a few Sulphur and Chromium rich precipitates ahead of the oxidation layer / corrosion front along the leading edge and fracture surface, which is indicative of sulphidation (Fig 22). Although the cause of the fatigue crack initiation could not be determined with certainty the

presence of sulphidation may have been a contributing factor to the fatigue crack initiation process.

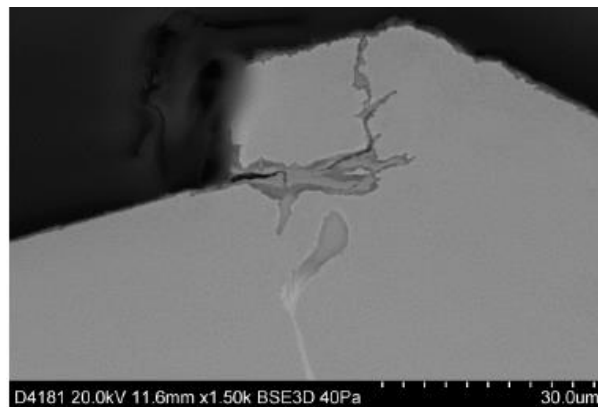
Fig 23

- The crack shown in the middle yellow box in Fig 20, adjacent to the fatigue origin region, exhibited an oxidised crack associated to a Niobium rich phase (Fig 23) most likely as an interdendritic complex carbide based on the SEM - EDS analysis results.

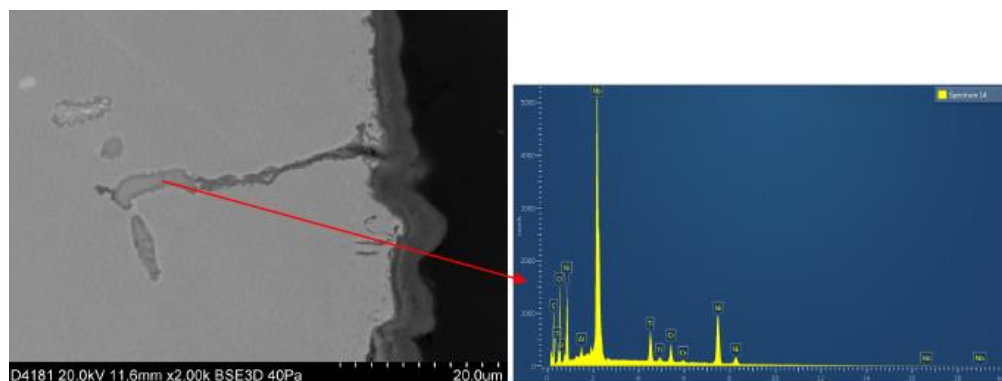
Fig 24

- SEM examination at higher magnification of the boxed region away from the fracture surface along the suction side of the airfoil as indicated by the boxed region on the right side of the airfoil in Fig 21 showed the presence of an oxidised crack associated with a Niobium-rich phase (Fig 24).

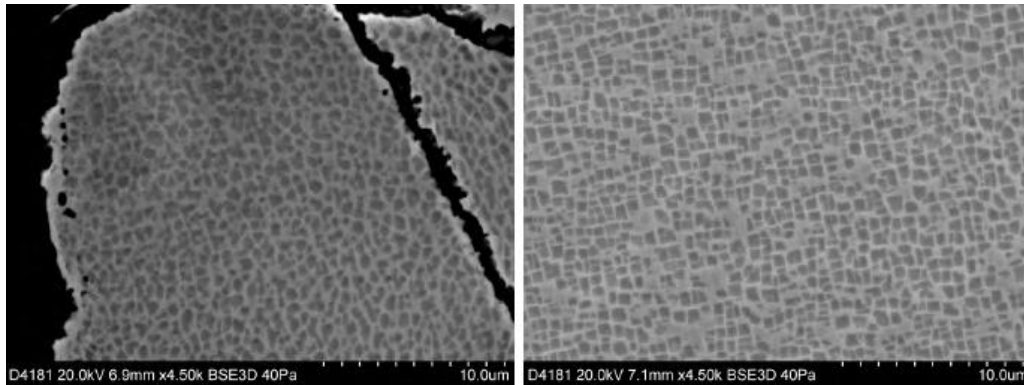
Fig 25

- SEM examination of the microstructure underneath the fracture surface showed slightly rounded gamma prime precipitates (left side, Fig 25) compared to quasi-cuboidal gamma prime precipitates in the root area (right side, Fig 25). This indicates an essentially unaffected microstructure.

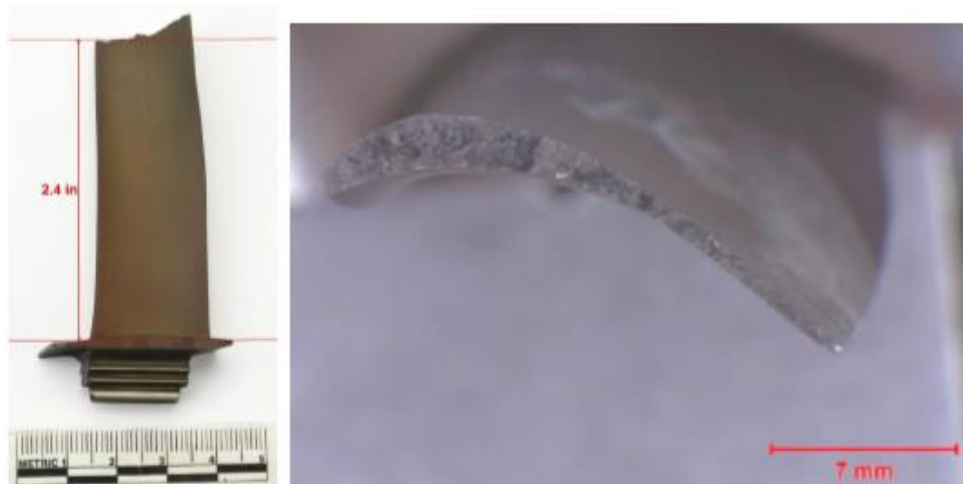
Fig 26

- SEM-EDS standard less semi quantitative analysis of the base material on a polished surface of blade No. 13 showed that the proportions of the major elements detected were consistent with the drawing material requirements.
- Examination of fractured blade No. 14 (left side, Fig 26) showed the blade had fractured approximately 2.4 inches above the platform. The fracture surface morphology was indicative of fracture by overload (right side, Fig 26). No evidence of fatigue was observed.

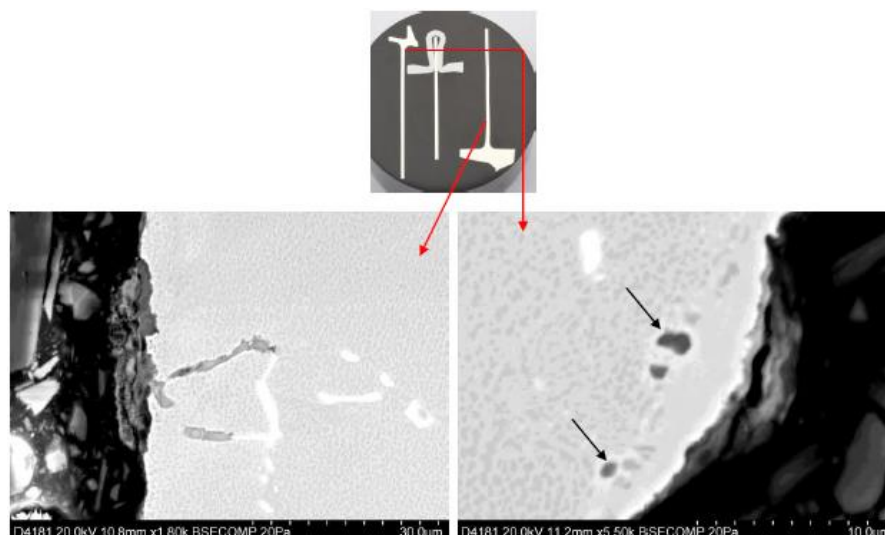
Fig 27

- Blade No. 42 was sectioned longitudinally for over temperature microstructural evaluation along the trailing edge (inset, Fig 27). The cross-section revealed an essentially unaffected microstructure consisting of quasi-cuboidal gamma prime precipitates in a gamma matrix with carbides. No evidence of any over temperature was observed. The presence of Type I sulphidation (left image, Fig 27) which followed an inter - dendritic path due to the presence of an elongated Niobium-rich phase, was observed at approximately the same height as the fracture of Blade No.

13. The Type I sulphidation was confirmed with the presence of Chromium Sulphides (black arrows, right image, **Fig 27**).
