**FINAL REPORT OF SERIOUS INCIDENT OF MYANMAR NATIONAL
AIRLINES EMBRAER-190 (Reg: XY-AGQ) AND
MANNYADANARPON AIRLINES ATR-72-212A (Reg: XY-AJP) AT DAWEI
DOMESTIC AIRPORT ON JUNE, the 25th, 2016**

SYNOPSIS

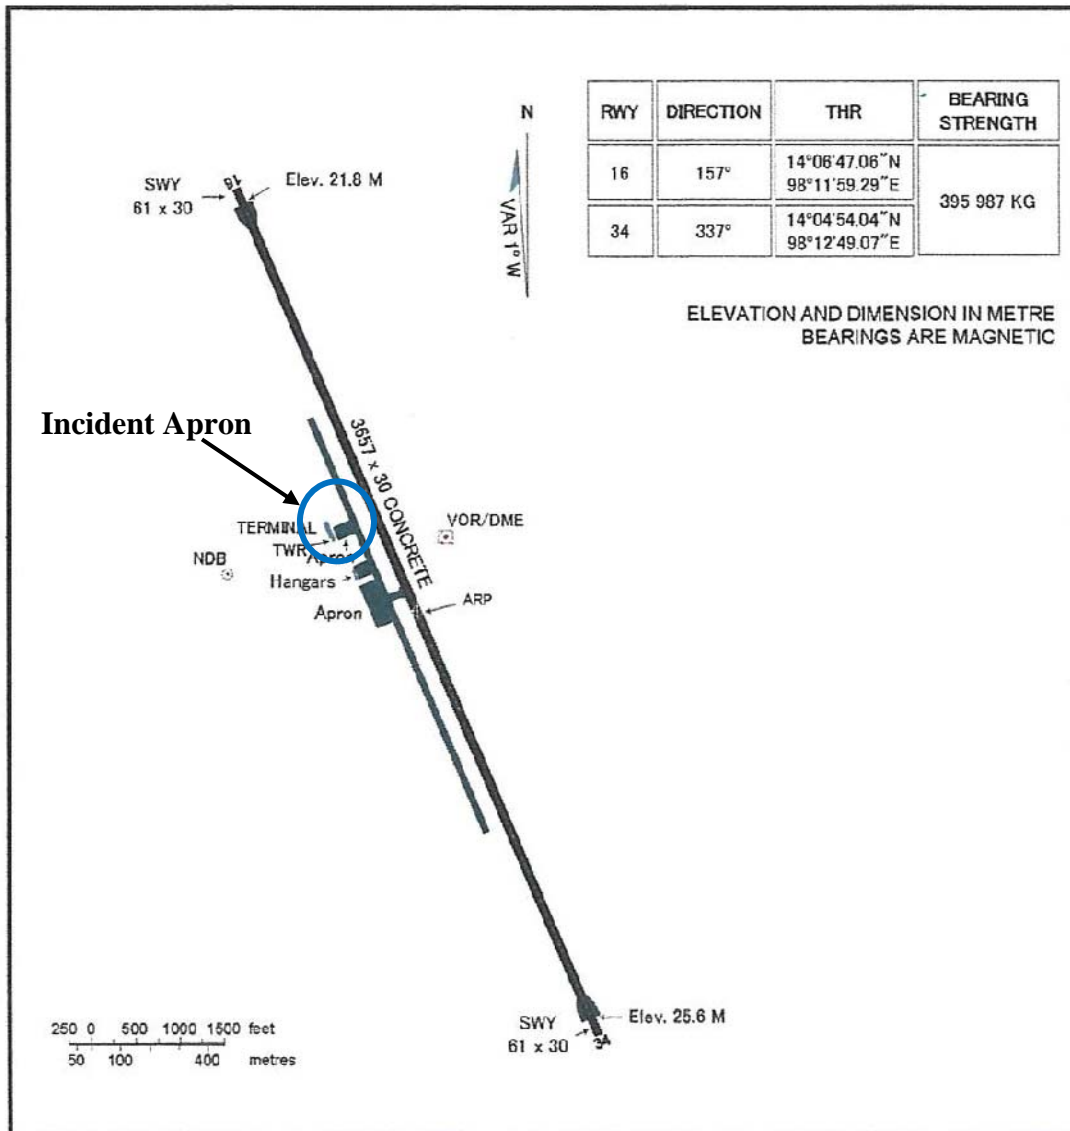
Figure: 1 Layout of Incident Site

As shown in **Figure 1** the old runway had been used as a taxiway which had connected to the aprons. No taxiway markings, aircraft stand markings and apron safety lines existed on the so-called taxiway and the incident apron.

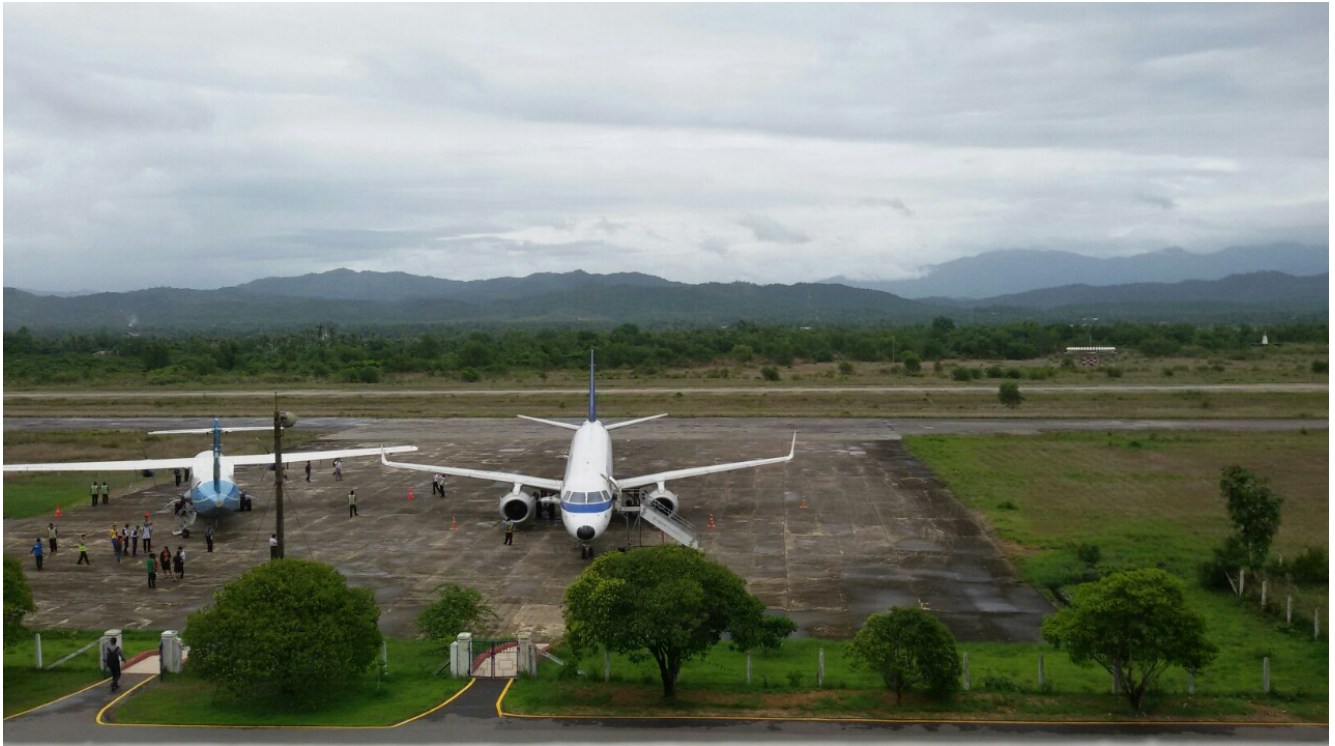
Figure: 2 Layout of Incident Site

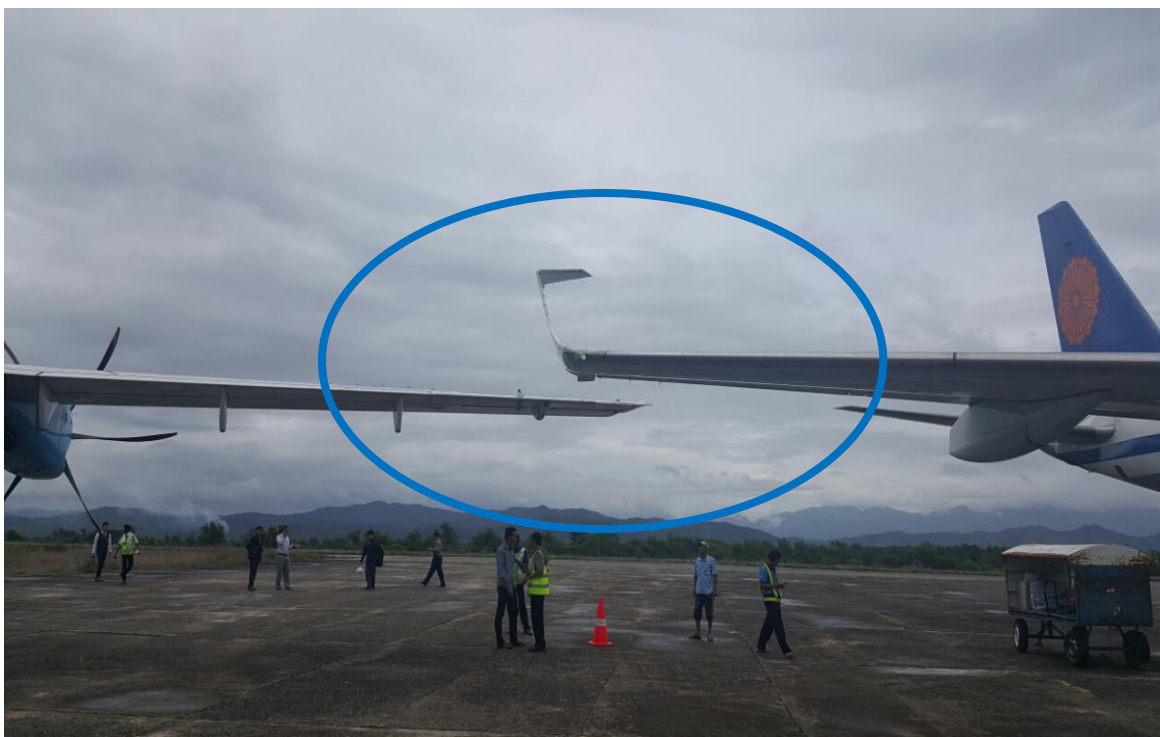
The R/H Winglet was broken.

- (a) The R/H Wing Tip was broken.
- (b) The Aileron attachment rib of R/H Wing was broken.
- (c) The lower and upper skin of R/H Wing was damaged.

Figure: 3 Overview of damages to both aircraft

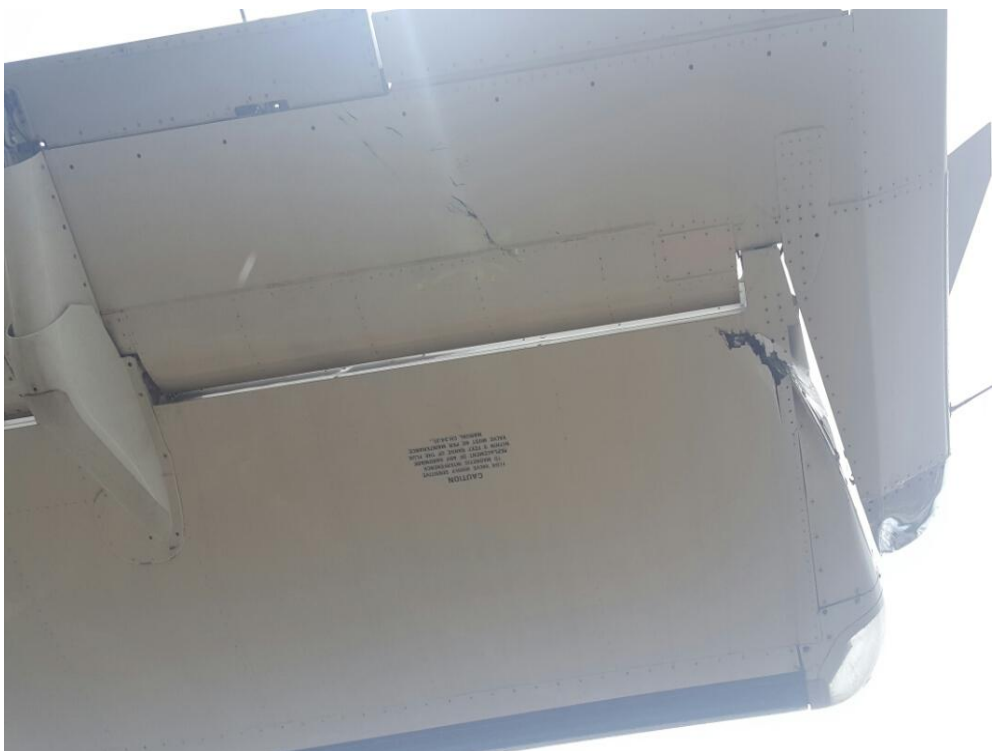
Figure: 4 The damaged aileron of the RH wing of the ATR-72-212A (600 version) aircraft

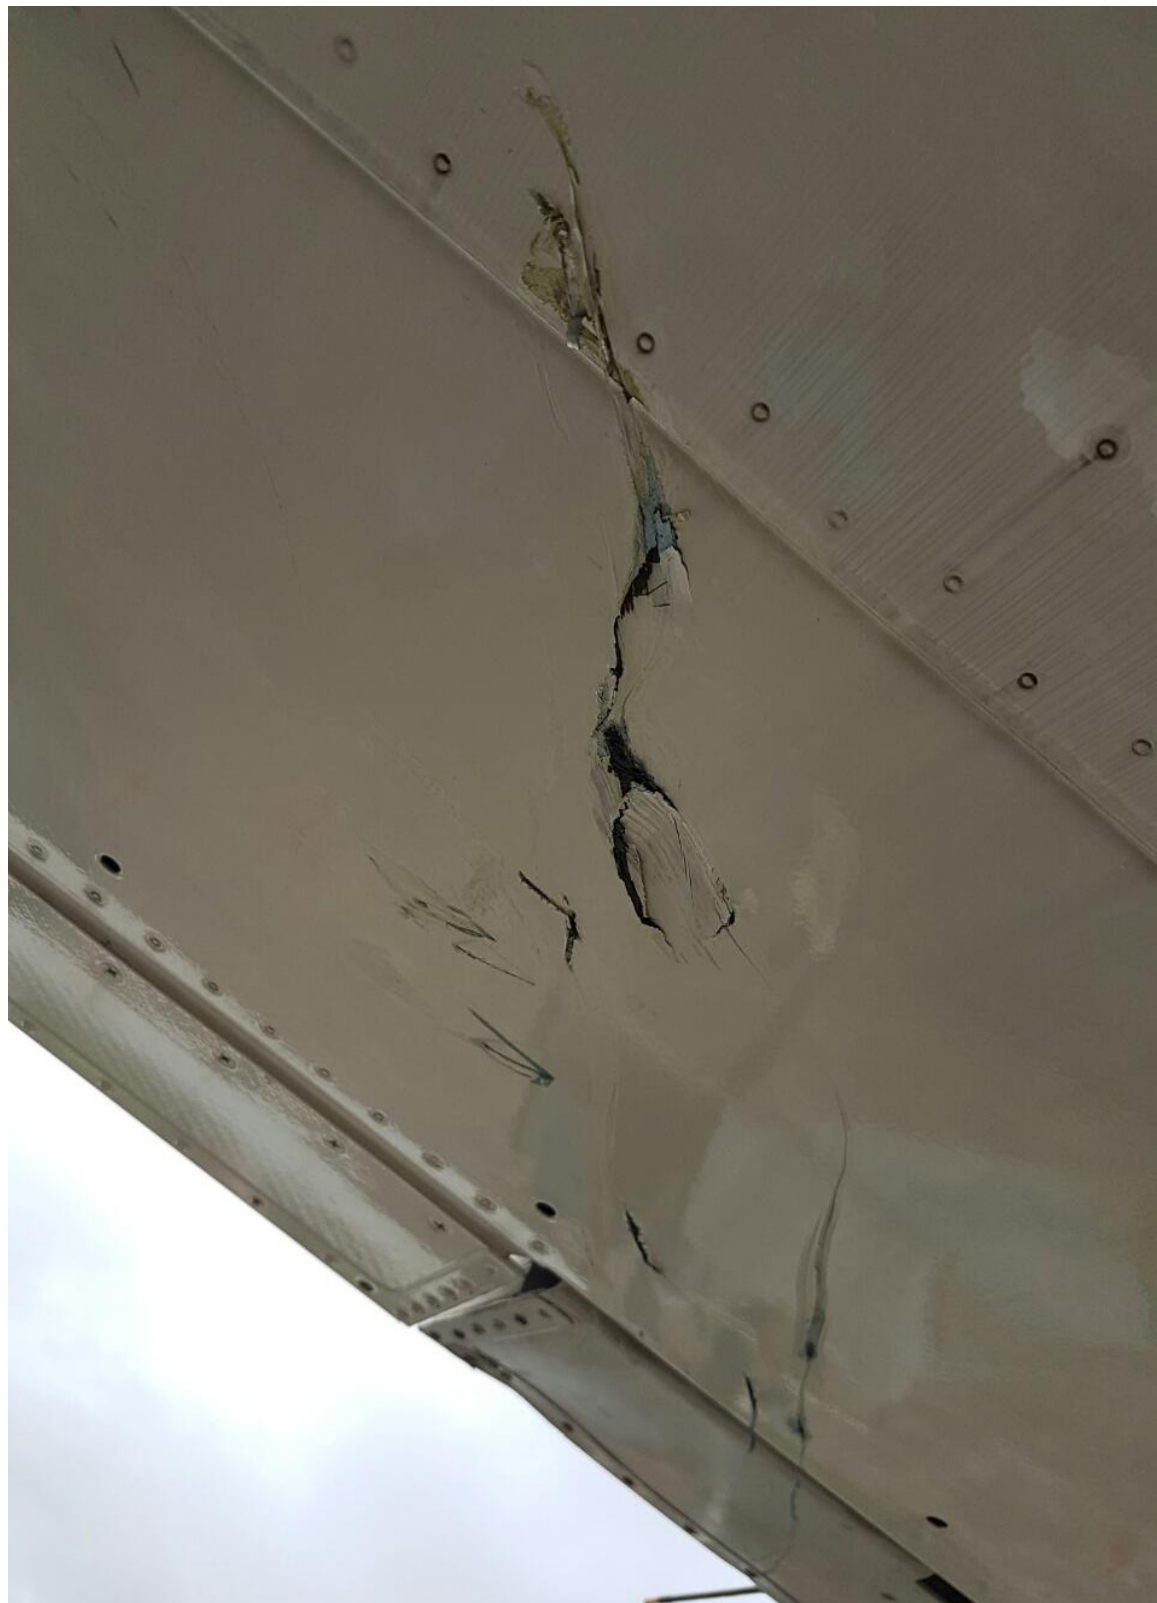
Figure : 5 The damaged lower skin of the RH Wing of the AT -72-212A (600 version) aircraft

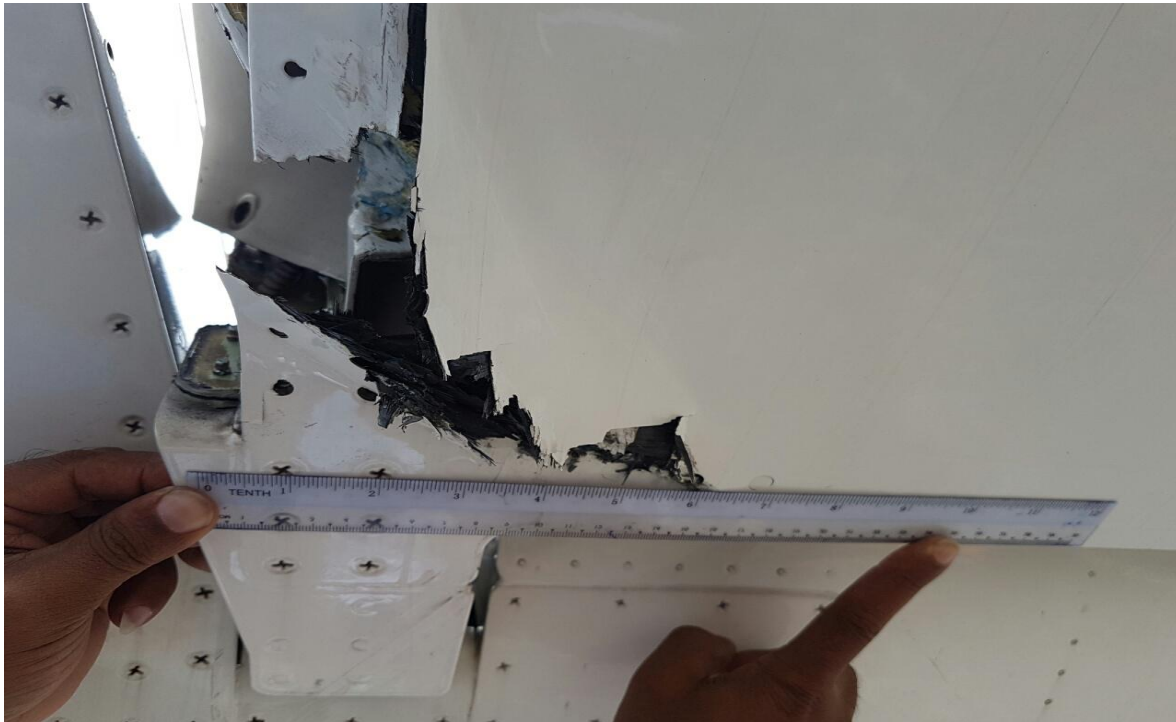
Figure: 6 The damaged lower skin of the RH Wing of ATR – 72-212A (600 version) aircraft

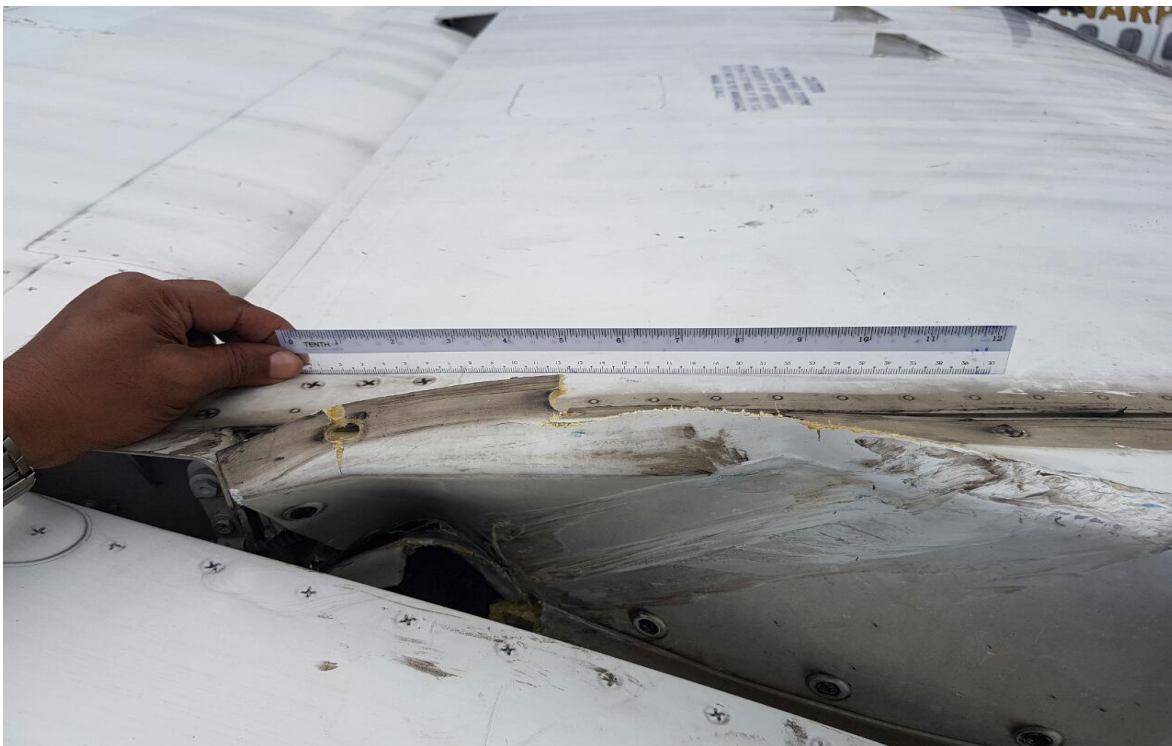
Figure: 7 The damaged upper skin of the RH Wing of ATR – 72-212A (600 version) aircraft

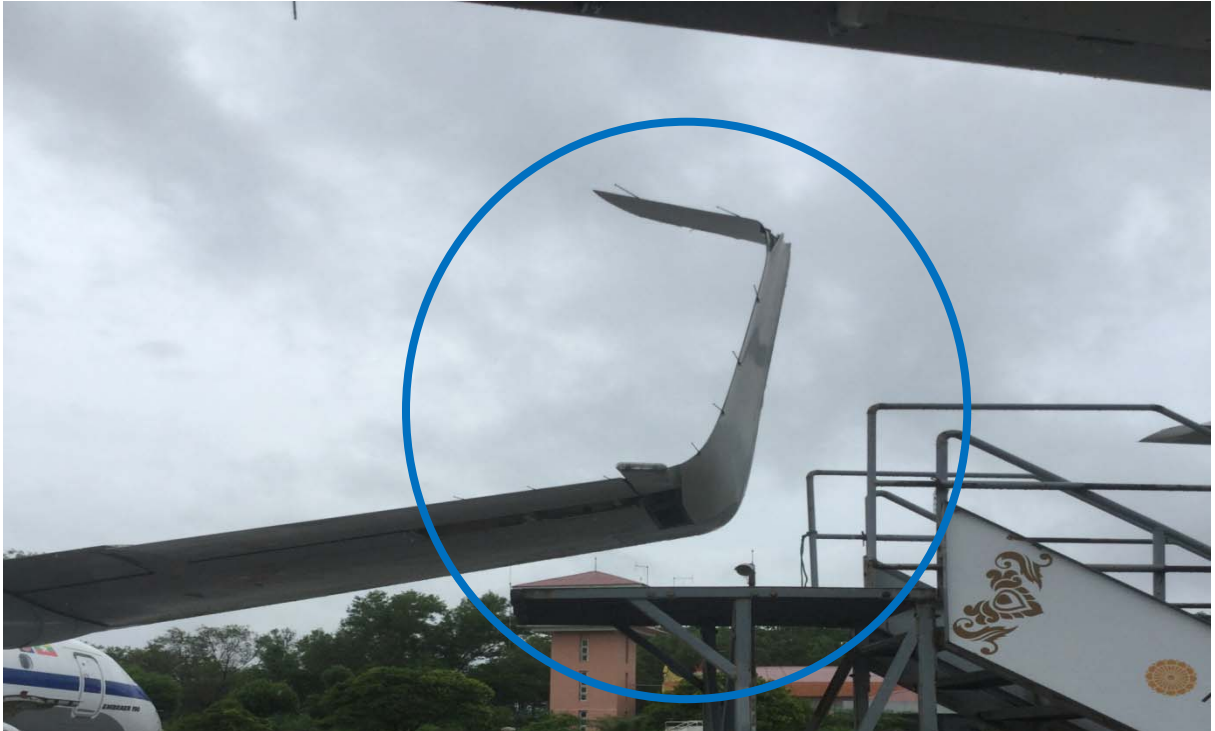
Figure: 8 The broke winglet of the RH Wing of the Embraer-190

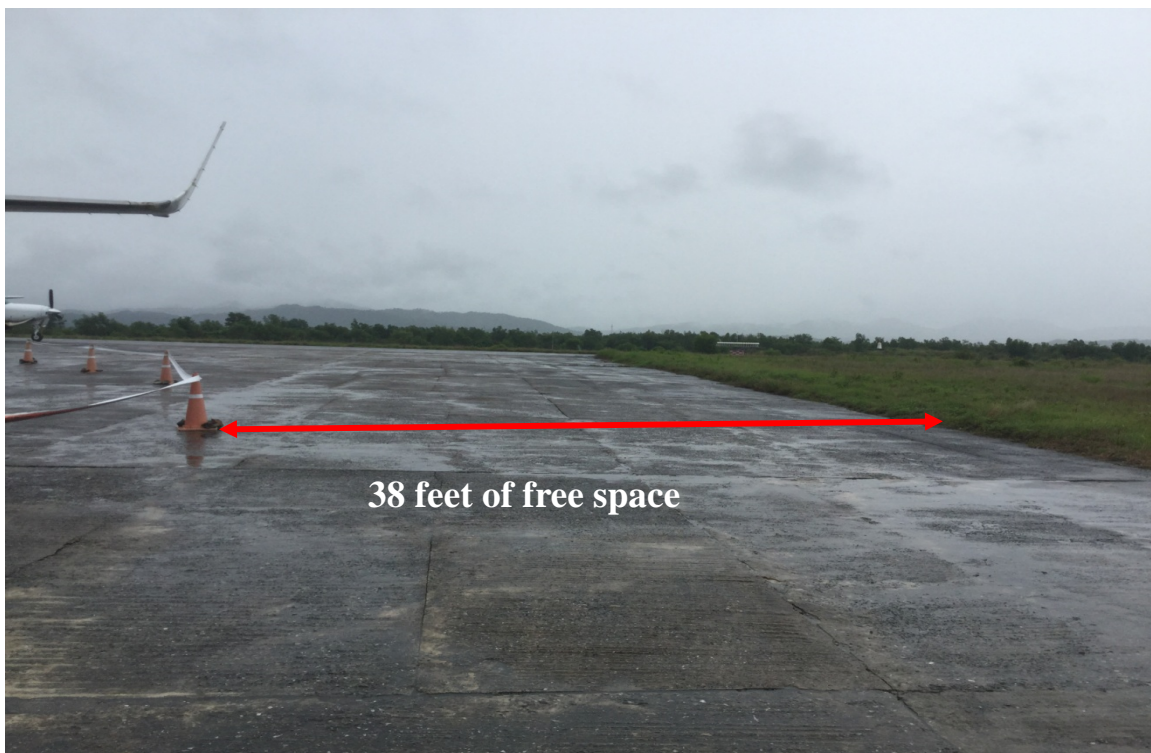
Figure: 9 Available space from the wing tip of the Embraer-190
