Aircraft Accident Investigation Board (AAIB)

Incident Investigation Final Report

State File Number: 950524EPTTA
Type of Occurrence: Serious Incident
Date of Occurrence: August 13, 2016
Place of Occurrence: Tehran Mehrabad Airport
Aircraft Type: A320
Registration: EP-TTA
Operator: Atrak Airlines

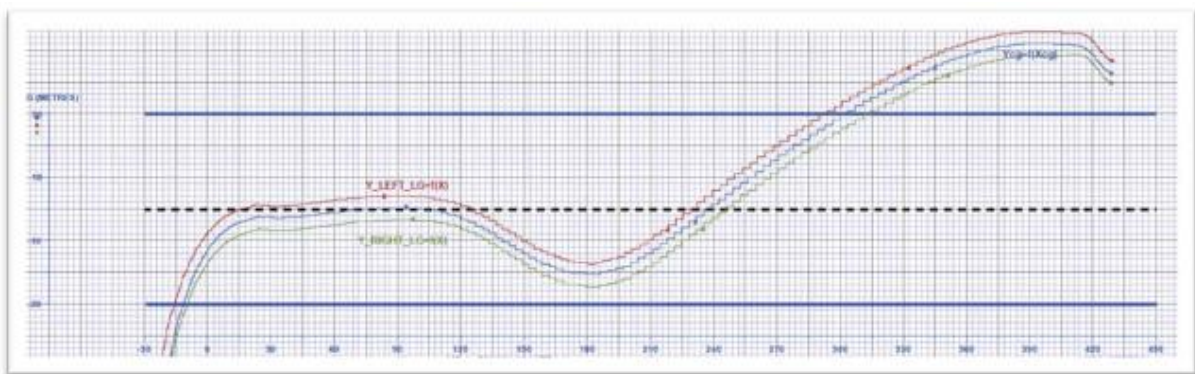
AIRCRAFT TRAJECTOGRAPHY

As per computed trajectography, the aircraft exited the runway at about 300m after runway threshold and 47m from the runway centerline.

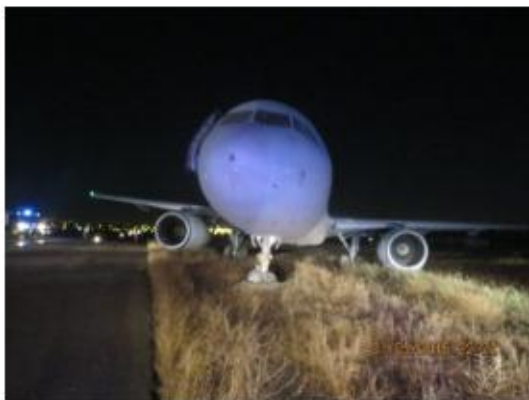
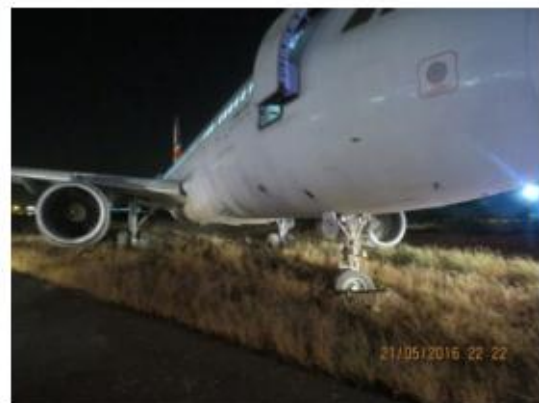
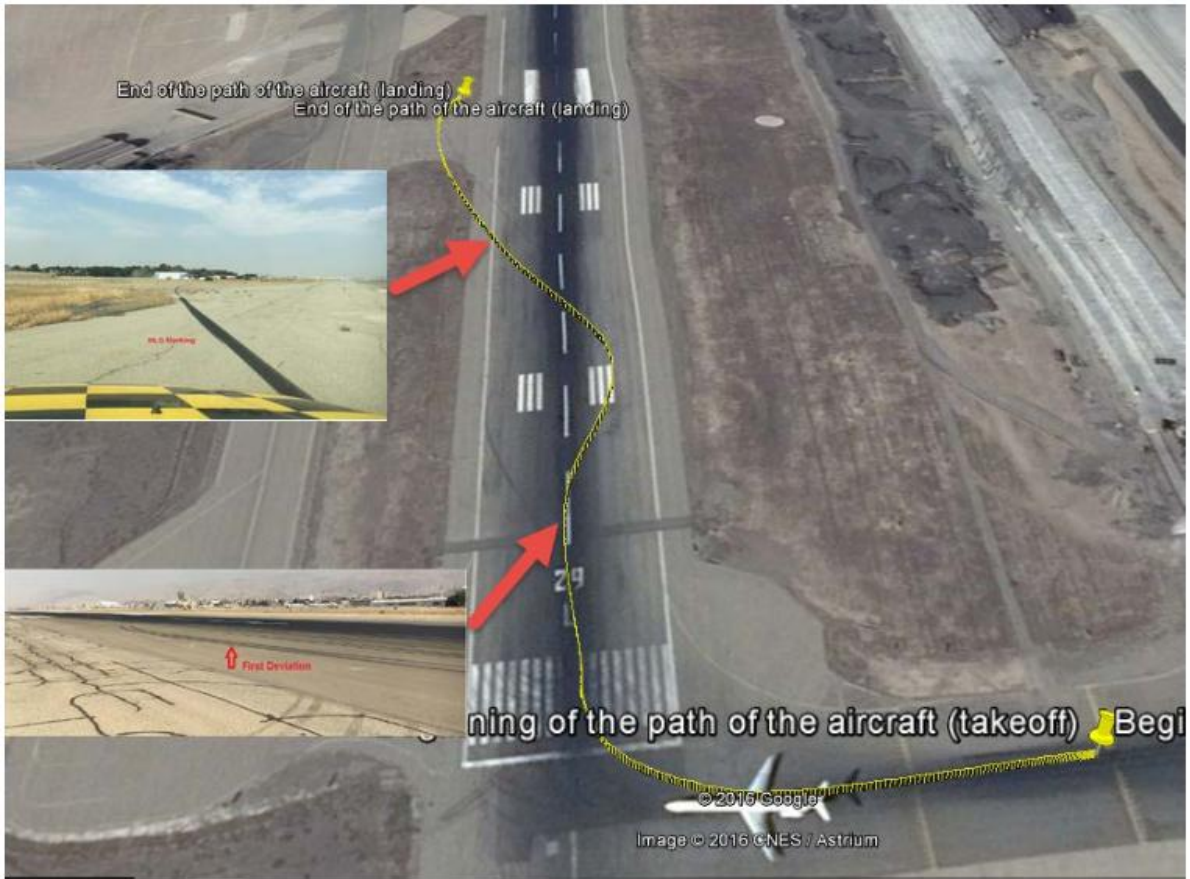
Finally the aircraft stopped in the soil area out of the RWY and the pilot requested stand to evacuate the passengers.

Below is the trajectory and provided photographs of the incident site which are taken shortly after the event.

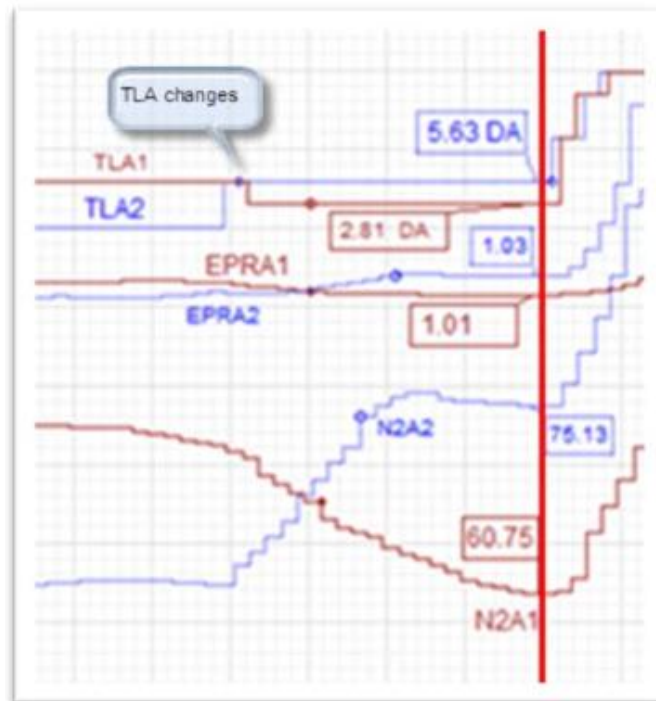
A. ALIGNMENT TO RUNWAY

The aircraft completed its taxi on to the runway, coming to a standstill once aligned with the runway centerline. TLA1 was reduced to 2.81° while TLA2 was increased to 5.63°, resulting in respective changes in engine N2A and EPR parameters. Ground speed remained zero during these TLA changes.

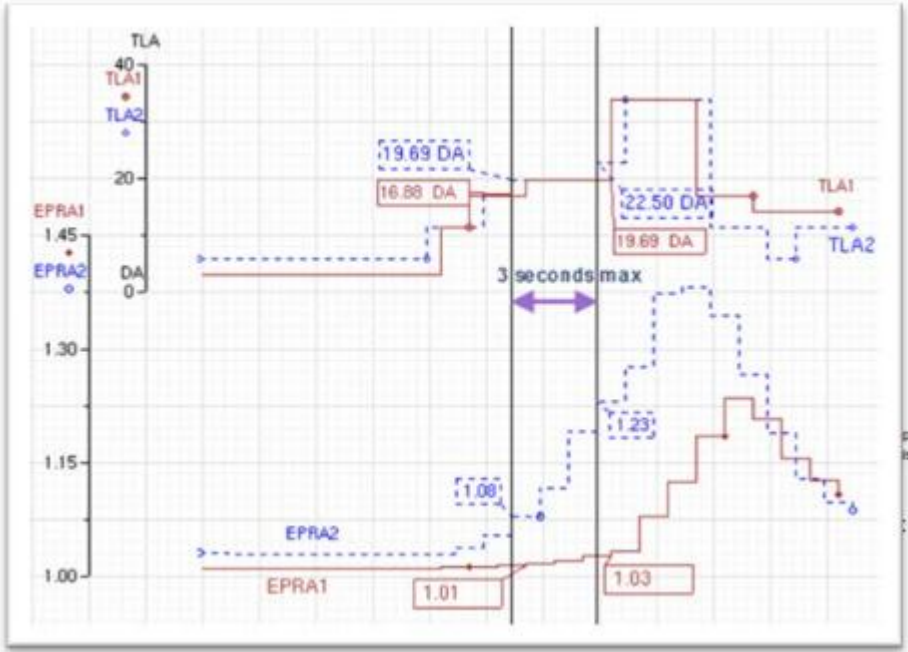
Both TLAs were advanced, pausing momentarily for between 2s and 3s (taking into account the sampling rate) at 20°, just before the Climb gate. During that time, EPRA1 increased from 1.01 to 1.03 while EPRA2 increased from 1.08 to 1.24.

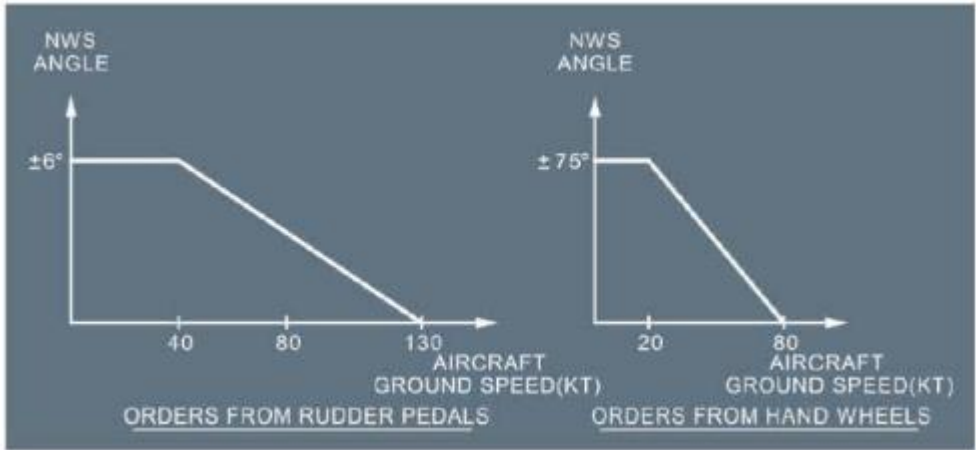
During the event, the ground speed did not exceed 31kt, therefore rudder deflection would not have any influence on the aircraft handling. However rudder pedal inputs would also be directed to the nose wheel steering. Below 40kts, this is upto +/- 6°

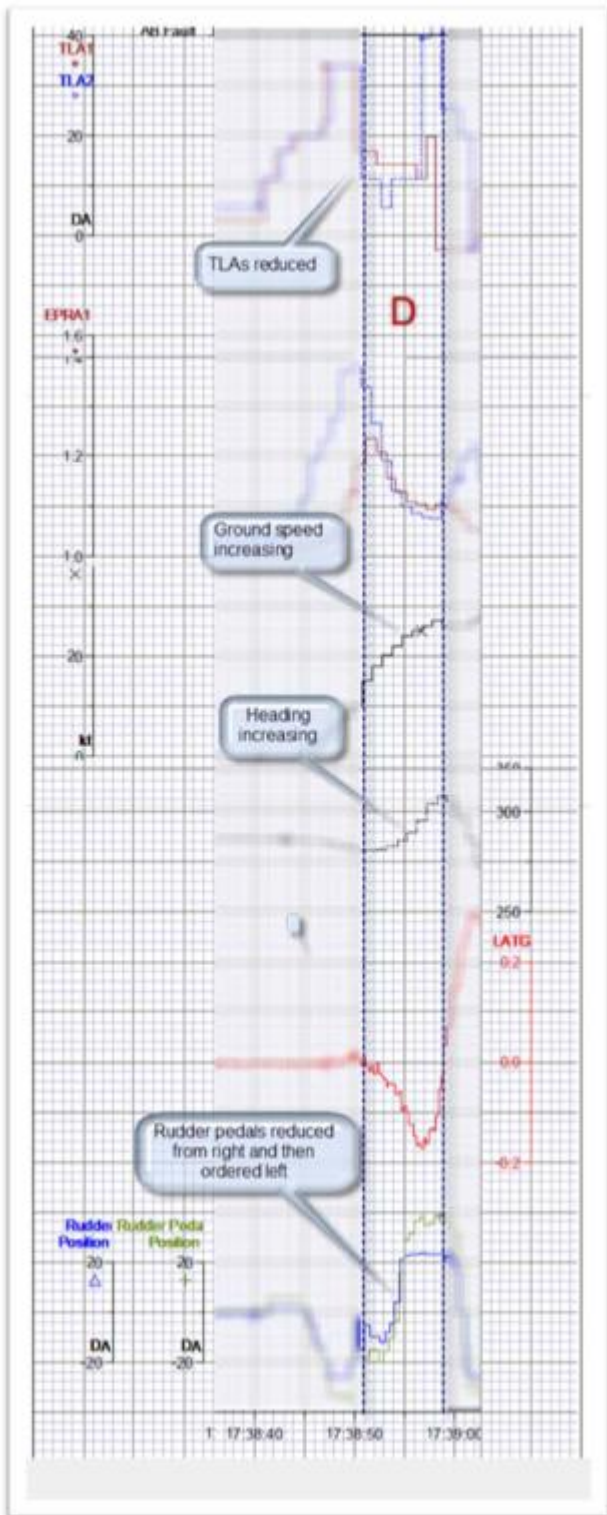
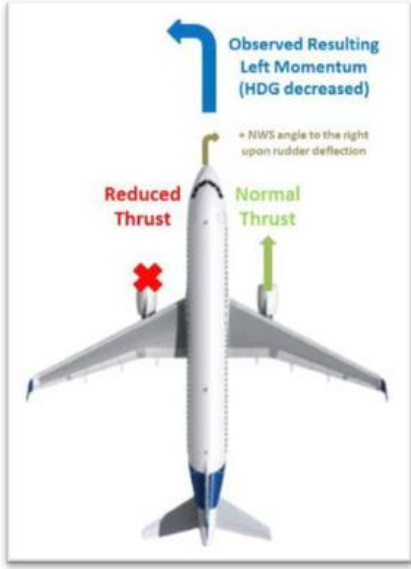
As the aircraft started to move forward, the heading decreased (aircraft turning towards the left). A thrust dissymetry leads to a yawing moment towards the engine with the lowest thrust. Rudder pedal deflection resulted in the NWS steering to the right hand side to counter the veer towards the left. The overall result is a slight left yawing moment, as heading was recorded decreasing.

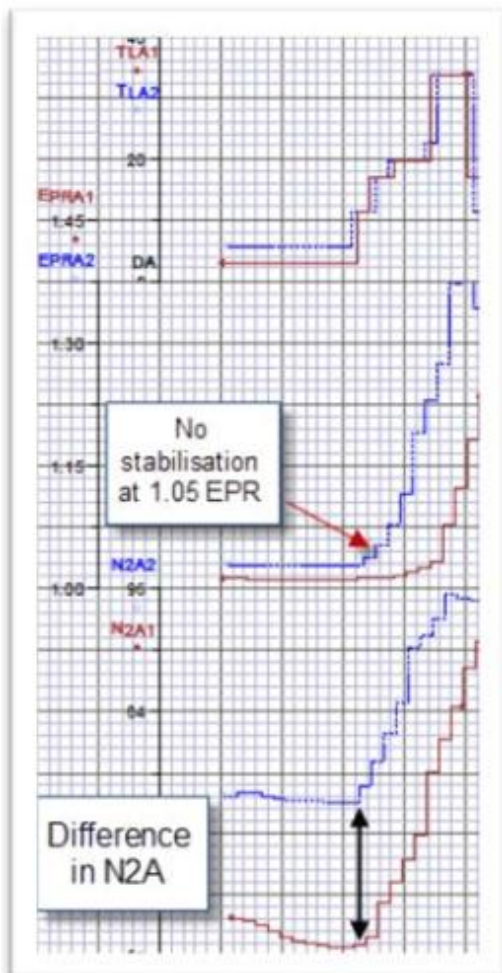
2.3.1 Engine Spool Up:

Following the asymmetric engine spool up, to ensure that there was no engine related issues, an analysis of engine behavior during the event was completed. The graph below presents the N2 vs EPR for both engines compared to the Airbus stabilized model.

Considering the sampling, the use of the stabilized model in transient phase and the engine to engine variability, both engines are consistent with the model, showing no abnormal behavior.

The EPR delta between the engines during the take-off roll is due to the longer acceleration of engine 1, which is normal due to its lower initial N2 level.

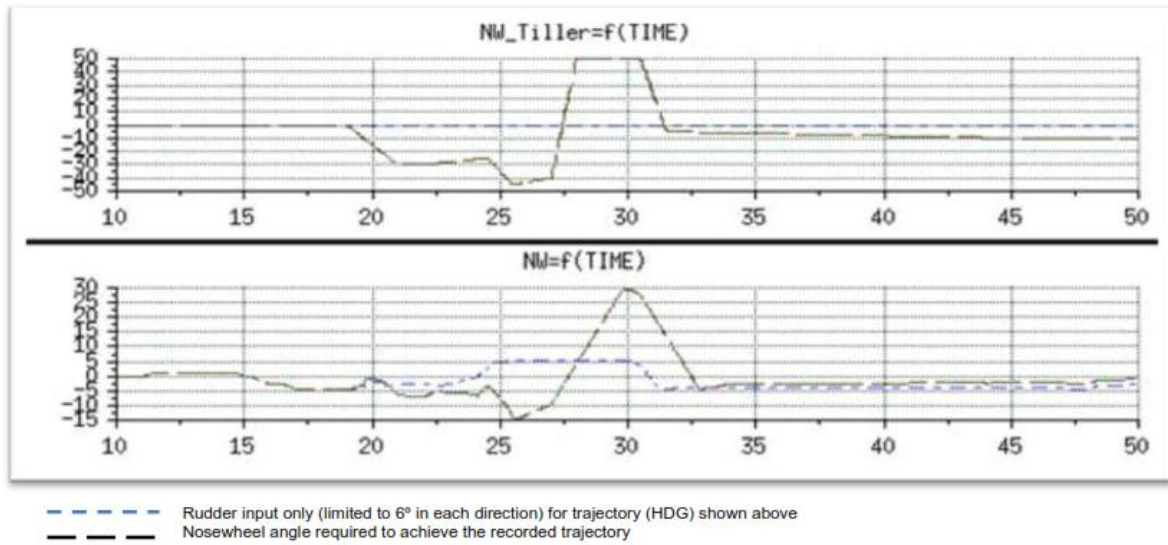
Nose wheel and tiller angles vs time

The above simulation was performed using the Airbus engineering models.

The objective of the simulation was to determine whether the tiller was used, and ascertain the nose wheel steering functionality during the event. The simulation concludes:

- That the actual trajectory is only possible with the use of the NW tiller deflection of the nose-wheel steering is commanded, firstly to the left and then to the right.
