DUTCH
SAFETY BOARD

Cabin crew injured during flight as a result of turbulence

The Hague, June 2018

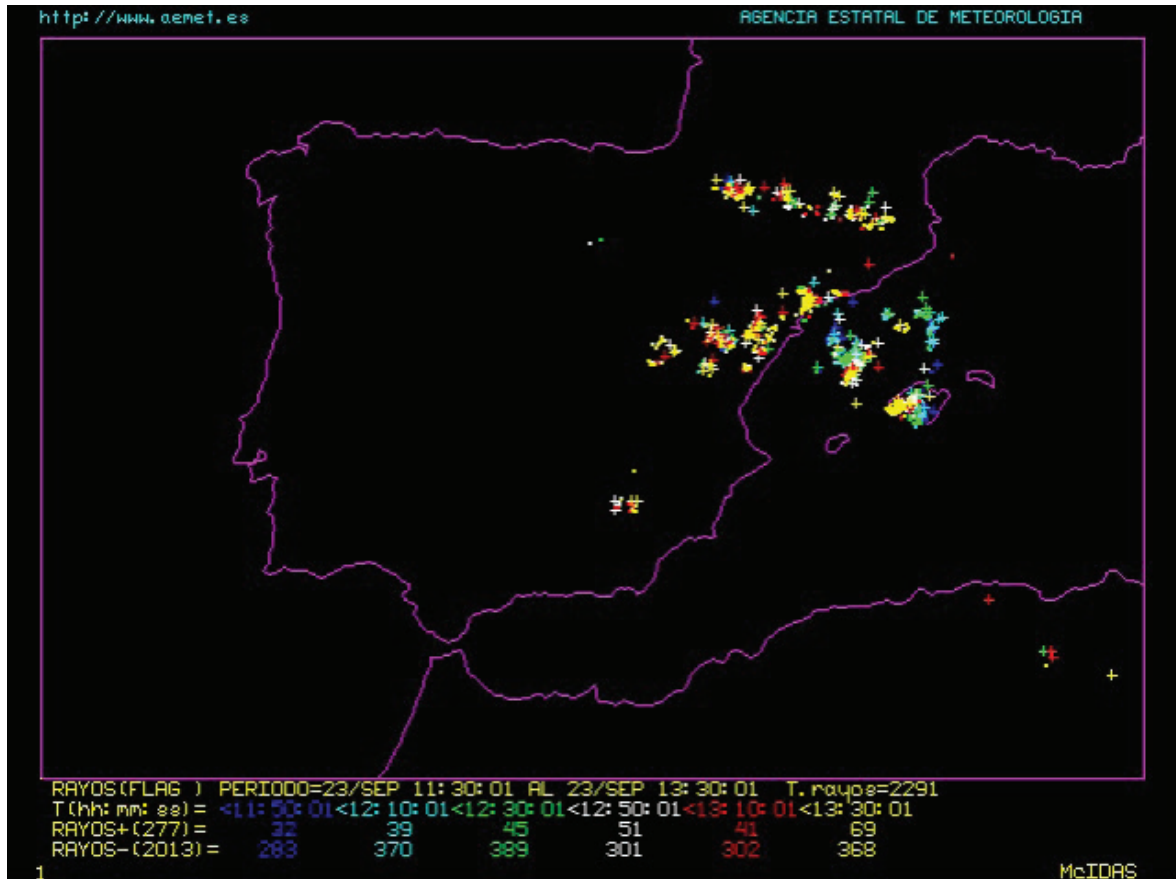
In the area of the occurrence (located north of the island of Mallorca), storm activity was present both in the hours before and immediately around the time of the occurrence, as shown in the aggregate lightning strike images in figure 2. The radar images show a line of activity north of the Balearic Islands, with the highest intensity returns occurring at around 13.20.

Figure 2: Lightning strikes between 11.50 and 13.30 in the area of the flight. (Source: AEMET)

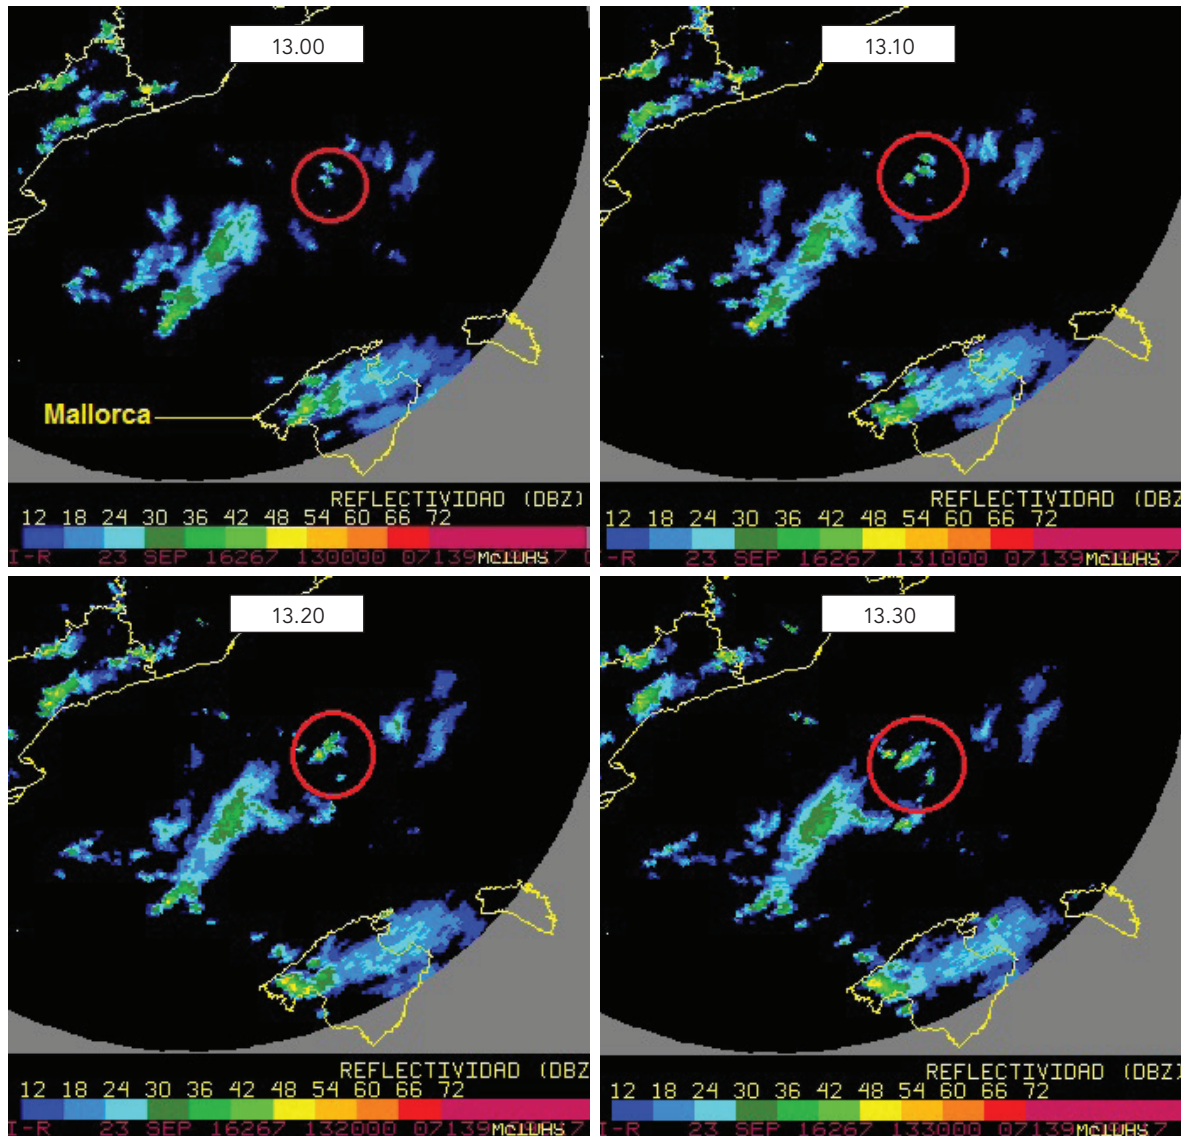
Figure 3 shows the development of clouds in the area of the occurrence between 13.00 and 13.30 in intervals of 10 minutes. In the middle between the two large areas of clouds, which the flight crew saw, a third cloud was developing quickly (in the red circle). The different colors indicate the number of drops per volume unit (dBz).

Figure 3: Radar reflectivity in the area of the incident (red circle) for different time stamps showing the development of the clouds. The colours in the bar correspond to the colours on the radar images and the numbers give an indication of the drops per volume unit (dBz). (Source: AEMET)

The thunderstorm that caused the occurrence developed very quickly. Initially the thunderstorm must have been hardly visible on the weather radar due to low dBz returns.

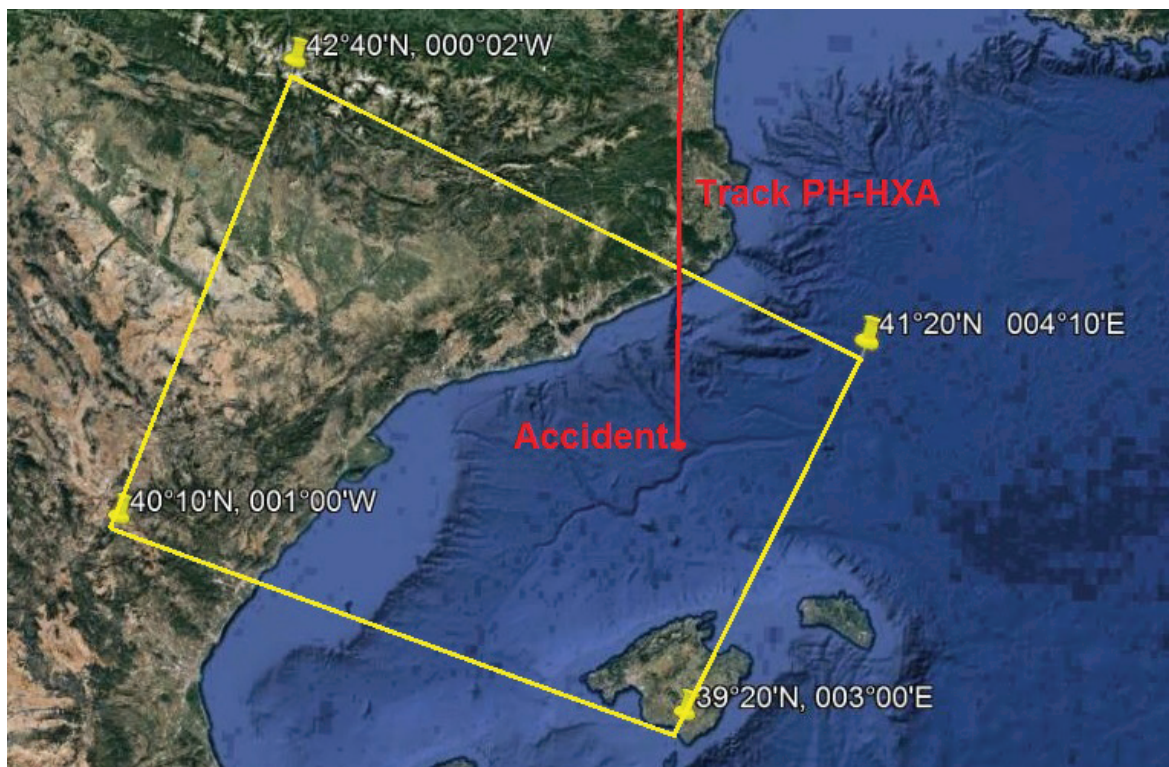
The content of these SIGMETS means: Embedded thunderstorms are observed (SIGMET 4) and forecasted (SIGMET 5) within the defined area with tops up to FL360/380 and intensifying, while remaining stationary.

Figure 6: The area with embedded thunderstorms as mentioned in SIGMET 5 and track of PH-HXA. (Source: Dutch Safety Board)

Because the crew was not aware of the published SIGMETs, containing warning for embedded intensifying thunderstorms in the area of their flight, they were not able to anticipate fully on the hazardous weather situation that could develop over the Balearic Sea.

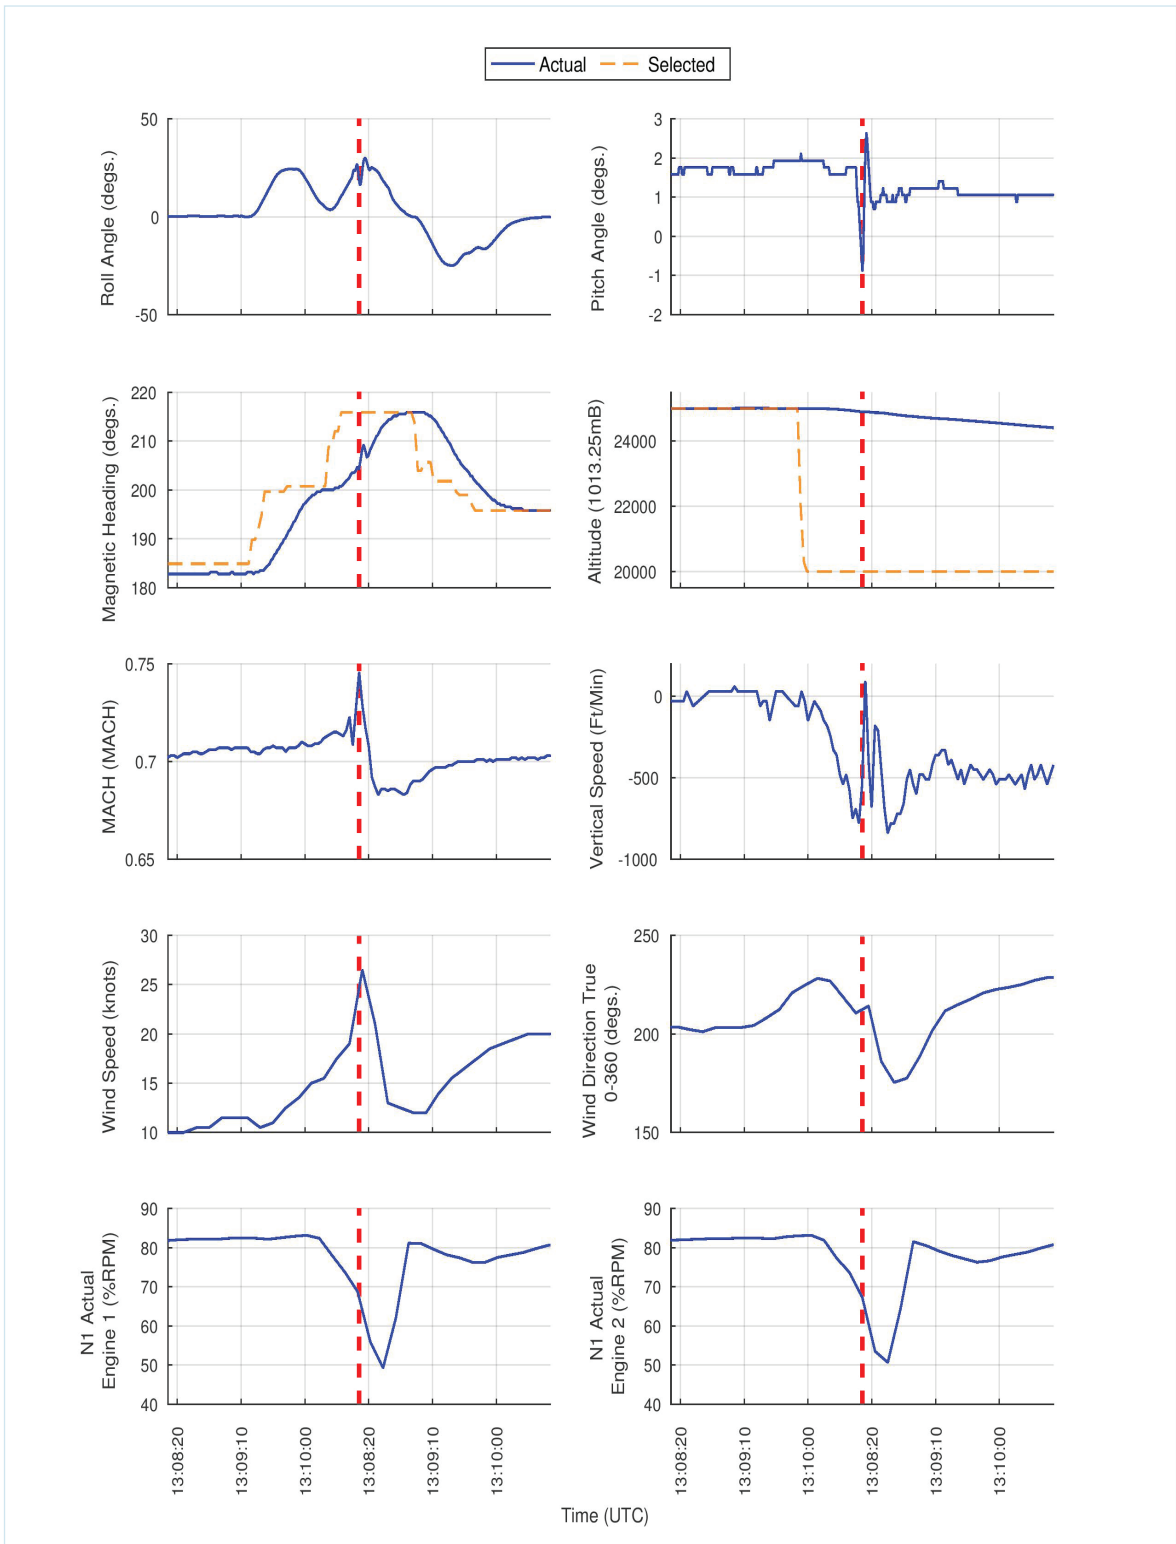
Figure 7: Overview of the aircraft and engine state parameters together with the selected heading and altitude as obtained from the FDR. (The dotted line indicates the moment of the occurrence).

According to the FDR data, at 13.08:20, the aircraft was flying at an altitude of 25.000 ft with zero roll angle and a pitch angle of approximately 1.6 degrees¹⁴. At that time, the aircraft was flying with a magnetic heading of 183 degrees and a Mach number slightly above 0.7. The observed wind speed was approximately 10 kts with a true heading of 203 degrees. Both engines showed a constant speed (i.e. RPM) of 80% N1.

Earlier, at 13.03:04, the aircraft's selected heading was changed from 182 to 185 degrees. At 13.08:42 another series of heading changes was applied; the selected heading was increased to 201 degrees. This led to a change in roll angle (+24 degrees¹⁵), followed by a change of the actual heading. Shortly after this heading change, the selected altitude was set at 25.000 ft from 20.000 ft at 13.08:57. Approximately 14 seconds later the selected heading was changed again, to 216 degrees. At that time the aircraft had already started descending: the altitude decreased to 24.955 ft and vertical speed started increasing in magnitude to end up at approximately 750 ft/min.

Moments before the occurrence, the wind speed started picking up from 10 to 15 kts, and later from 15 to 20 kts. Wind direction changed slightly to approximately 220 degrees. Also, the measured Mach number increased to 0.72.

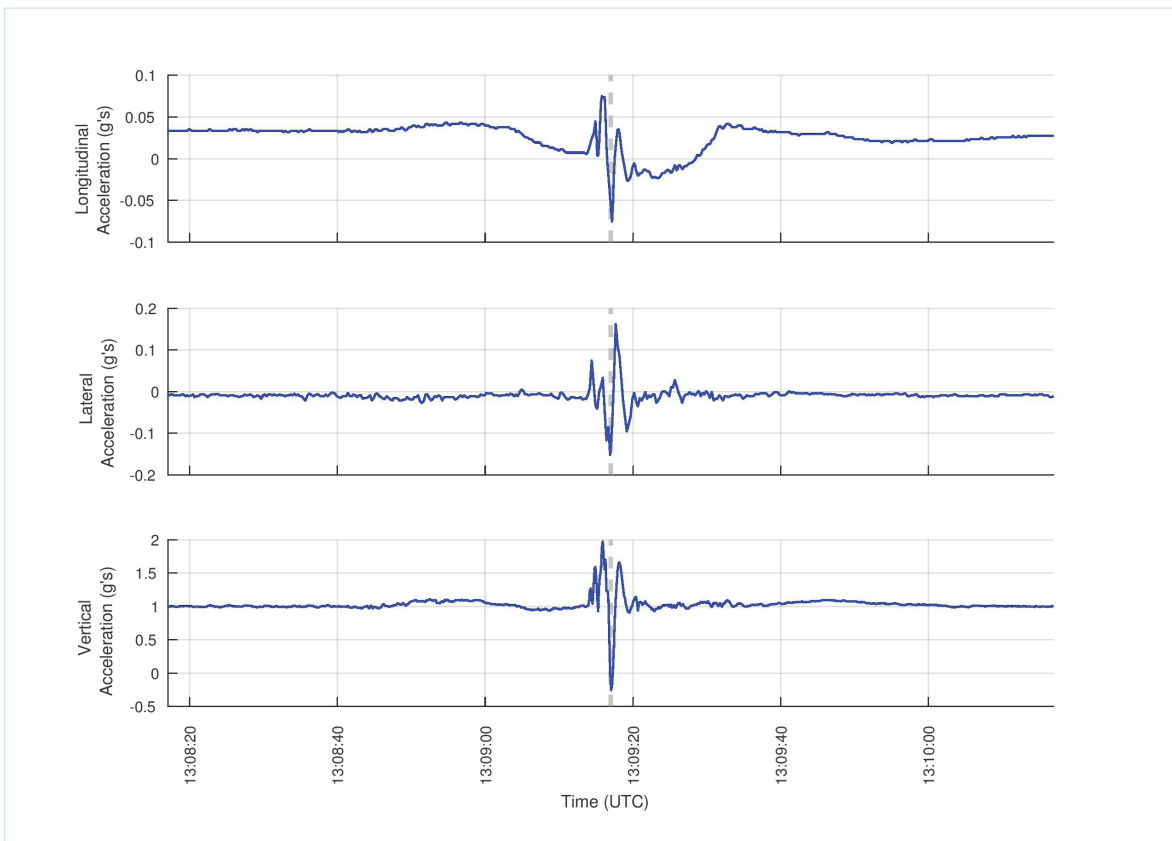
Figure 8: Aircraft (body) accelerations as measured during the incident. (The dotted line indicates the moment of the accident).

According to the FDR data, a series of large peaks in vertical acceleration were observed between 13.09:14 and 13.09:23. Initially, at 13.09:14, vertical acceleration¹⁶ shortly increased to 1.26g¹⁷. One second later, a vertical acceleration of 1.59g was measured. The largest magnitude peak in vertical acceleration was observed at 13:09:16, with a value of approximately 1.97g. Finally, after momentarily experiencing an upward acceleration (-0.2g at 13:09:17), another large magnitude peak in vertical acceleration with a value of 1.66g was observed at 13.09:18.

During the series of large magnitude peaks in vertical acceleration, a number of peaks were also observed in longitudinal¹⁸ and, more significantly, in lateral¹⁹ acceleration. The lateral acceleration showed recorded values ranging between -0.15g and 0.16g, with the latter peak occurring simultaneously with the 1.66g measurement in vertical direction.

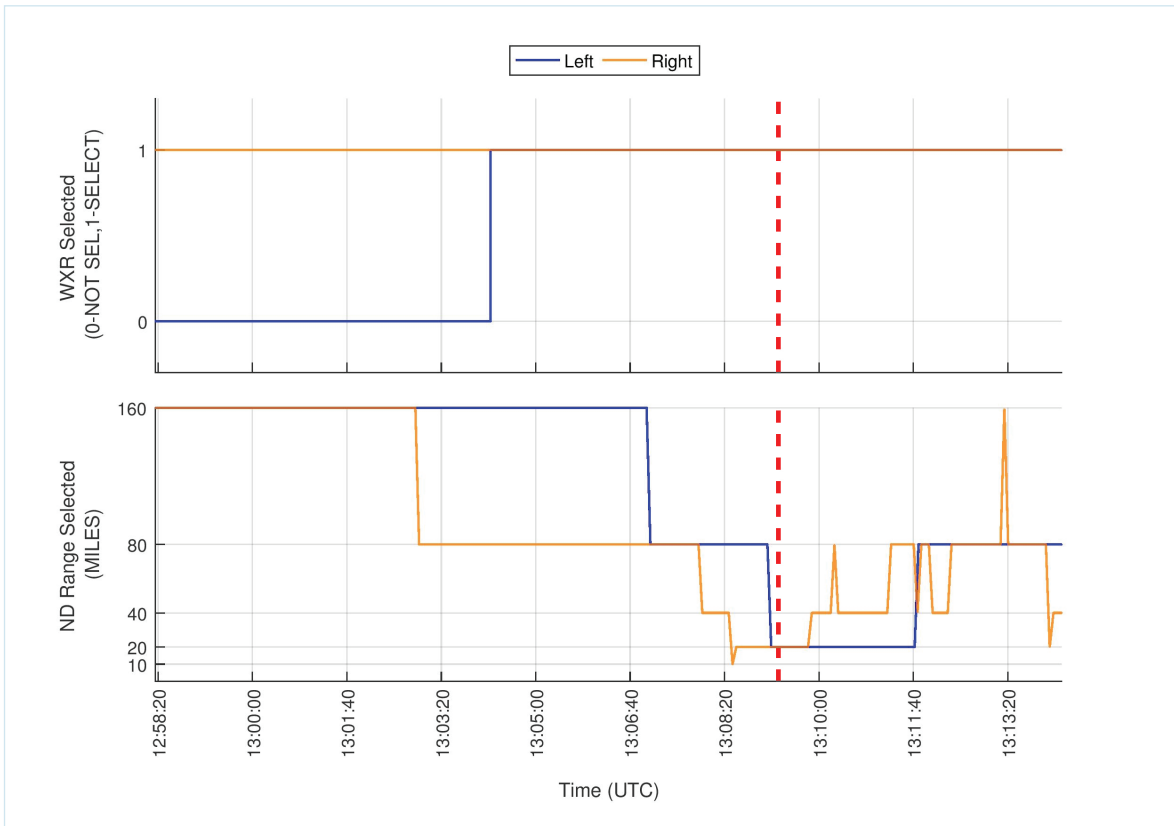
According to the FDR data, the flight crew changed the weather radar settings several times. Initially the weather information was displayed only on the ND of the first officer; the captain switched on the ND about 5 minutes before the occurrence. Both flight crew changed the range several times. The settings are depicted in figure 9.

Figure 9: Settings of the weather radar by the flight crew. (The dotted line indicates the moment of the occurrence).

Although the first officer switched to the manual mode before the descent, the pilots did not use the manual mode in combination with a variable gain to assess the visible storm cells left and right of track before entering IMC conditions.
