# FINAL REPORT

on the Expert Investigation of an Aviation Accident  
of an aircraft type **NEICO Lancair 360**  
registration number **SE-XRH**

Ref. No.: **SKA2016009**

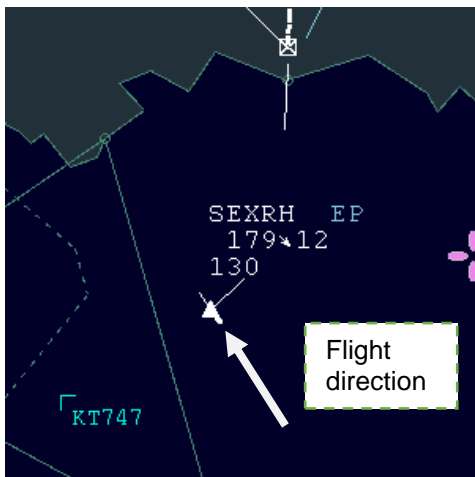
Figure 4

At **09:48:14**, there was a significant change in the direction of the flight SE-XRH (Figures 4 and 5).

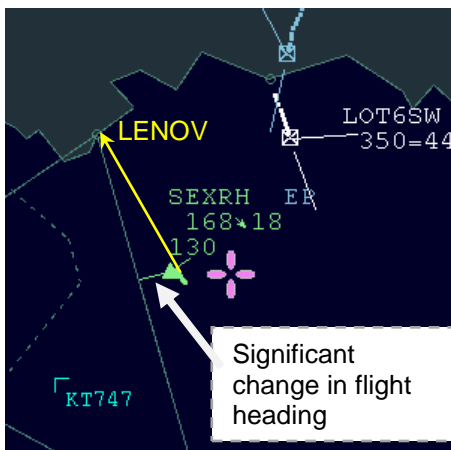
Figure 6

At **09:48:48**, there was a significant change in the heading of the flight SE-XRH (Figures 6 and 7).

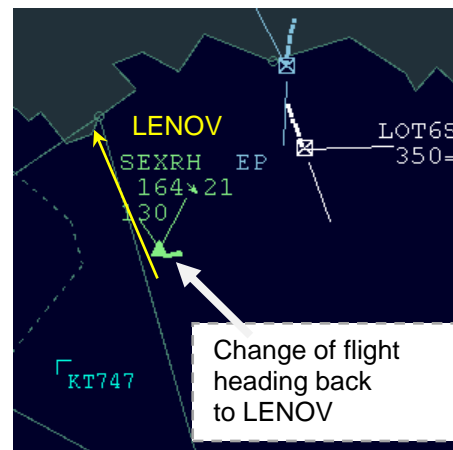
Figure 7

At **09:49:16**, flight SE-XRH was again heading towards LENOVA (Figure 7).

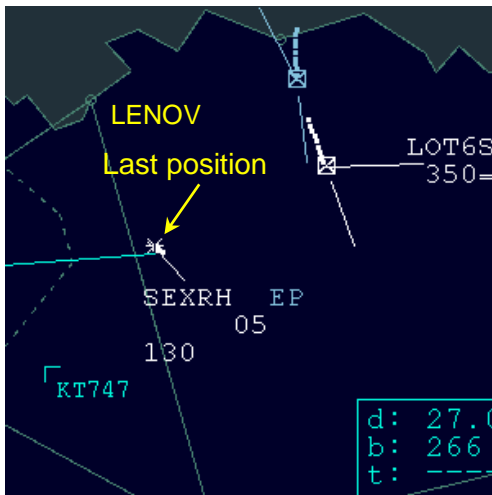
Figure 10

At **09:49:51**, radar contact with flight SE-XRH was lost (Figures 10 and 11).

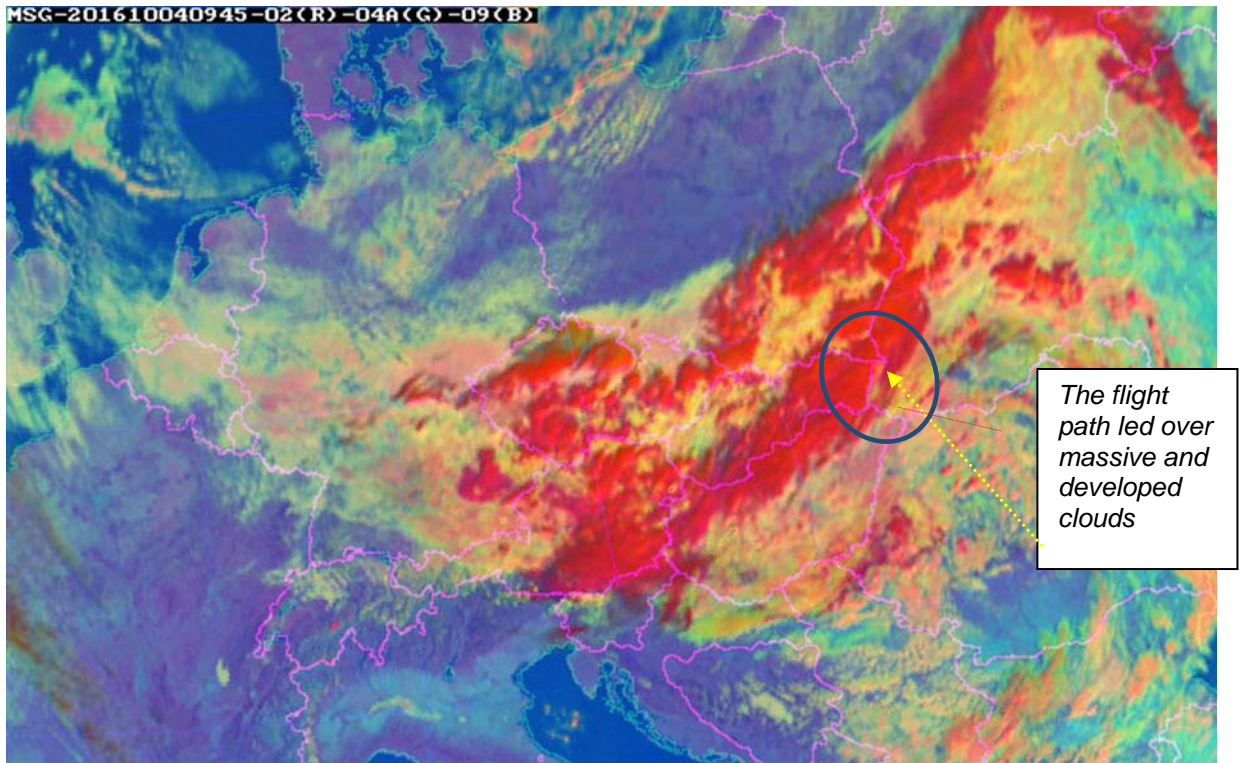
Fig. 12 Satellite images of the density of clouds over Europe

of icing on the leading edges of the wings and propeller; he incorrectly assessed the situation as reduced engine thrust and began to address this problem. It is likely that he also realised that he had been flying at the unsuitable FL190 for a relatively long period of time and requested a descent to FL130, despite the fact that there was massive cloud cover of the occluded front underneath him (*Fig. 12*), in which the likelihood of ice formation was even higher.

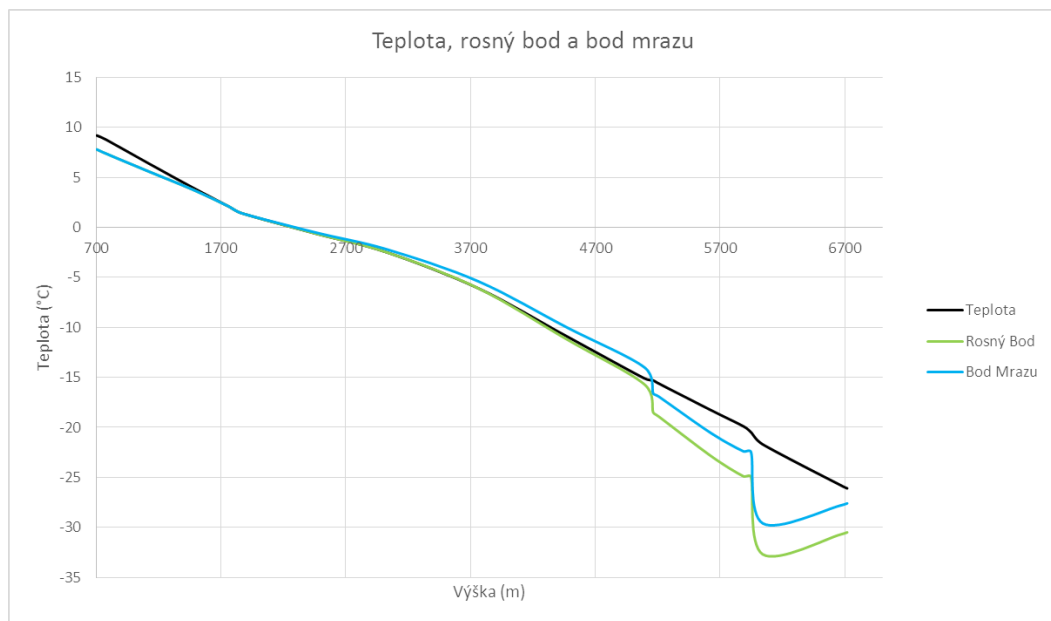
The zero-degree isotherm was at an altitude of about 2,300 m asl. From the altitude of 2,300 m asl to 4,400 m asl (-10 °C isotherm level), there were suitable conditions for the formation of moderate to heavy ice. At higher levels, with a further decrease in temperature as well as relative air humidity, there were worse conditions for ice formation. Only light ice could have formed above the altitude of 4,400 m asl to the cloud top.

Fig. 13 Temperature and humidity profile according to radio probing measurements on 4 October 2016, noon, in Gánovce (temperature, dew point and freezing point)

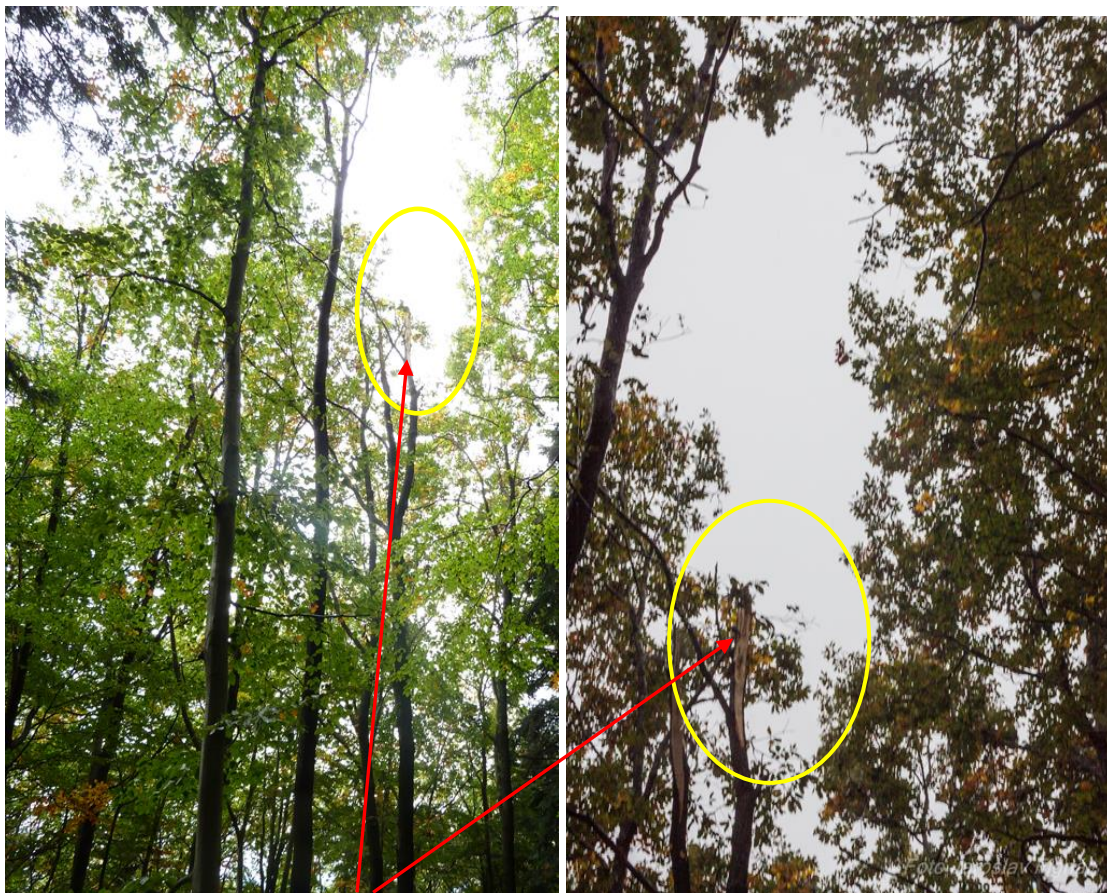
The aircraft initially caught onto a tree and then fell in a forested terrain with hard rocky subsoil. The debris was scattered across an area of about 100x50 m. The fuselage and wings of the aircraft were completely defragmented.

*Fig. 14 Location of initial contact with a tree*

Although the pilot had an oxygen tank available on board, the cockpit was not pressurised and it is not known whether he was breathing oxygen before the accident. The noticeable change in this voice mentioned above points to probable changes in the pilot's body that could have been manifested by incorrect perception of the situation on board and the associated incorrect perception of a decrease in the air speed, which was caused by rapid changes in flight altitude and direction (manoeuvres in the horizontal and vertical directions). An analysis of the altitude and speed profile of the flight showed that the flight over the Slovak territory took place at a steady speed of 140-150 kt on FL189-190 without significant changes in flight direction. However, significant changes in all the above values occurred at 09:46:57, when the aircraft began to change direction and began to increase the horizontal air speed to 186 kt due to descent and then started to climb to the original FL rapidly, which caused a decrease in speed to 112 kt in 34 seconds. The pilot probably interpreted such a rapid decrease in speed as reduced engine thrust and reported the situation to the RC (*I have problem with the engine*). He requested a descent to FL130 after reaching FL187. After obtaining permission, he began to gradually descend at a vertical speed of about 5-6 m/s, the air speed increased from the original 112 kt to 226 kt and the flight direction also changed. After reaching FL167, the pilot stabilised the flight in the clouds at this level for about 40 seconds and then the aircraft began to change direction - this time it was rapid descent, i.e. between FL150 - FL092, the vertical component of air speed reached 147 m/s (530 km/h). However, this descent was no longer controlled and the aircraft was in a steep spiral which the pilot was not able to handle, also due to the dense clouds. In this movement and with the maximum engine performance, the aircraft first caught onto a tree and then at a tilt angle of 80° and a lateral incline of 35° the aircraft crashed into the ground in a forest (*Fig. 14-19*).

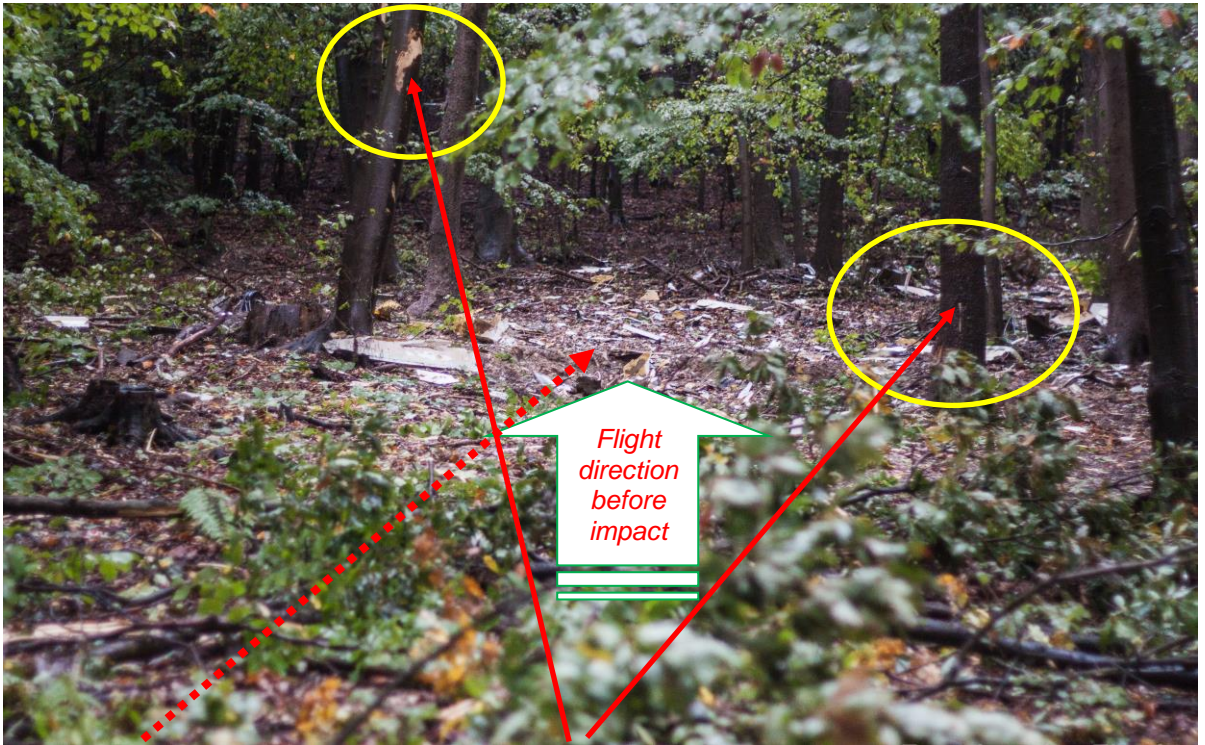
*Fig. 15 Location of the engine and traces of wings before impact with the terrain - incline about 35°*

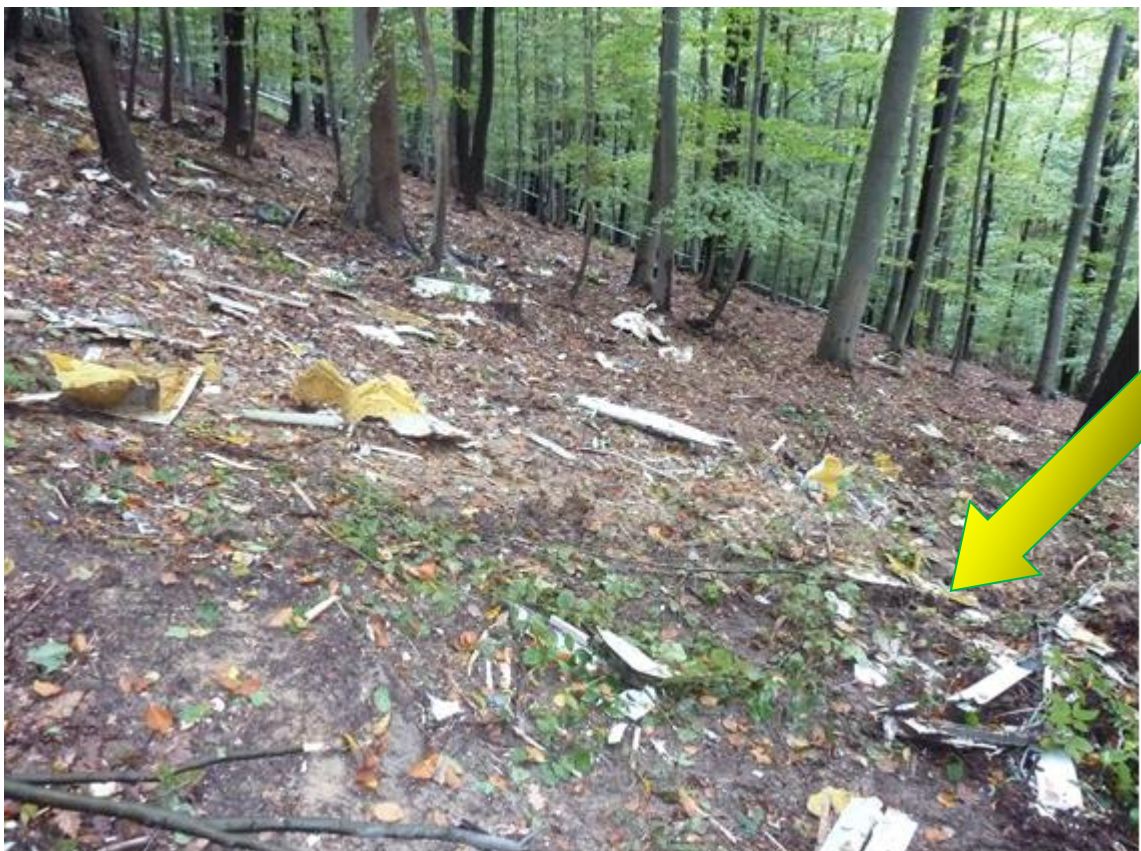
*Fig. 16 Overall view of the scattered debris / impact direction*

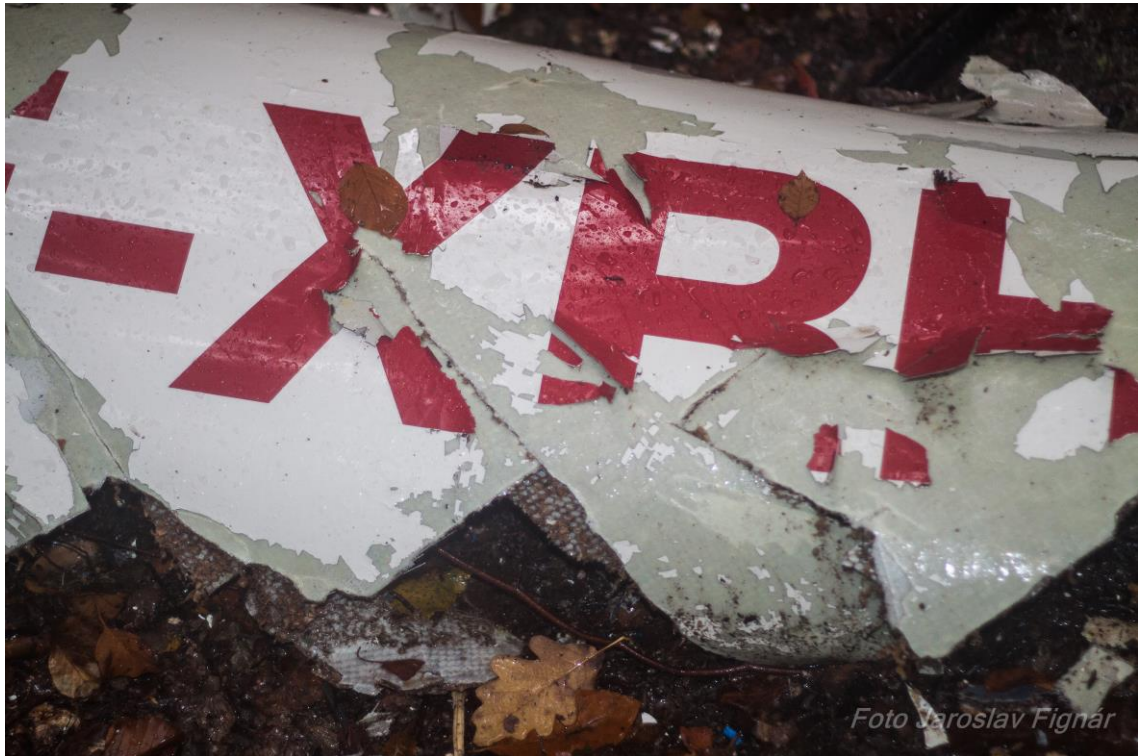
*Fig. 17 Fragment of the coating with registration details*

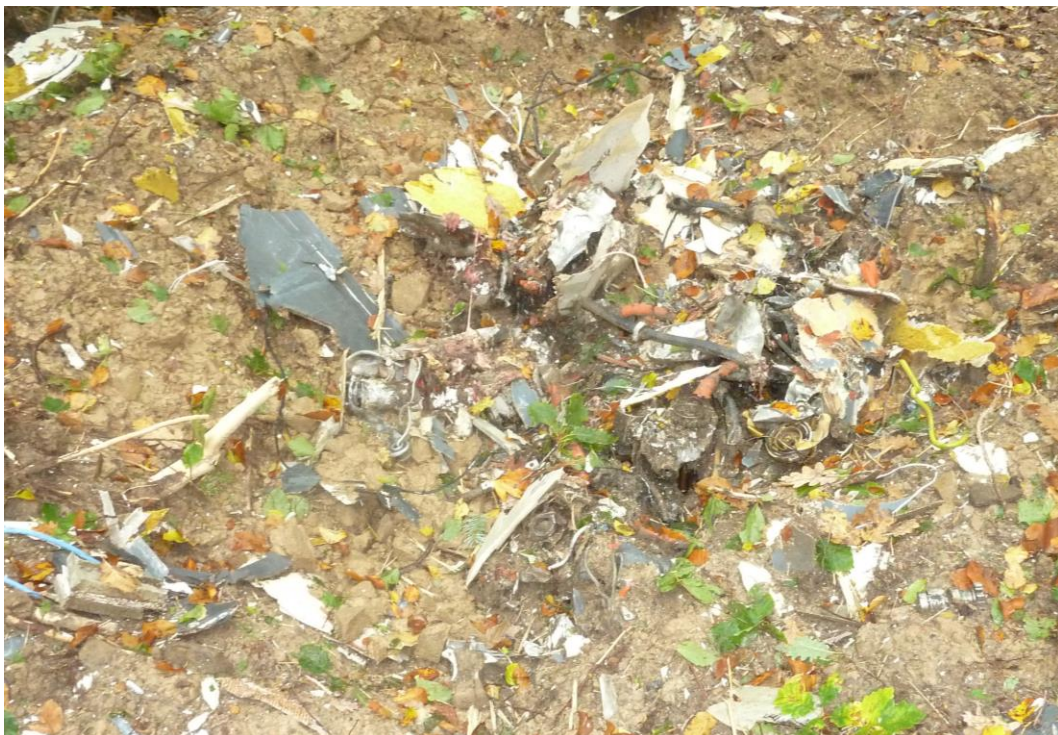
*Fig. 18 Engine position*

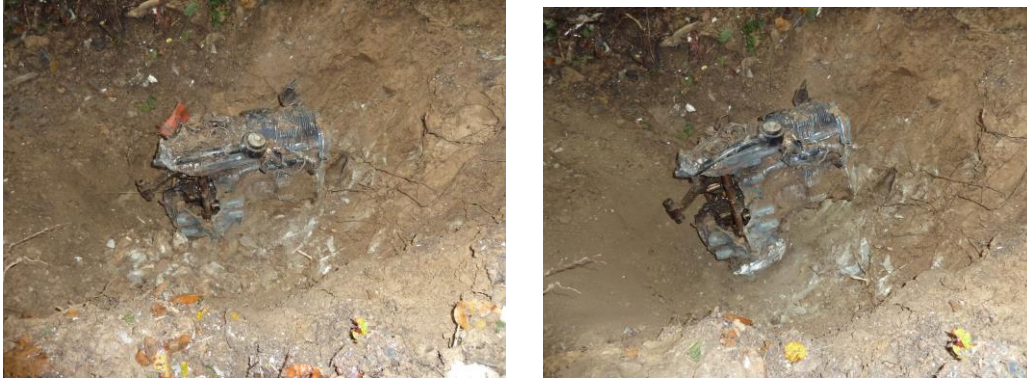
Fig. 19 Engine after partial uncovering

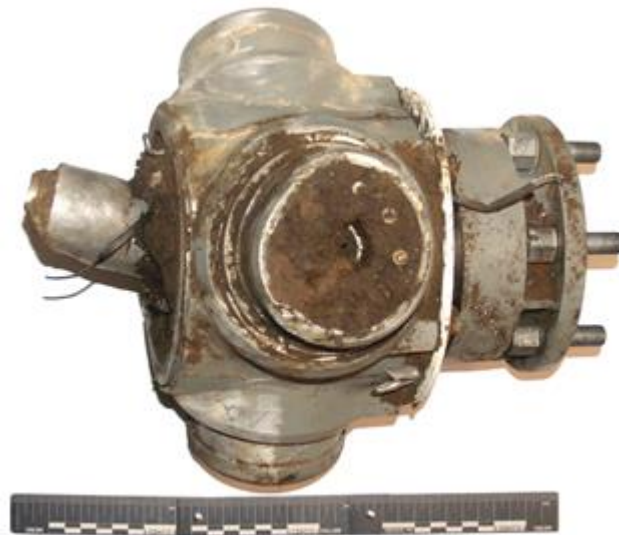
The propeller hub was submitted for investigation at the KEÚ Bratislava in order to **determine whether the propeller was driven by the engine at the time of the impact.**

Fig. 20 Propeller hub presented as evidence No. 1

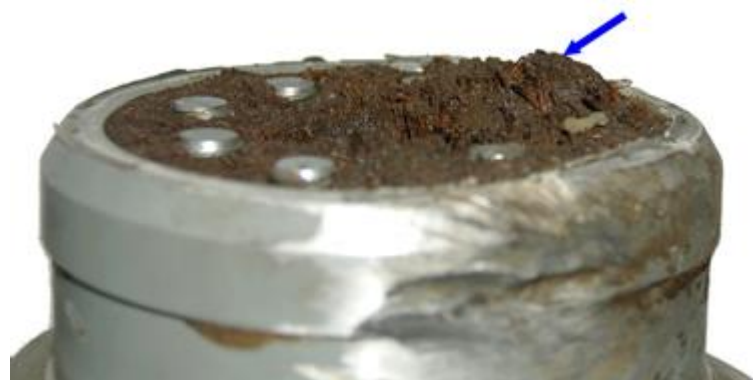
Fig. 21 Side view of one of the fracture areas of the broken-off bottom part of the propeller blade.

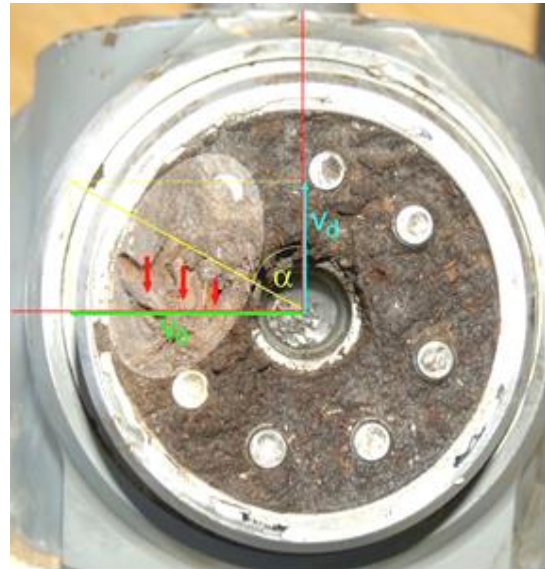
Fig. 23 Position of part of the blade in the fracture area in the hub above the level of fixation (light ellipse), indicated vectors of forward and peripheral speed and directions of the secondary chipping of the projecting wood

Fig. 23 also shows that the fracture area projecting above the level of fixation of the propeller blade is located substantially to the left from the forward speed  $v_d$  vector. This misalignment was caused by the presence of a significant vector of peripheral speed  $v_0$ , which was, in the present case, very likely greater than the forward speed of the aircraft ( $\alpha > 45^\circ$ ). For the left-hand propeller, this means that the engine driving the propeller was in revolutions, meaning that the propeller was driven by the engine at the time of impact.

**Conclusion:** At the time of impact, the peripheral speed of the aircraft propeller was greater than the forward speed of the aircraft, meaning that the propeller was driven by the engine at the time of impact.

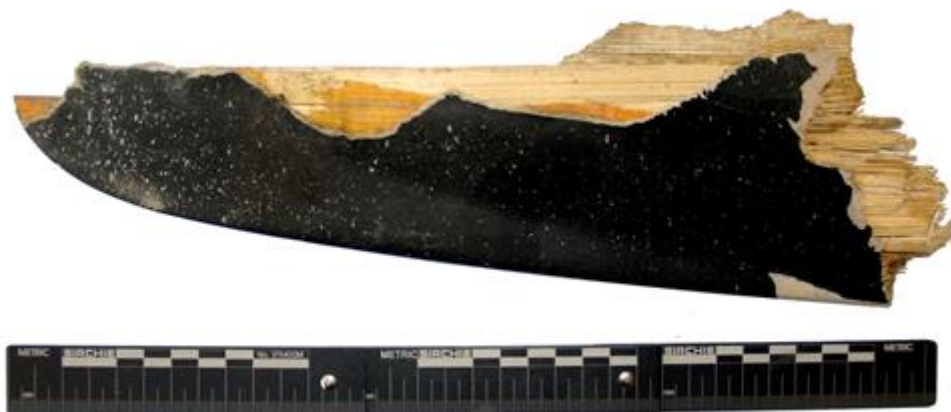
Fig. 24 Fragment of the propeller blade submitted as evidence No. 2
