AIRCRAFT ACCIDENT REPORT AND EXECUTIVE SUMMARY

Reference:	CA18/2/3/9574	
Aircraft Registration	ZS-FAI	Date of Accident	13 October 2016		Time of Accident	1010Z
Type of Aircraft	Piper PA-28-235		Type of Operation	Private Part 91		
Pilot-in-command Licence Type	Private Pilot (PPL)		Age	67	Licence Valid	Yes
Pilot-in-command Flying Experience	Total Flying Hours	619.0		Hours on Type	619.0	
Last point of departure	Manzengwenya Airfield KwaZulu-Natal (KZN) Province					
Next point of intended landing	Brakpan-Benoni (FABB) Gauteng Province					
Location of the accident site with reference to easily defined geographical points (GPS readings if possible)						
Jozini in KwaZulu-Natal at GPS coordinates : S27° 18'.32' & E032° 15.55' at 203 feet AMSL						
Meteorological Information	Surface Wind: Calm; Clouds: SCT018 BKN018; Cloud base:1800ft AGL; Precipitation: Drizzling.					
Number of people on board	1 + 1	No. of people injured	0	No. of people killed	2

AIRCRAFT ACCIDENT REPORT

Name of Owner : Trade A Plane CC
Name of Operator : Private
Manufacturer : Piper Aircraft Corporation
Model : PA-28-235
Nationality : Germany
Registration Marks : ZS-FAI
Place : Jozini in Kwa-Zulu-Natal at GPS S27°

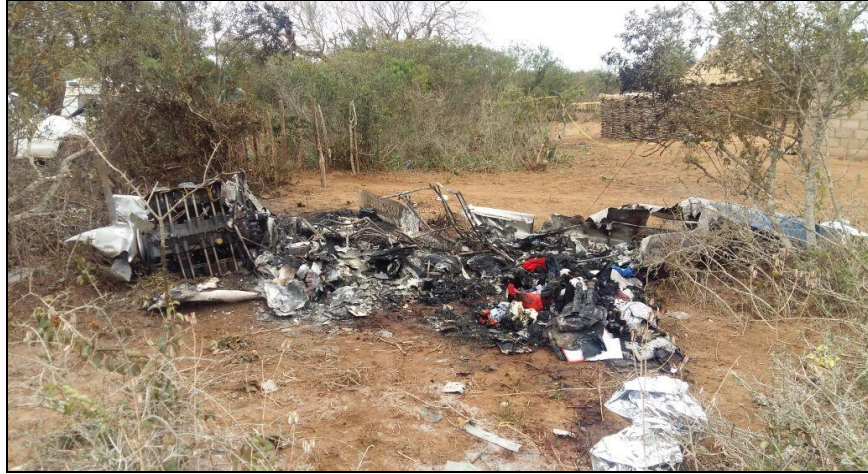
1.3.1 The aircraft was destroyed during accident by impact and post impact fire.

Figure 1: Wreckage of the aircraft destroyed by impact and post-impact fire

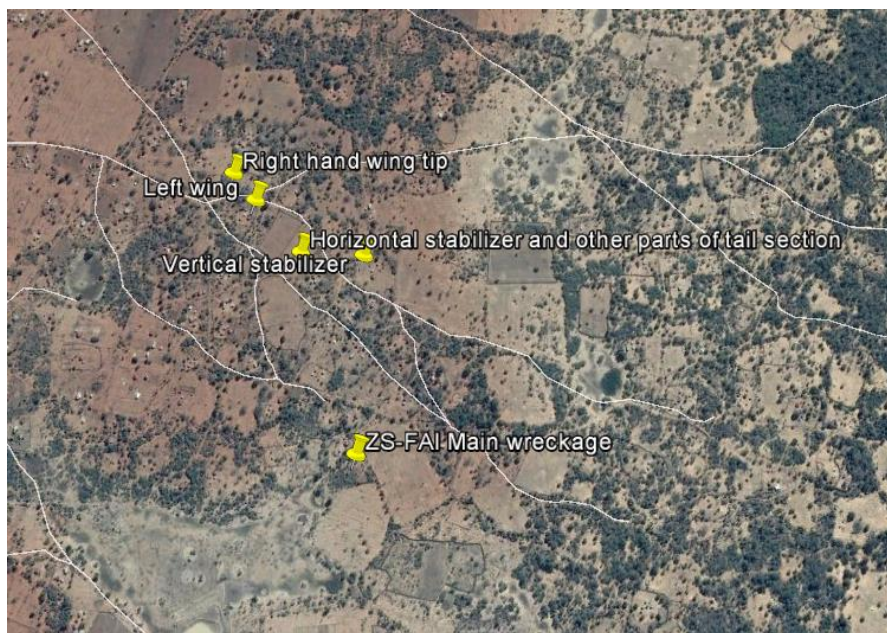
1.12.1 The main wreckage was located in the backyard of a homestead at the GPS coordinates of S27° 18.543' & E032° 15.916'. The main wreckage consisted of the engine and fuselage with the right-hand wing still attached to the main wreckage. The left wing was located 584.03m and the vertical stabilizer located 412.78m from the main wreckage. The horizontal stabilizer and part of the tail section were located 445.77m from the main wreckage.

1.12.3 Examination of the aircraft wreckage revealed signatures consistent with the inflight break-up of the aircraft. Debris of the aircraft wreckage was found scattered in different locations around the accident area. The map below indicates the wreckage distribution path plotted with all the debris which is indicative of an in-flight break-up.

FIGURE 2 SHOWS THE WRECKAGE PLOT AFTER THE A/C BREAK-UP IN FLIGHT

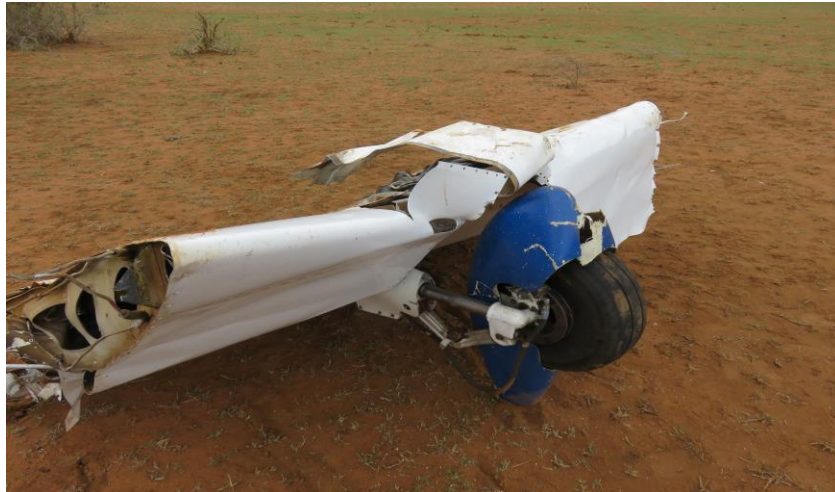
- 1.12.5 The wreckage was recovered from the accident site in order to conduct a detailed examination of the failure modes and to determine whether the in-flight break-up was caused by any mechanical failure. All fracture surfaces and tear lines on the wing section and the aileron were consistent with overload failures. No evidence of any pre-existing deficiency such as fatigue fractures or corrosion were found.

Figure 2: Shows the left-hand wing that separated from the a/c

- 2.8 The main wreckage with the right wing and engine still attached, impacted the ground in a nose down attitude. The left wing failed first and was located 584.03m from the main wreckage. The vertical stabilizer was located 412.78m from the main wreckage. The horizontal stabilizer and part of the tail section were located 445.77m from the main wreckage. The wreckage distribution is indicative of an inflight break-up.
- 2.9 The investigation revealed that the pilot entered IMC conditions and subsequently became disorientated, putting the aircraft in an unusual attitude. In an attempt to correct the attitude he overstressed the aircraft structure which led to an inflight break up.
- 2.10 The pilot and passenger sustained fatal injuries and the aircraft was destroyed.
