# **FINAL REPORT**

## **of civil aviation safety investigation**

OCCURRENCE TYPE	Serious Incident
Owner	Artem Avia, Ukraine
Operator	Genex Ltd., Belarus
Manufacturer	Antonov
Aircraft	AN-26B
Registration	EW-259TG
Location	Timisoara International Airport, platform northern side
Date and time	17.10.2016 / 17 :11 LT (14 :11 UTC)

**Platform lighting poles hitting during parking**

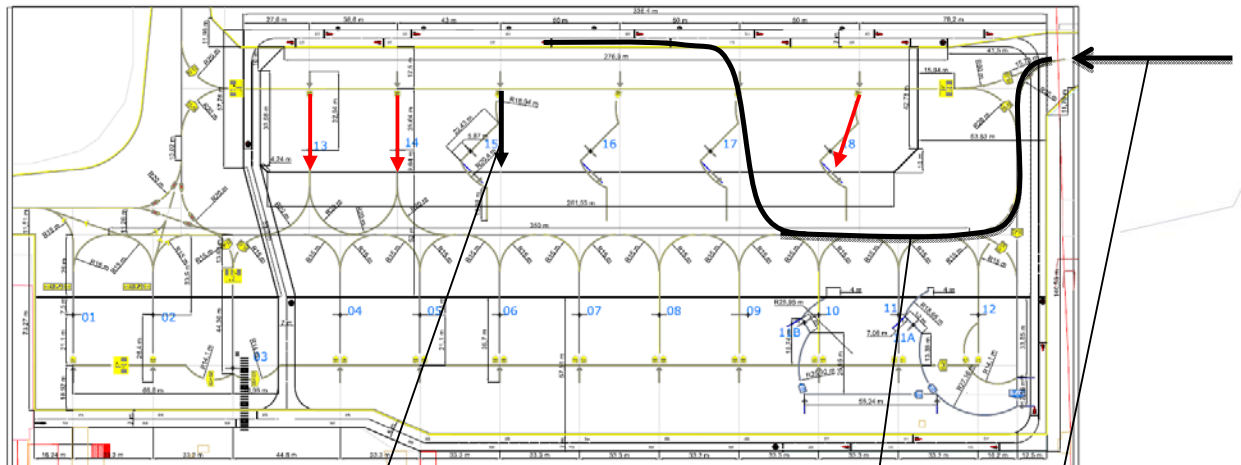
Fig. 1 Aircraft route to parking place (the red arrows are parked aircraft)

The aircraft followed the route indicated by the FOLLOW-ME car: "M" taxiway (platform midline), which was left by a right turn, the FOLLOW-ME car leading it to the north in order to perform the last two turns (both to the left) for positioning at designed parking place, facing south.

During the first left turn, the aircraft hit a parking platform lighting pole with the right wing, which was knocked down, then it continued taxiing, without noticing the dispatcher emergency stop signal. The aircraft stopped when it hit the second lighting pole, which was inclined.

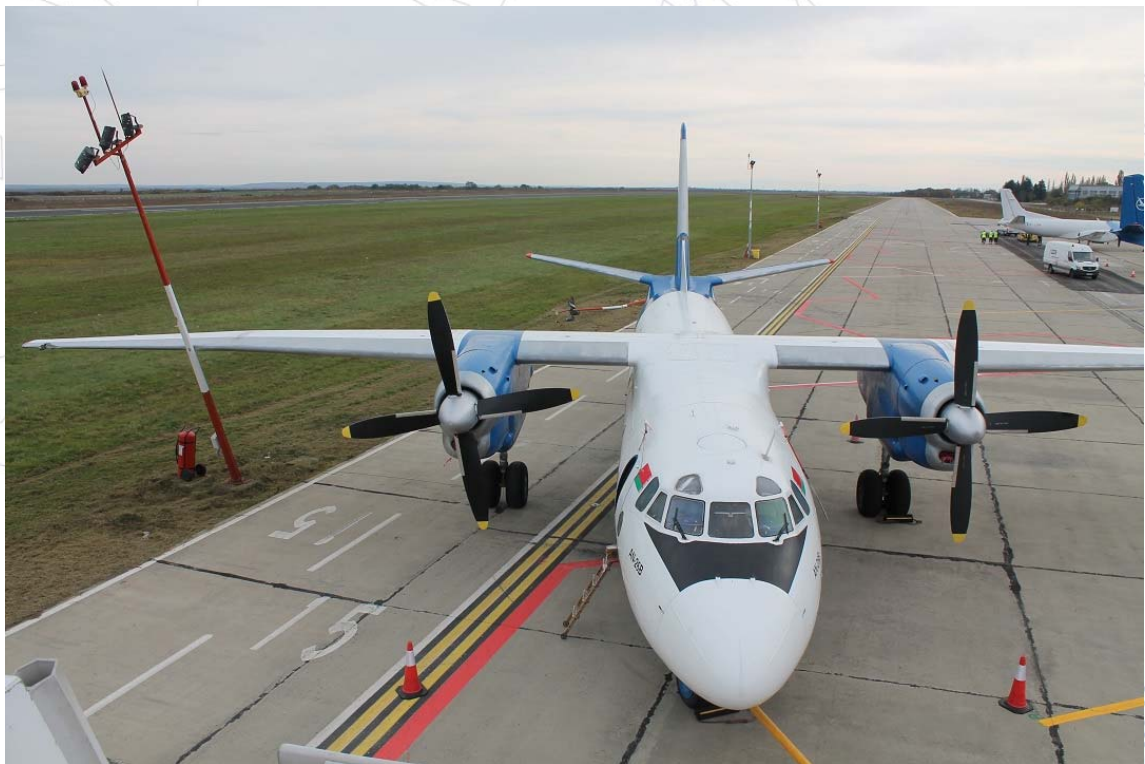
Fig.2 Aircraft position after impact with the two poles

Both the aircraft Commander and co-pilot focused on visual follow of FOLLOW-ME car, namely on the route followed by this and did not pay the necessary attention when approaching the platform edge and the present obstacles (parking platform lighting poles). As a result, during left turn the aircraft right wing exceeded the platform edge and hit two lighting poles.

Therefore, during work of platform markings restoration, the aircraft guidance for parking shall be made as follows: the aircraft shall be taken-over by FOLLOW-ME car from platform edge and it shall be accompanied on "M" taxiway up to the position where it shall be parked, from where it should be manually guided with specific signs and signals. In addition, for parking on platform northern side, where there are the lighting poles, guiding shall be supplemented with a wing walker, confirming to the aircraft crew that the area for exterior turn wing is obstacle free.

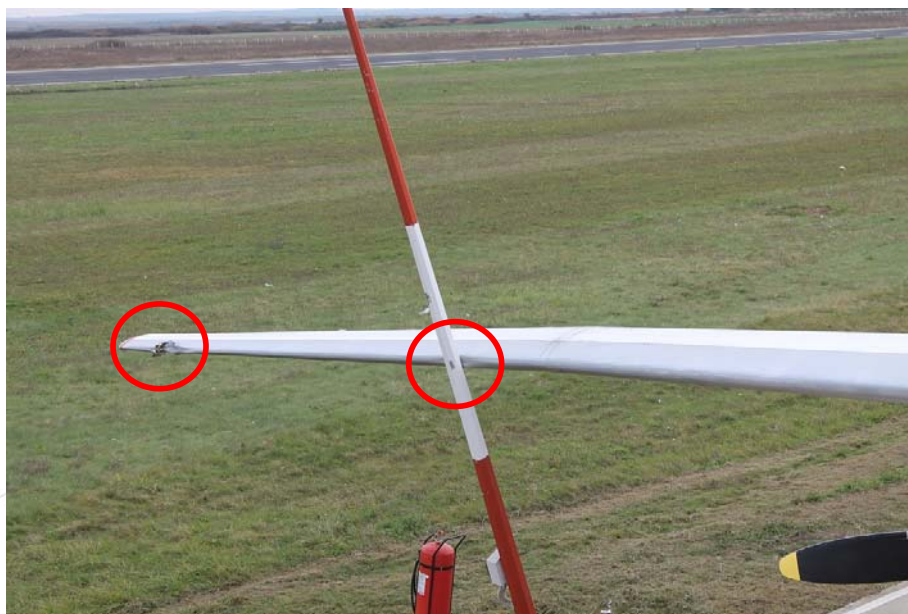
Fig.3 Aircraft wing damages

The aircraft damage was minimal: the leading edge of right wing have two dents corresponding to the impact with the lighting poles.
