AIRCRAFT ACCIDENT REPORT AND EXECUTIVE SUMMARY

Reference:	CA18/2/3/9577	
Aircraft registration	ZS-HAH	Date of accident	25 October 2016		Time of accident	0455Z
Type of aircraft	Cameron A-415 (Hot Air Balloon)		Type of operation		Hot Air Balloon (Part 136)	
Pilot-in-command licence type		Hot Air Balloon	Age	58	Licence valid	Yes
Pilot-in-command flying experience		Total flying hours	863.3		Hours on type	69.9
Last point of departure		Skeerpoort Balloon Field, North West province				
Next point of intended landing		Agricultural field on the farm Little Waters, North West province				
Location of the accident site with reference to easily defined geographical points (GPS readings if possible)						
On the farm Little Waters near Buffelspoort dam (GPS position: 25°48'10.58" South 027°30'09.66" East)						
Meteorological information		Probable strong surface wind, Temperature; 11°C, Visibility; + 10km, CAVOK				
Number of people on board	1 + 14	No. of people injured	2	No. of people killed	1

AIRCRAFT ACCIDENT REPORT

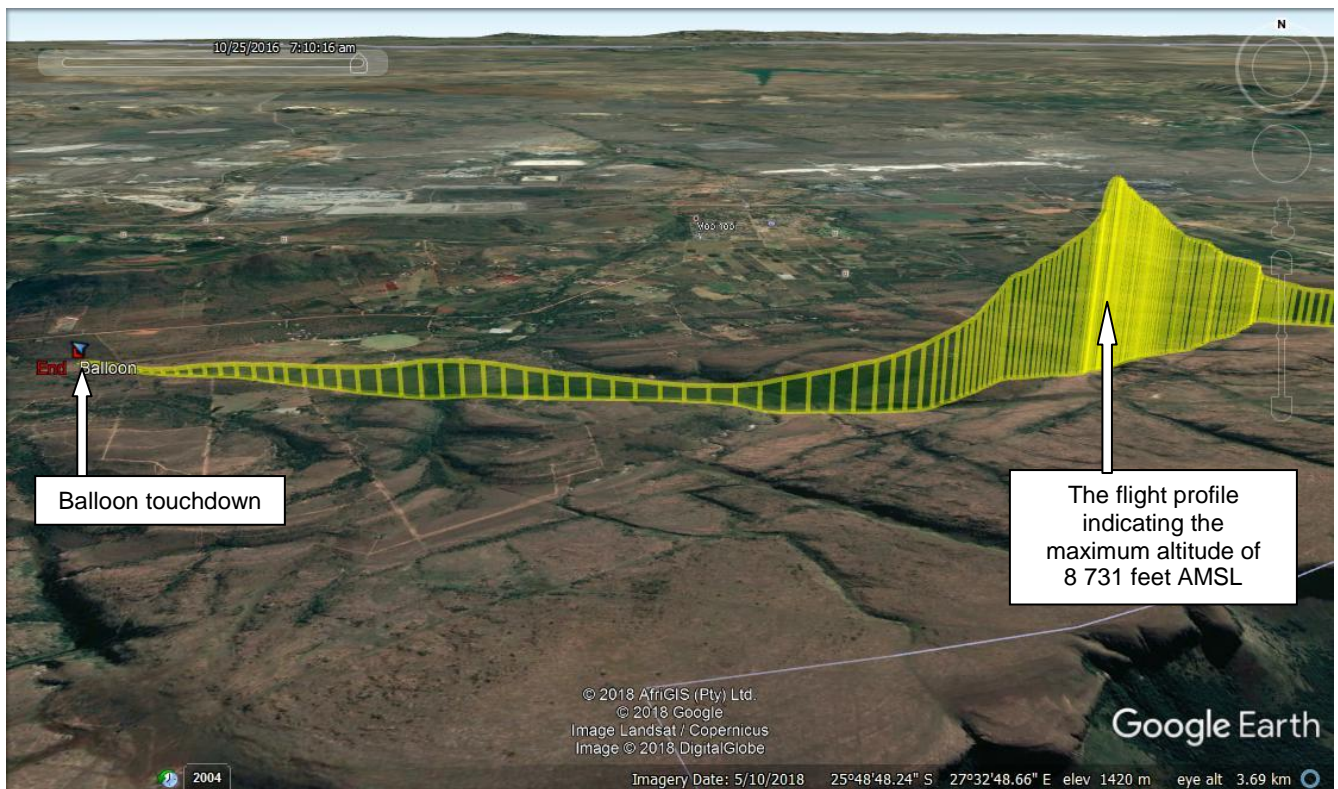
Figure 10: Google Earth overlay of the last phase of the flight until first ground impact

From the flight profile (yellow vertical lines) as depicted in Figure 10 below it could be seen that the pilot ascended the balloon to a height of 8 731 feet and then commenced with the descent towards the open harvested maize field. The flight profile data was obtained from the GPS unit that was on board.

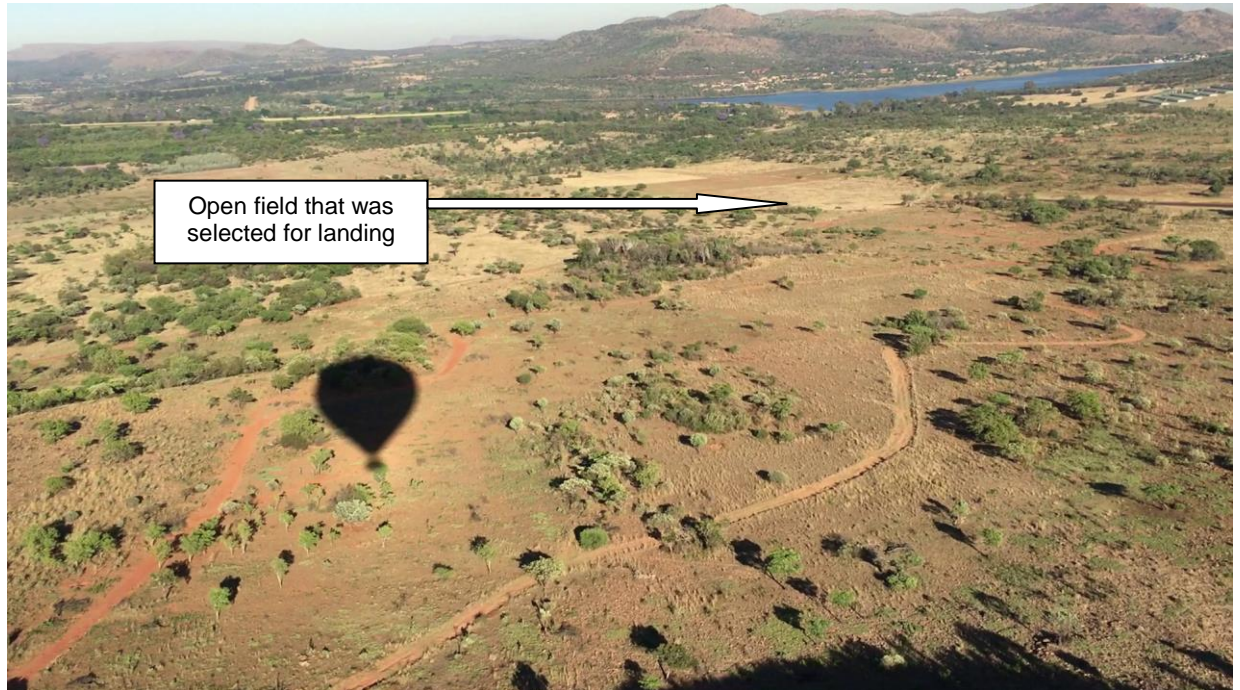
Figure 11: A snapshot from video footage with the open field visible

1.12.2 In Figure 11 the field is visible straight ahead. This was a snapshot taken from video footage that was obtained courtesy of one of the passengers that was on board the flight. The balloon basket first made contact with the ground 108.7m past the maize field perimeter fence, on a heading of 320°M. Ground markings indicated that the balloon then bounced a first time, contacting the ground a second time after a

distance of 26.2 m. The basket remained in contact with the surface of the field for a further 72.5 m, before bouncing a second time and it travelled 52.8 m on the second bounce. Following its third touchdown, the basket remained in contact with the ground until it came to rest against some trees 76.8m further on. The total distance covered from first ground contact until the balloon and basket came to rest was 228.3m.

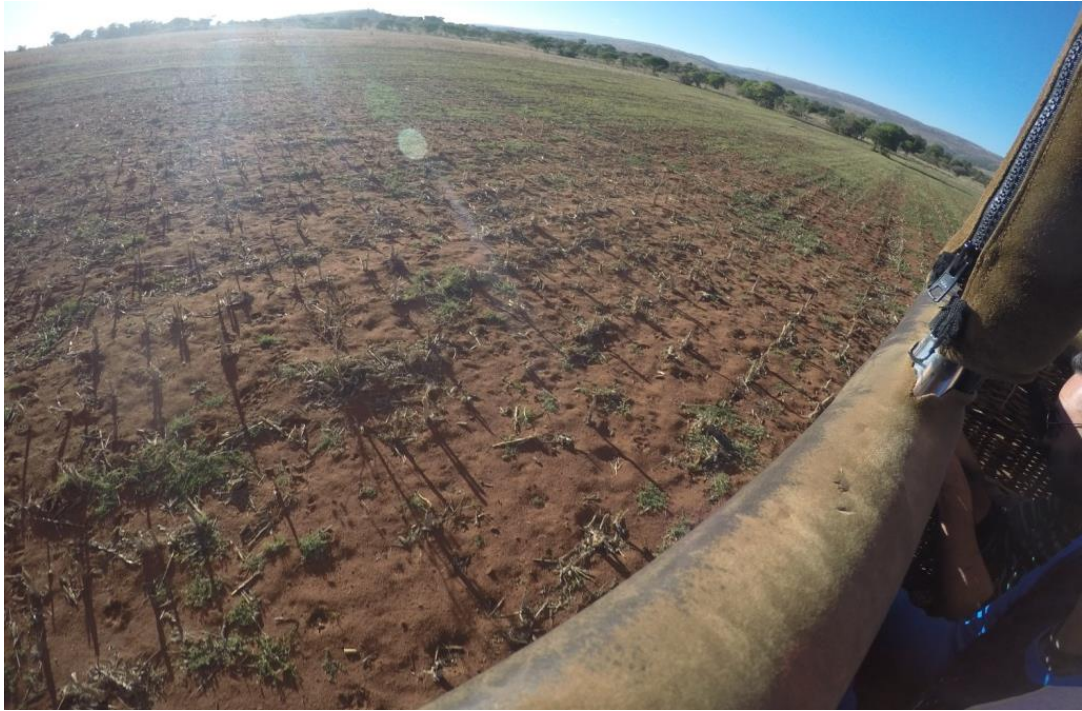
Figure 12: Photograph was taken just before the first ground contact was made by a passenger

1.12.3 The two photographs below, Figures 12 and 13 were obtained courtesy of one of the passengers that were on board the flight. Figure 11 was taken just prior to the basket impacting with ground for the first time, and Figure 12 was taken when the basket impacted with ground for the second time.

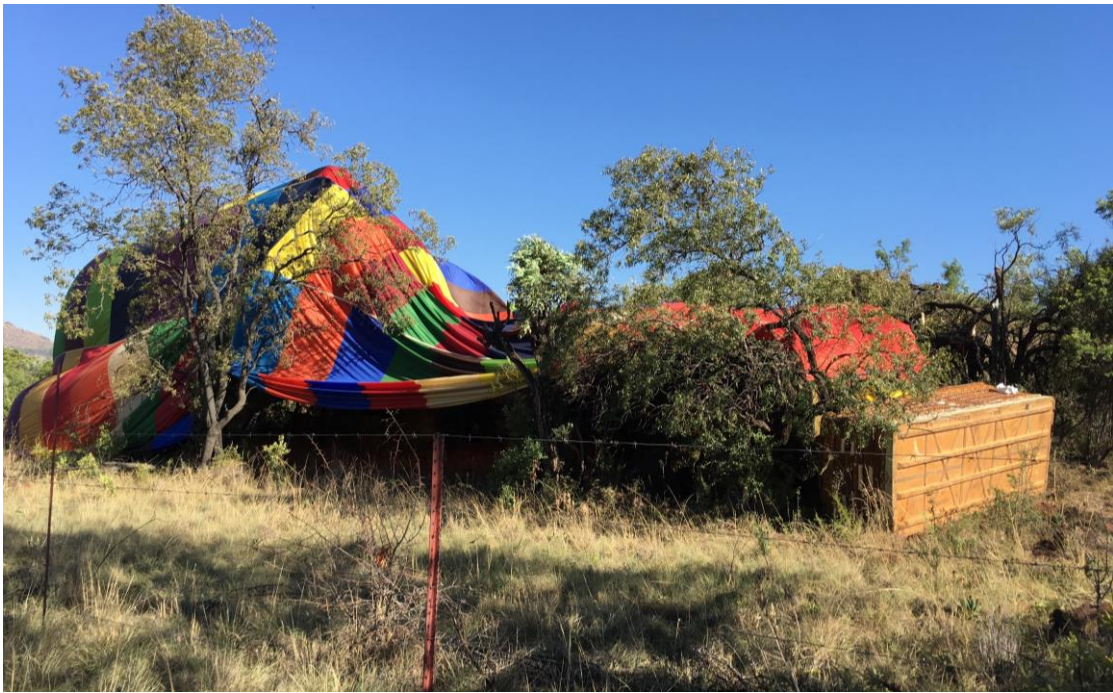
Figure 14: The balloon and basket as it came to rest prior to recovery (photograph courtesy of a passenger)

1.12.4 Over the last 30 to 40m before the balloon/basket came to a rest against trees and shrubs. The basket flattened a barbed wired fence that was approximately 1.5 m in height. The basket was then dragged over rocky terrain before coming to rest on its side as can be seen in Figure 14. The photograph below was obtained courtesy of one of the passengers that was on board the flight.

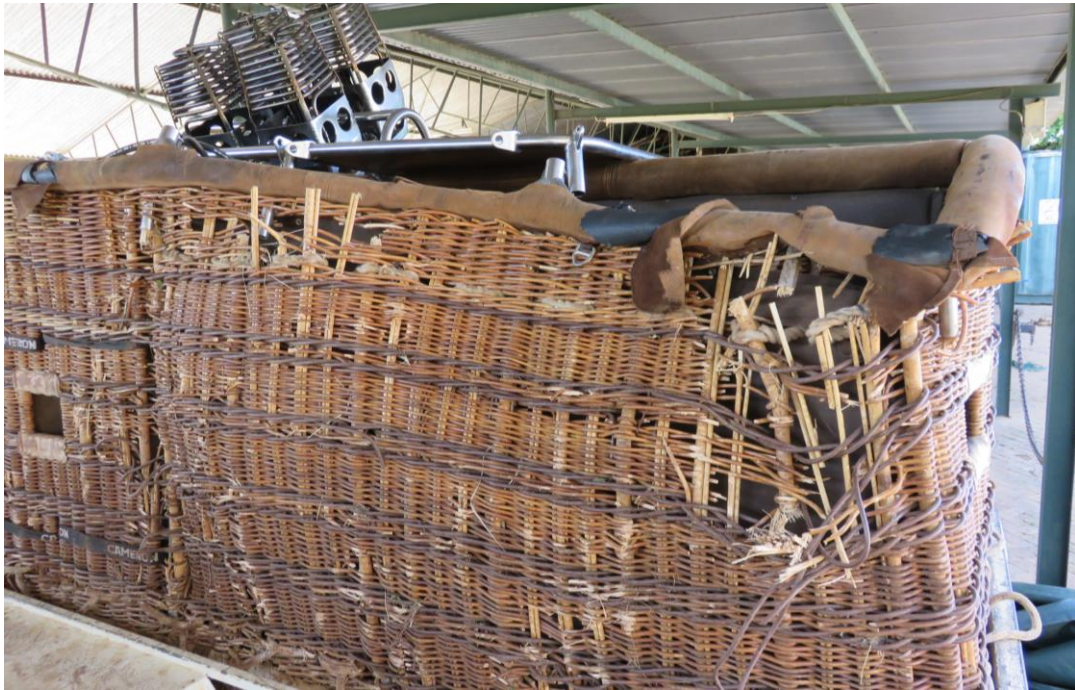
Figure 15: Damage visible to the basket

1.15.1 The accident was considered to be survivable; however, three of the passengers were ejected from the basket during the landing sequence and suffered from serious injuries, which required hospitalisation and emergency surgery. One of the adult passengers succumbed to her injuries several hours after the accident while in hospital during emergency surgery where her spleen was removed as it had ruptured during the accident sequence.

3.1.17 A section of the balloon basket sustained substantial impact damage.

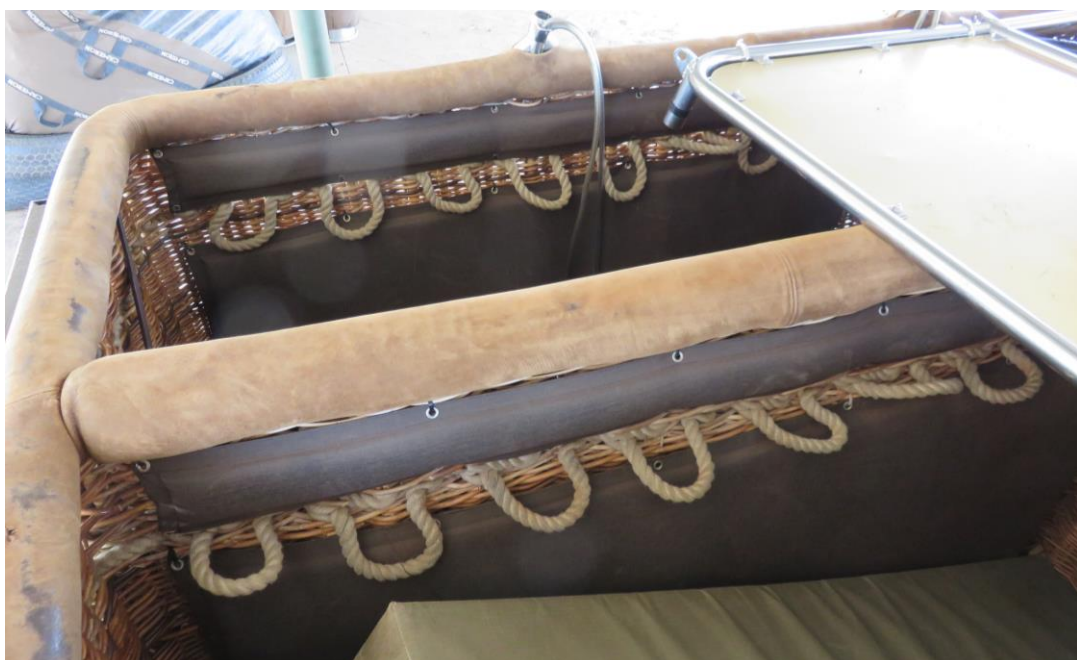
Figure 16: The spiral-twisted rope handles for passengers to hold onto inside the basket

In Figure 16 on page 27 of the report, the traditional spiral-twisted type looped rope handles can be seen from the basket that was involved in the accident. The primary purpose of these handles were for the passengers to hold onto during landing (depending on whether the operator endorses this type of procedure) or during landing; holding onto the handles should be compulsory during a fast or high wind landing. Figure 19 shows a close-up view of the woven rope handle, this photograph was obtained courtesy of the balloon manufacturer. Also visible were two attachment harnesses, (black in colour), the pilot is not allowed to secure his safety harnesses to these attachments as there is a special attachment on the floor structure of the basket for that. In the accident flight, the pilot was the only person that was secured to the basket with a restraining/safety harness.

An additional safety method for young children is recommended whereby they should be secured to the basket by means of a safety harness, similar to the harness used by the pilot.

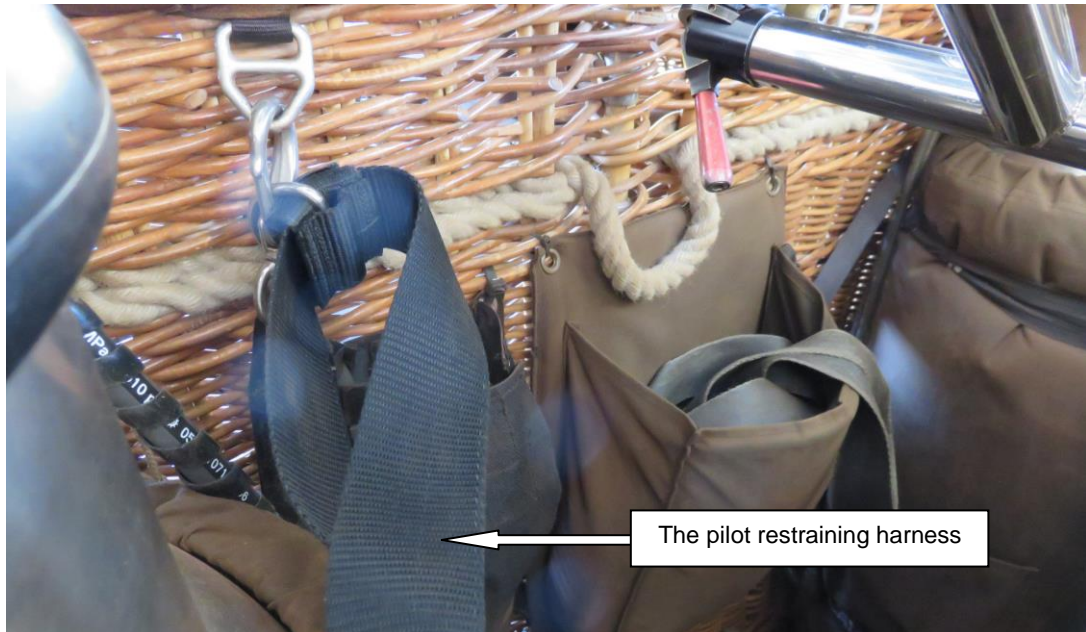
Figure 18: The pilot compartment with his restraining harness hooked to the basket

1.15.5 The pilot compartment with his restraining harness temporarily hooked to one side of the basket as can be seen in Figure 18. When the harness is worn by the pilot during flight it is attached to a secure bracket on the floor structure of the basket. The primary purpose of the harness is to prevent the pilot from falling out of the basket during a fast landing, as he would not be able to hold onto the rope handles to remain in the basket because he would be handling controls and pulling deflation ropes.
