| <b>SHORT REPORT AND EXECUTIVE SUMMARY</b> |

| | | | | Reference: | CA18/2/3/1150 | |
| <b>Aircraft Registration</b> | ZS-KEW | <b>Date of Accident</b> | 23 November 2016 | | <b>Time of Accident</b> | 07:10Z |
| <b>Type of Aircraft</b> | GRUMMAN G-164B | | <b>Type of Operation</b> | | Commercial Training Part 137 | |

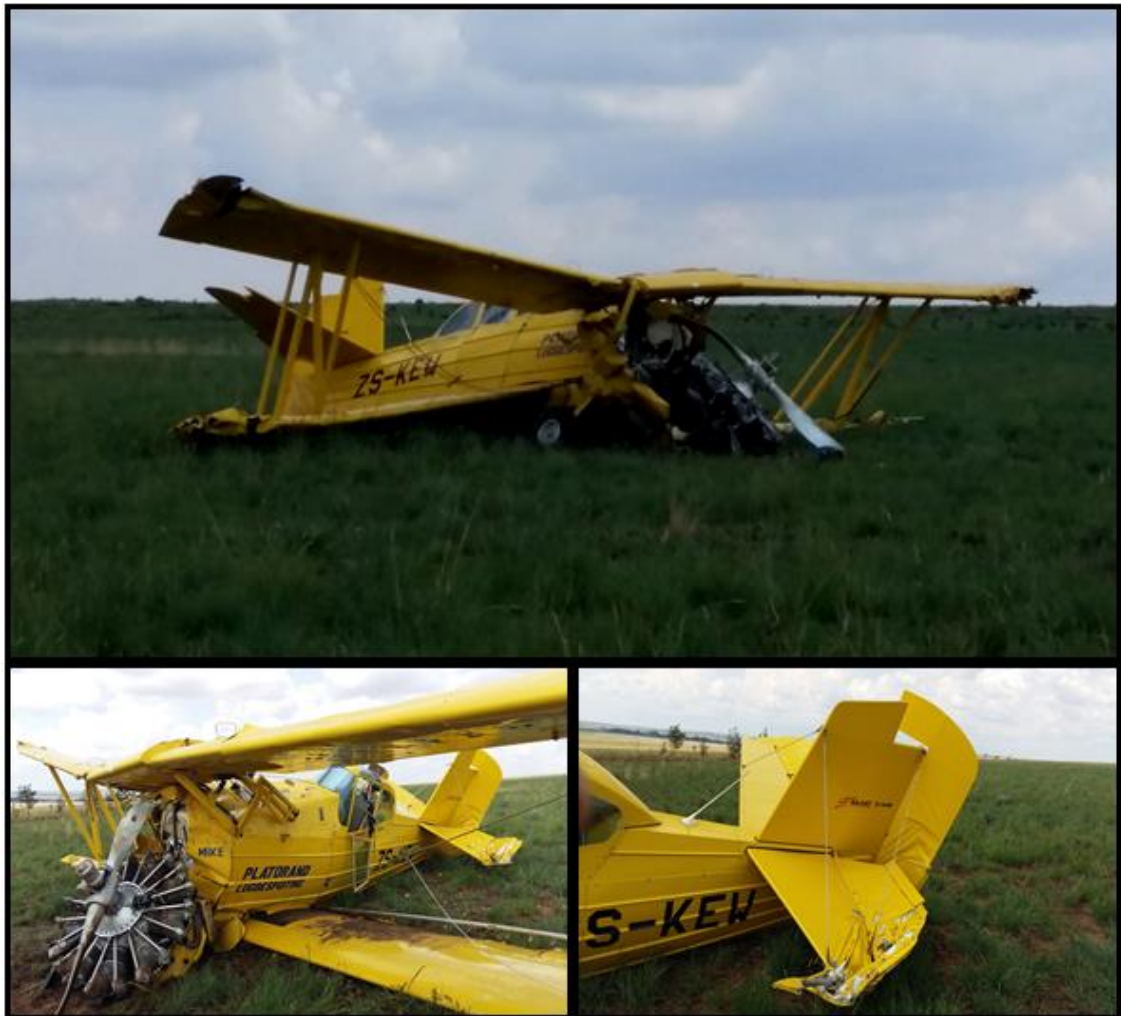
**Figure 2:** Shows the aircraft after the accident

1.2.4 The aircraft collided with some tree during an attempt to gain forward speed following an early attempt of a stall correction.

1.2.5 The aircraft sustained substantial damages on the fuselage, wings, cockpit elevators and engine mountings.

- 2.2.1 The aircraft crash was due to collision with a tree in an attempt to regain forward speed following a stall during a crop spraying training exercise.
