GOVERNMENT OF INDIA
DIRECTORATE GENERAL OF CIVIL AVIATION
NEW DELHI

FINAL INVESTIGATION REPORT

**GROUND INCIDENT BETWEEN SEJ123, B738, VTSGV AND IGO769,A320, VTINT AT IGI
AIRPORT, NEW DELHI**

**OFFICE OF DIRECTOR OF AIR SAFETY (NORTHERN REGION), GOVERNMENT OF INDIA,
SAFDARJUNG AIRPORT,NEW DELHI-110003**

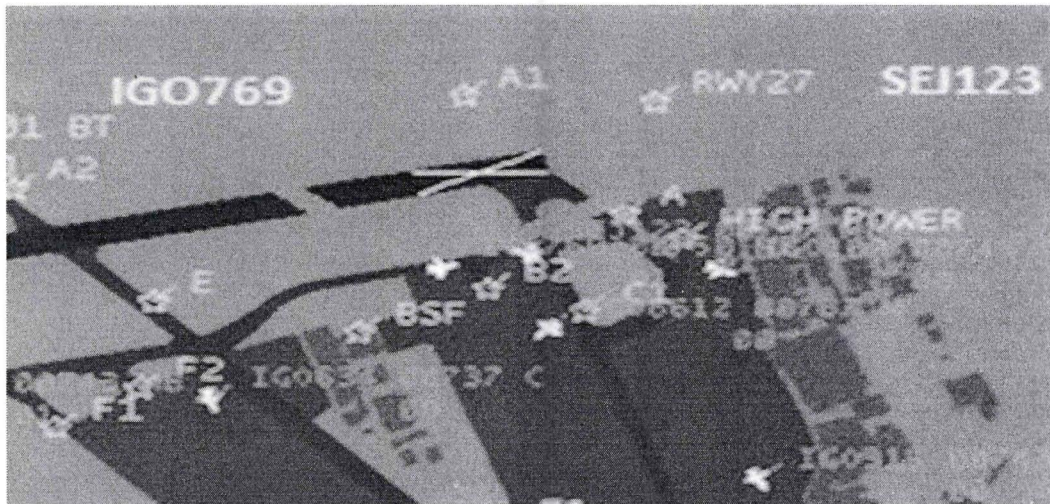
- m. SEJ123 turned left to join E2 and came face to face with IGO769 which was taxiing on taxiway E2 for A lane.

- m. SEJ123 was monitoring the ground frequency but at that time there was no conversation with IGO769. Thus she was not aware of any opposite traffic on TWY E2 assuming this she turned left on taxiway E2 without confirming the route. Visibility was very low and there was no follow me to assist or cross check the route or to advise the opposite traffic. Follow me jeeps are equipped to monitor the frequencies of their area and can communicate with aircraft and tower.
- n. On turning left SEJ123 and IGO769 came face to face and the separation between the two became approximately 30m which was abeam B2 thus none of them could take a turn. To resolve the traffic they were towed to their respective bays.
