**COMANDO DA AERONÁUTICA**  
**CENTRO DE INVESTIGAÇÃO E PREVENÇÃO DE**  
**ACIDENTES AERONÁUTICOS**

**FINAL REPORT**  
**A-013/CENIPA/2017**

<b>OCCURRENCE:</b>	<b>ACCIDENT</b>
<b>AIRCRAFT:</b>	<b>PR-SOM</b>
<b>MODEL:</b>	<b>C90GT</b>
<b>DATE:</b>	<b>19JAN2017</b>

During the second approach attempt to land at the Paraty Aerodrome, RJ, the aircraft flew into a region under restricted visibility conditions, which caused the pilot to lose visual contact with the terrain references, leading to loss of control and the impact of the aircraft against water.

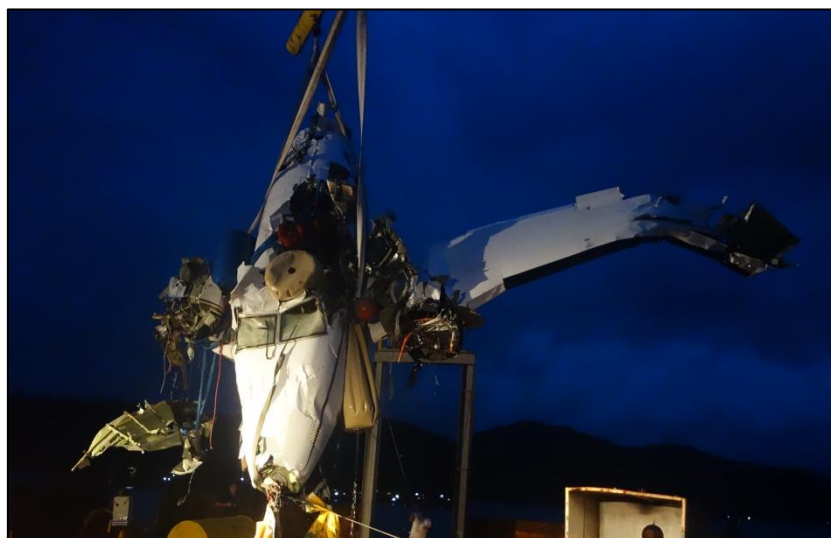
The damages observed on the left side of the fuselage were manually made during rescue operations.

Figure 1 - Condition of the aircraft at the time of lifting.

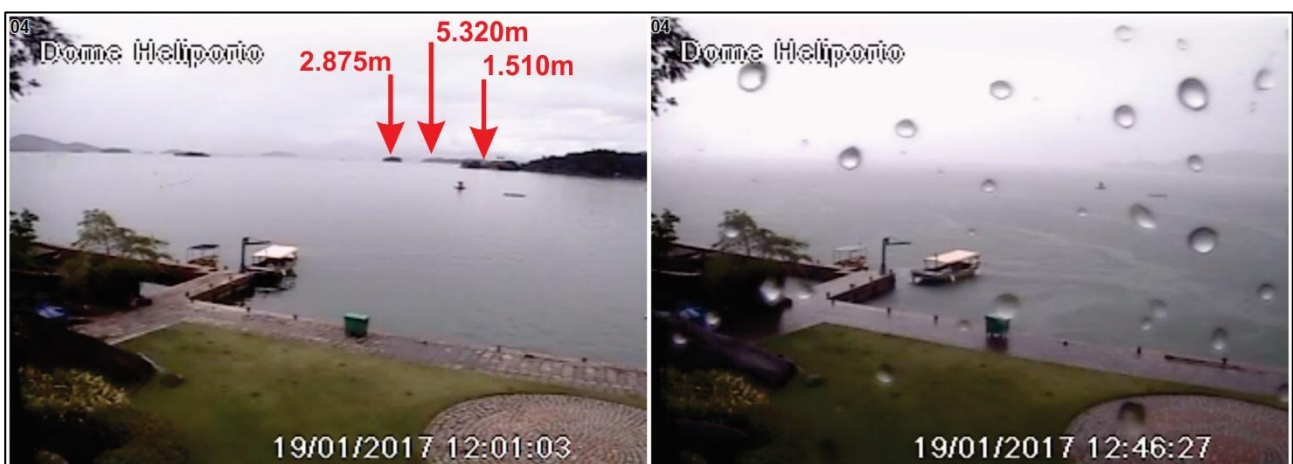
In the image generated at 15:46:27 (UTC), about two minutes after the estimated time of the accident, the presence of rain with restriction of visibility is verified. At this point, it is possible to observe, with some difficulty, only the reference of 1,510m (Figure 20).

Figure 20 - Comparison of the visibility conditions at the aircraft crash site in two moments: on the left - takeoff time, and on the right - two minutes after the accident.

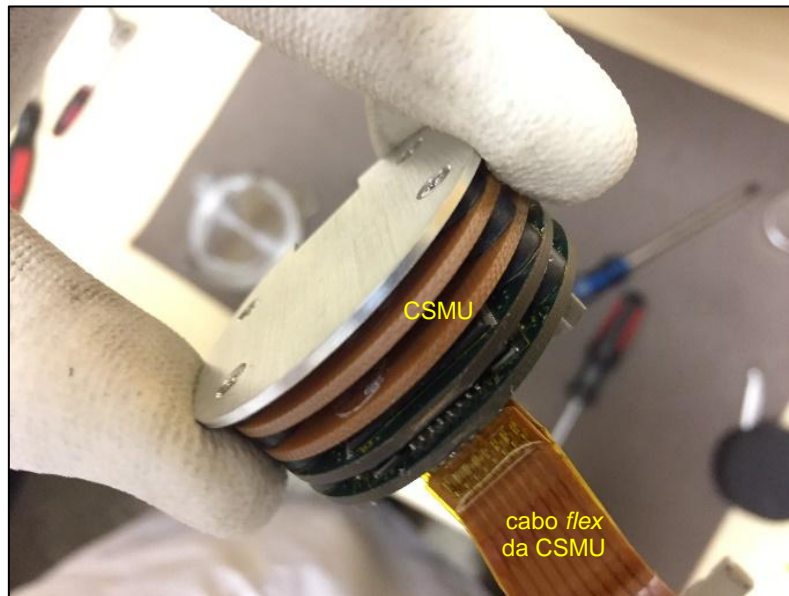
By separating the Crash Survivable Memory Unit (CSMU) from the chassis, it was noted that there was no penetration of liquid in the memory and no physical damage to the recorder, such as kneading, twisting or submission at great pressures.

Figure 22 - Condition of the CSMU when removed from the CVR.

After that a CSMU flex cable replacement service was performed, it was possible to successfully read the last thirty-one minutes and four seconds of audio, according to the requirements of the recorder.

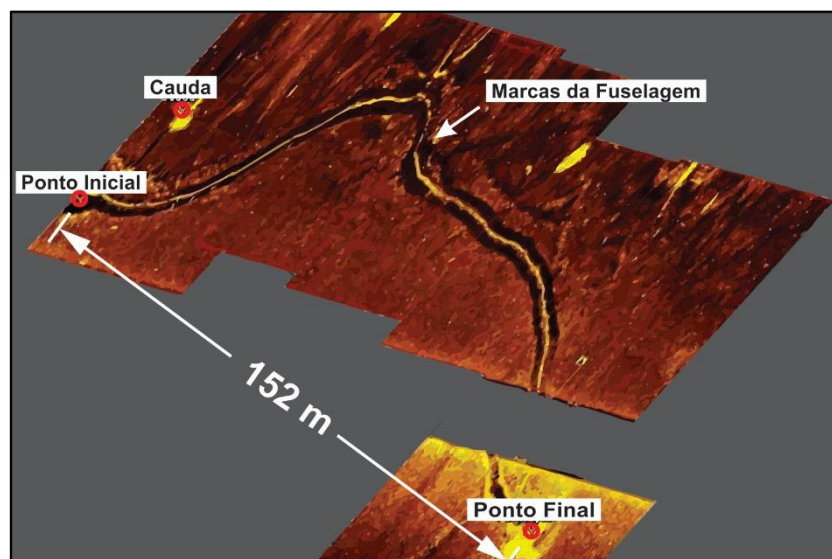
The position of the aircraft's fuselage was altered by boats in an attempt to rescue survivors, and its initial position could be defined by means of a scanner mapping of the marks left at the bottom of the sea (Figure 23).

Figure 23 - Mapping of the marks left by the fuselage at the bottom of the sea.

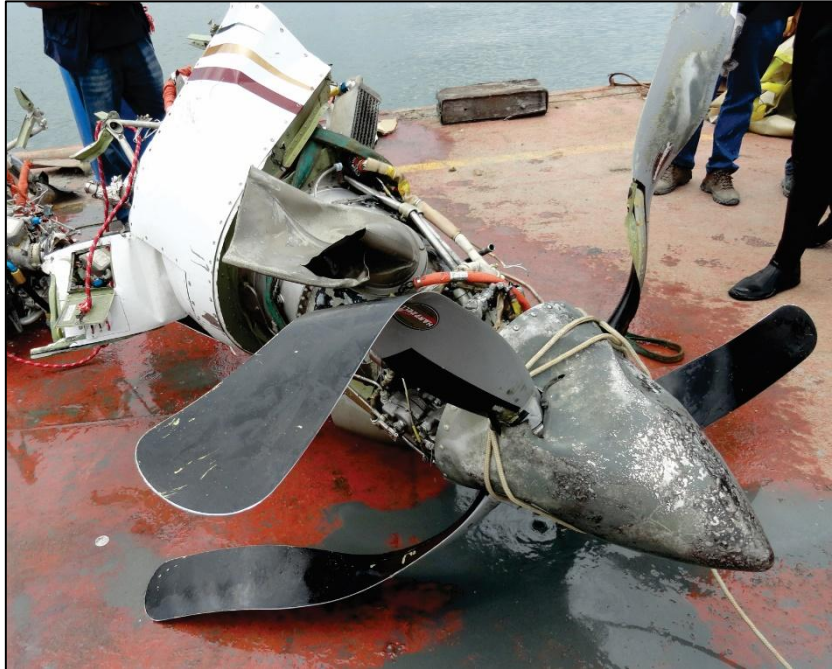
The left propeller was found fixed to the respective engine. However, the right propeller and its reduction box separated from the right engine, being found at 145.72m from this. At that site, there were also fragments of the aircraft associated with the right wing.

Figure 24 - Left engine and propeller.

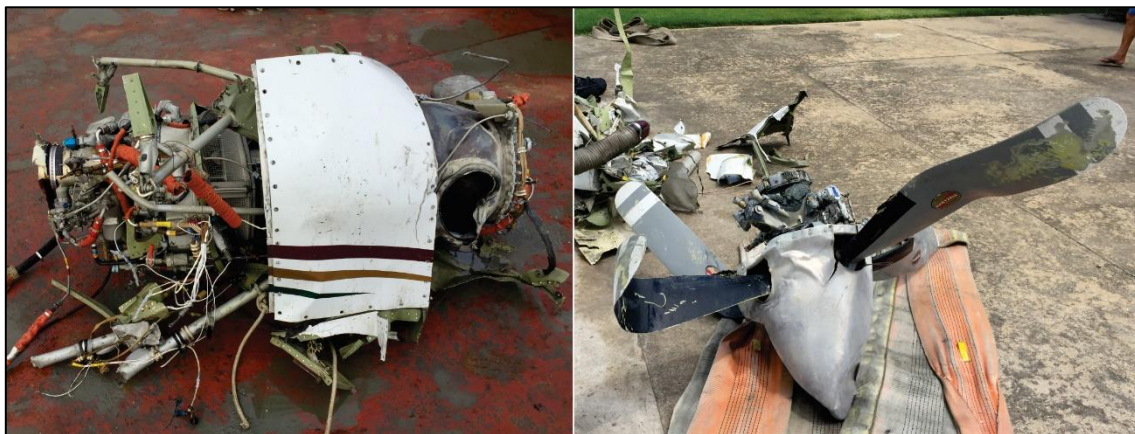
Figure 25 - Right engine and propeller.

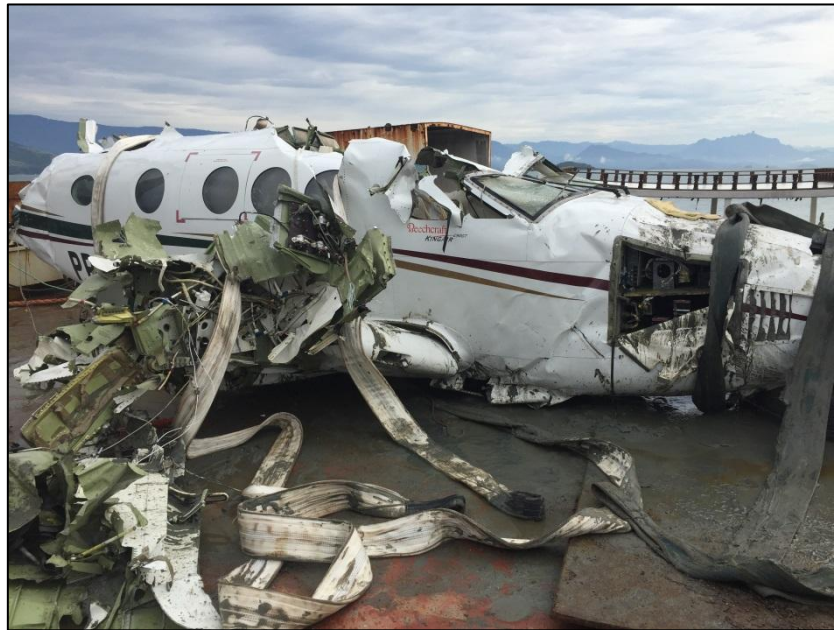
The right wing was sectioned at the inner section level of the right motor nacelle and fragmented into several pieces. The left wing was fixed to the aircraft and the damage was mainly observed on the leading edge of the outermost sections.

Most of the impact damage was concentrated on the right side of the aircraft, while the damage observed on the left side of the fuselage resulted from the rescue actions of the accident victims.

The force of resistance resulting from the impact of the right wing against the water generated a moment in its center of gravity, causing the aircraft to turn and the damages observed in the fuselage (Figure 26).

Figure 26 - Right side view of the aircraft after its removal from the sea.

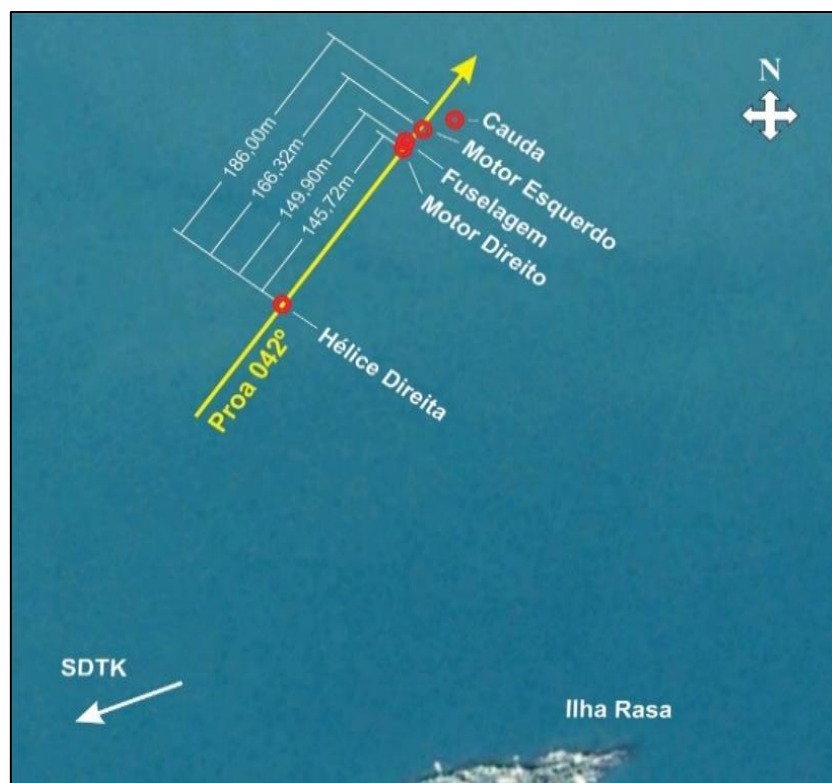
The larger mass components were thrown forward, projecting a magnetic bow corresponding to  $042^\circ$  (Figure 27).

Figure 27 - Distribution of the aircraft wreckage at the bottom of sea.

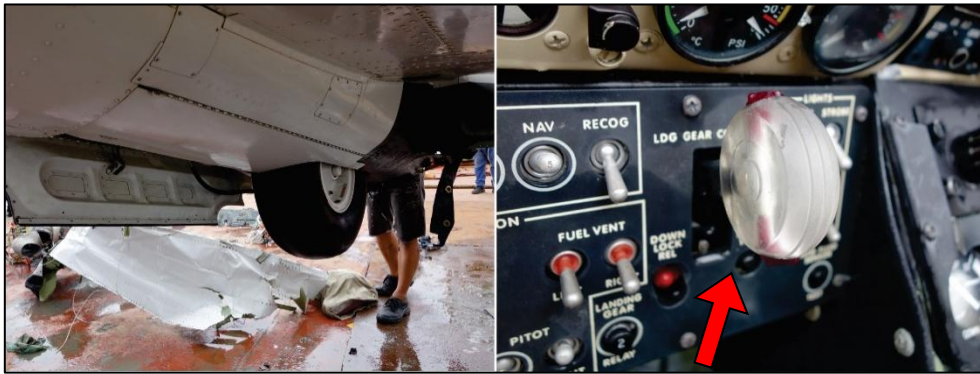
The left main landing gear and the nose landing gear were in the above locked position, corresponding to that of the control lever on the aircraft panel (Figure 28).

Figure 28 - Left landing gear positions and the control lever (red arrow).

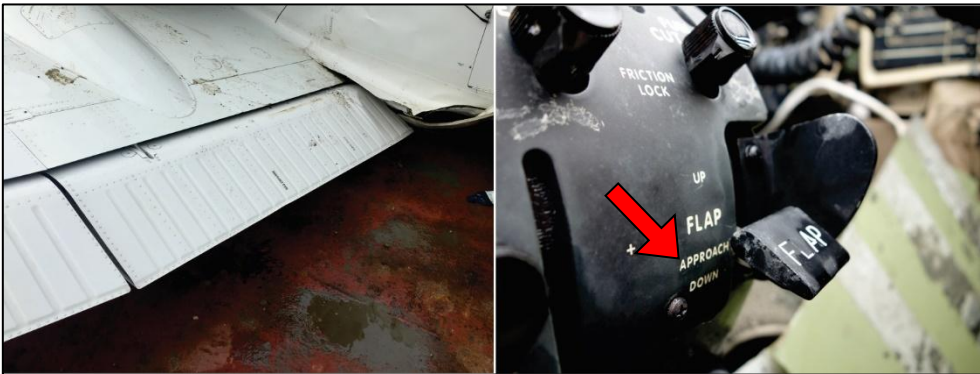
The internal and external surfaces of the flaps of the left wing were deflected in an intermediate position, corresponding to 15°. The flap lever in the cabin was in the APPROACH position (Figure 29).

Figure 29 - Position of flaps and control lever (red arrow).

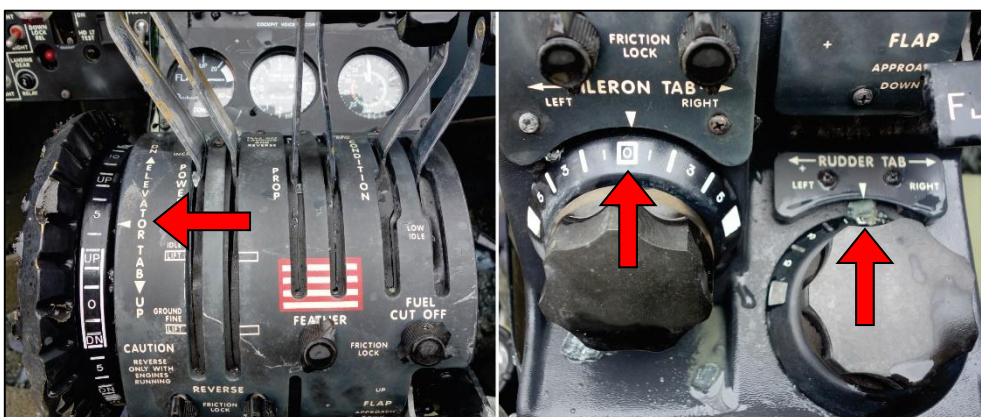
The power, propeller and fuel levers were advanced. The elevator compensator was in a position corresponding to UP 4.5, while the aileron and rudder compensators were in a neutral position.

Figure 30 - Positions of the levers and the compensators.

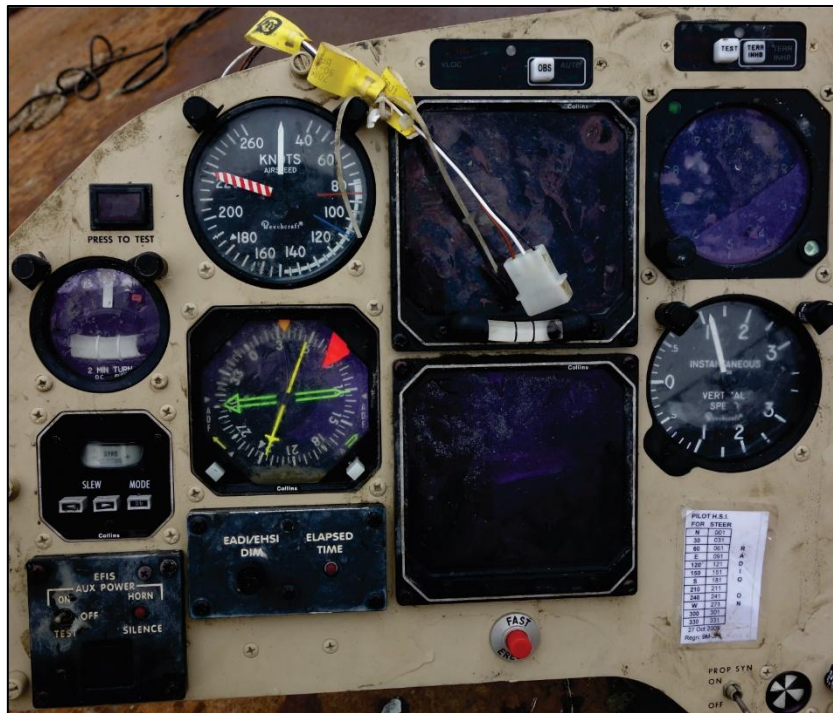
It was found that the Instrument panel of the left station had no damage due to the impact of the aircraft (Figure 31).

The propeller synchronization switch (PROP SYN) was in the OFF position.

Figure 31 - Left-hand station instrument panel.

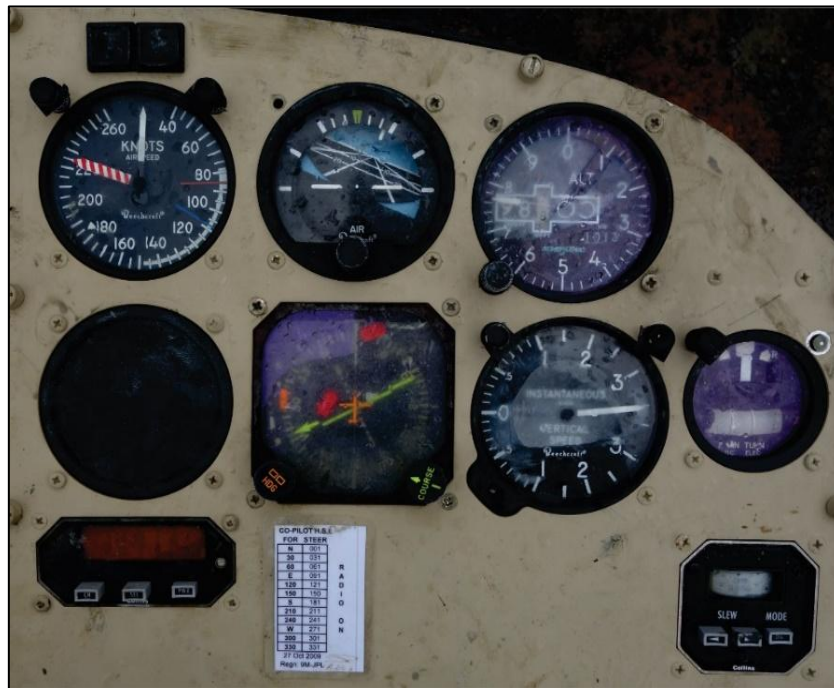
On the instrument panel of the right station (Figure 32), it was found that, similar to the panel of the left station, the airspeed indicator and the VSI had no readings indicating the aircraft's flight parameters at the time of impact.

The HSI indicated the magnetic bow corresponding to 030°.

Figure 32 - Right-hand station instrument panel.

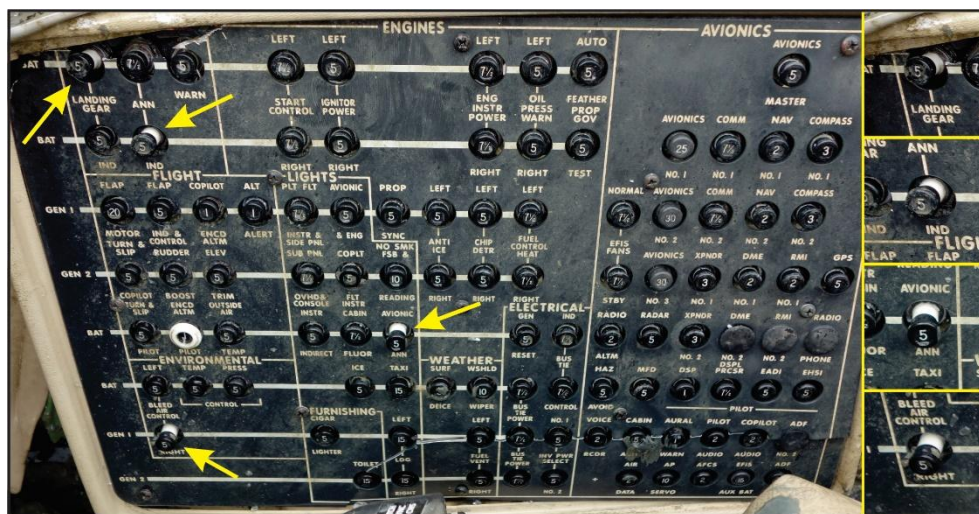
The right circuit breaker panel was broken in its upper left corner and had a crack in its lower right. It presented four disarmed circuit breakers (Figure 33).

Figure 33 - Panel of circuit breakers on the right side. On the right, the disarmed circuit breakers (yellow arrows) are highlighted.

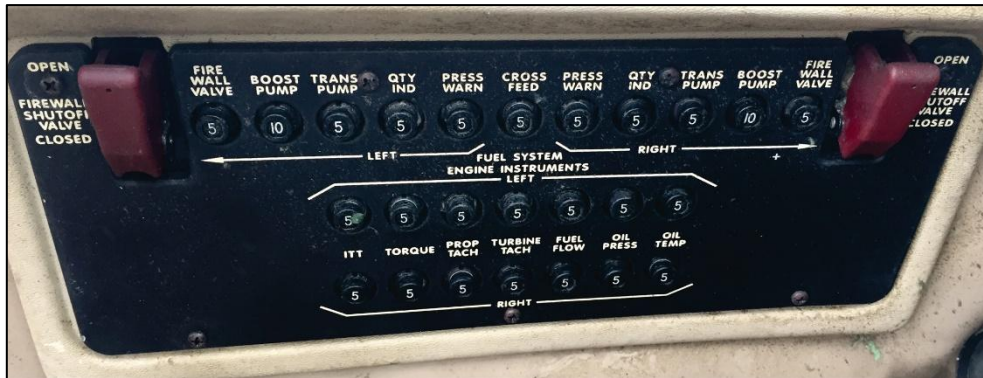
The left circuit breaker panel remained undamaged and did not have any circuit break disarmed (Figure 34).

Figure 34 - Left circuit breaker panel.

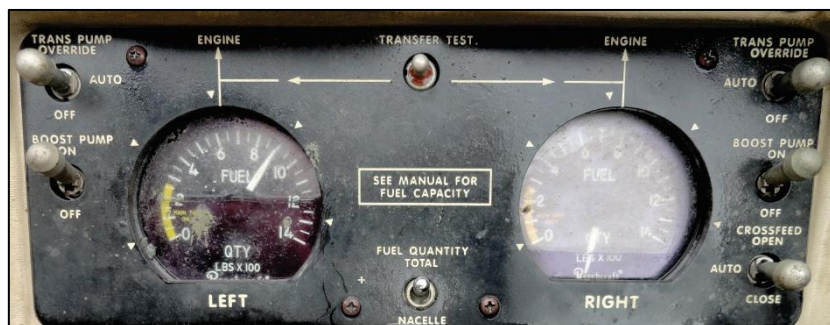
- Trans Pump Override Left - Auto
- Boost Pump Left - On
- Transfer Test - Neutral
- Fuel Quantity Total / Nacelle - Neutral
- Trans Pump Override Right - Auto
- Boost Pump Right - On
- Crossfeed - Auto

Figure 35 - Fuel control panel.

The positions of the fuel panel switches corresponded to the positions expected for a normal flight condition.

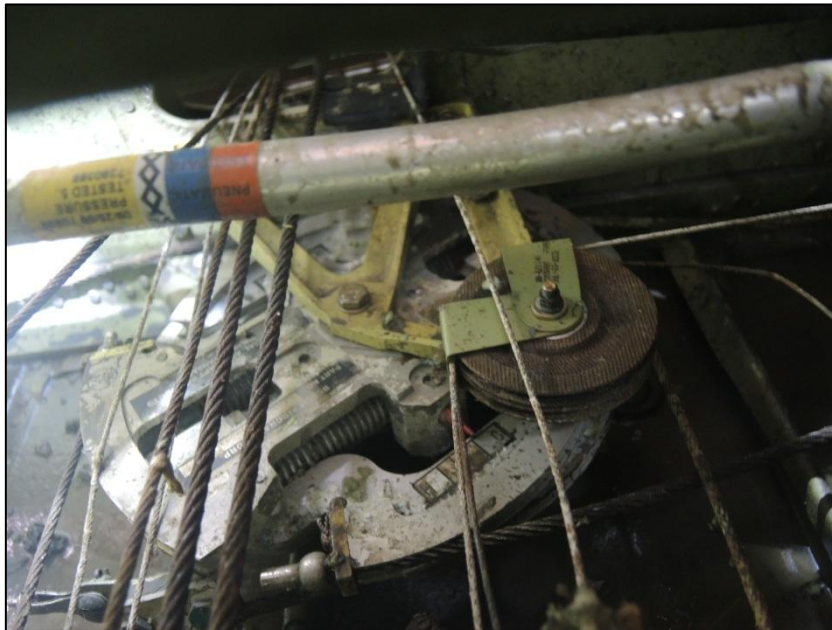
It was observed that the control cables showed signs of oxidation due to contact with salt water and exposure to the ambient atmosphere.

Figure 41 - Overview of the central quadrant on the aircraft floor with oxidation signs on the control cables of the primary surfaces and the compensators.

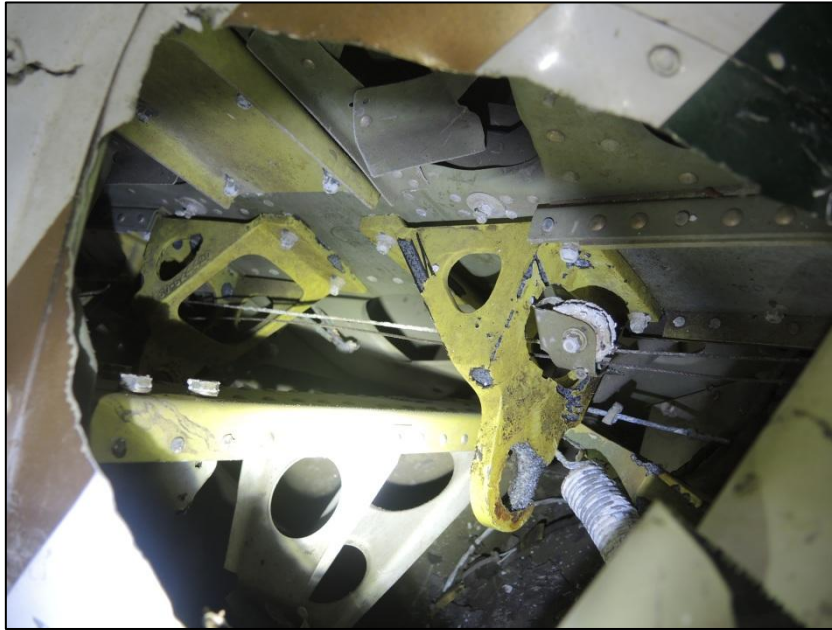
Near the point of rupture, pulleys and fractured fixtures were observed, both in the fuselage section and in the tail area. The observed damages had characteristics of overload due to the impact forces. No conditions were observed that could interfere with the authority of the elevator and rudder controls of the aircraft.

Figure 42 - Elevator control cables.
