FINAL REPORT ON INCIDENT TO M/S INDIGO AIRLINES AIRBUS A320
AIRCRAFT VT-ITF AT Mumbai ON 21/01/2017

| 14. Type of incident | : #1 Engine stall during take-off run |

M/s IndiGo Airlines A320 NEO aircraft VT-ITF (MSN 6860) operating the scheduled flight 6E-248 (Mumbai to Delhi) was involved in an incident at Mumbai (VABB/BOM) on 21st January 2017. There were 165 passengers including six crew members on board the aircraft.

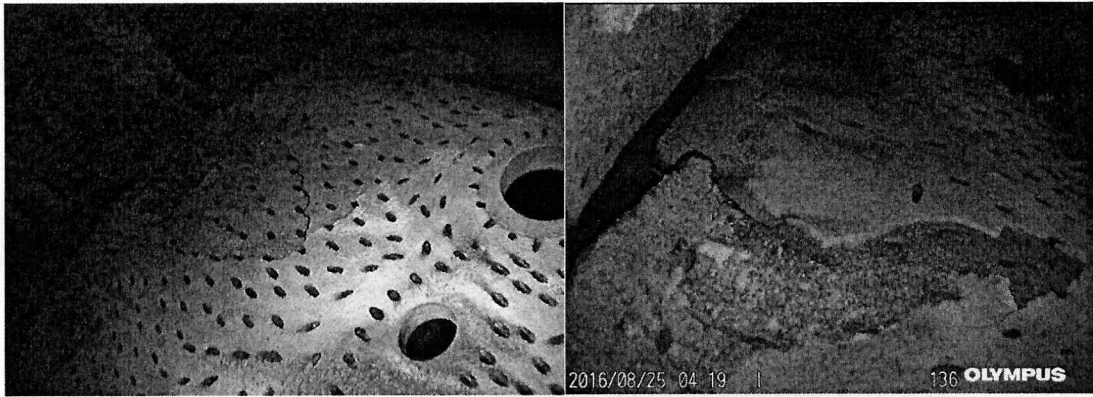
1. Observed unchanged 1" crack in Inboard Liner L2 (IBL2) & crack with raised material in Outboard Liner L1 (OBL1). Additional 1" crack found in same OBL1 segment.

Figure 1 Unchanged 1" Cracks in IBL2 on 24th August 2016

P&W disposition: If the crack is greater than 0.750 inch (19.050 mm) length maximum. Continued reduced inspection interval of 350 hours & required BSI of 1st HPT blade.

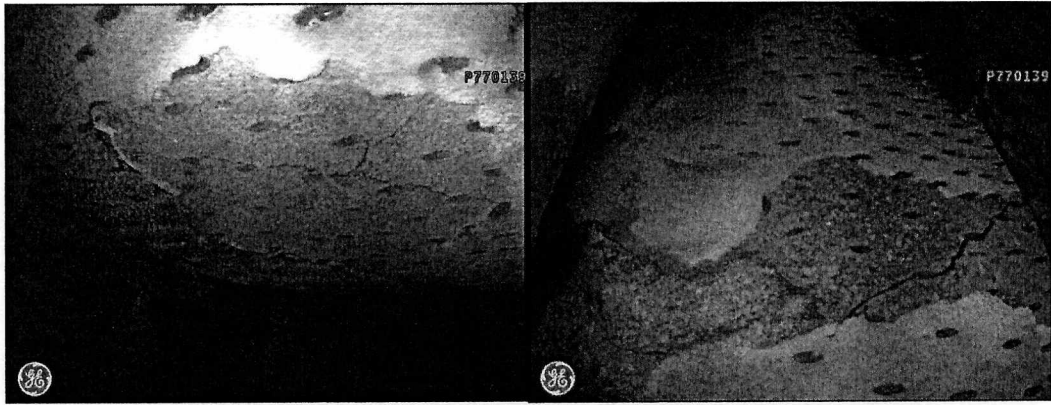
Figure 2 Crack more than 0.750" in IBL2 Segment.

Figure 3 Additional 1" crack now in OBL1 segment

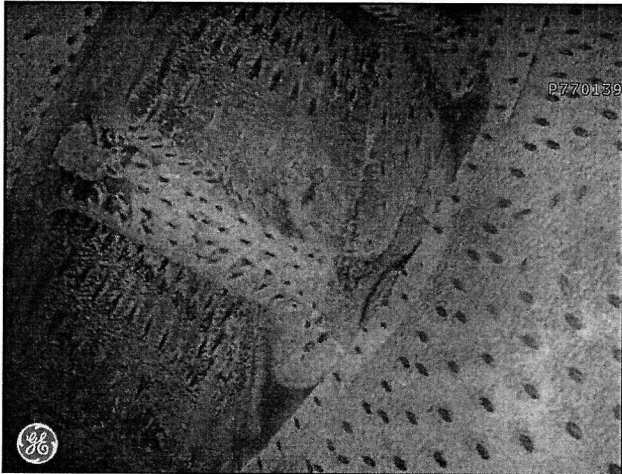
2. Observed bow wake distress in 1st vane LE platform.

Figure 4 Bow wake distress in 1st vane LE platform.

P&W disposition: All quantities up to 0.080 inch wide all around are permitted if the metallic undercoat is there. Continued reduced inspection interval of 1350 hours.

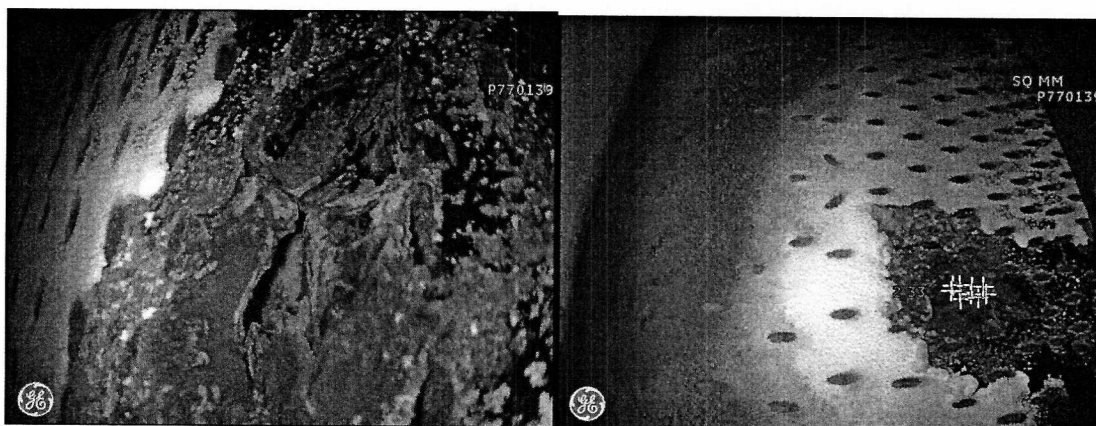
3. Observed burn-through less than 0.5" (12.7 mm) length

Figure 5 Burn Through less than 0.5"(12.7mm) length

P&W disposition: Any burnback or burn through less than 0.500 inch length maximum. It is within limits and continued reduced inspection interval for monitoring progression.

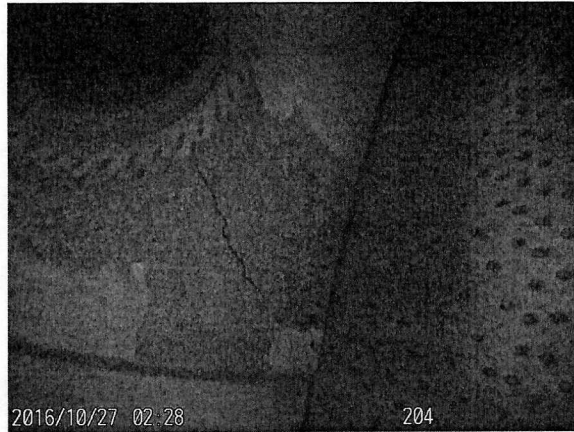
1. Crack <0.750" within zone A (Bulkhead segment)

Figure 6 Bulkhead Shell for cracking in zone A

P&W Disposition: Any crack between 0.000 – 0.750 inch length maximum.

Permitted for inspection interval of 750 hours.

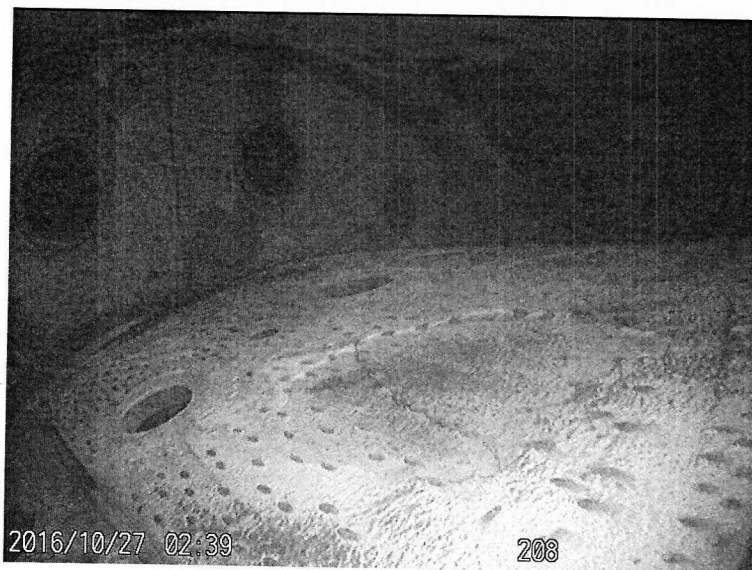
2. Crack is greater than 0.750" in rear Inner segment.

Figure 7 rear inner and outer liner segments for cracks.

P&W Disposition: Cracks with a length of less than 2000 inches, separated by less than 1500 inches and more than 0.750 inches from the circumferential edge. Permitted for inspection interval of 750 hours.

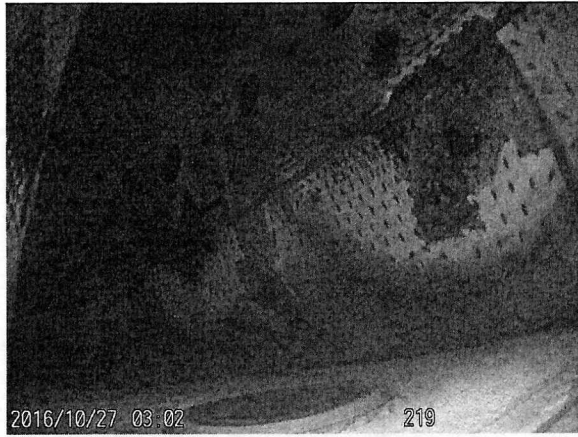
3. Crack full segment axial length (Fwd Outer segment)

Figure 8 Full segment view (FWD outer segment)

P&W disposition: 1 crack that is upto the linear segment axial length, separated from other cracks by more than 2.500 inches and more than 0.650 inches from the circumferential edge. Permitted for inspection interval of 750 hours.

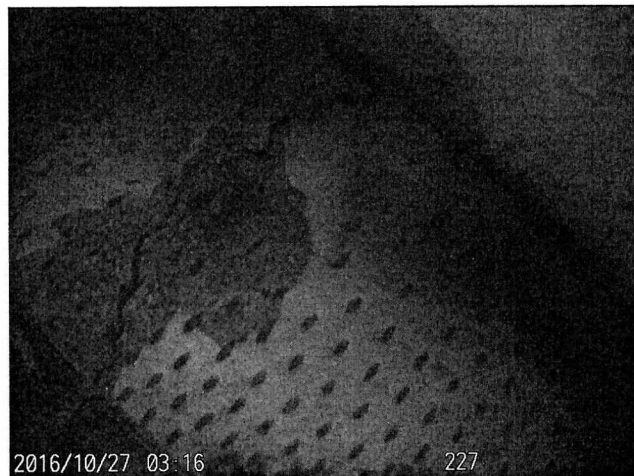
Figure 9 Close-up of full axial length crack (Fwd Outer segment)

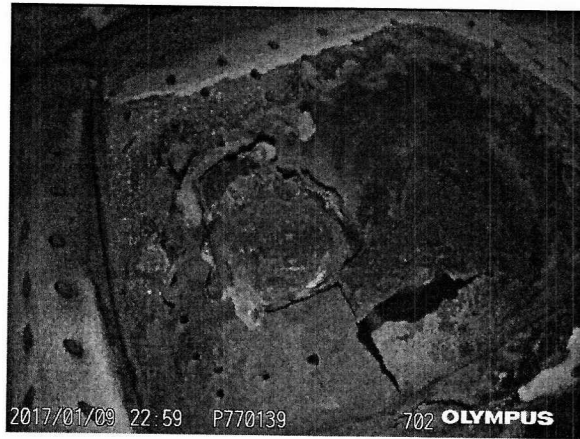
Figure 10 cracking that has led to 1 partially detached stud (OBL1 segment)

During the fourth borescopic inspection on 9th January 2017, the operator had reported that 'Stud appears partially attached to segment'. The OEM had given a disposition stating that any cracking that causes partial detachment or exposure of stud is permitted for inspection interval of 375 hours.

Any cracking that causes partial detachment or exposure of stud. Permitted for inspection interval of 375 hours.

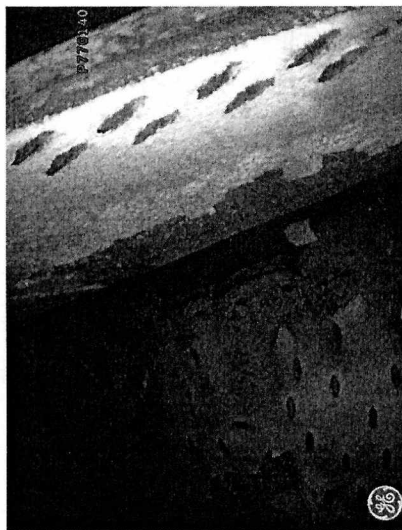
Figure 12 Burn back less than 0.500 in OBL1 Segment.

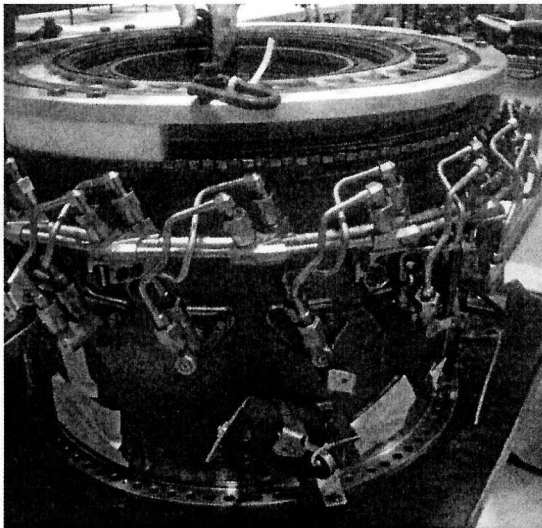
No sign of major distress or fire on the outer combustor/diffuser case (Figure 2). The fuel nozzles (Figure 3) are consistent with field run hardware, including the number 1 nozzle which is located near the burn through (Figure 4).

Figure 2: Diffuser case module

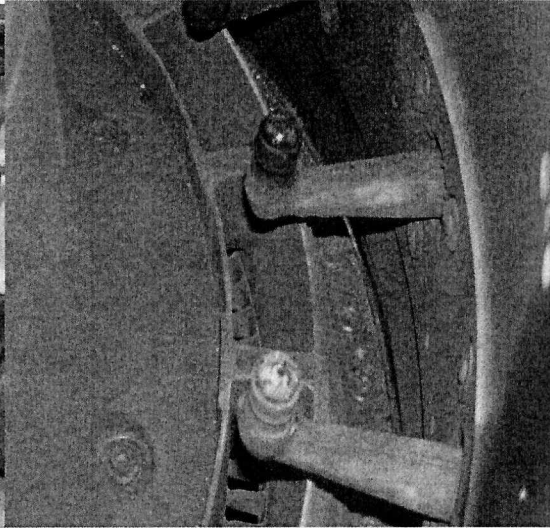
Figure 3: Installed Fuel Nozzles

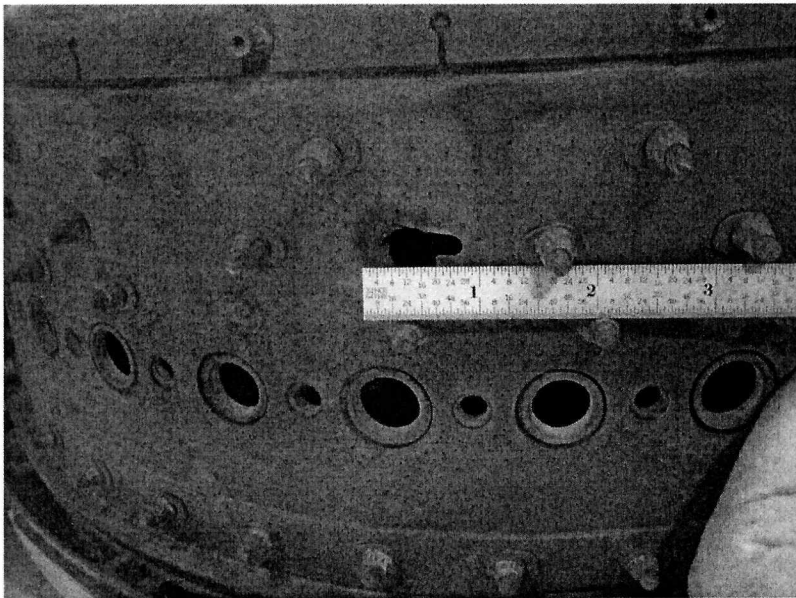
Figure 4: Hole in combustor liner with ruler for reference

A burn through hole is located at the 12:30 position on the combustion chamber outer liner and floatwall liner segment where a stud is typically located. The hole is 0.4 inches by 0.7 inches in dimensions (Figure 4). The metal around the perimeter of the hole is bent inwards (Figure 5), the stud is missing and was not found during investigation.

inches long and secured with a washer and nut (Figure 4). There is coating and parent material loss on multiple combustor floatwall segments on the outer and inner liners (Figure 6). The bulkhead also shows coating loss and cracks in the parent material. The number 1 floatwall segment where the burn through hole is located is missing 25% of parent material.

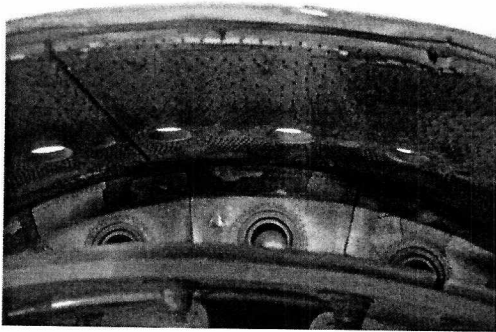
Figure 6: Floatwall segments and bulkhead

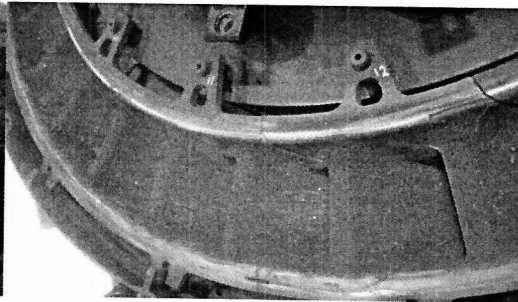
Figure 8: Black residue on 1st stage nozzle guide vanes

The 1st stage HPT vanes are all intact. The pressure side of all the vanes has a layer of black residue on the majority of their surfaces (Figure 8). This finding is consistent with exposure time on this engine and the event. Coating erosion was noted on the trailing edges on the non-pressure side for the majority of vanes.

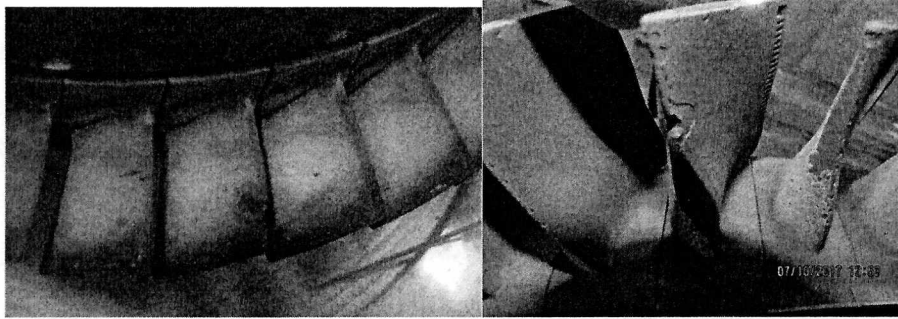
All 1st stage blades and disk are intact. Three blades have impact damage on the non-pressure side on the outer 50% of their span (Figure 10). These three blades exhibited displacement of the trailing edge forward at the damage location. There was coating loss on the leading edge on majority of blades.

All 2nd stage vanes are intact. The leading edge of the non-pressure side has coating loss. There is one blade with an impact indication at the centre of the trailing edge on the non-pressure side (Figure 11).

Figure 10: Impact damage on 1st stage HPT blade Figure 11: Impact damage on 2nd stage HPT blade

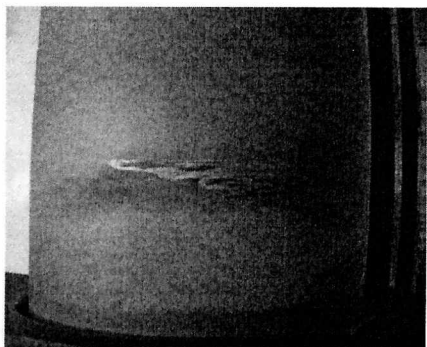
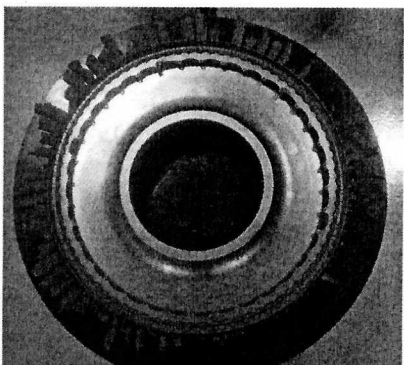
Multiple rub indications were found along the same side of the LPT shaft. The largest rub extended half of the shaft circumference and was 7/8 inches wide (Figure 13, right hand photo, bottom rub).

All 3rd stage blades were visibly damaged (Figure 16). An arc encompassing 40% of the disk had blades fractured above and close to the platform (1:00 to 6:00 in Figure

Figure 13: multiple rubbing indications on LPT Shaft

Figure 16: 3rd stage rotor/blades removed from LPT

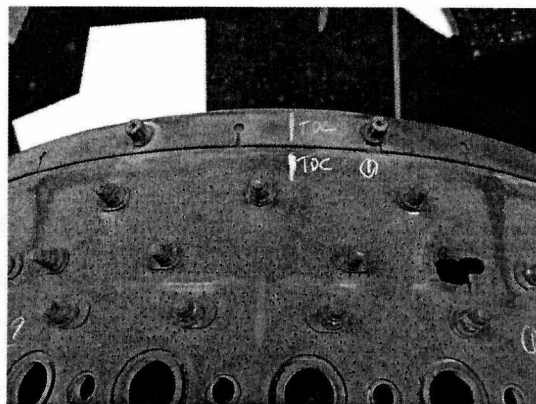
The combustion chamber was then removed and returned to Pratt and Whitney for disassembly and further detailed visual evaluation. Combustor P/N 30G4038 is the current Bill of Material combustor and termed the "Block B" configuration. As mentioned during the field report, the major distress was located at the 12:30 position (aft looking forward) on the row 1 OBL panel segment. The burn through corresponded with a location where there is a panel attachment stud (Figure 18).

Figure 18: Outer Combustion Chamber Burn

The combustor floatwall segments displayed coating thermal distress throughout including localized areas of parent material loss. There was a burn through hole at the 12:30 position on the combustion chamber outer liner and floatwall segment where a stud is typically located. The distress in the combustor of this engine is within PWs experience for a Block B combustor configuration, and was on a recurring inspection interval for combustor distress.

This is the first instance of this type of failure on a PW1100G-JM engine. As this engine was currently under a recurring inspection interval, PW has revised its combustion chamber limits specifically regarding how much distress is allowed around panel attachment studs. The new limit was released on Engineering Authorization (EA) 16CCE00A on February 1, 2017 and is consistent with proven limits on legacy PW commercial engine products.
