**SERIOUS INCIDENT**

<b>Aircraft Type and Registration:</b>	Dornier 328-120, D-CTRJ	
<b>No &amp; Type of Engines:</b>	2 Pratt & Whitney Canada PW119C turboprop engines	
<b>Year of Manufacture:</b>	1994 (serial no: 3015)	
<b>Date &amp; Time (UTC):</b>	26 January 2017 at 1513 hrs	
<b>Location:</b>	Sumburgh Airport, Shetland	
<b>Type of Flight:</b>	Certification test flight	
<b>Persons on Board:</b>	Crew - 2	Passengers - 2
<b>Injuries:</b>	Crew - None	Passengers - None
<b>Nature of Damage:</b>	None	
<b>Commander's Licence:</b>	Airline Transport Pilot's Licence	
<b>Commander's Age:</b>	64 years	
<b>Commander's Flying Experience:</b>	10,379 hours (of which 4,035 were on type) Last 90 days - 75 hours Last 28 days - 16 hours	
<b>Information Source:</b>	Aircraft Accident Report Form submitted by the pilot and further information from EASA following post-flight data analysis

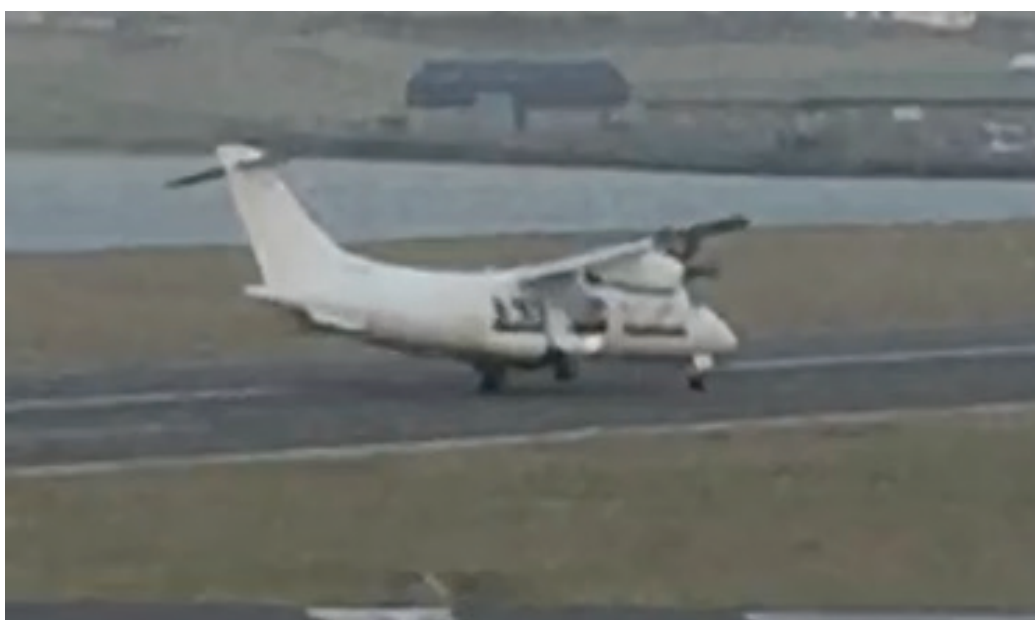
**Figure 1**

Right main landing gear lifting off the runway

Flight data showed that, during the first 1.5 seconds after touchdown, aileron deflection increased to approximately 14° in a 'roll right' sense. Over the following 5.5 seconds, the aileron deflection reversed to reach approximately 11° in a 'roll left' sense as the right main landing gear lifted from the runway.

The PF stated that he had attempted to regain control on the runway through the application of asymmetric braking and cancellation of reverse thrust. While doing so, he inadvertently relaxed the left aileron input causing the right wing and main landing gear to lift off the ground.

The aircraft commander considered that, when the right main landing gear lifted from the runway, the aircraft began to “weather-cock” into wind. Subsequently, there was insufficient directional control in the strong crosswind conditions to prevent the aircraft from leaving the runway.
