INVESTIGATION
REPORT
ON INCIDENT TO M/s GO AIRLINES
A320N AIRCRAFT VT-WGB

DUE
IN-FLIGHT SHUT DOWN AT DELHI ON
08TH FEB 2017.

**REPORT ON INCIDENT TO M/s GO AIRLINES (INDIA) LTD AIRBUS A320N AIRCRAFT VT-WGB AT
DELHI ON 08TH FEB 2017.**

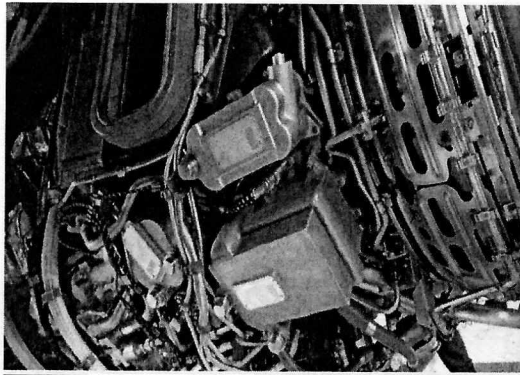
RH Core

1. Fan and N2 rotation is OK. Not seized. Slight squeaky sound from N2
2. On removal of N2 drive pad for BSI facilitation. Abnormal quantity of Oil drained out (10 liters) from drive pad which is normally dry.
3. No external oil leaks seen in Core engine.
4. Oil seen at the last stage turbine with oil smeared on the aft center body. Coking seen on the 05:30 o' clock strut of ALF turbine.
5. Engine Air inlet area is clean.
6. The MCD except for MGB had nil findings. Also when the MGB MCD was pulled out, oil just poured out due to particles blocking the self-sealing feature.

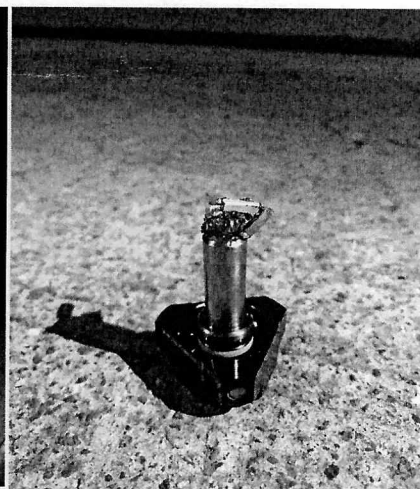
MGD Metal Chip Detector

1. Oil leak was observed from Engine#1 Exhaust and oil quantity visually checked observed not within gaugable limit.
2. Found oil splashes on engine exhaust area.
3. Fan inlet/exhaust area visually checked no damage observed.
4. Chip detectors of No 1, 2, 3 and 4 bearing were checked and NO CHIP observed
5. Metal chips were found in MGB chip detector.
6. Upon` removal of MGB chip detector, oil drained out up to a bucket.

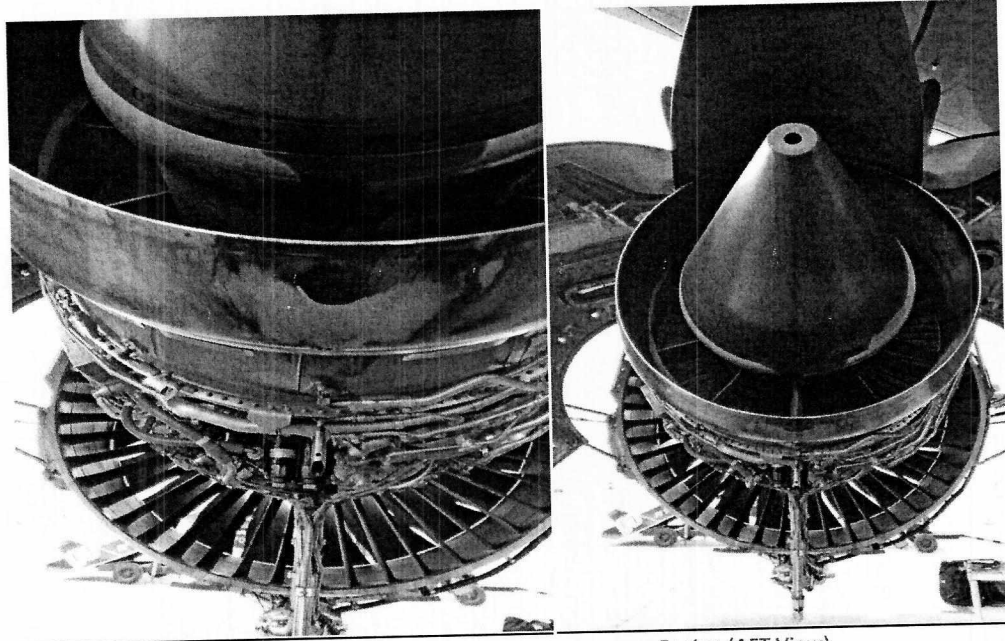
Bottom view of Engine

Tailpipe Fire from Engine No 1 was noticed by passengers and Cabin Crew and the same was reported by Cabin crew to the Cockpit Crew. However during strip examination no fire marks were observed.

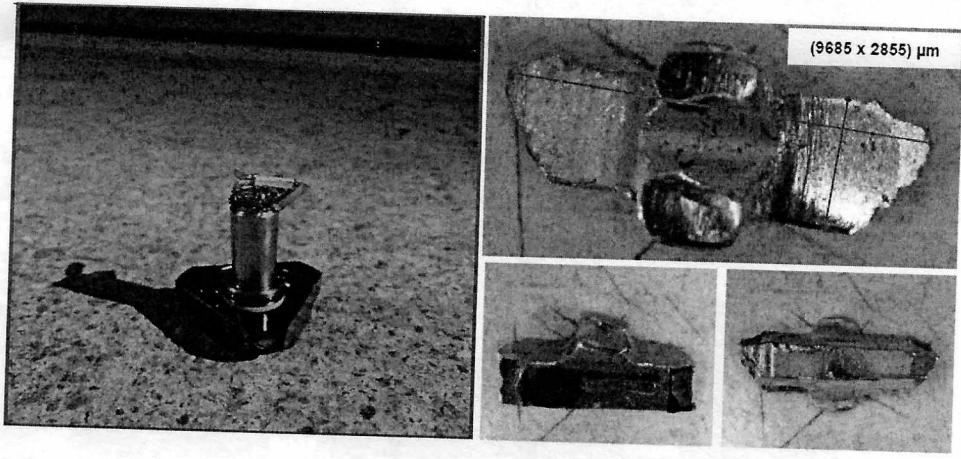
1. It was found that there is presence of M50 and low alloy steel particles similar to UNS G43400 (larger particles found with silver plating) observed in the oil samples and in the debris.
2. Presence of an interaction between low alloy steel particles and 300 stainless steel particles (best possible match is probably 17-7 PH). This interaction was observed in the previous oil samples from this engine.

a) Metal Particles of Main gear Box on Magnetic chip Detector
 b) Metal particles found in the oil samples.

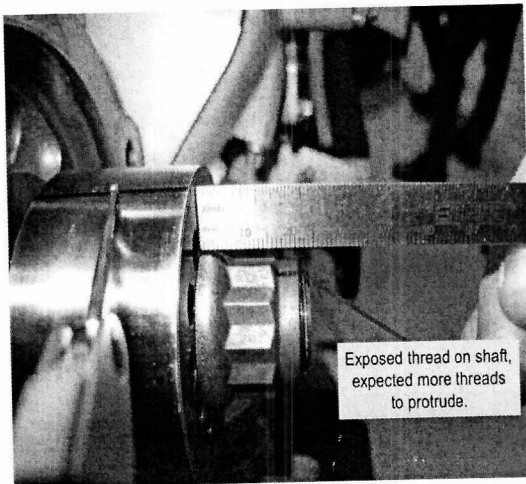
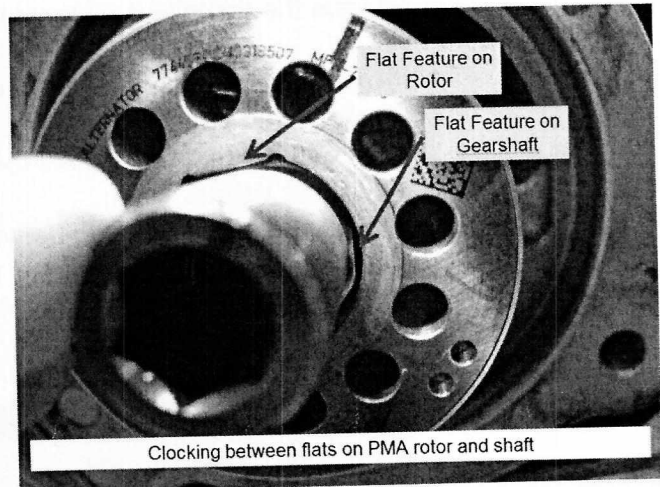
1. The Permanent Magnet Alternator (PMA) rotor was out-of-position axially and circumferentially on the PMA gear shaft. PMA Rotor was incorrectly installed on gearshift during assembly allowing slinger to spin freely on gearshaft.

The cause of the incident was an error during assembly stage as the PMA Rotor was incorrectly installed on gearshift which over the period of time generated FOD and eventually resulted in to chip warning and subsequently engine shut down.

1. In reference to finding 3.1. (m) DGCA may direct all operators to ensure that their certifying staff needs to follow DGCA approved documents/requirements strictly during certification work.
2. During assembly the PMA rotor was installed out-of-position axially and circumferentially on the PMA gear shaft which was observed during Strip examination of the engine. DGCA may take up the matter with P & W regarding the error during assembly stage of the engine.

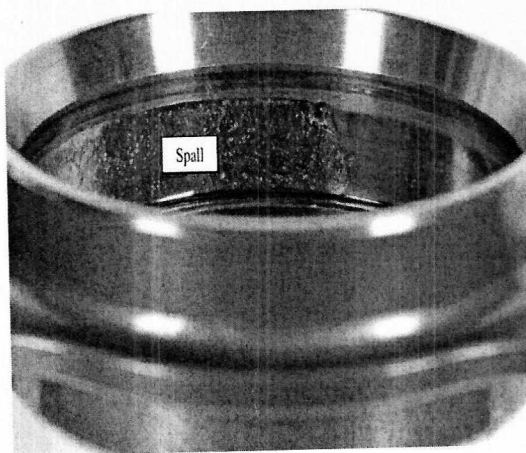
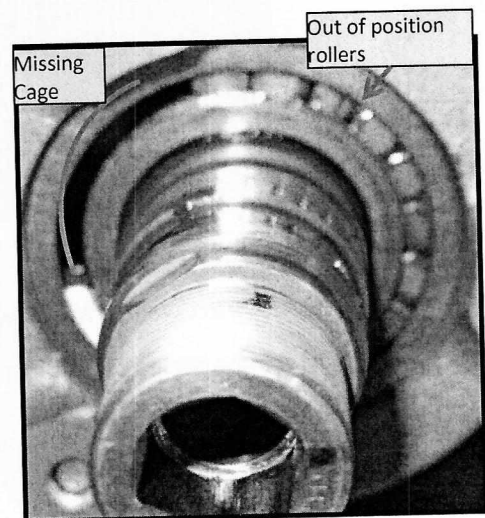
2. Foreign Object Damage (FOD) from the loose nearby slinger initiated a spall on the PMA bearing race. Also increased vibration loads from the spall caused the cage to fracture.

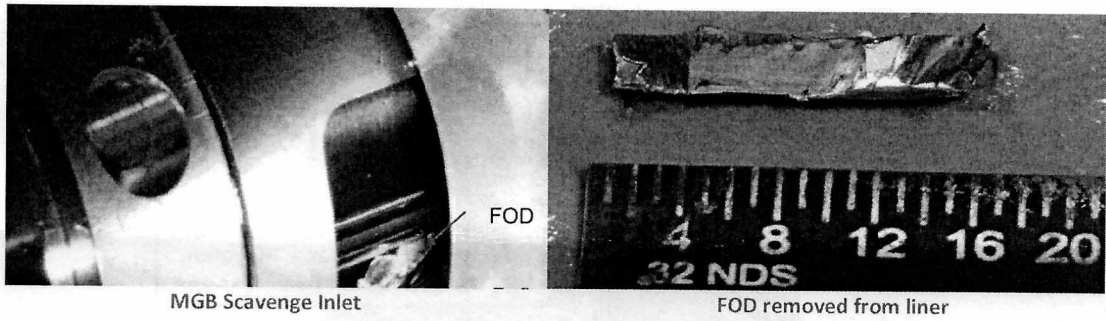
3. Large FOD found on the Chip Collector in the MGB Scavenge return and scavenge stack of Lube & Scavenge Oil Pump (LSOP) was seized and did not spin freely. It was

identified that last chance screen was not included on MGB Scavenge return due to design escape and missing screen allowed bearing cage FOD to be ingested into pump.

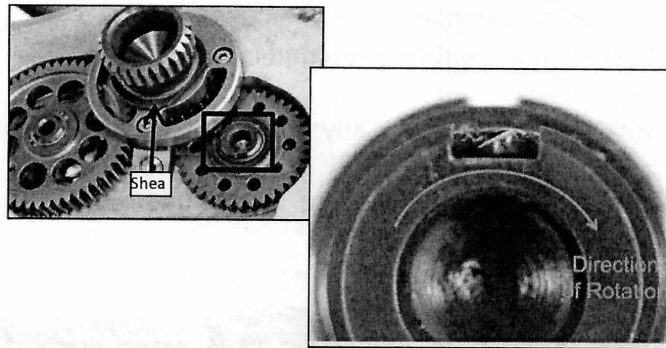
4. Input drive and Lube stack spun freely and the scavenge stack did not spin when the input drive was spun.

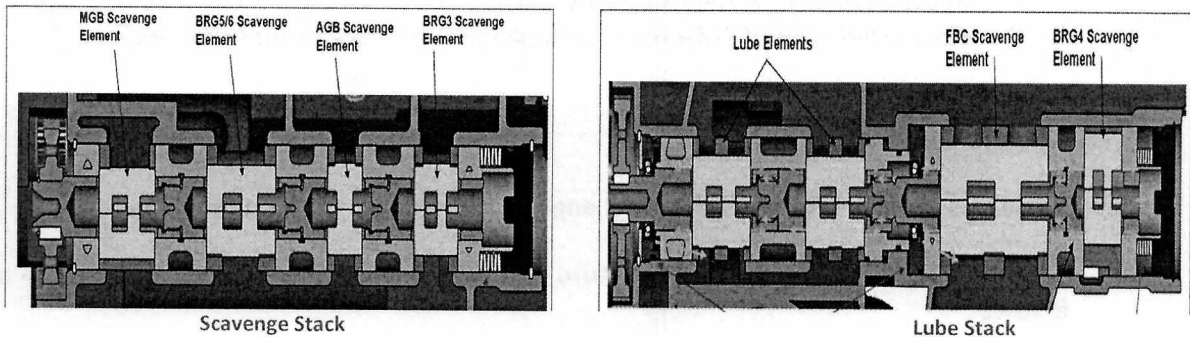
5. Scavenge stack seized prior to shear neck as intended and also the Lube stack continued to pump oil to the entire lube system. Hence MGB, AGB, #3BC, and #5/6 BC flooded due to loss of scavenge function.

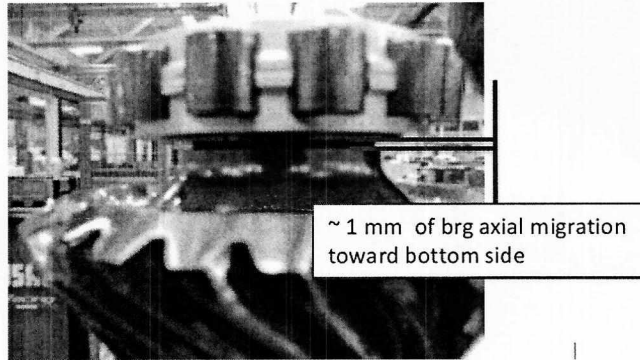
The lube scavenge pump scavenge stack did not rotate when the input gear was turned by hand. During detailed examination it was identified that the PMA rotor was not completely seated on its gear shaft and fractured the PMA bearing cage which over the period of time generated metal debris and eventually resulted into chip warning.
