Aircraft Accident Final Report –
C172 – 8R-AFS Training Flight Accident
at CJIA on 27th March, 2017

TITLE

REPORT No. GAAIU 3/1/14

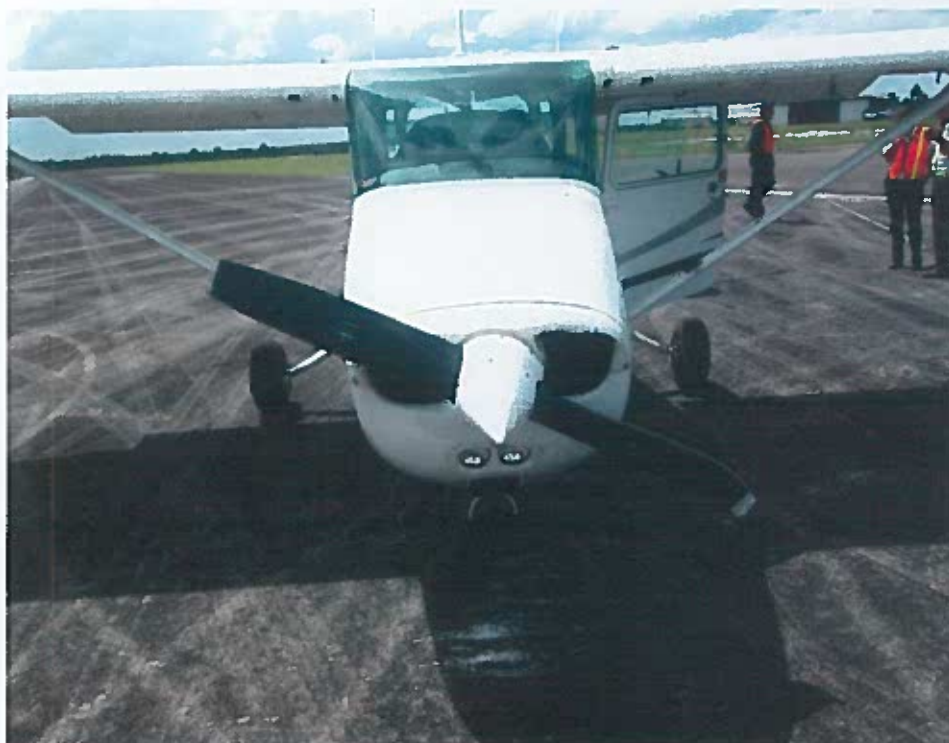
The aircraft touched down on its nose wheel which became separated from the nose wheel fork. The aircraft continued travelling along the runway, skidding on the nose wheel fork. This resulted in the nose wheel fork being eroded to approximately half its original length. The nose oleo strut was fully decompressed. Both propeller blades were broken at the tips. The engine and propeller suffered from the sudden stop. The propeller and the nose landing gear suffered extensive damages.

Picture #1 – showing damage to nose wheel fork and propeller blades

1. The aircraft had a valid Certificate of Airworthiness and was maintained in compliance with regulations.
2. There were no outstanding maintenance or MEL issues with the aircraft.
3. The aircraft bounced on touchdown and then touched again on its nose wheel. This caused the nose wheel to be separated from its fork.
4. The aircraft's engine, propeller blades and nose and nose wheel were damaged in this accident.
