AIRCRAFT ACCIDENT REPORT AND EXECUTIVE SUMMARY

Reference:	CA18/2/3/9615	
Aircraft registration	ZS-VDM	Date of accident	22 April 2017		Time of accident	0810Z
Type of aircraft	Bell 430 (Helicopter)		Type of operation	Private (Part 91)		
Pilot-in-command licence type	Commercial		Age	30	Licence valid	Yes
Pilot-in-command flying experience	Total flying hours		1 480.0		Hours on type	91.3
Last point of departure	Grand Central Aerodrome (FAGC), Gauteng Province					
Next point of intended landing	Spartan Helistop, Kempton Park, Gauteng Province					
Location of the accident site with reference to easily defined geographical points (GPS readings if possible)						
Spartan Helistop (GPS position; 26°07'20.0" South 028°13'02.0" East), elevation of 5516 feet AMSL						
Meteorological information	Surface wind; 360°/6kt, Temperature; 20°C, Dew point; 5°C, CAVOK					
Number of people on board	1 + 1	No. of people injured	0	No. of people killed	0	
Synopsis

AIRCRAFT ACCIDENT REPORT

Name of Owner : Quantum Leap Investment 572 (Pty) Ltd
Name of Operator : National Airways Corporation
Manufacturer : Bell Helicopter Textron
Model : 430
Nationality : South African
Registration markings : ZS-VDM
Place

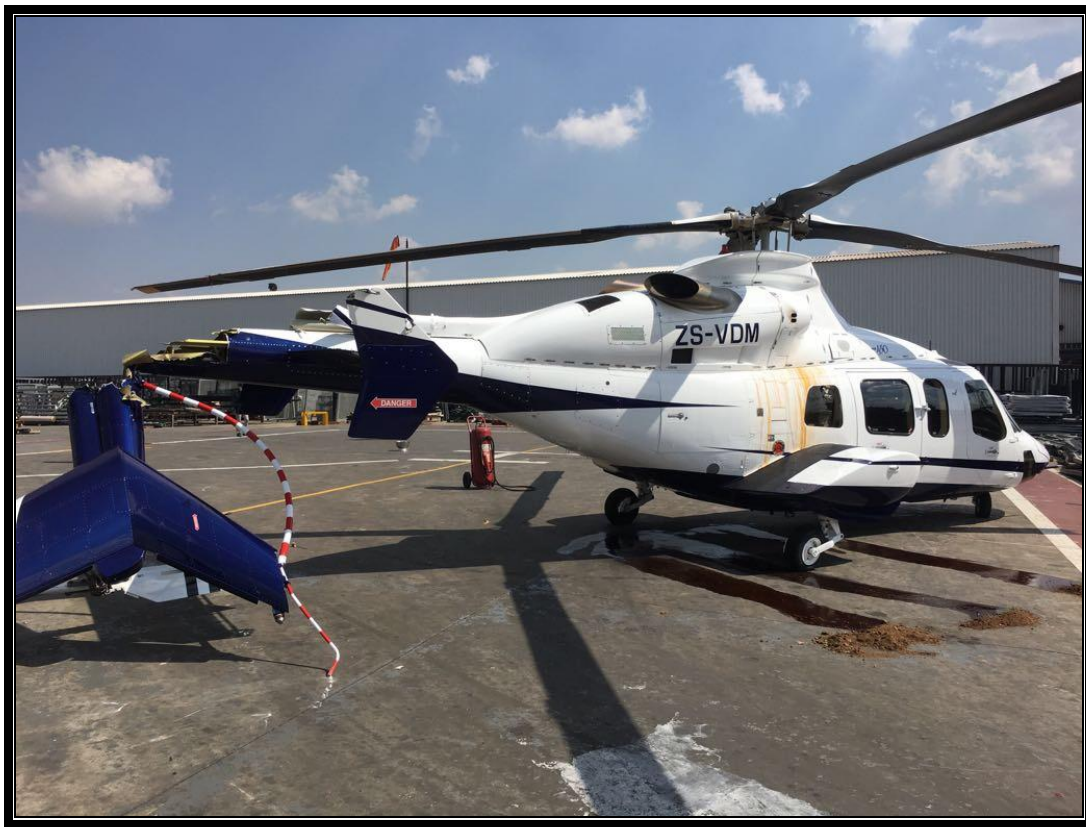
1.3.1 The helicopter sustained substantial damage when the main rotor blades severed the tail boom. Damage was also caused to the main transmission, the transmission deck and the airframe structure.

Figure 1: The helicopter as it came to rest on the helistop

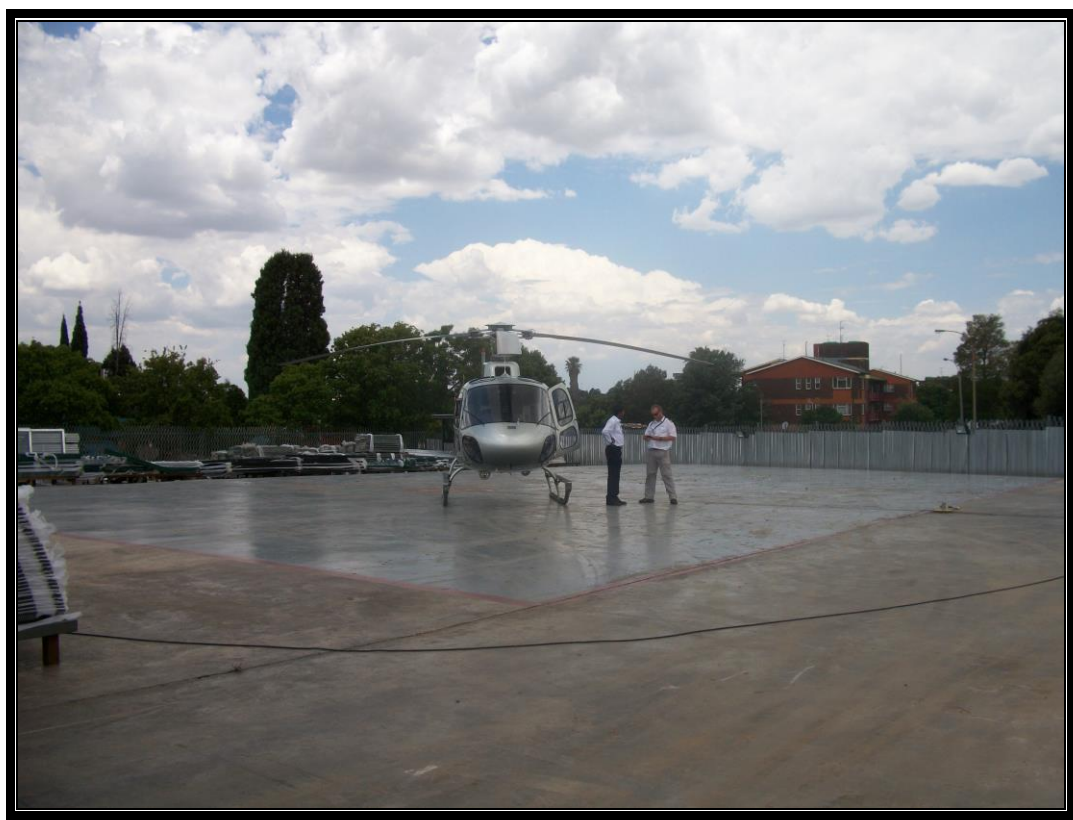
Figure 5: A photograph of the Spartan helistop with an AS350B2 parked on it.

The Spartan helistop is a private helistop owned by a large international steel company located in the Spartan Industrial area. It was designed for day time VFR operations only. Every helicopter pilot that intending to make use of the helistop is to ensure that he/she is familiar with the standard operating procedures before any intended flight. The helistop had stacked steel structures on the north and southerly side of the helistop. The helistop had a slight north easterly down slope for water drainage.

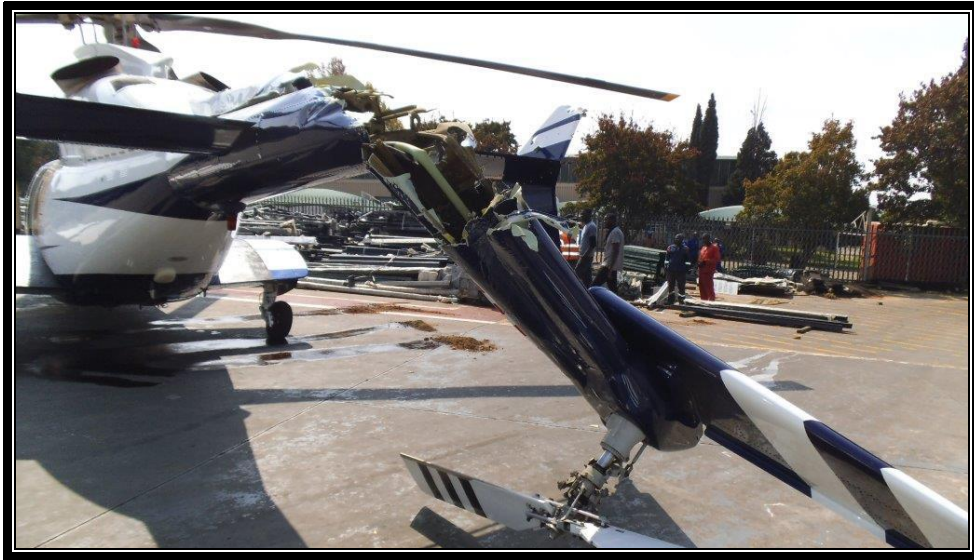
1.12.1 The helicopter had landed on the helistop and all three main wheels were on the ground. It then started rolling forward slowly, the pilot stated that she applied the toe brakes but it had no effect, she then applied back pressure on the cyclic control stick in an attempt to stop the forward rolling motion. The main rotor blades contacted with vertical stabiliser and severed the tail boom.

Figure 7: The severed tail boom structure.

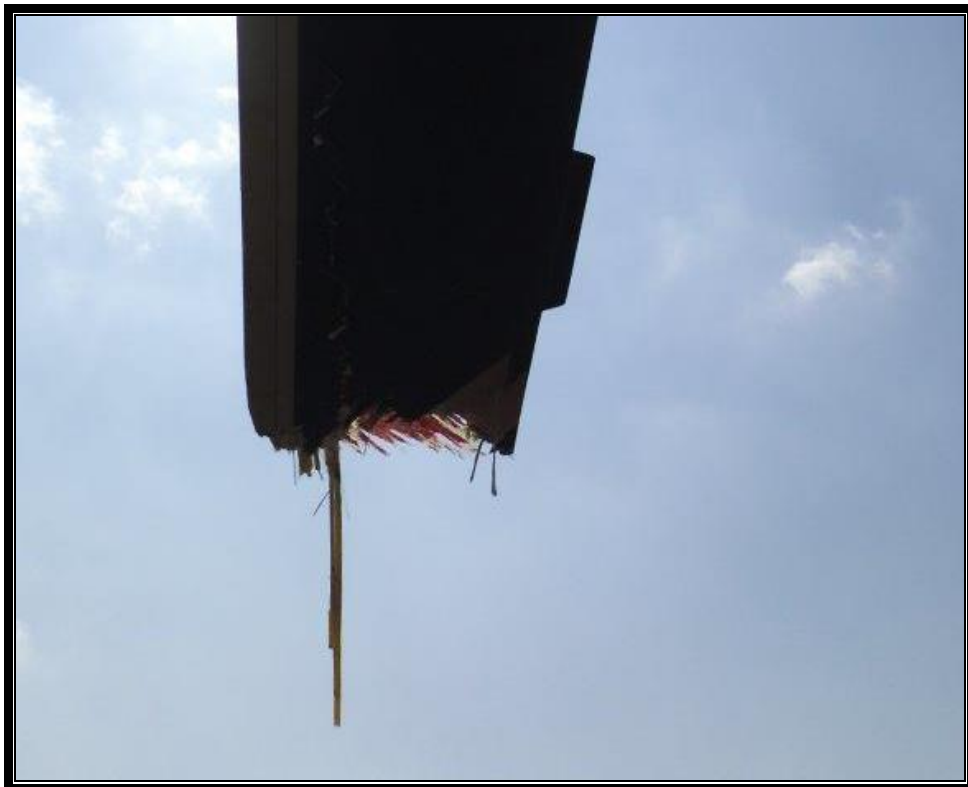
- 1.4.1 Minor damage was caused to some vegetation when a section of one of the main rotor blades separated and was projected some distance from the helistop.
- 1.4.2 A fencing wall of the nearby residential property was damaged by the same piece of main rotor blade that separated.

Figure 8: Damage to one of the main rotor blades.

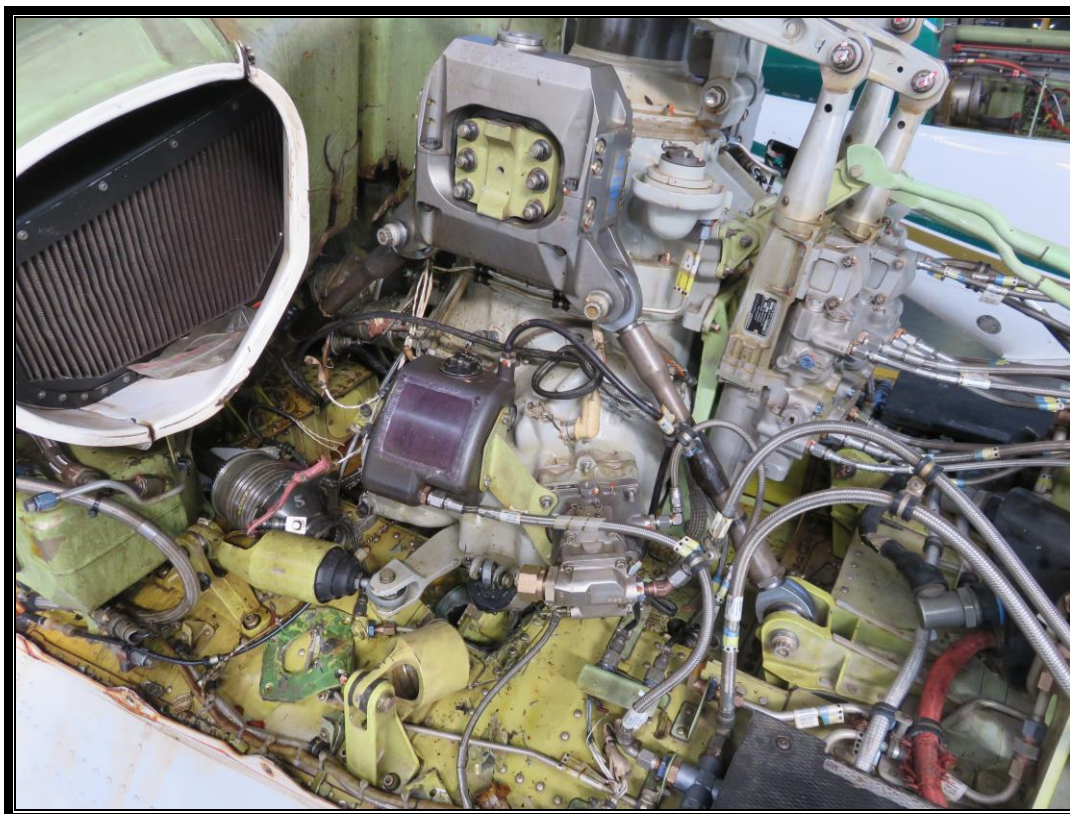
- 1.1.6 Neither of the two occupants was injured. They exited the helicopter after it came to a stop. It was observed that the main rotor blades had severed the tail-boom and substantial damage was caused to the main transmission, with transmission oil leaking from the transmission deck onto the ground from both sides of the fuselage.

Figure 9: A view of the transmission deck taken from the right-hand side of the fuselage.

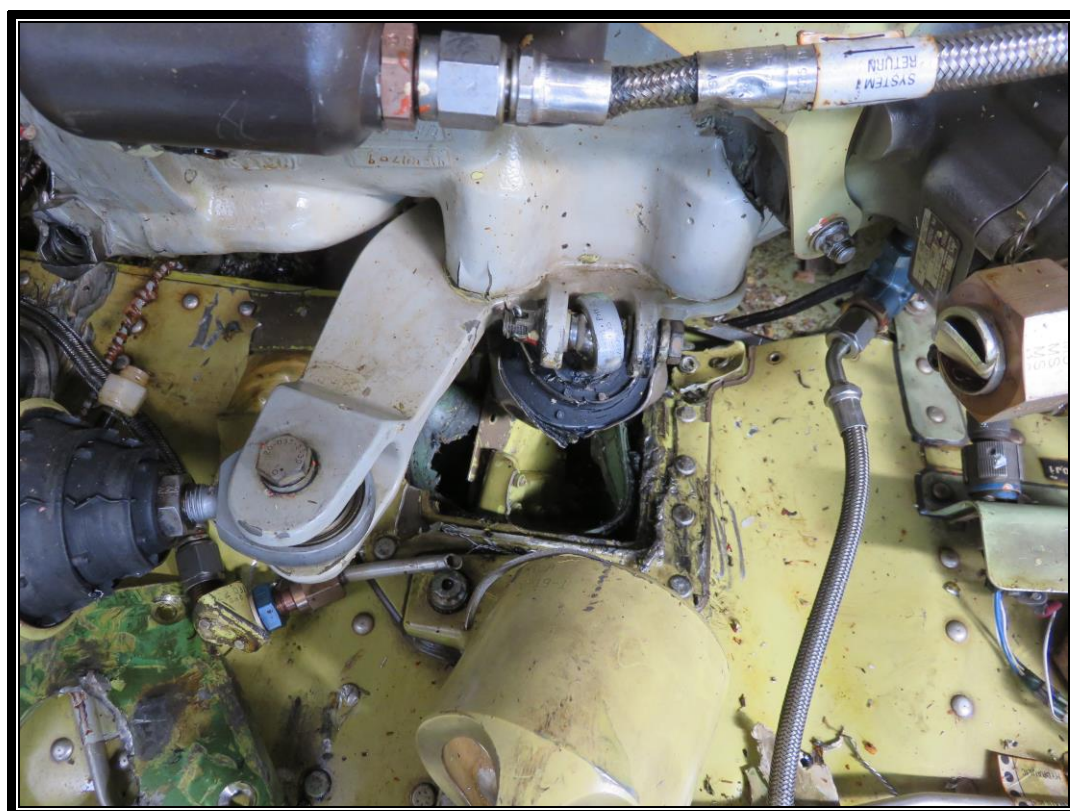
Figure 10: Structural damage caused by a lateral isolation mount that failed.

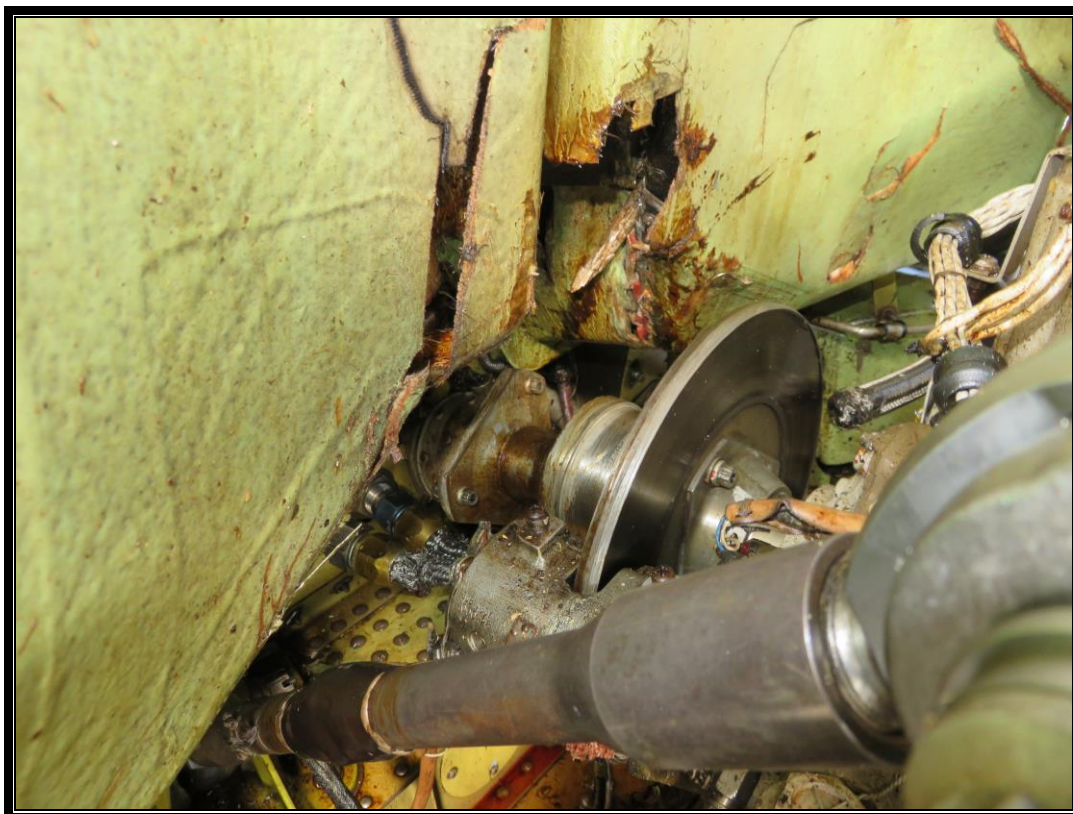
Figure 11: Damage caused by tail rotor drive shaft that failed aft of the rotor brake assembly.

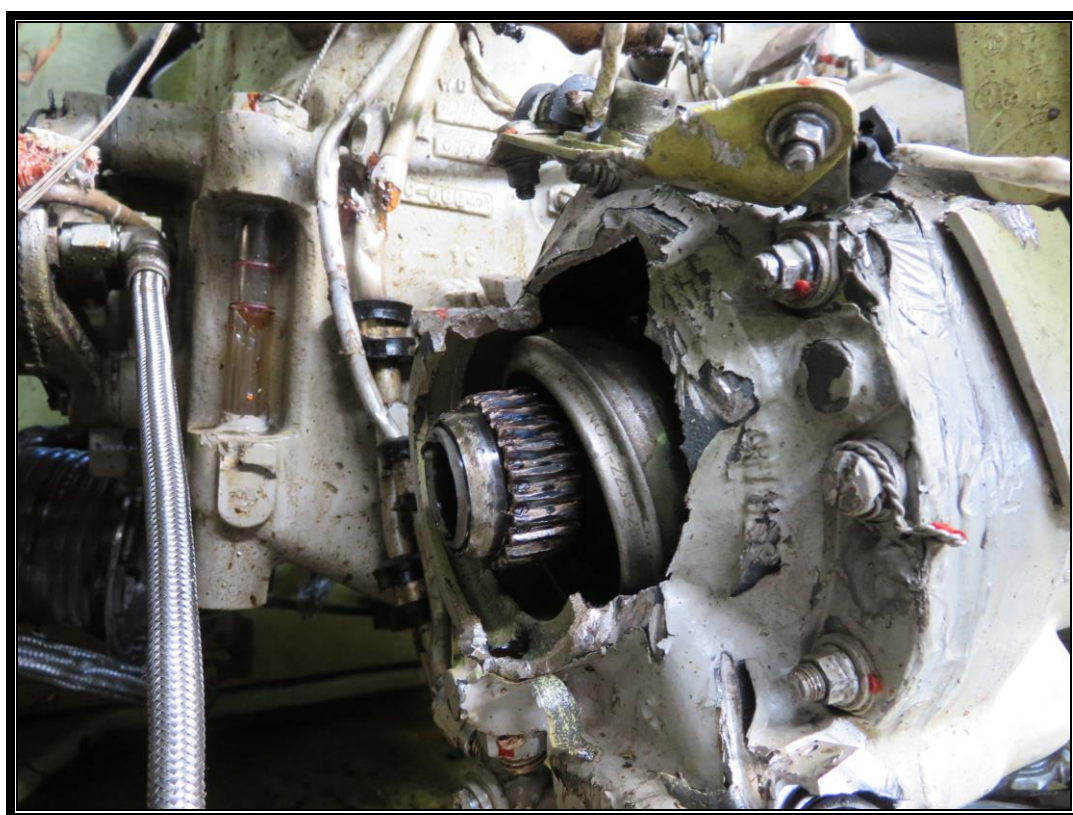
Figure 12: Number 2 engine drive shaft coupling housing on the main rotor gearbox.
