**FINAL REPORT ON ACCIDENT**

**DIAMOND DA-42 AIRCRAFT VT-NFM**

**NATIONAL FLYING TRAINING INSTITUTE**

**ON 26/04/2017 AT GONDIA**

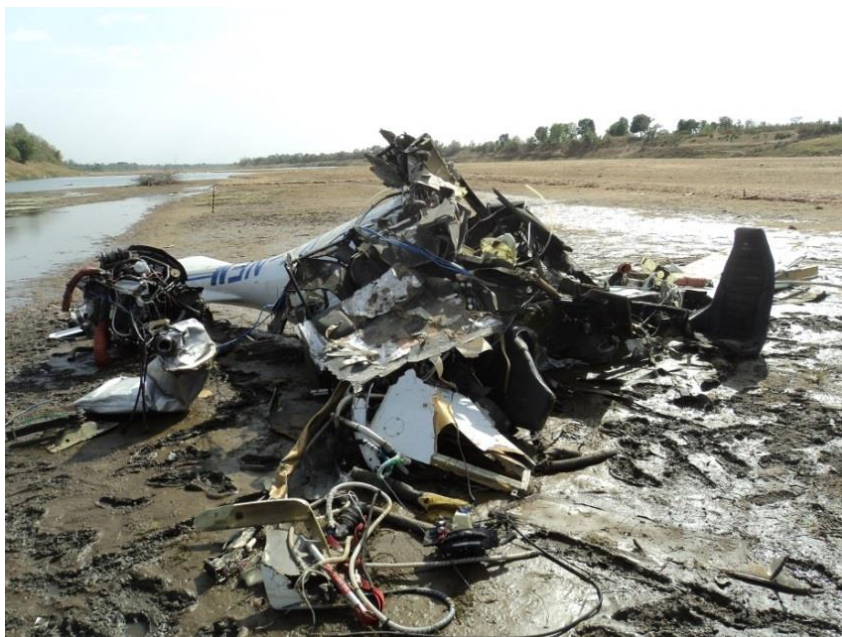
**Fig 5: Aircraft Wreckage at crash site**

The aircraft had impacted a steel cable of approximately 02 inches thickness. This impact caused the top area of cockpit and tail to be sheared off. The sheared tail caused the aircraft to lose its stabilizer, pitch down and hit the ground.

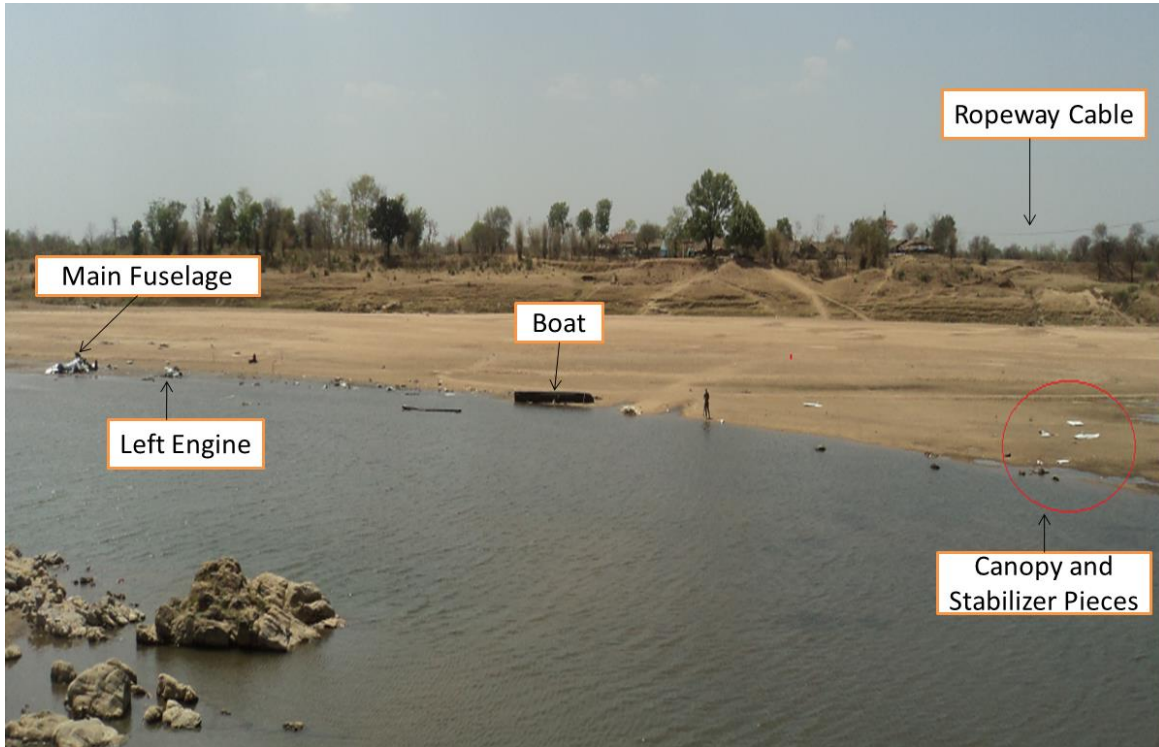
**Fig 6: Crash Site**

The aircraft's final position was 190 meters away from the point of impact. Before reaching its final position aircraft grazed the base of a boat on the river bed and toppled.

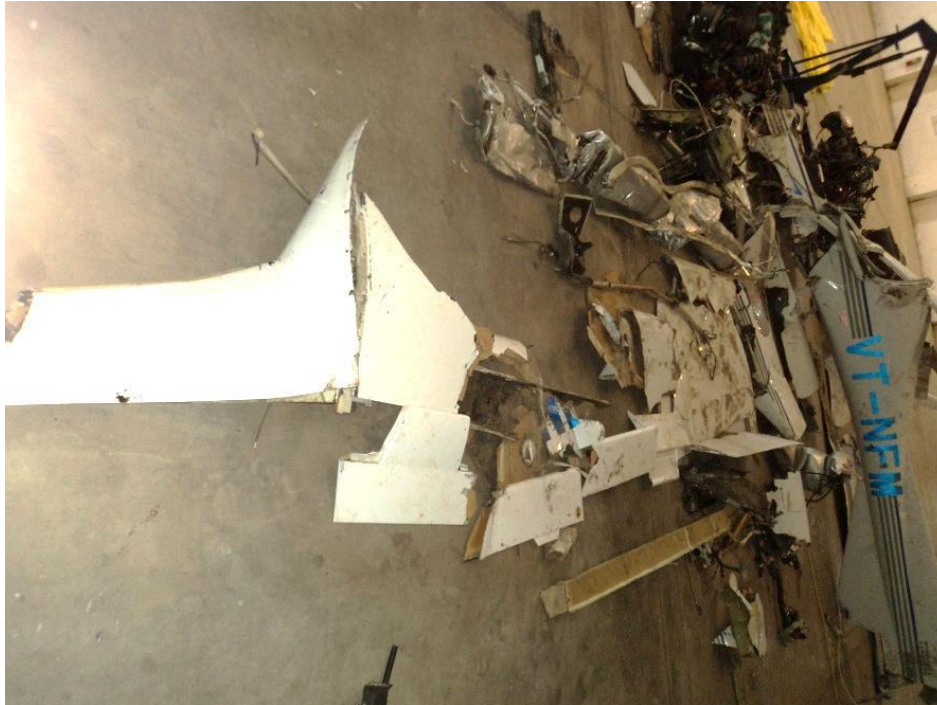
**Fig 8: LH wing wreckage after layout**

After impact the aircraft had disintegrated and scattered into mainly three major sections which were composed of main fuselage, engines and wings. The left wing was completely damaged and only fuel filler section along with fuel tank was recovered.

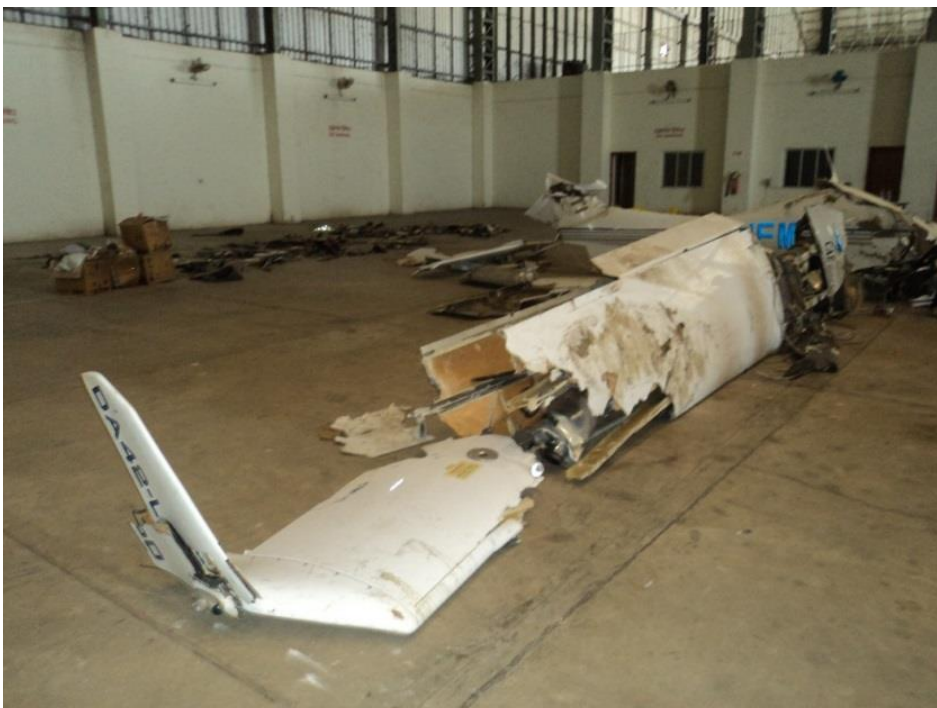
**Fig 9: RH wing wreckage after layout**

The right wing was also detached but was lying near the fuselage. The fuel tanks were also recovered in damaged condition and wing was broken into two sections.

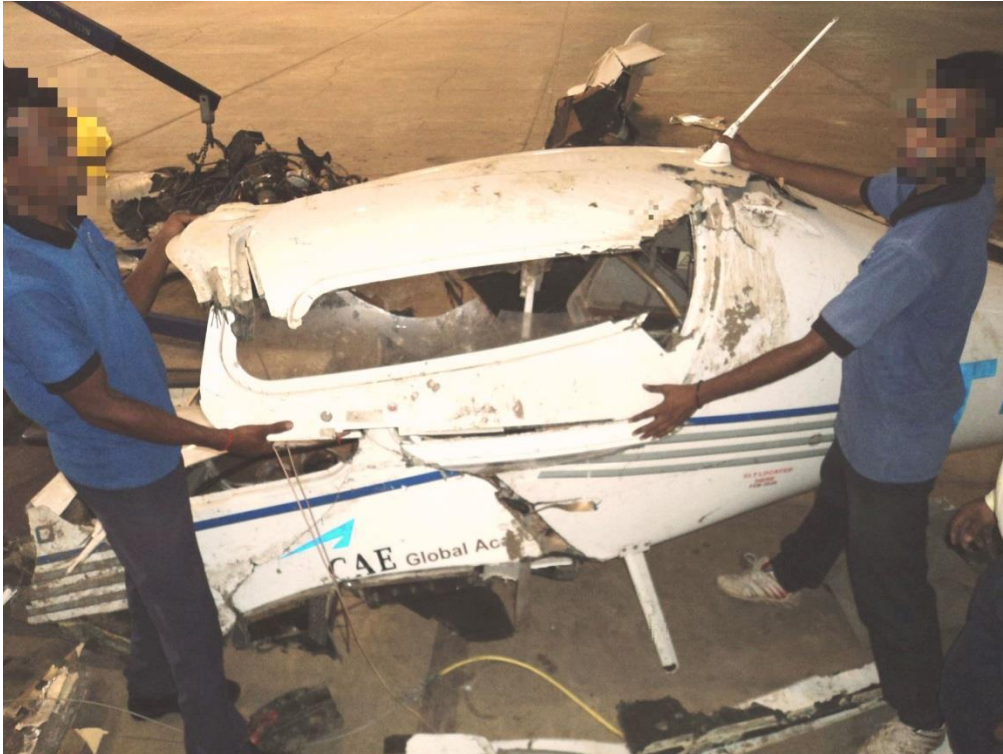
**Fig 10: Front Fuselage wreckage**

The front portion of fuselage structure was badly damaged due to impact with ground and ropeway cable. The canopy was sliced by the ropeway cable. Front as well as rear seats were detached from the fuselage after impact.

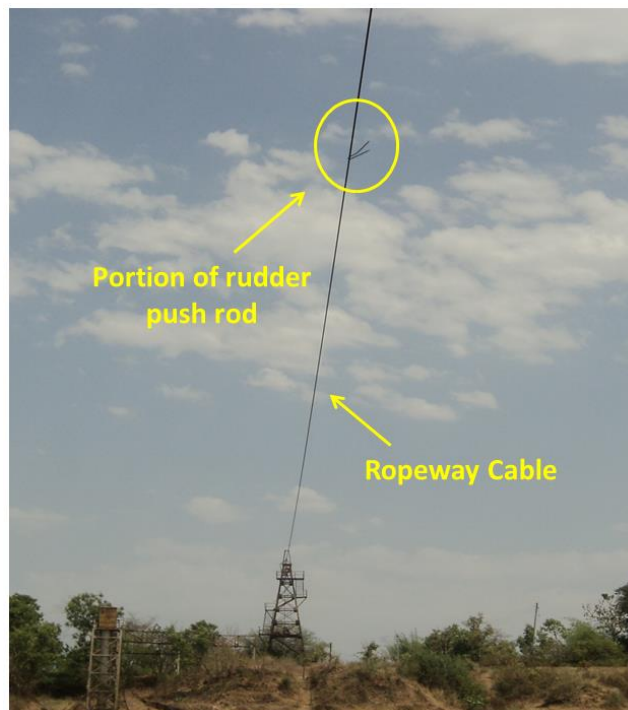
**Fig 12: Portion of rudder stuck in Ropeway cable**

Vertical stabilizer was also sliced by the ropeway cable. The rudder was damaged and rudder push rod was seen hanging from the ropeway cable and could not be retrieved.

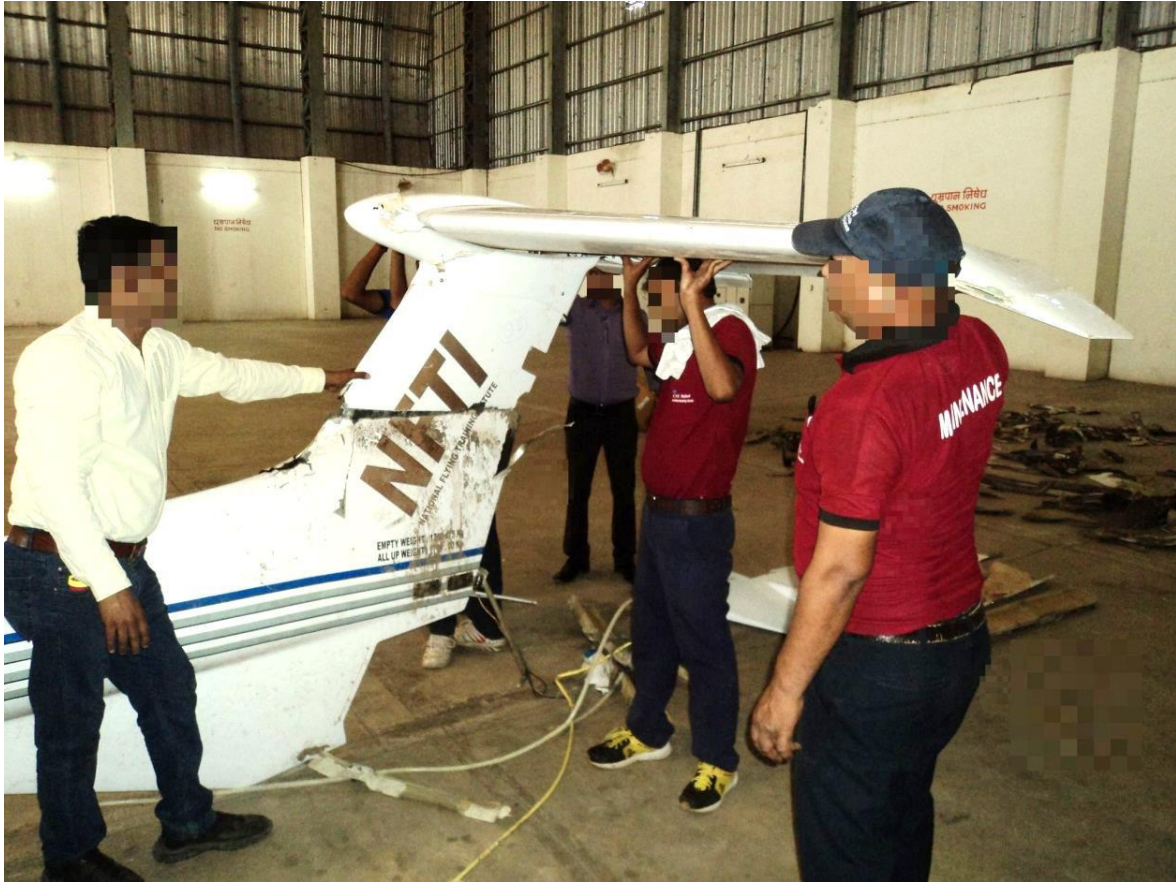
**Fig 11: Wreckage of vertical stabilizer**

Horizontal stabilizer was found in one piece but detached from the vertical stabilizer. The tail section was found mainly intact with some damages due impact.

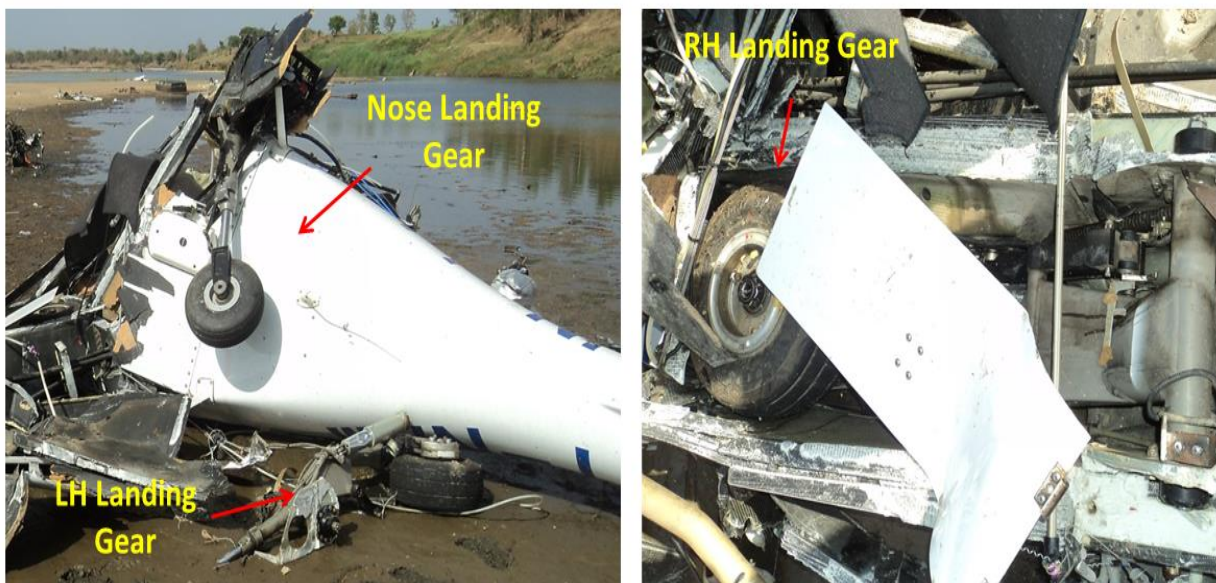
**Fig 13: Landing gears at crash site**

Due to impact the right landing gear was pushed into the wheel well and left gear & nose gear had disengaged from the gear bay and linkages.

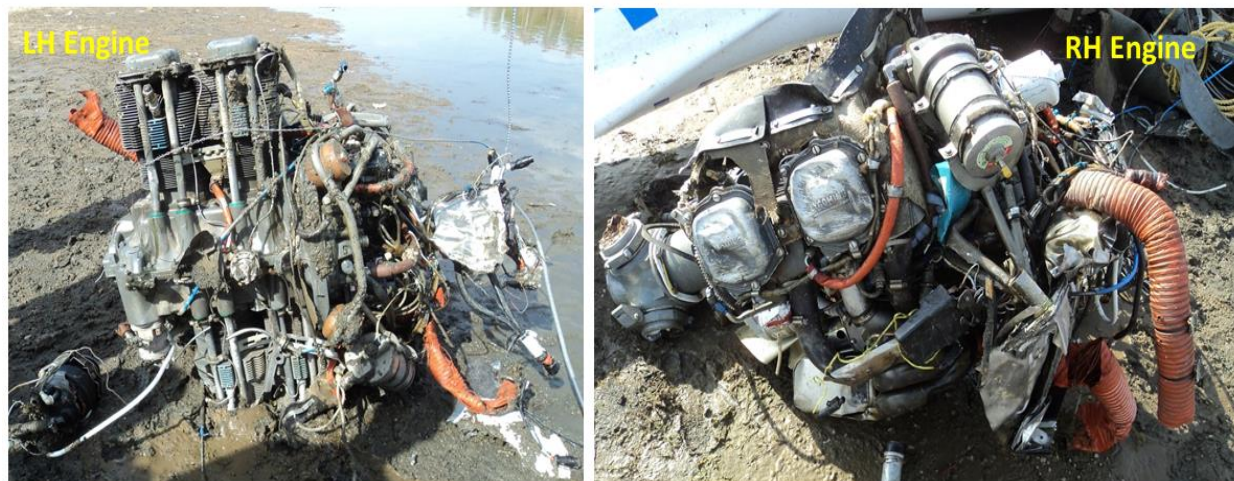
**Fig 14: Engines at crash site**

Both the engines completely detached from airframe. The left propeller hub had got disconnected from engine and blades had completely sheared off from the root. The right propeller hub was attached with the engine and blades were sheared off at the root except for one blade which had about one feet blade remaining.

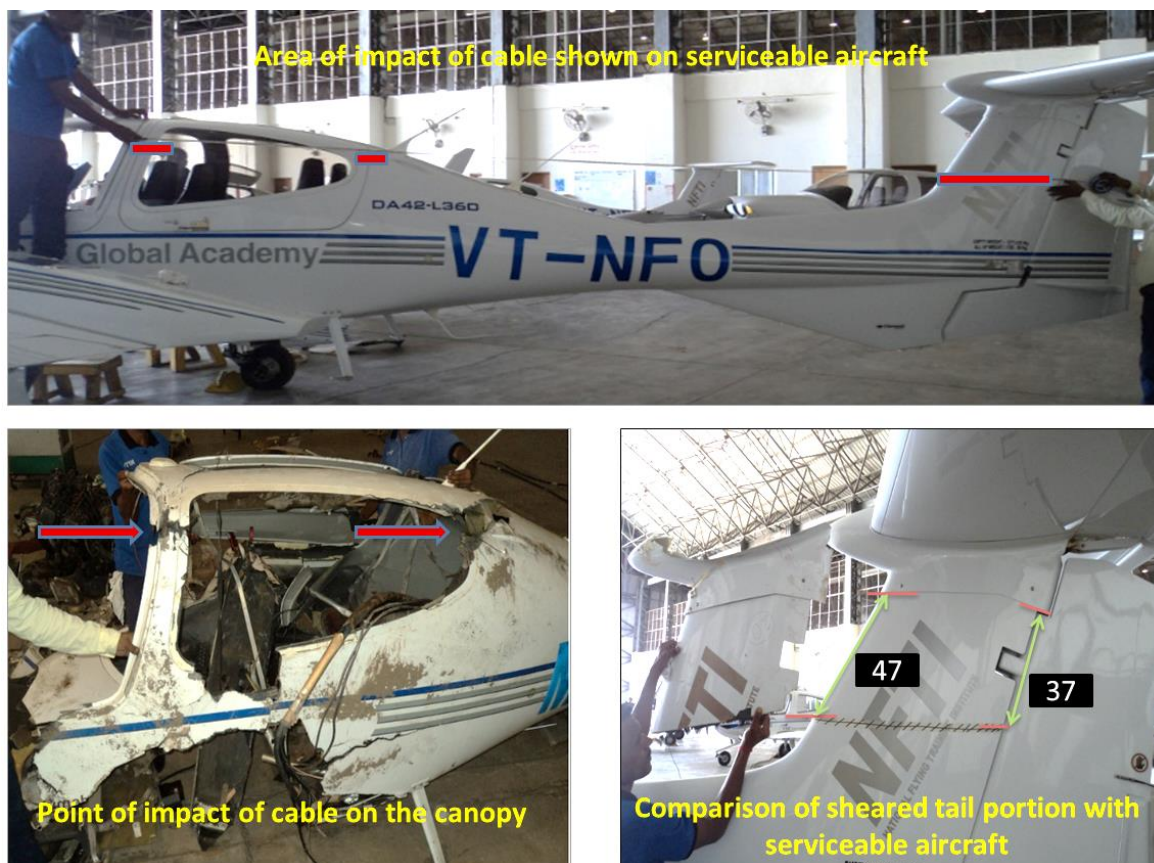
**Fig 15: Comparison of wreckage with serviceable aircraft**

Further comparison of the wreckage was done with the serviceable aircraft and it was seen that, the direction of impact on the canopy was in line with the direction of impact on the vertical stabilizer as seen in the fig below.

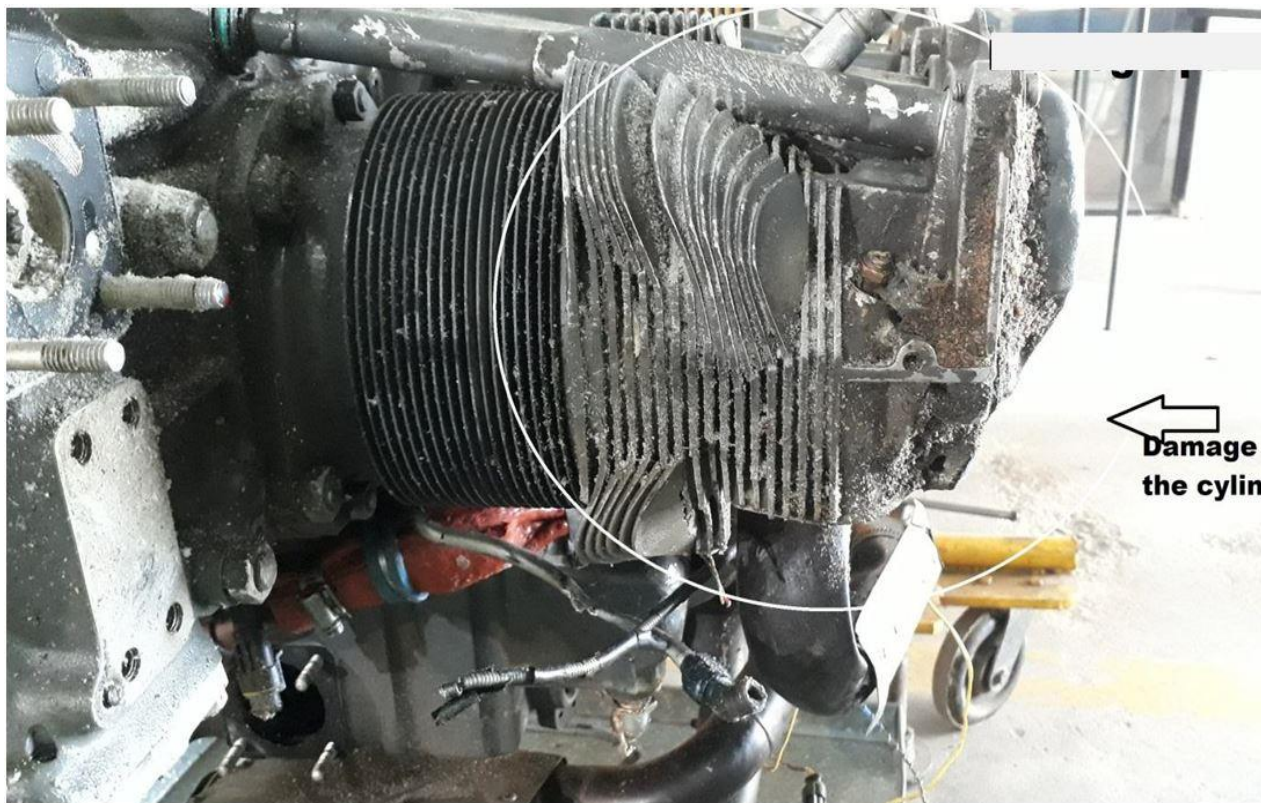
**Fig: 18: Damaged Cylinder**

The fuel pump was found dislodged from its position and hanging on fuel lines. Cylinder fins were found damaged.

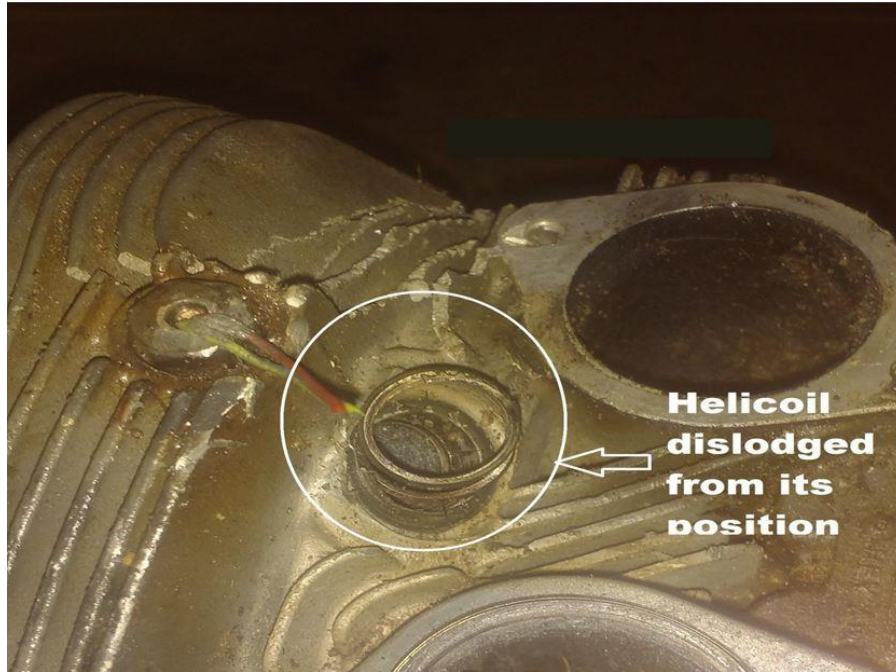
**Fig:19: Dislodged Helicoil**

Seven quantities of spark plugs out of eight were retrieved from the wreckage site. The remaining spark plug possibly had dislodged from its position due to impact. The condition of the spark plugs was satisfactory. The helicoil of missing spark plug was found dislodged from its position.

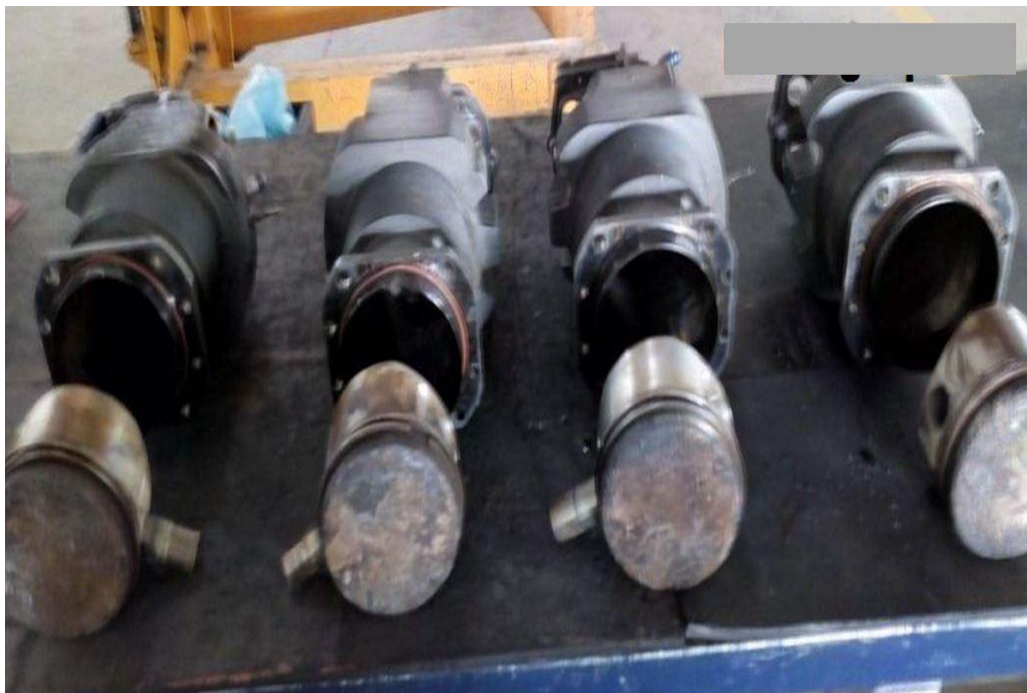
**Fig 20: Piston and Cylinders**

Engine was disassembled for inspection. Carbon deposits were seen on the internal wall of cylinders, no deposits were noticed on Oil screen. High amount of carbon deposit was found in the ring grooves of Pistons. Carbon deposits were also noticed on dome of Piston. Piston rings of all the pistons were found in stuck piston without any movement and were corroded.

The external damages observed on parts and accessories were resultant of impact on the engine due accident .The carbon deposits noticed on piston were normal and are also normally observed on engines received for overhaul. The bench check of spark plugs was found satisfactory.

The sand particles seen at electrode locations of the spark plugs & internal walls of the cylinders were possibly due to ingestion of sand particles through the broken induction tube at the time of accident. The start of spark of right hand magneto at higher RPM was possibly due to change in time setting because of impact on magneto at the time of accident.

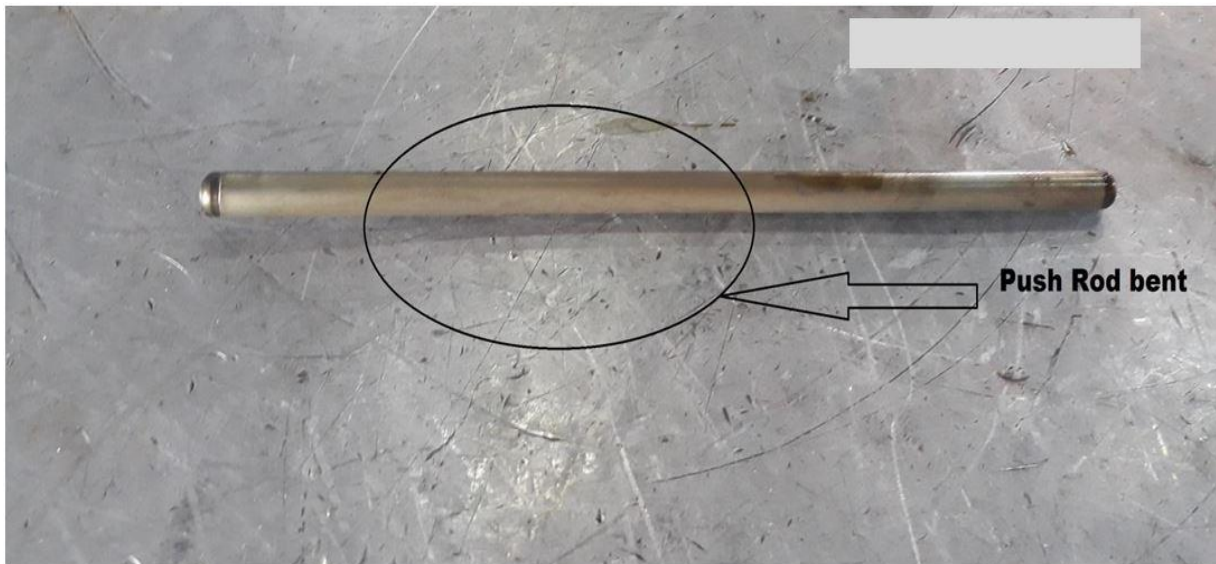
**Fig: 22: Damaged push rods**

The Pushrods were bent.

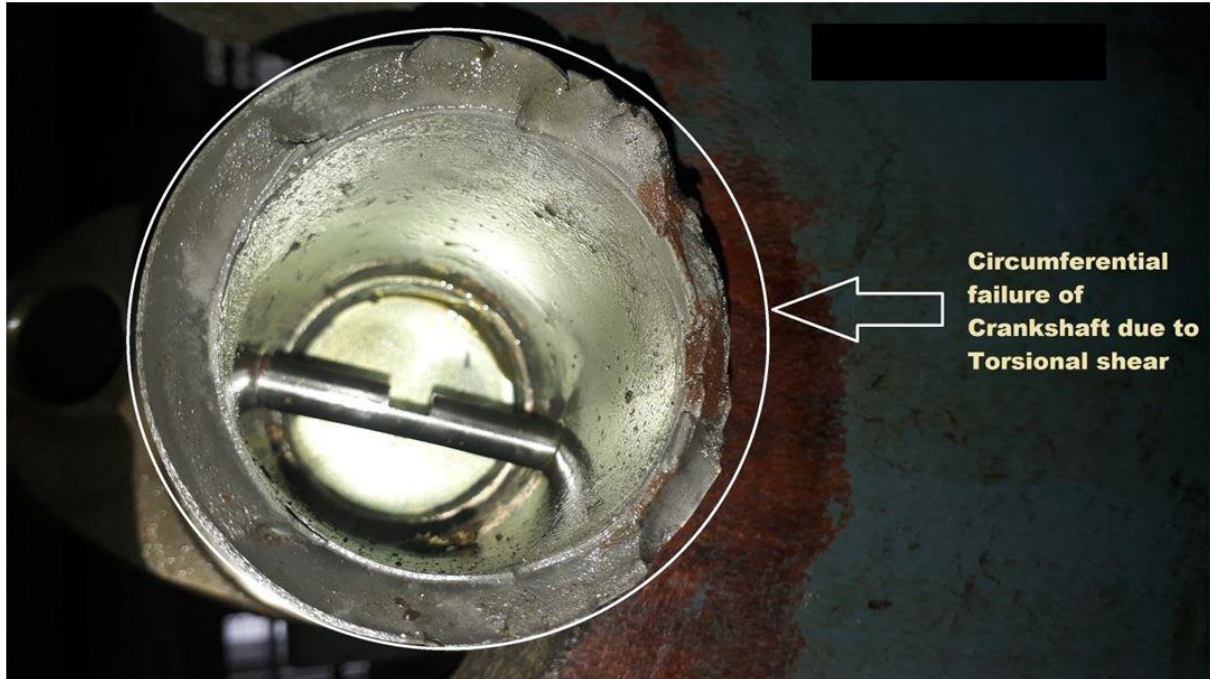
**Fig: 23: Failed crankshaft**

The Crankshaft had sheared behind the flange. The condition of connecting rods with the bearing was satisfactory. No abnormal wear out or scuffing of bearing was found.

It can be inferred from the failure observed on the crankshaft during detailed examination of the LH engines that the shaft had failed due to torsional

shear indicating the engine was delivering full power at the time of accident. The other damages observed were resultant of impact to the engine at the time of accident.

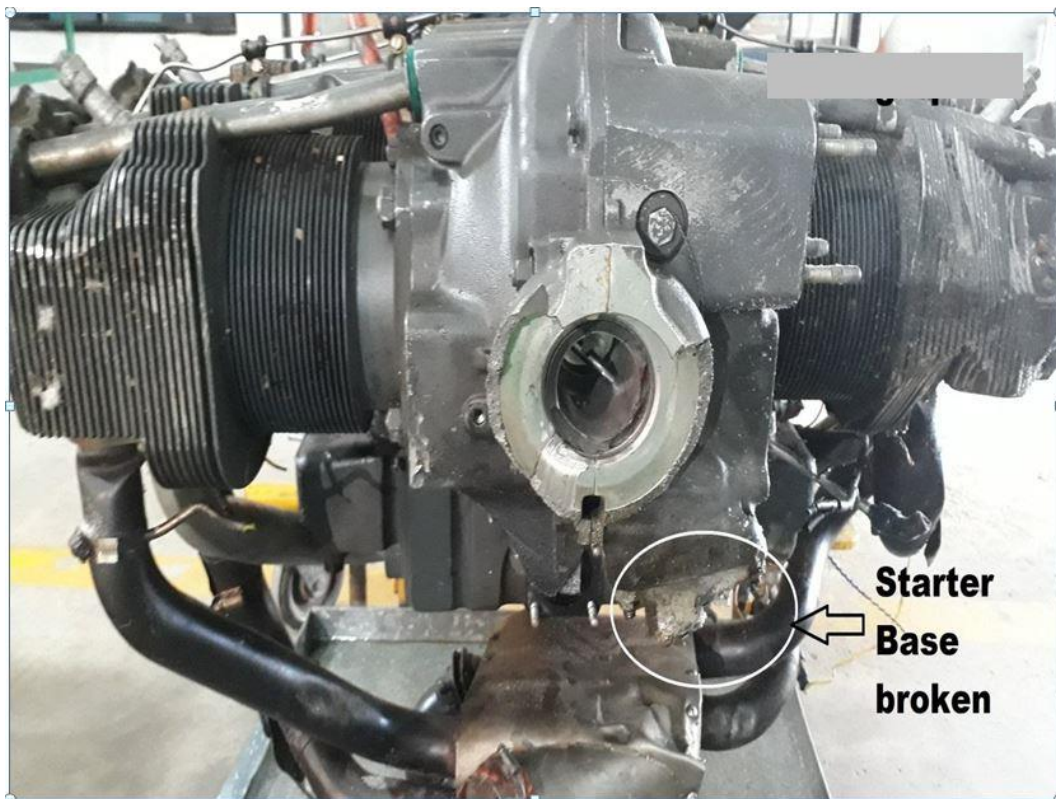
**Fig: 24: Starter base broken**

During Inspection of electrical system it was found that Ignition Harness was cut and damaged. Starter was found broken at the base.

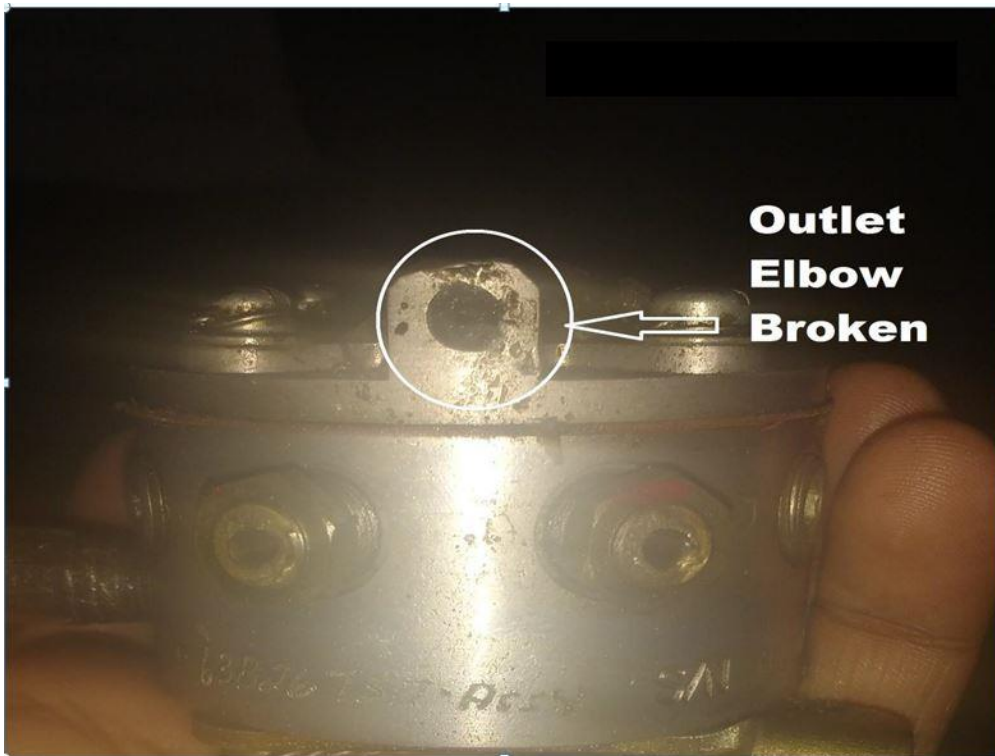
**Fig: 25: Broken fuel outlet elbow**

The inspection of fuel system revealed that the external condition of Fuel flow divider was satisfactory. The outlet elbow was broken. The fuel pump was

dislodged from its mounting and broken. Fuel injectors were missing and fuel lines were bent and dry.

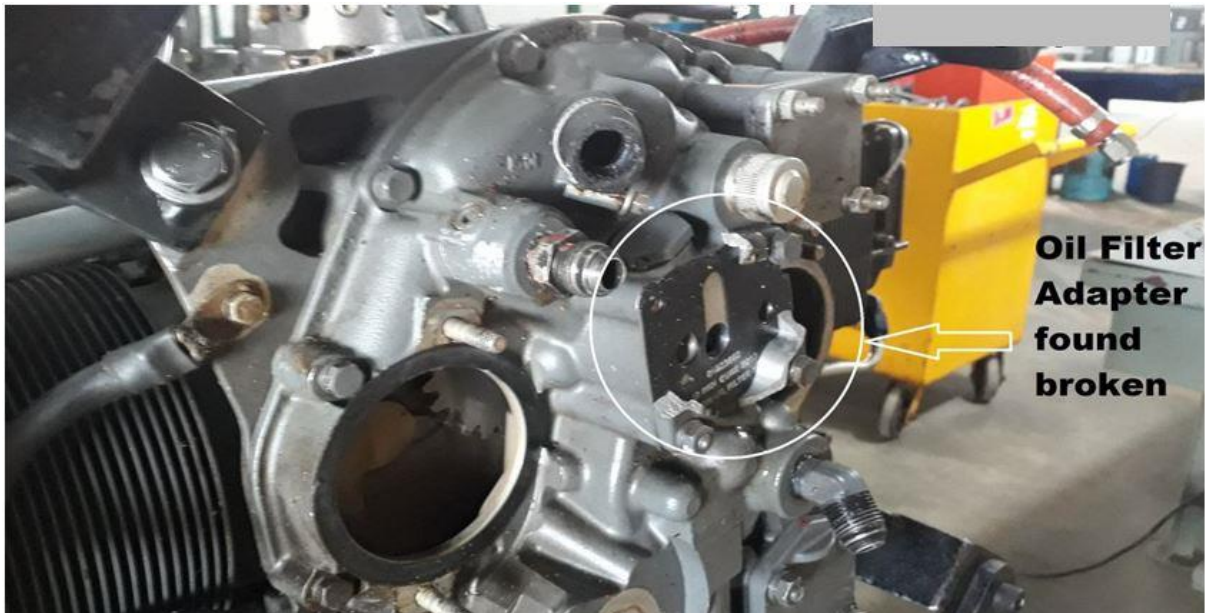
**Fig: 26: Broken oil filter adapter**

The oil filter adapter was broken and oil filter was missing.

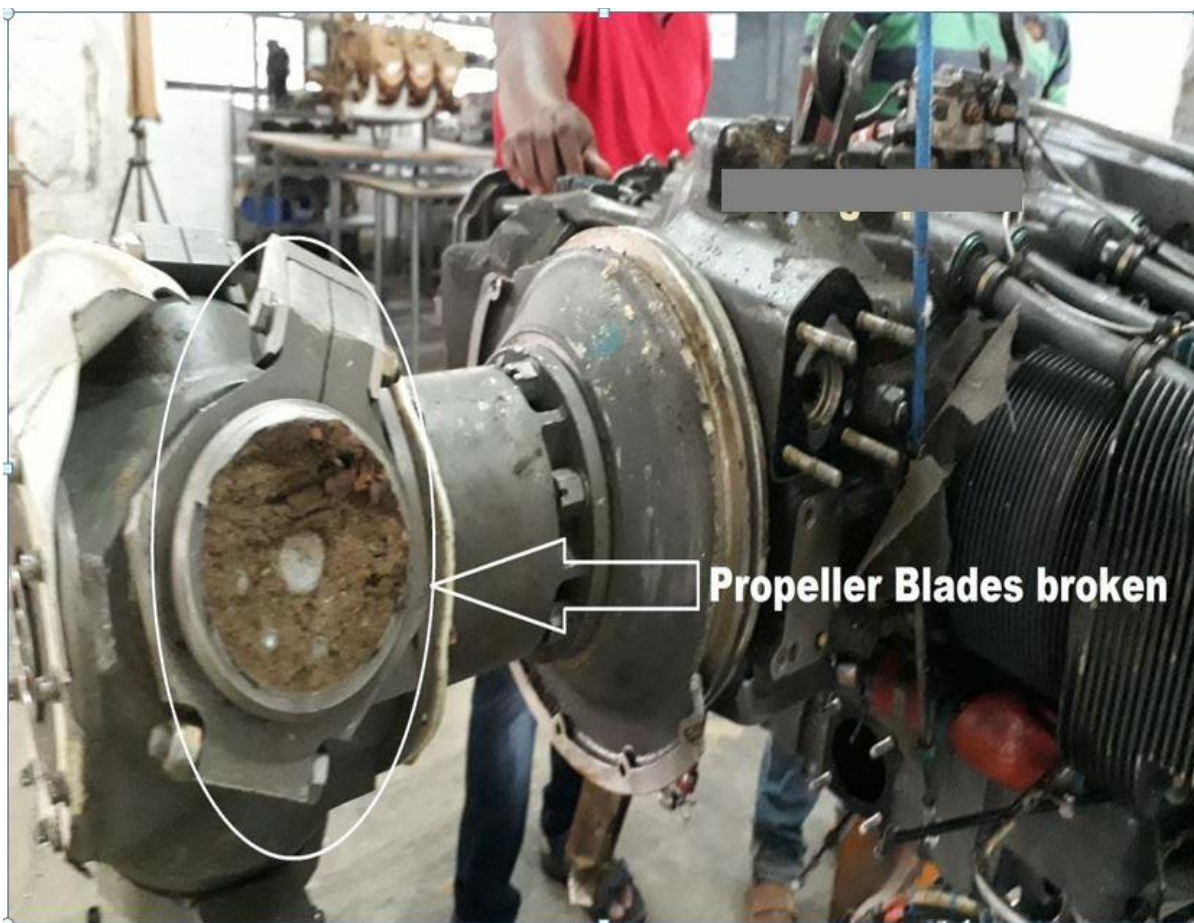
**Fig: 27: Sheared propeller blade**

Propeller hub was attached to the flange of crankshaft and root section of propeller blades were stuck in the hub.

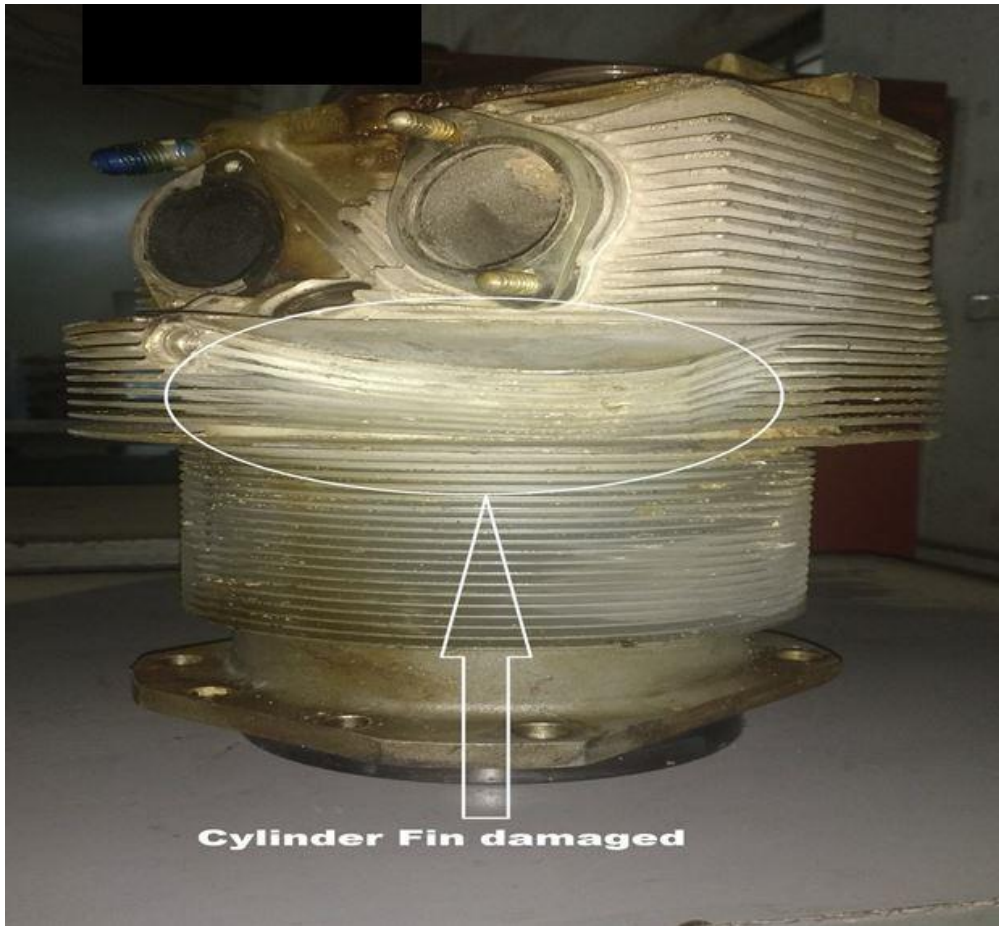
**Fig: 28: Damaged Cylinder Fin**

The fins of all the four cylinders were damaged

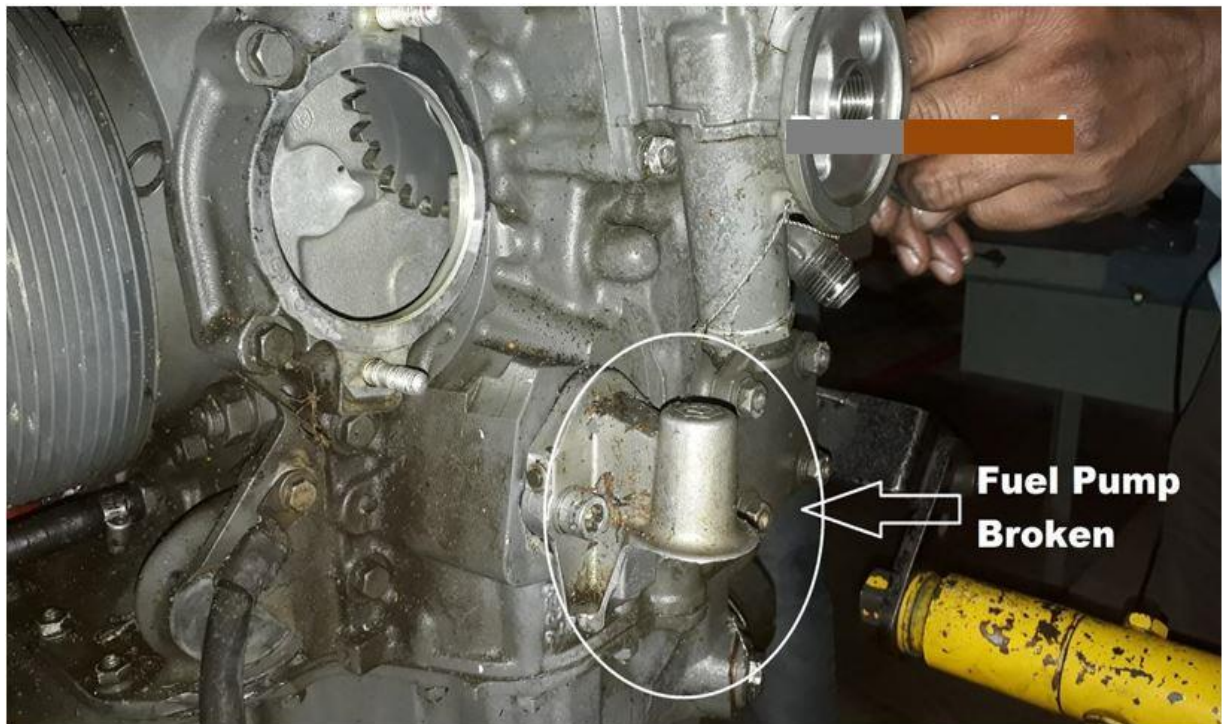
**Fig: 29: Broken fuel pump**

The fuel pump was broken and detached from the engine.

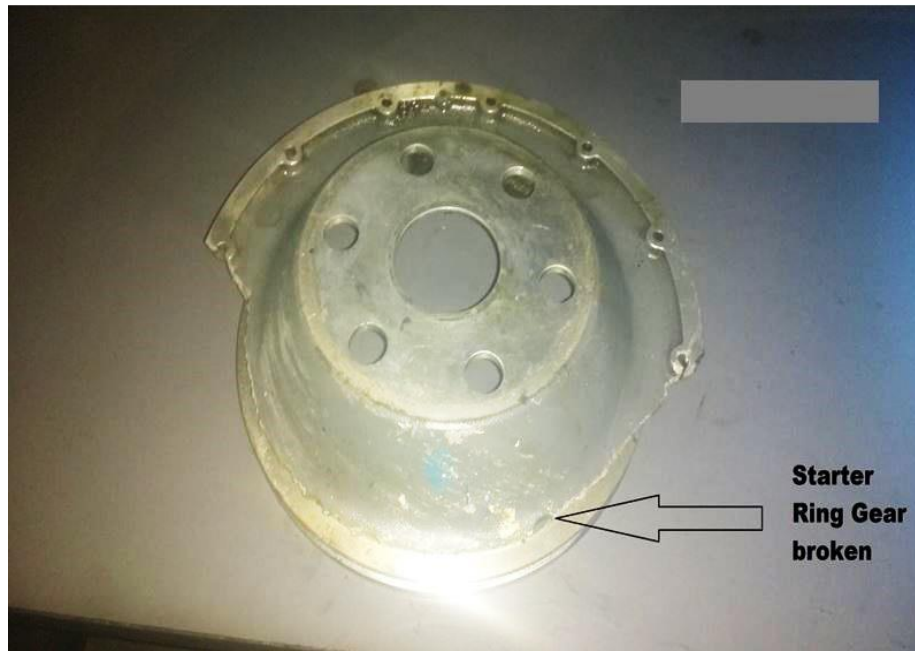
**Fig: 30: Broken starter ring gear**

Starter ring gear was broken.

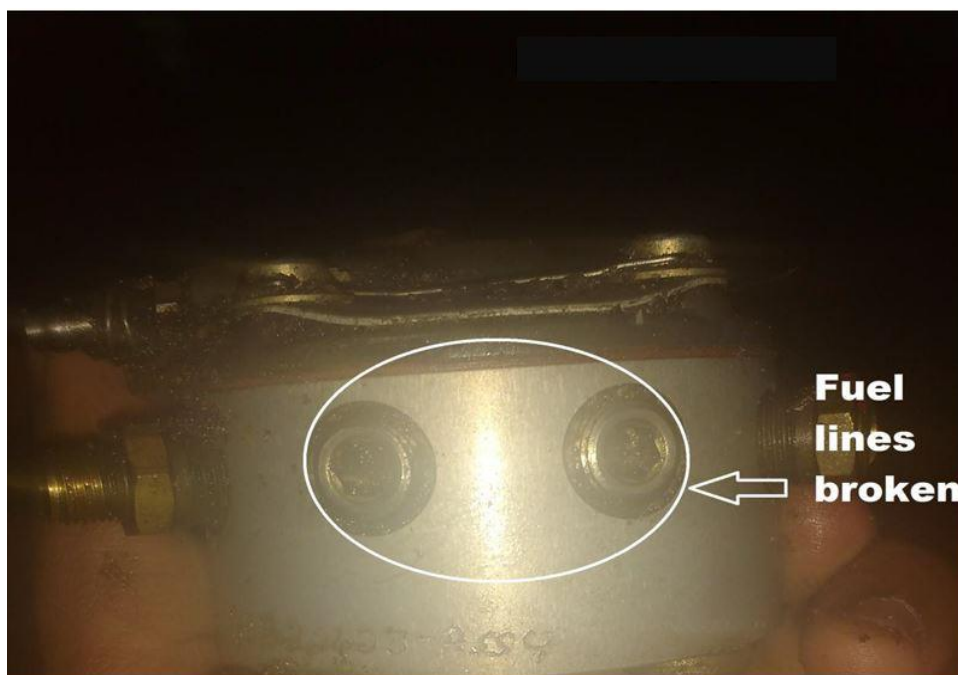
**Fig: 31: Broken fuel lines**

Fuel System inspection revealed that fuel injector got detached and the external condition of fuel flow divider was not satisfactory. Fuel lines attachment was broken. Fuel pump was also broken. The Fuel lines were bent and dry.

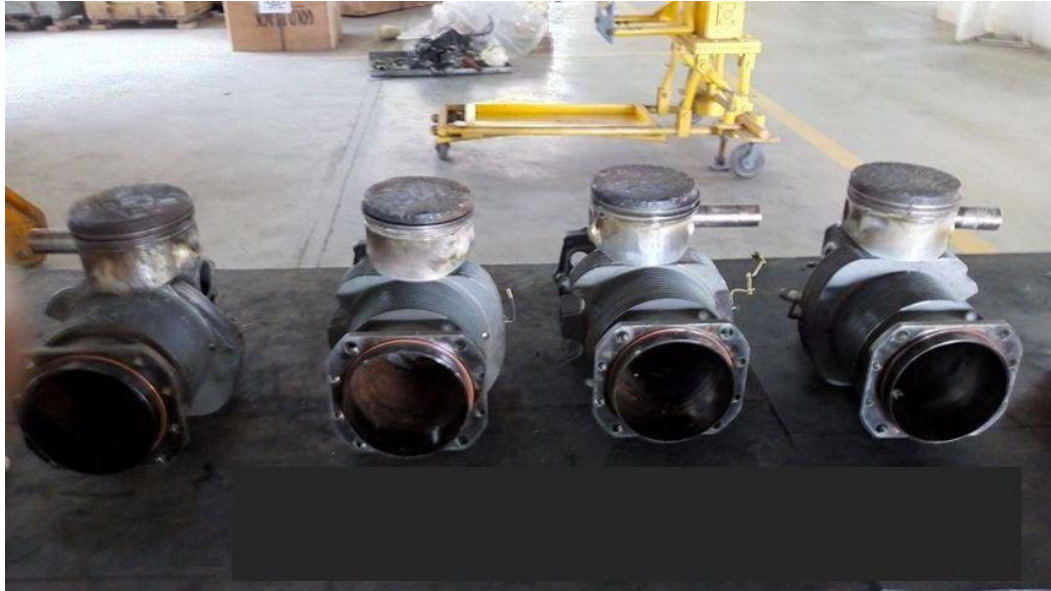
**Fig: 32: Piston and Cylinders**

During inspection of the dis-assembled right engine, high amount of carbon deposit was found in the ring grooves of Pistons and carbon deposits were noticed on dome of the Piston. Piston rings of all the pistons were found in stuck piston without any movement and corroded.

due to accident. The carbon deposits noticed on piston dome were normal and similar to those observed on engines received for overhaul. Propeller hub was found attached to the flange of crankshaft. The blades of propeller were found stuck in the hub.

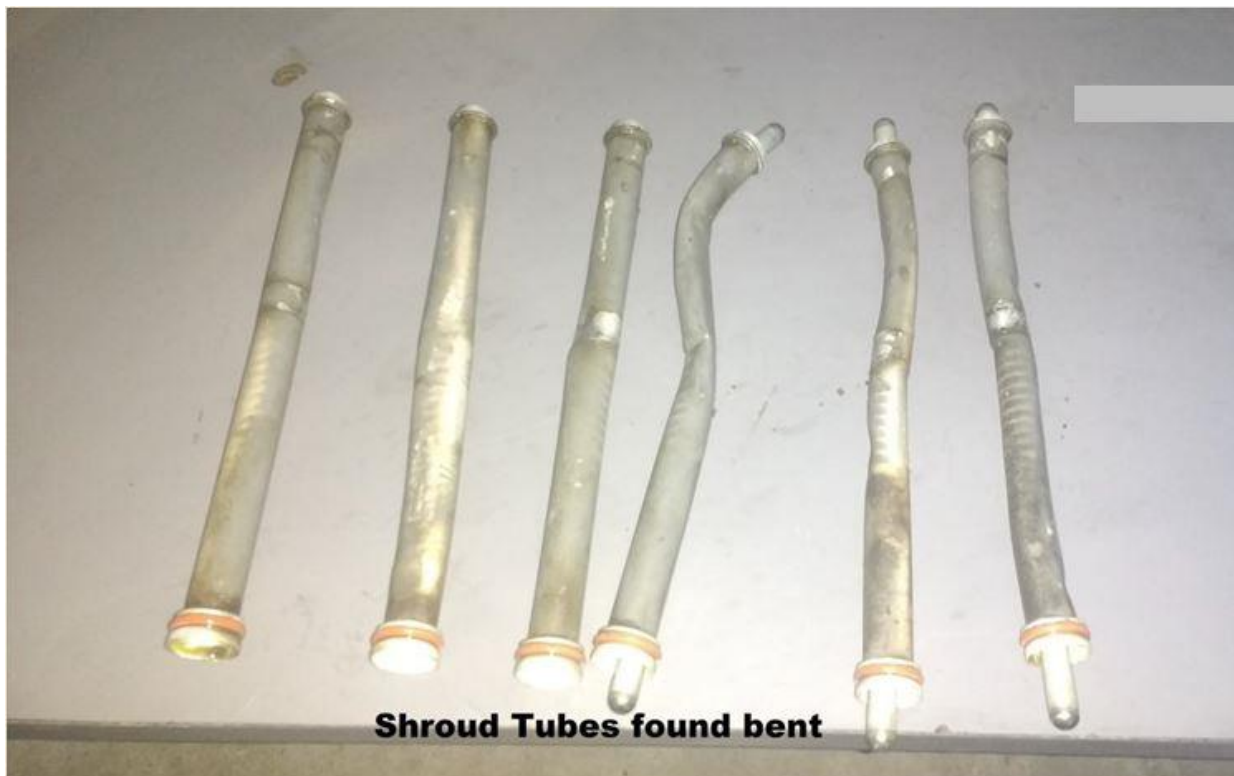
**Fig: 35: Bend shroud tubes**

All the Push rods shroud tubes of right engine were bent.
