**FINAL REPORT OF SERIOUS INCIDENT OF ENROUTE CONFLICT
BETWEEN CHINA SOUTHERN AIRLINE (A319, B-6202) AND CHINA
SICHUAN AIRLINE (A 330-300, B-5900) ON LSO-LINSO AIR ROUTE IN
YANGON FIR ON MAY, the 3rd, 2017**

SYNOPSIS

At 0845 (UTC) on May, the 3rd, 2017, there was an enroute conflict between China Southern Airlines (A 319, B-6202, CSN 6068) and China Sichuan Airlines (A 330-300, B-5900, CSC 603) on LSO-LINSO air route in Yangon FIR. No aircraft was damaged and no one was injured in this serious incident.

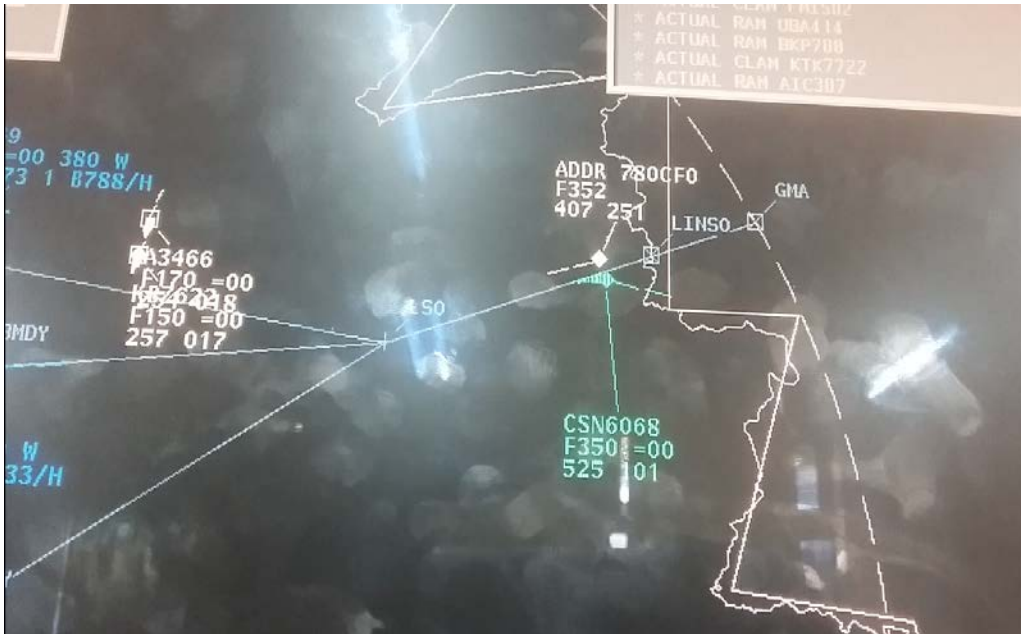
The radar coverage of air route A 599 between LSO and LINSO was insufficient and did not work properly for that purpose of radar operation as per radar readback. According to the witness statements there has been such deficiencies for long time. Around the time of occurrence CSC 603 could not be seen because of lack of radar coverage.

Fig 1. ADS- B data appeared at 08:45:27 (UTC)

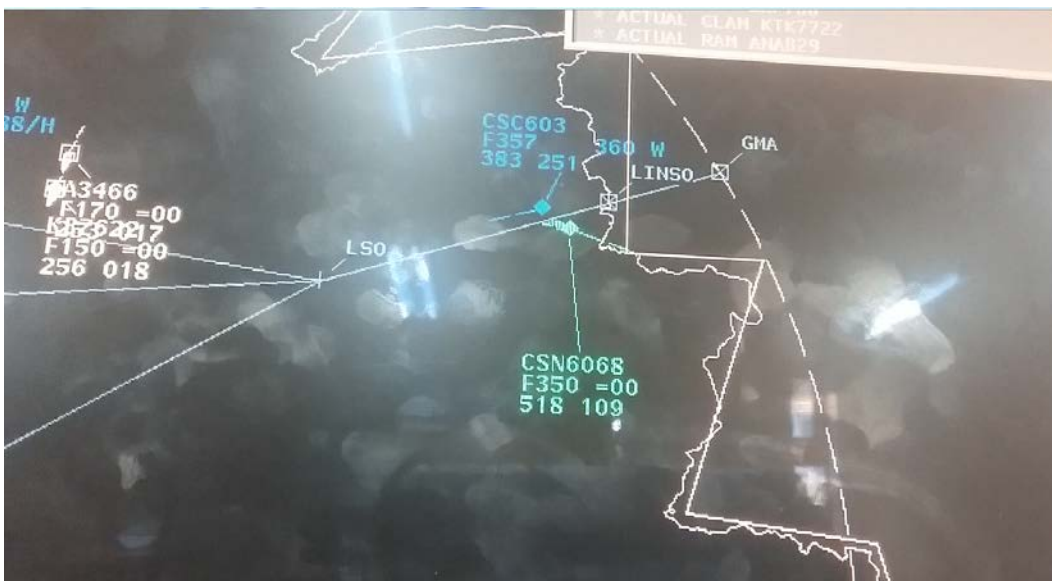
Fig 2. Radar Track appeared at 08:45:57 (UTC)

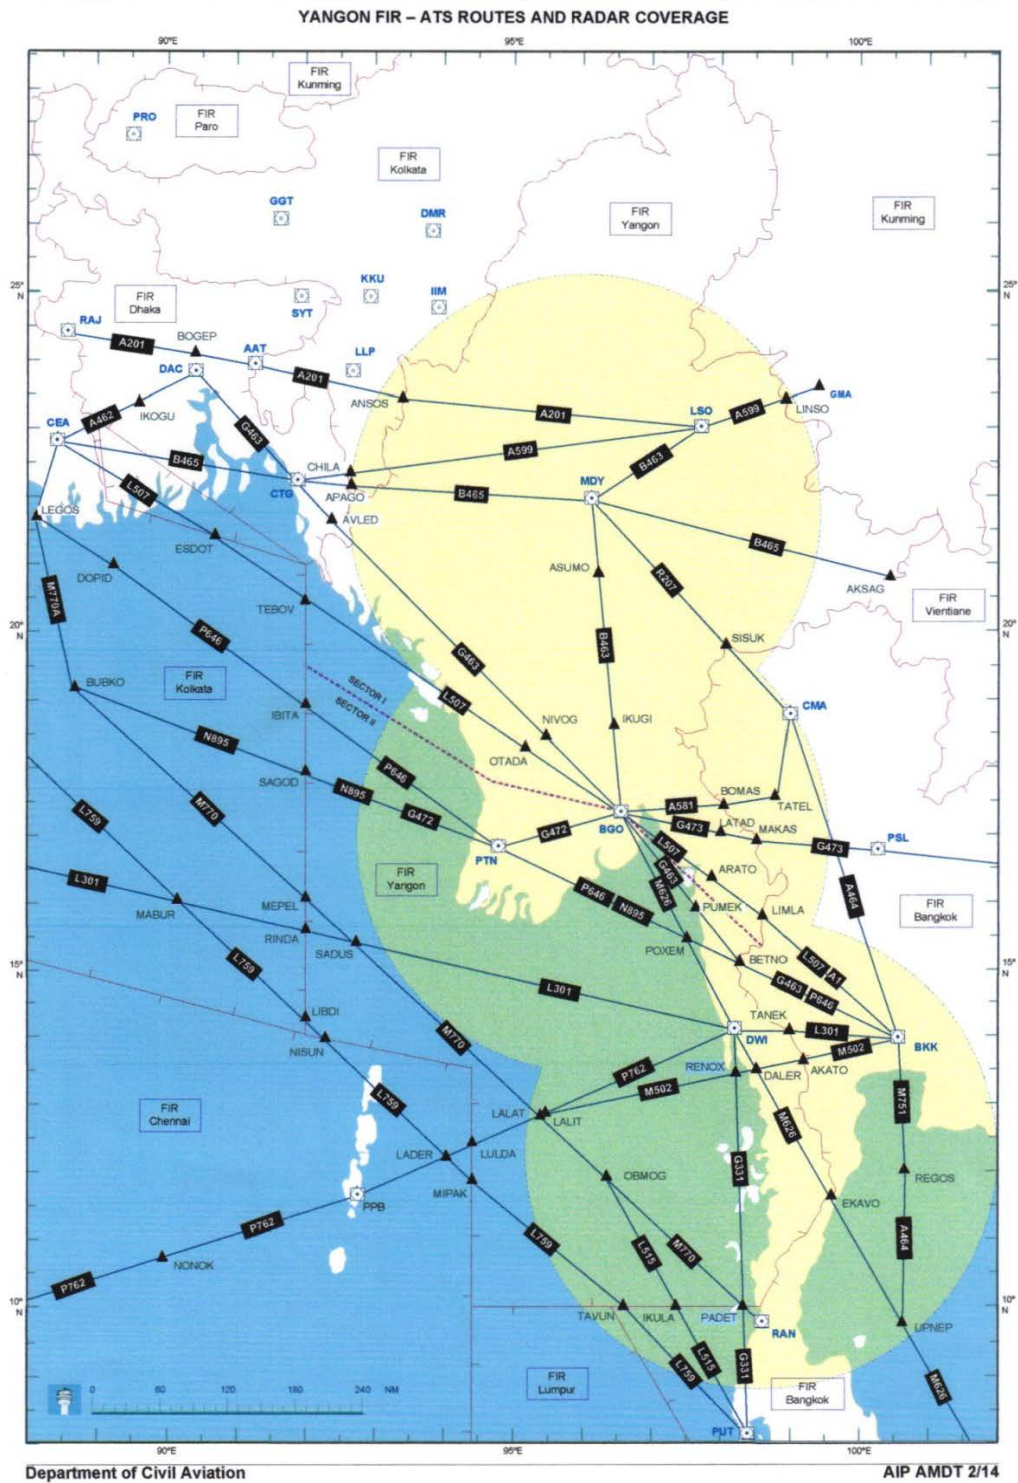
Fig 3. Yangon FIR –ATS Routes and Radar Coverage

- a) The radar coverage on air route A599 between LSO and LINSO was not intermittently working properly and not good enough for radar operation **around the time of occurrence**.
