## AIRCRAFT ACCIDENT REPORT AND EXECUTIVE SUMMARY

| | | | | Reference: | CA18/2/3/9619 | |
| <b>Aircraft Registration</b> | ZS-RIT | <b>Date of Accident</b> | 20 May 2017 | | <b>Time of Accident</b> | 1145Z |
| <b>Type of Aircraft</b> | Robinson R22 | | <b>Type of Operation</b> | Agricultural Part (137) | | |

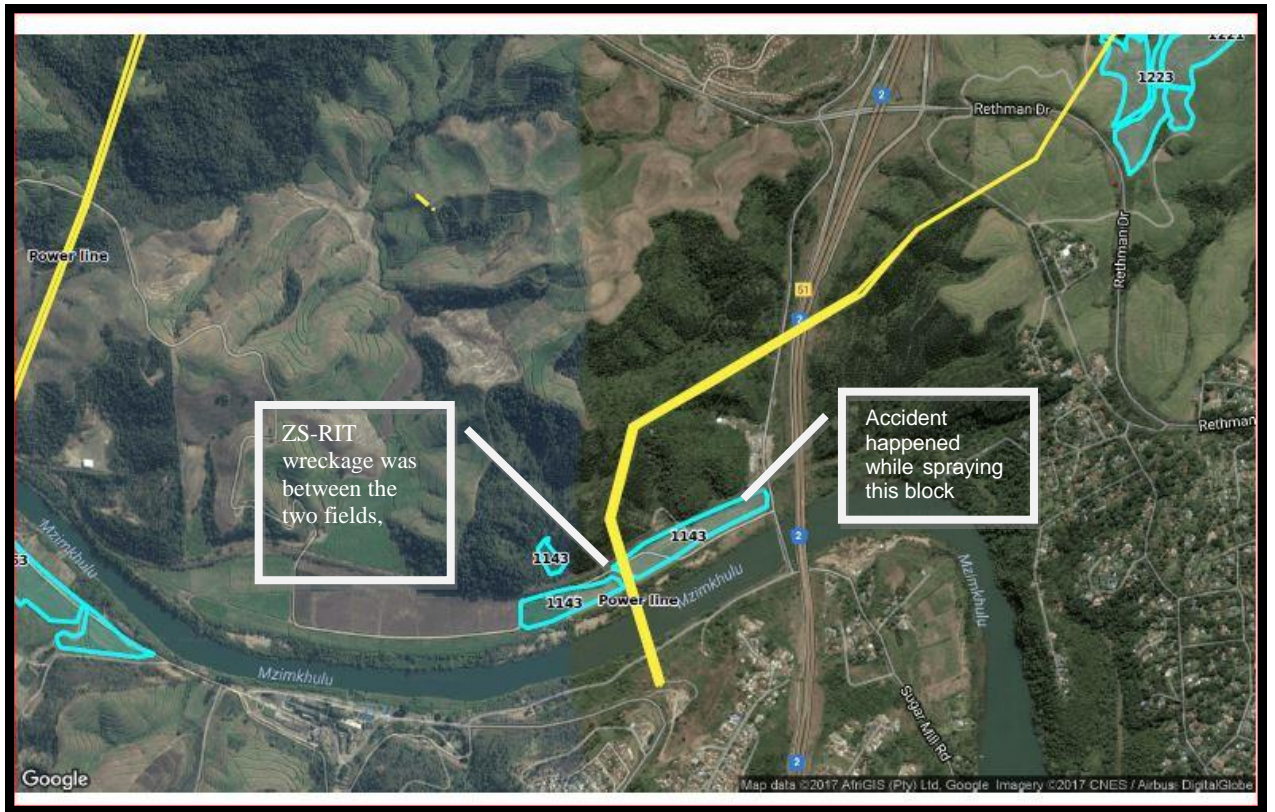
**Figure 1:** The sugar cane blocks to be sprayed indicating the position of the power lines. Picture supplied by the sugar milling company.

- 2.3 A map of the fields they are supposed to spray had the electrical power lines clearly indicated (Figure 1). It is not clear if the pilot followed the company SOPs, which state that before commencing with spraying one should familiarise oneself with the field and identify where power lines lie. The pilot started to spray from east to west; when he reached the end he initiated his climb and collided with the high-tension electrical cables running north to south. As a result, the main rotor blades flexed downwards, severing the tail boom, and the pilot lost control of the aircraft before crashing into a stream nearby.

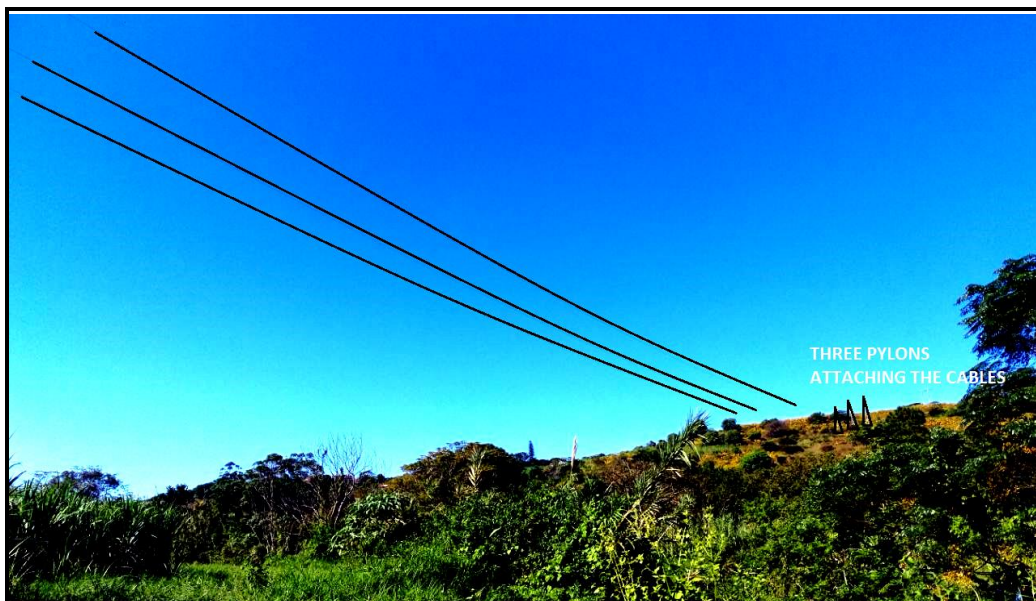
**Figure 2:** The high tension electrical cables impacted by the helicopter.

- 1.1.4 On his climb, the helicopter’s main rotor blades impacted some of the three high tension power cables that were running north to south, see figure 2&4. After the impact, the helicopter’s main rotor blades curled downwards and started to inflict damage to the tail boom, tail rotor and the spray equipment. The components were severed into two parts and the pilot lost control of the helicopter and entered into an uncontrollable spin which resulted in the helicopter crashing approximately 60 meters west of the point of impact.

1.4.1 None. There was no visible oil or Avgas spillage in the river. The high tension power cables impacted by the helicopter did not break.

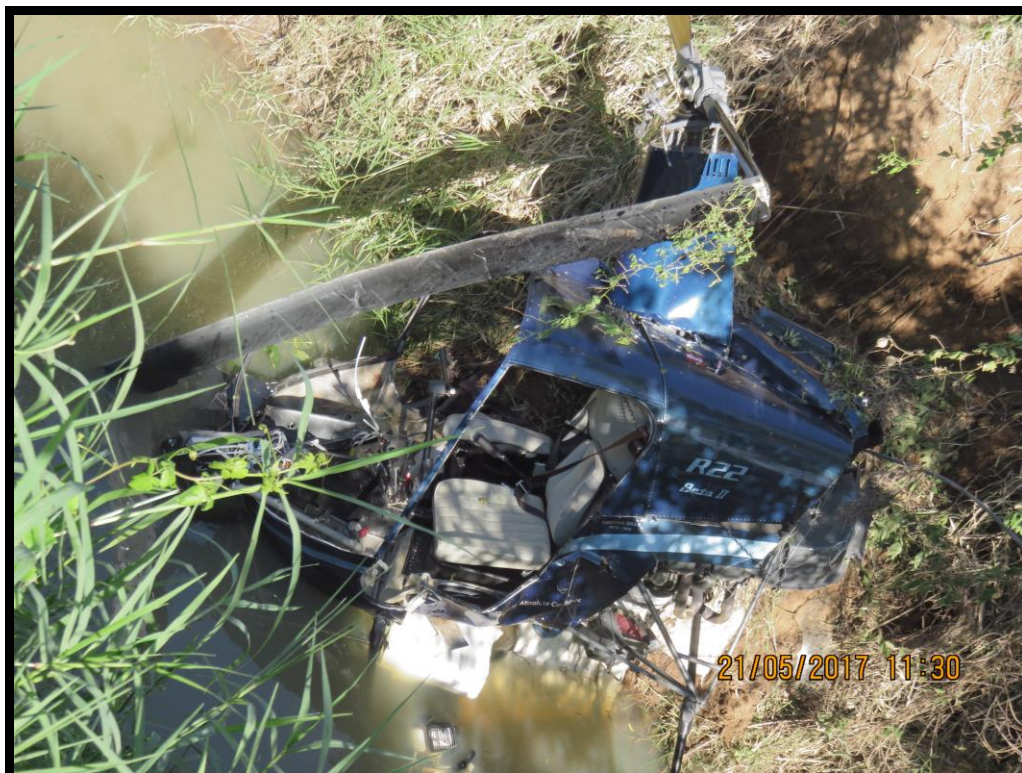
- 1.1.5 The pilot was fatally injured and the helicopter was destroyed. The helicopter crashed into a river stream which feeds UMzimkhulu River and ended up on its bank. The river was shallow considering the height of its bank and that made the recovery manageable. The accident happened at a sugar plantation that is 1.7nm from Port Shepstone with the following coordinates GPS S30° 42’ 55” E030° 26’ 08.9” elevation 44ft.

Figure 3: The River is approximately 3m deep. Water depth was less than 1m.

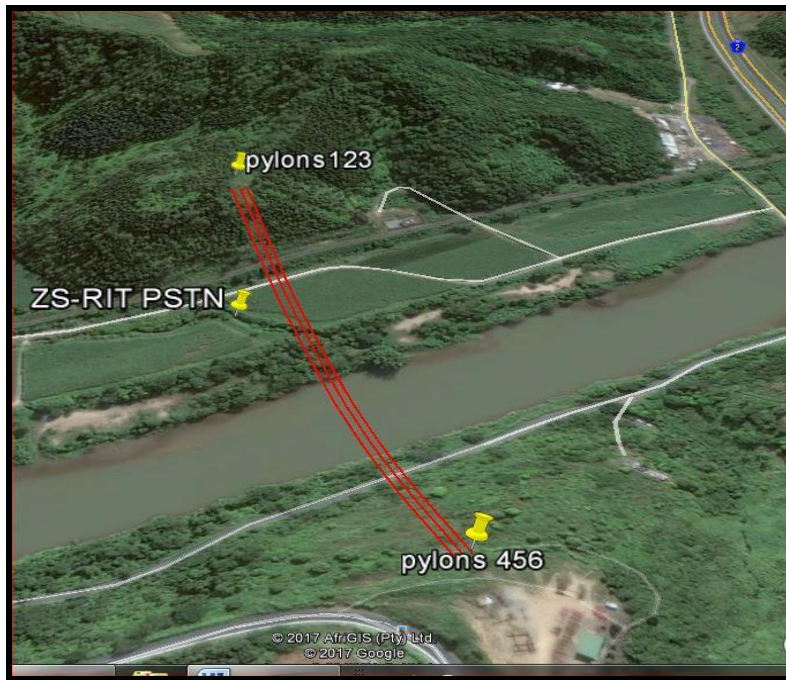
1.12.1 The helicopter left the loading zone with both doors removed and headed for the sixth sugar cane field for the day. The helicopter started spraying from an easterly direction to a westerly one and when it was close to the end of the half a kilometre area it initiated a climb during which, its main rotor blades impacted the electrical cables running north to south on figure 4.

Figure 4: The pylons attaching cables are approximately 600m apart.

- 2.4 It is the opinion of the investigator that even though the pilot did not do proper surveillance before starting. The pilot would have been unable to see the power cables because their pylons are approximately 600m apart. If the pylons were at least 100m to 200m apart, they would have been easy to identify.

- 3.1.7 The electrical cables were not fitted with red and white marker spheres.
- 3.1.8 The helicopter was extensively damaged but there was no post-impact fire.
- 3.1.9 The weight and balance of the aircraft was within limits.

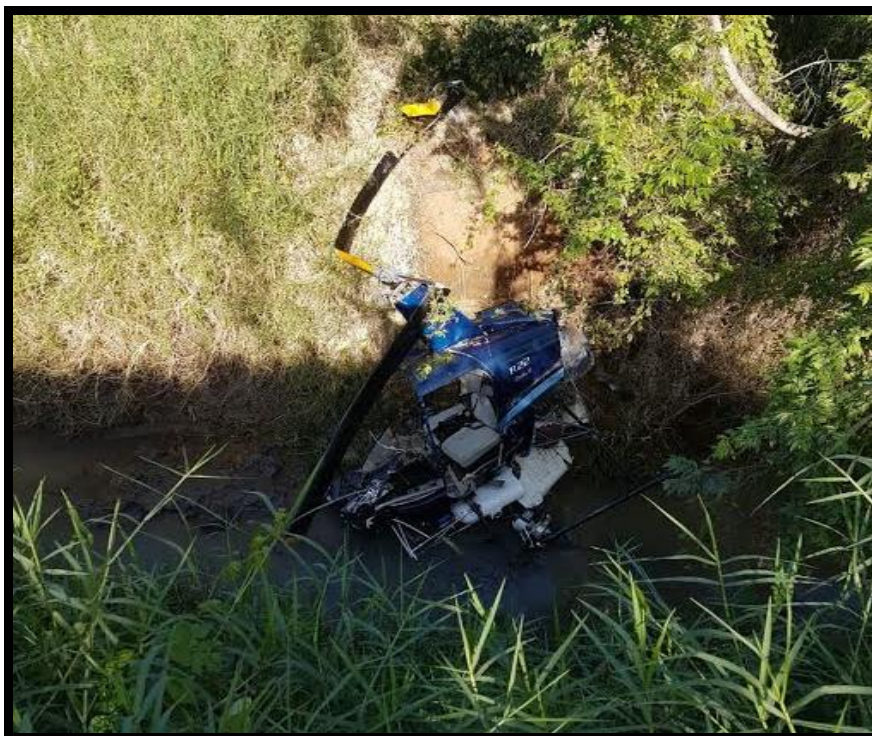
1.12.2 The helicopter's main rotor blades flexed downwards and severed the tail boom into two pieces as well as the spraying gear below the helicopter. The pilot lost control of the helicopter and it crashed into a stream approximately 60m from the electrical cables. The wreckage was facing south in the water against a river bank but was not submerged. Some debris which included fuselage panels, tail rotor, piece of the tail boom - were scattered between the electrical cables and the wreckage. The helicopter suffered further damages to the skids and spraying equipment fitted below the helicopter.

Figure 5: The stream is deep. Not easy to get down without ropes.
