AIRCRAFT ACCIDENT REPORT AND EXECUTIVE SUMMARY

Reference:	CA18/2/3/9622	
Aircraft registration	ZS-IGY	Date of accident	26 May 2017		Time of accident	1000Z
Type of aircraft	Beagle B121 (Aeroplane)		Type of operation		Private (Part 91)	
Pilot-in-command licence type		Airline Transport	Age	29	Licence valid	Yes
Pilot-in-command flying experience		Total flying hours	3 144.1		Hours on type	157.1
Last point of departure		Springs Aerodrome (FASI), Gauteng province				
Next point of intended landing		Springs Aerodrome (FASI), Gauteng province				
Location of the accident site with reference to easily defined geographical points (GPS readings if possible)						
Tafelkop Mountain near Wakkerstroom (GPS position; 27°16'30.63" South 030°16'24.31" East); elevation of 6 920 feet (2 110m) above mean sea level (AMSL).						
Meteorological information		Wind; 250°/28 knots, Temperature; 20°C, Visibility; + 10km				
Number of people on board	1 + 1	No. of people injured	2	No. of people killed	0

AIRCRAFT ACCIDENT REPORT

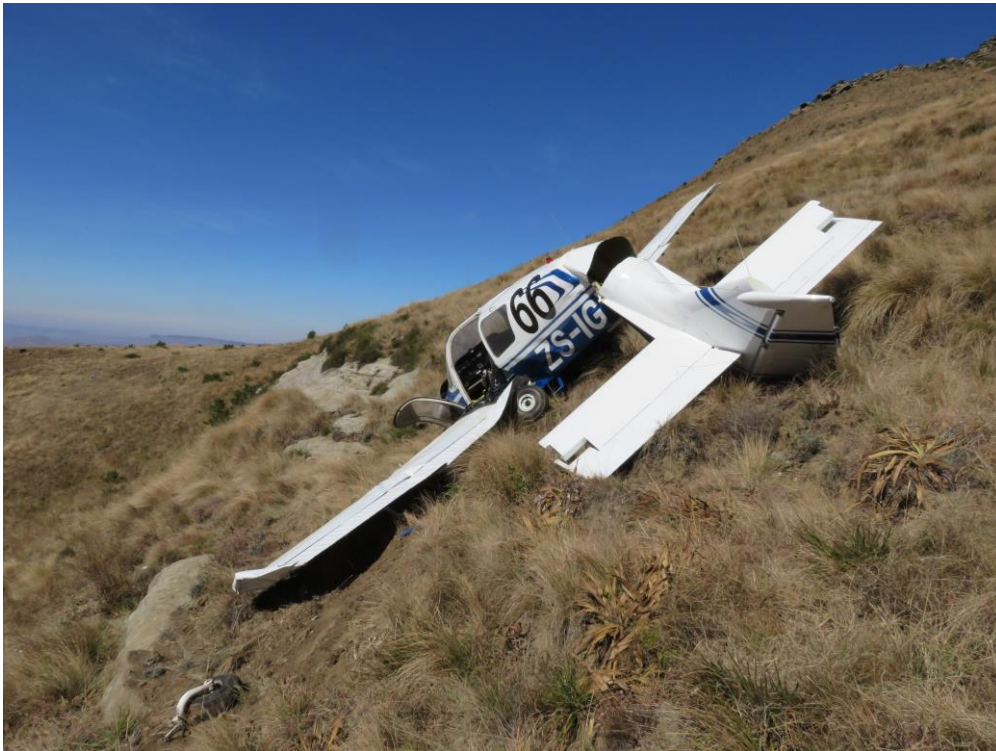
1.3.1 The aircraft was destroyed.

Figure 1: The aircraft as it came to rest on the side of the mountain

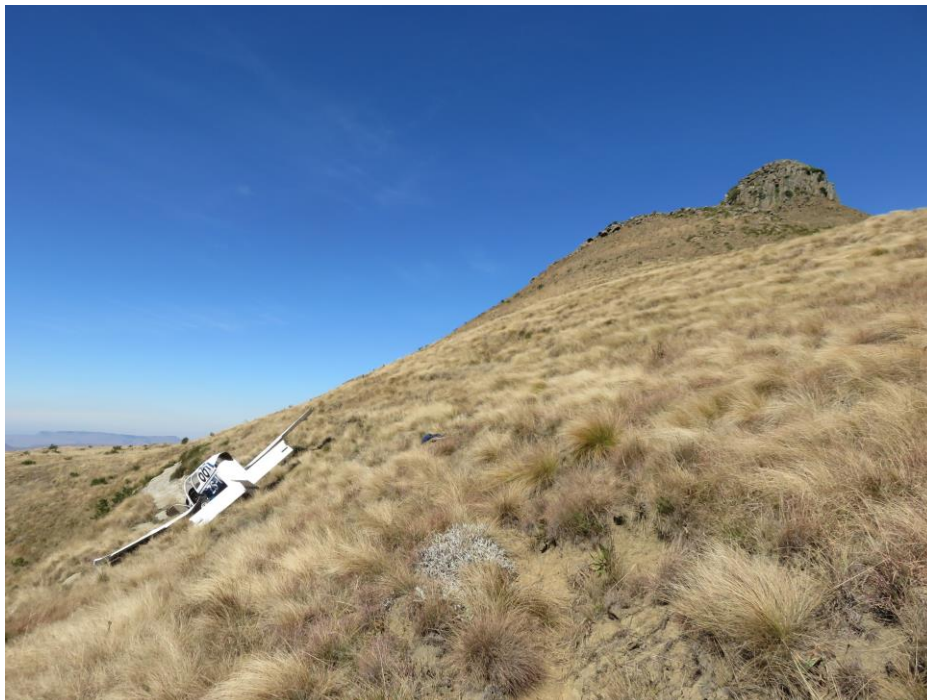
1.12.1 The aircraft impacted on the southern side of the Tafelkop Mountain on a heading of 170°M at an altitude of 6 920 feet above mean sea level (AMSL). The aircraft came to rest in a left wing low attitude against a steep slope. In Figure 3 the wreckage could be seen as it came to rest in relation to the highest point of the Tafelkop Mountain. The aircraft impacted hard with terrain, which caused the aft fuselage to sever partially and the nose gear broke off and came to rest next to the left wing as can be seen in Figure 4. The ground impact markings indicate that the aircraft came to rest within 3m after impact.

Figure 3: The wreckage in relation to the highest point of the Tafelkop Mountain

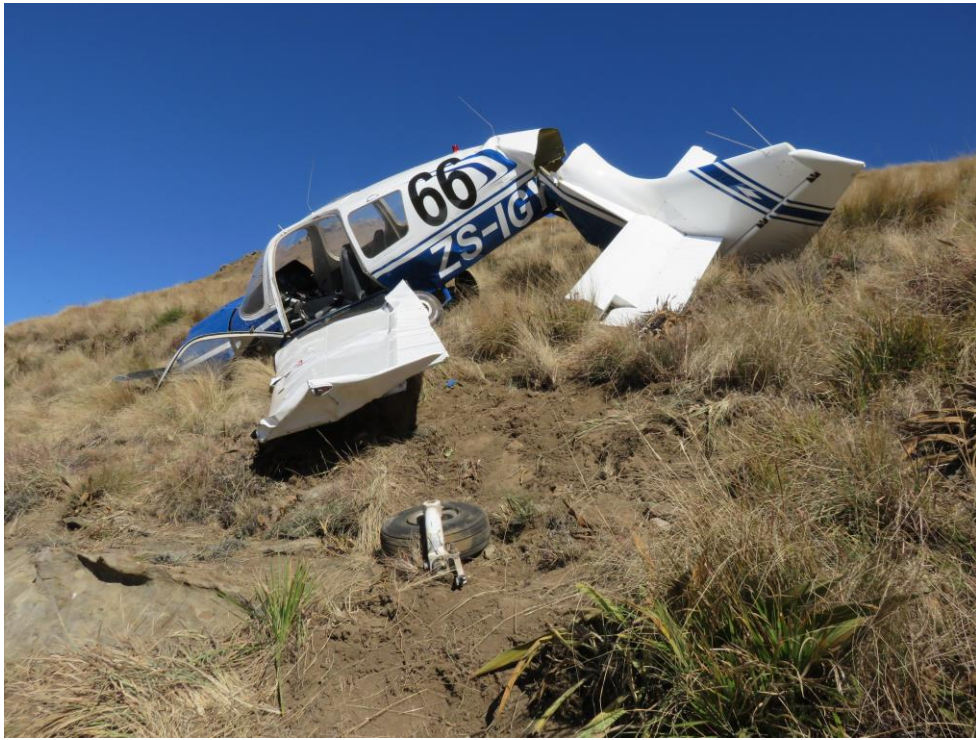
Figure 4: Side view of the wreckage as it came to rest, nose gear broken off

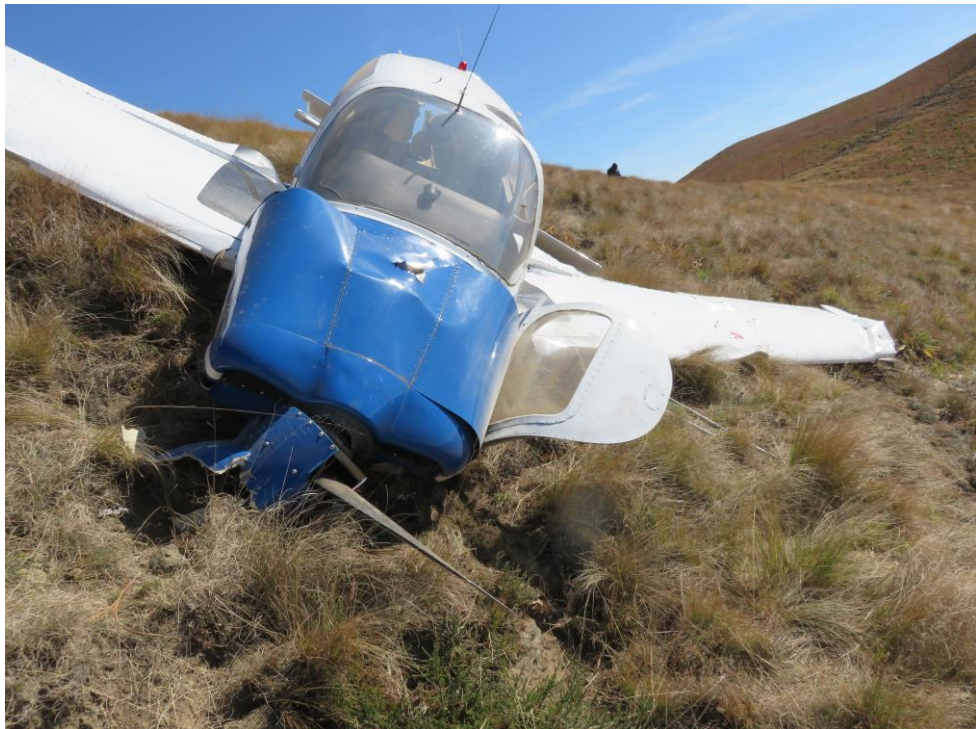
Both wings display impact damage, and flight control continuity was assessed and was found to be compromised. The left front door unlatched during the impact sequence according to the pilot and both occupants were able to disembark from the cockpit via the open door. The cockpit/cabin area remained intact. Both the control stick grips broke off during the impact sequence as can be seen in Figures 7 and 8. The four-point safety harnesses of both front seats remained intact and were unlatched by the occupants.

Figure 5: A front view of the wreckage

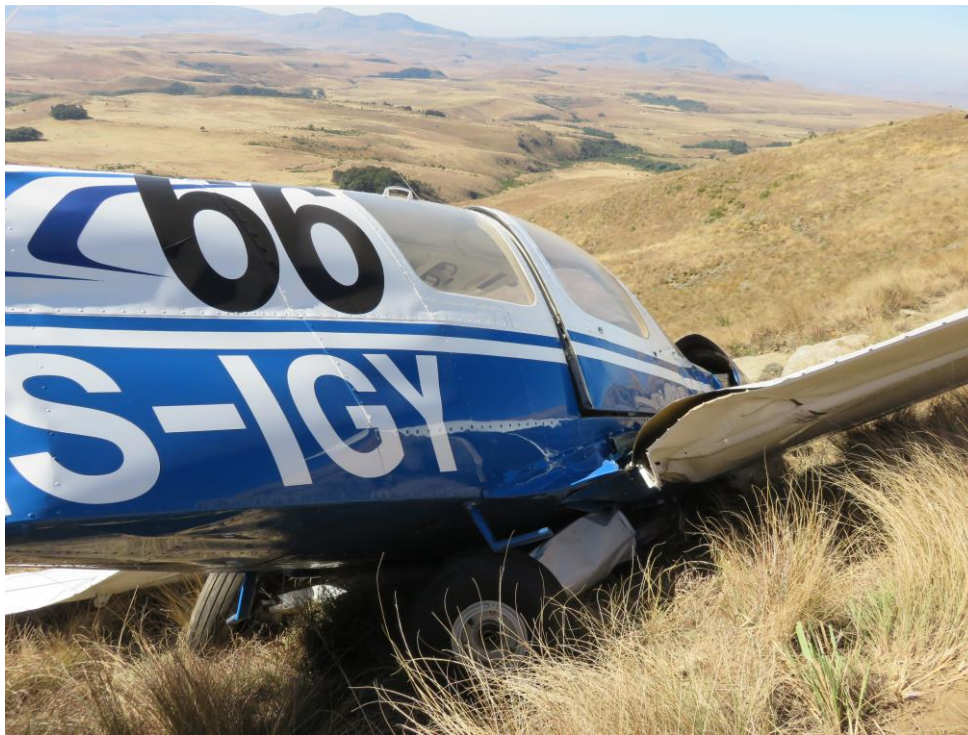
Figure 6: A view of the main landing gear that collapsed and folded backwards

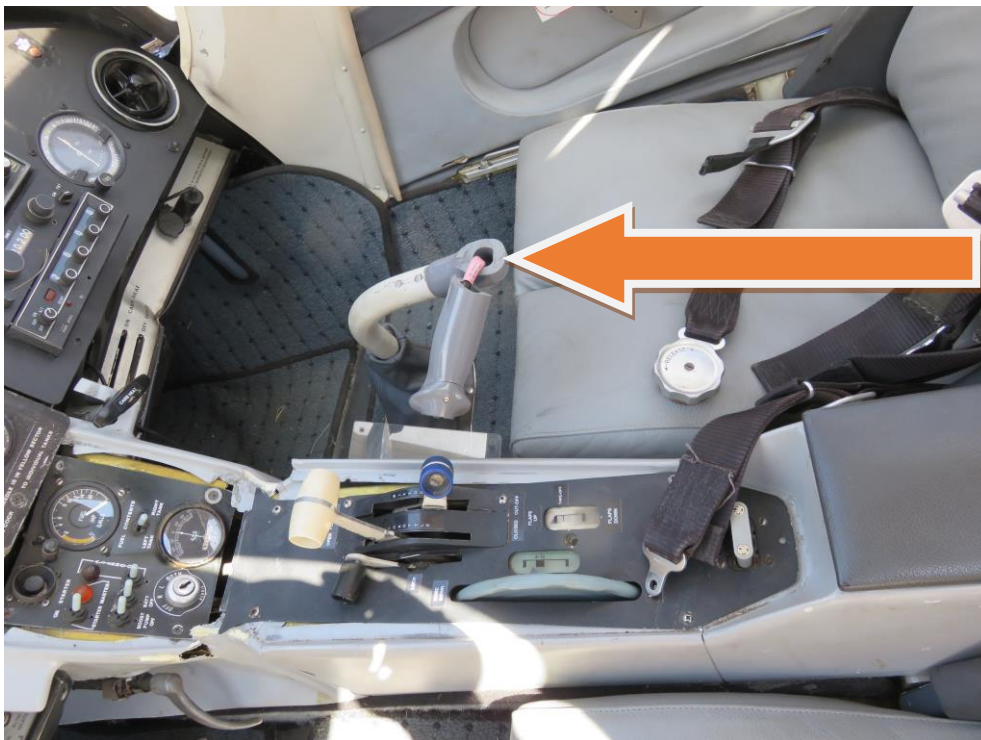
Figure 7: Arrow shows a view of the broken control grip on the navigator side.

1.15.2 The aircraft was equipped with dual flight controls and it was found that the control yoke/stick (similar to that of a helicopter) broke off on both sides. The passenger indicated that he was not injured by this failure. A substantial amount of blood was noted on the left side of the aircraft as well as the upper surface of the left wing, according to the passenger/navigator the pilot suffered from a blow to his head which was bleeding.

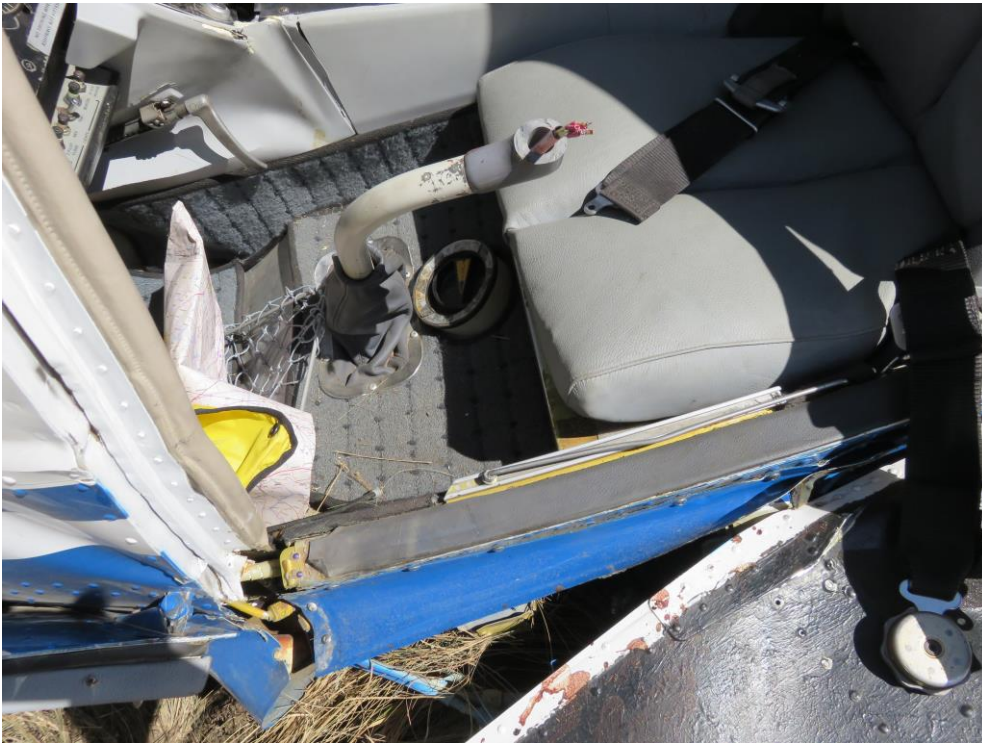
Figure 8: A view of the broken control grip on the pilot side

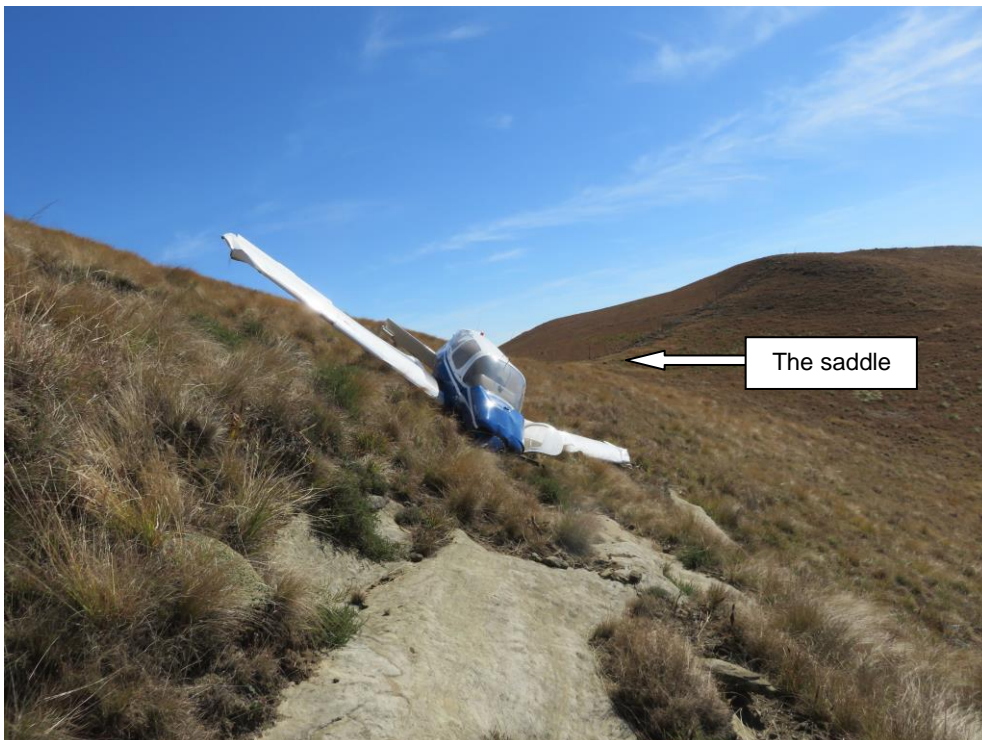
In Figure 9 below the saddle area that was identified by the pilot can be seen.

Figure 9: A view of the wreckage with the saddle area visible to the right behind it

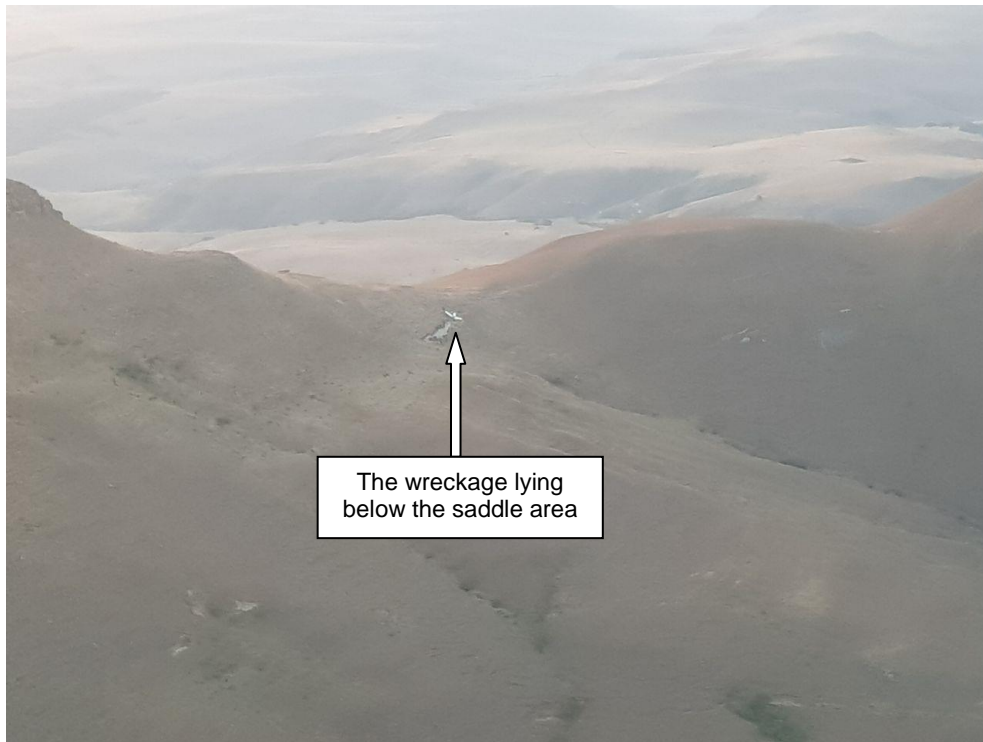
Figure 10: Aerial view of the wreckage below the saddle area (photograph courtesy of BP Greyling)
