**FINAL INVESTIGATION REPORT**

**GROUND INCIDENT INVOLING M/S ETHIOPIAN AIRLINES  
AIRCRAFT ET-AMG AND M/S AIR INDIA AIRCRFT VT-EXD AT DELHI  
ON 08.08.2017**

**FINAL INVESTIGATION**  
**REPORT ON GROUND INCIDENT INVOLVING M/S ETHIOPIAN AIRLINES**  
**AIRCRAFT ET-AMG AND M/S AIR INDIA AIRCRAFT VT-EXD AT DELHI**  
**ON 08.08.2017**

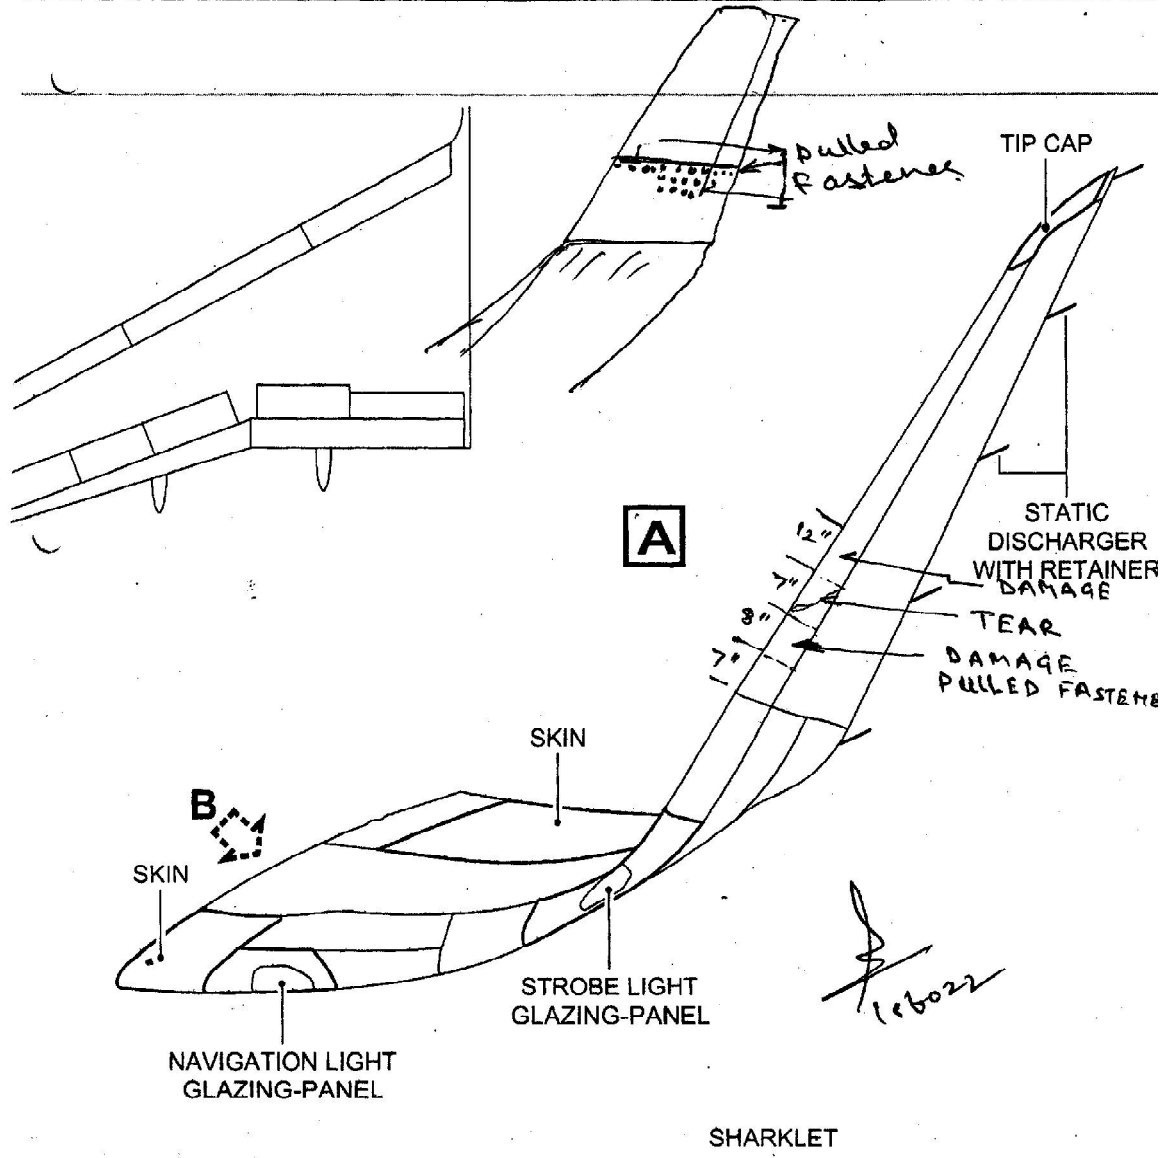
M/s. Air India A320-214 LHS Sharklet got damaged.

- A. Leading Edge of Sharklet Out Board side has the following damages;  
Dent and Distortion, Tear, Fasteners were pulled, Small portion of Leading Edge had separated from Sharklet spar.
- B. Inboard side middle chord wise joint has pulled 20 fasteners.

**DAMAGE REPORT**  
 LHS SHARKLET VT-EXD; MSN 6724  
LEADING EDGE - OIB SIDE HAS  
 DAMAGE, TEAR, PULLED FASTENER  
 SMALL PORTION SEPERATED FROM SPAR.  
MIDDLE CORDWISE JOINT → B || B \* FASTENER ARE PULLED

Schematic depicting damage to Air India aircraft

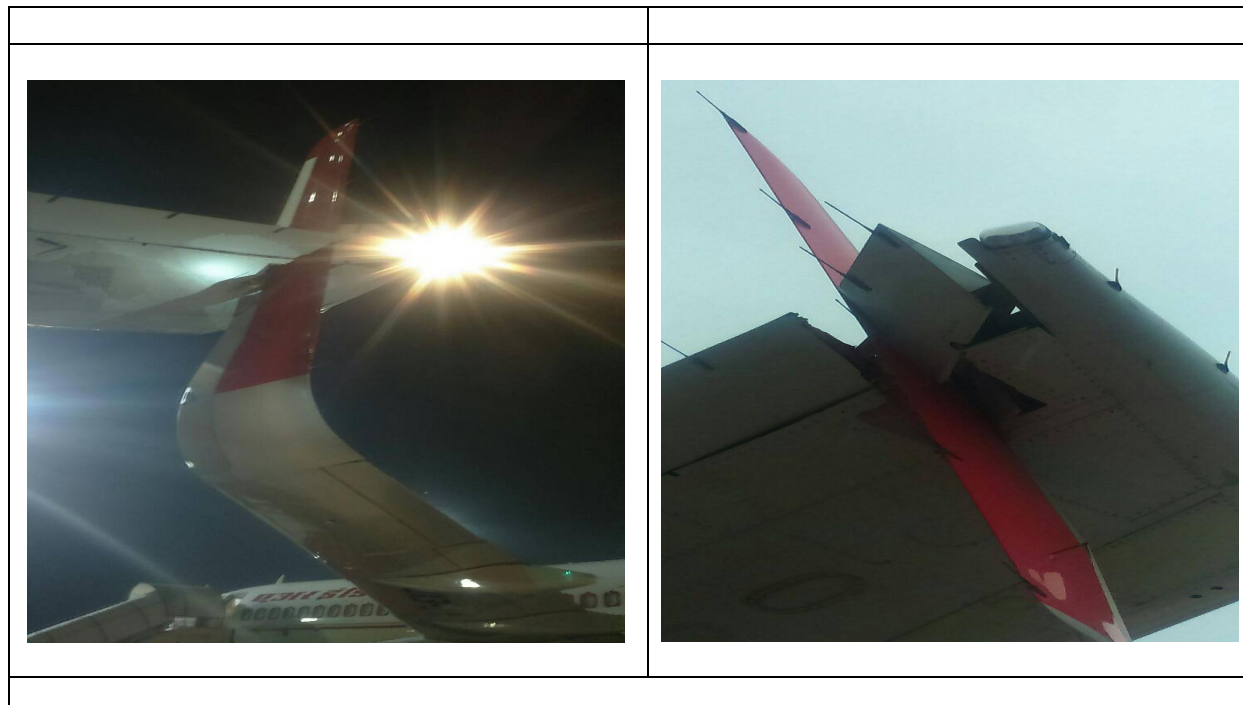
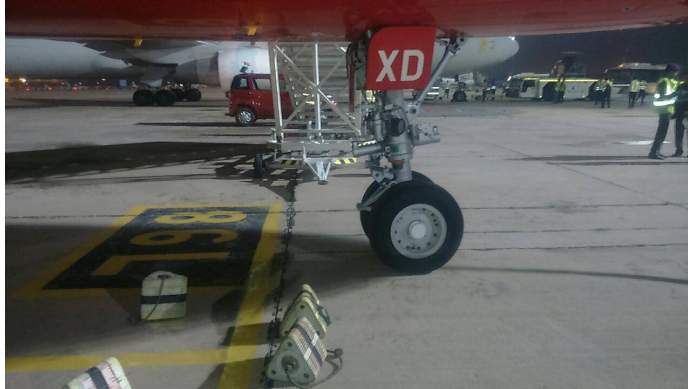
M/s. Ethiopian aircraft after being pushed back approximately 47ft from its nose wheel parked position on lead in/out line of Bay no.87, its starboard side wing made contact with the port side wing of M/s Air India aircraft which was parked on Bay no. 86L. M/s. Ethiopian aircraft starboard side aileron and wingtip sustained damages. M/s Air India aircraft shark let received damages. Approx. 2ft of Ethiopian aircraft starboard side wing pierced into Air India aircraft shark let on its portside.

The Air India aircraft was parked on stand 86L. However after the occurrence, the Air India aircraft got displaced towards the port side. At the displaced position, the nose wheel found approx. 3'4" ahead of nose wheel marking and 5'1" towards portside from the lead line.

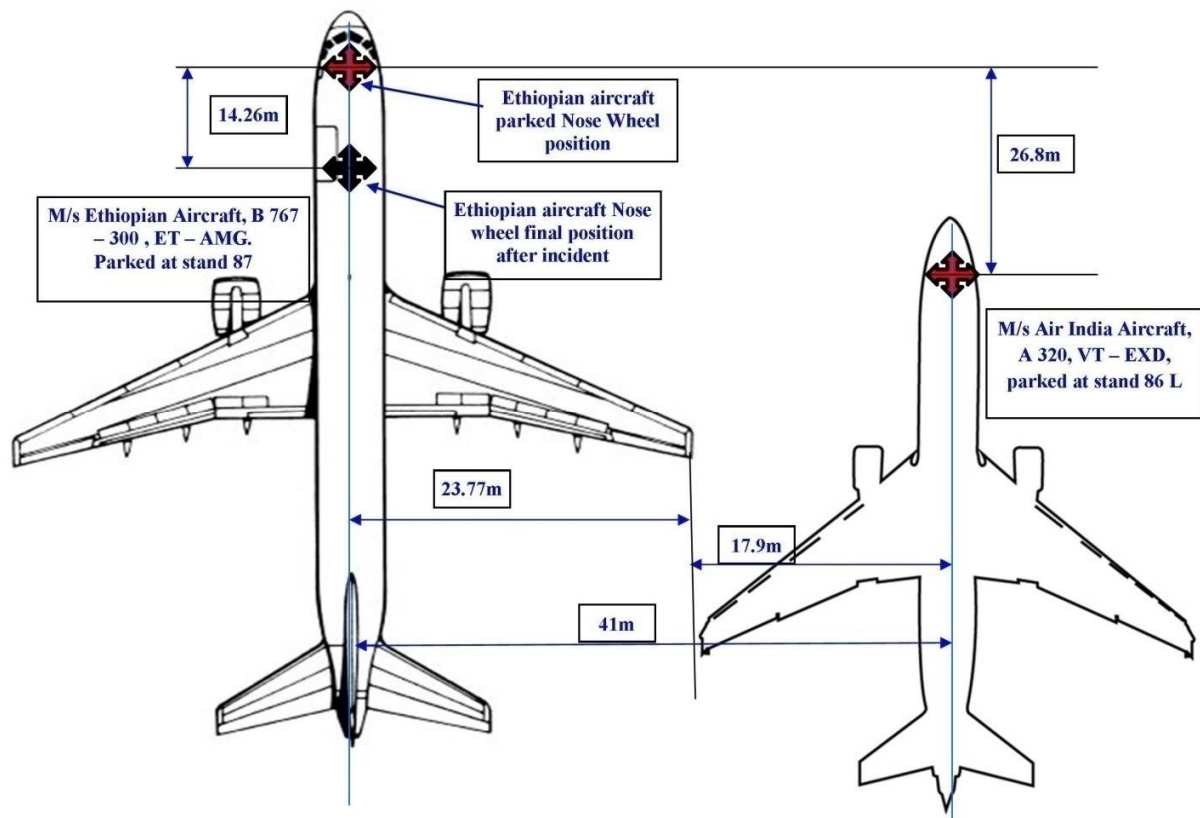
**Schematic of the Stand allocation to Ethiopian and Air India aircraft (not to scale).**
