# Air Accident Investigation Sector

- Final Report -

AAIS Case N°: AIFN/0010/2017

## Descent below Cleared Altitude during Approach and FMS not reconfigured following a reset during the Second Approach

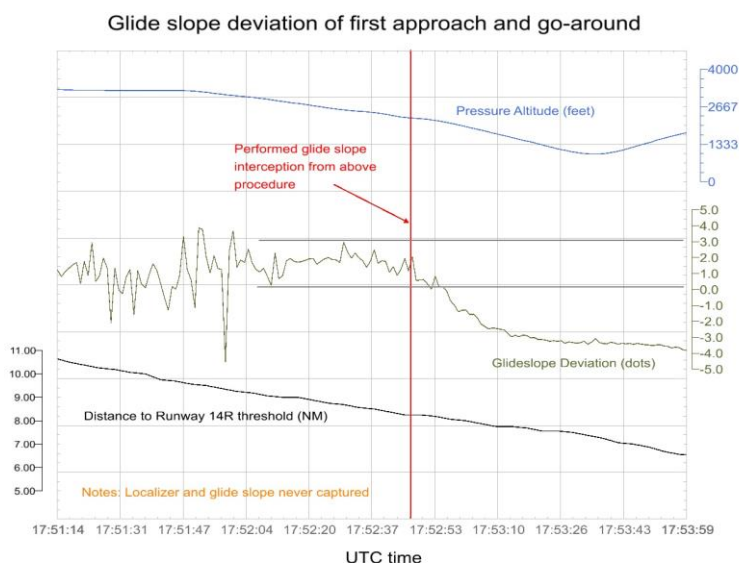
**Figure 32.** Glideslope deviation of the first approach and the go-around

The Aircraft never captured or established on the localizer, nor did it capture the glideslope.

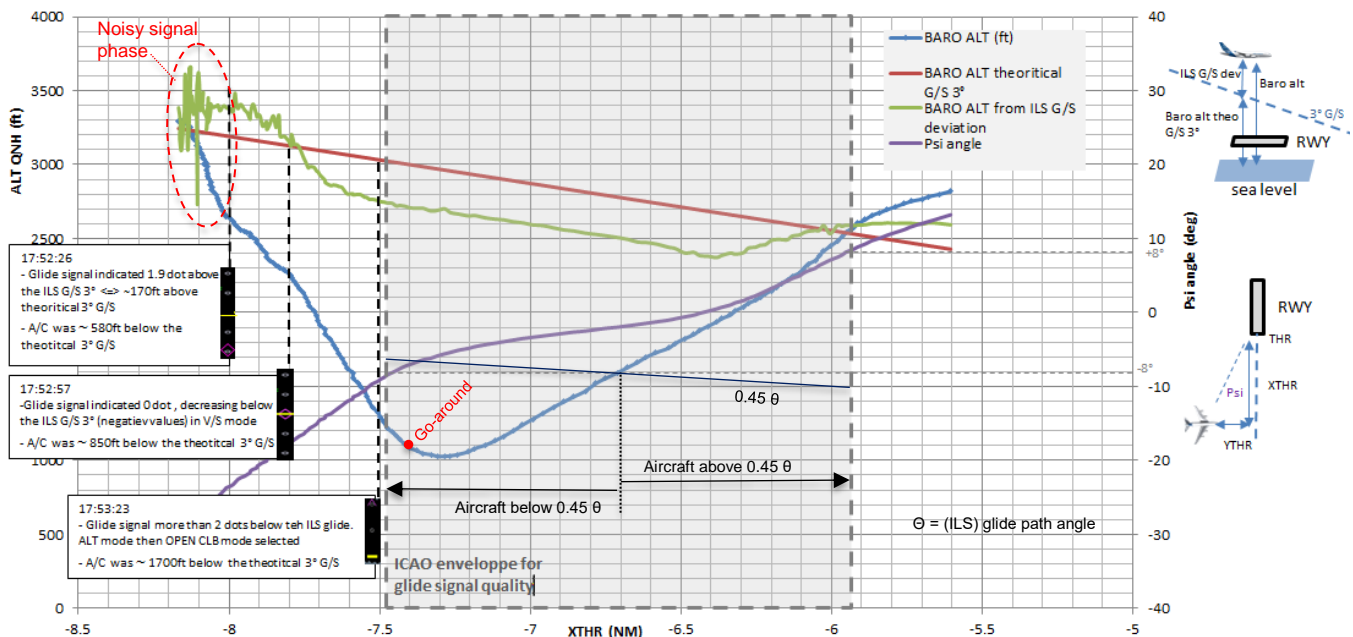
**Figure 33.** Selected Aircraft parameters as a function of the distance to the runway 14R threshold

deviation indication indicated that the Aircraft was on profile. Following this, the actual Aircraft height continued to decrease.

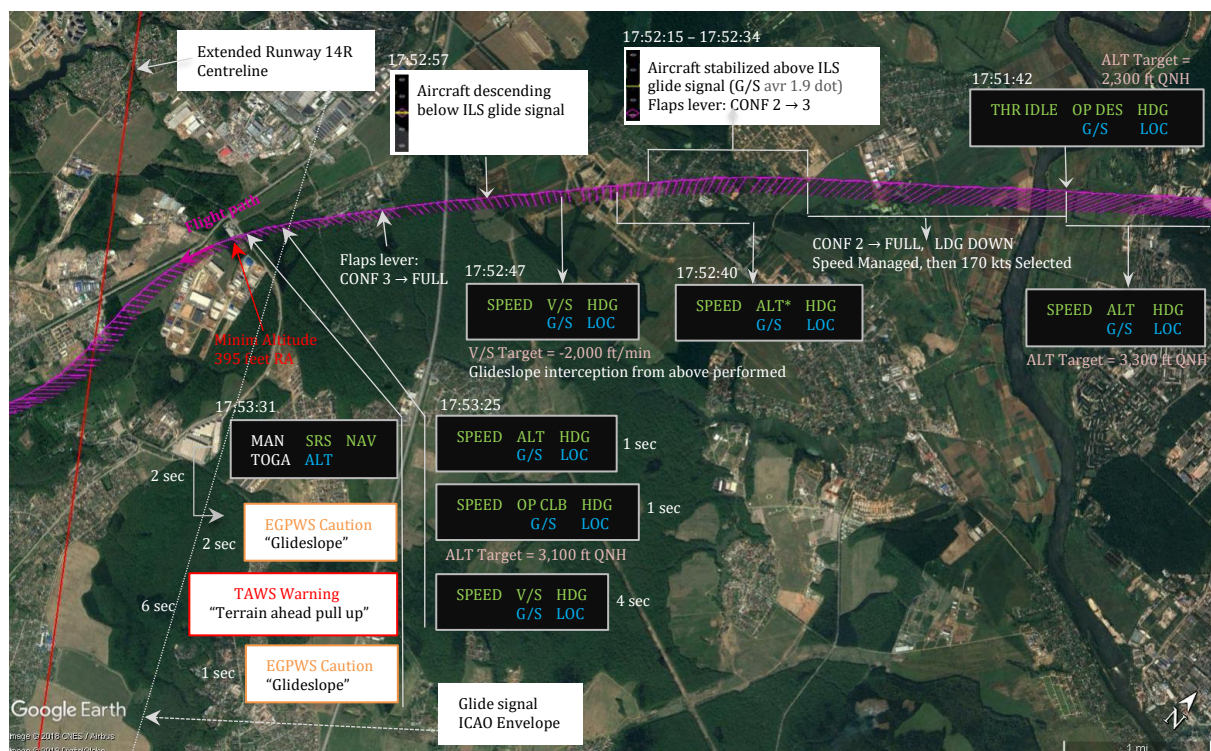
Figure 34. Aircraft trajectory of the first approach and the go-around

Neither pilot was aware that the Aircraft was descending below 500 meters QFE until the instruction 'not to descend further' came from the Radar Controller. On receiving this instruction, the Commander then decided to initiate an immediate go-around. He declared his intention to the Radar Controller approximately three seconds after the "not to descend" instruction.

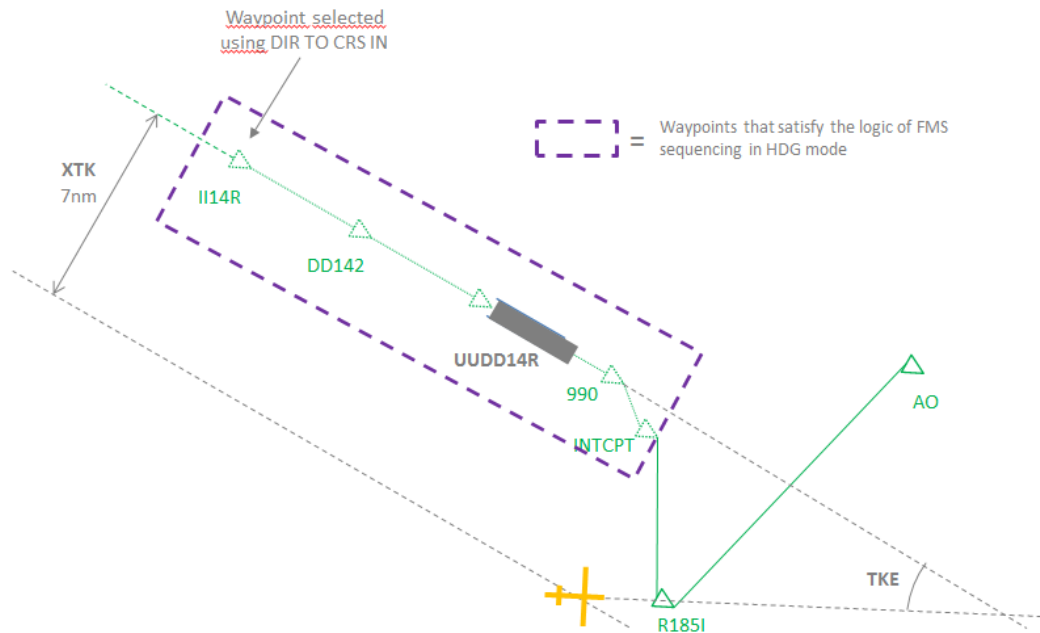
**Figure 35.** Illustration of the logic of waypoints sequencing

- (f) As the flight crew prepared for the second approach, a multi-waypoint sequencing in a row of the flight plan occurred when the crew performed a lateral revision of the flight plan using the DIR TO CRS IN pushbutton as per the SOP at a location where several waypoints satisfied the FMS geometrical waypoint sequencing rules. A real time computation issue caused an automatic reset of FMS1.

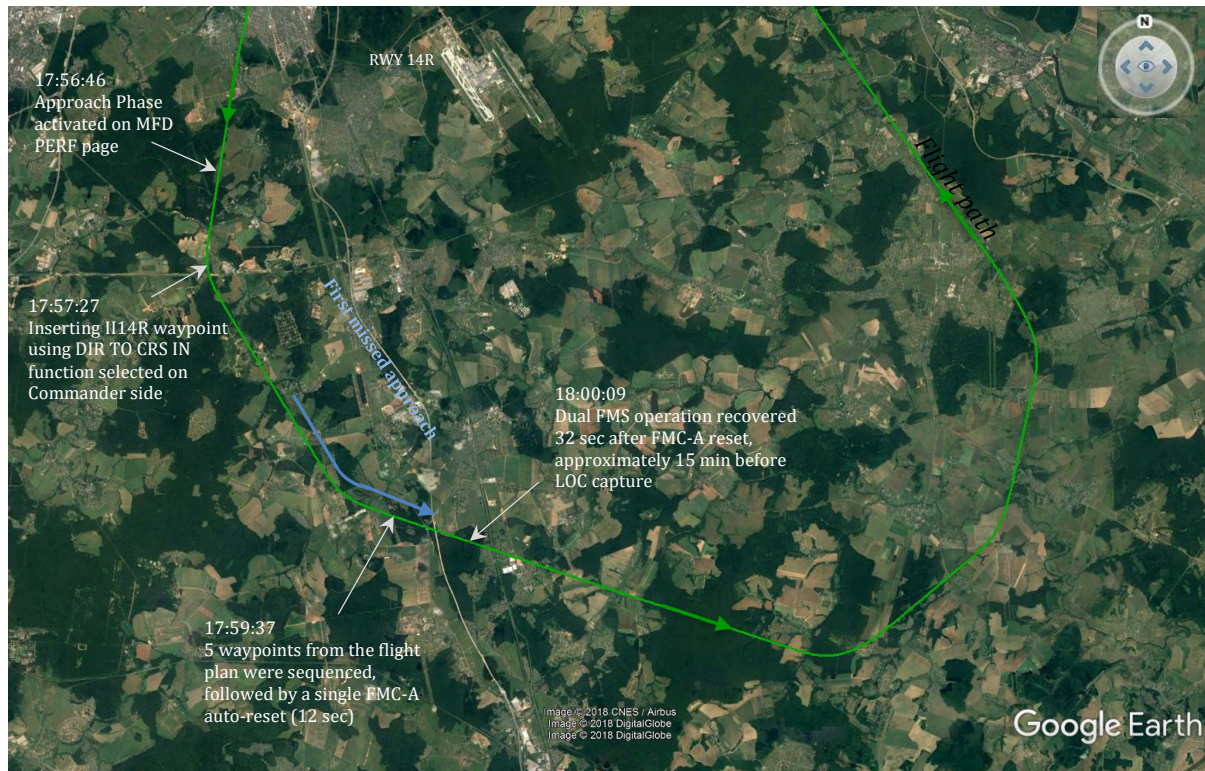
**Figure 36.** Aircraft trajectory after the go-around and preparation for the second approach

Consecutively to the multi-waypoint sequencing by the FMS, the FMS2 (FMC-B) and backup on standby (FMC-C) remained in its normal state during the FMS1 auto-reset. During this period, 'MAP NOT AVAIL' (in red), and 'FMS PAGE NOT AVAIL' (in amber) messages were displayed on the ND and MFD, respectively, on the Commander's side only. The flight plan was not lost and was still displayed on the Co-pilot's ND and MFD. Nominal dual FMS operation was fully recovered approximately 32 seconds after the single FMS1 auto-reset.

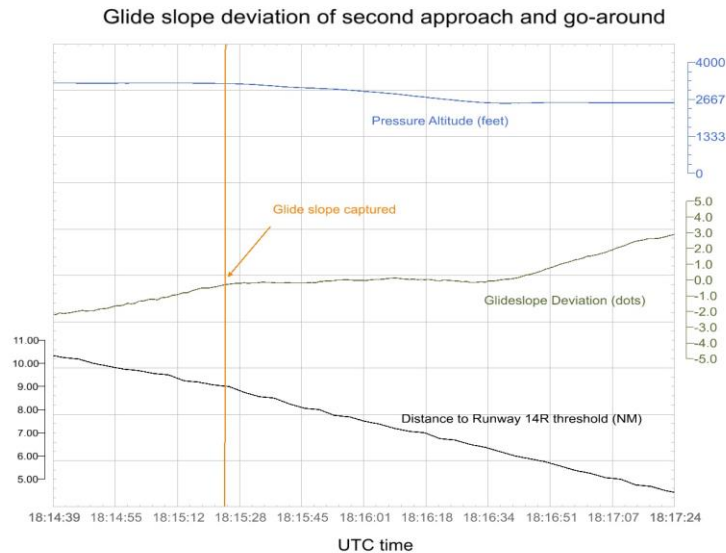
**Figure 37.** Glideslope deviation for the second approach and discontinued approach

Until the selection of the UDD14R waypoint using the DIR TO function, the Aircraft followed the glideslope, as shown in figure 37, the glideslope deviation indication showed approximately on the profile.

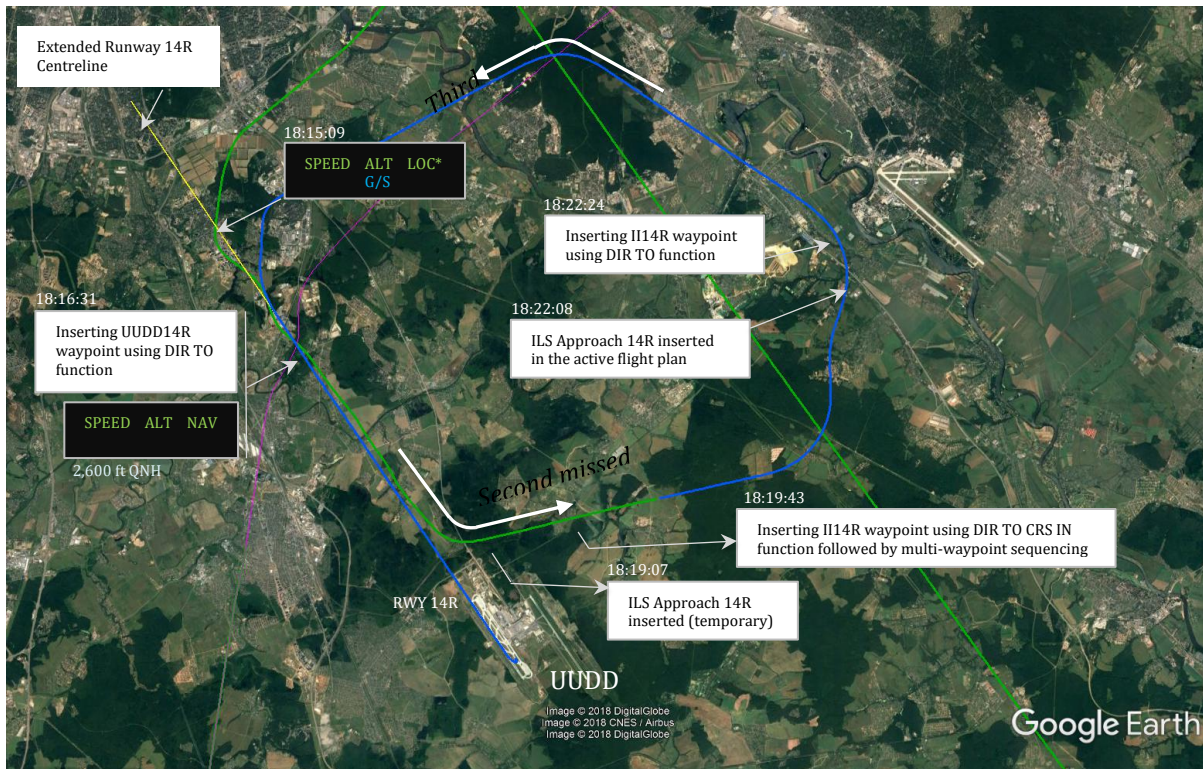
Figure 38. Aircraft trajectory of the discontinued approach, the third approach, and the landing

When the Aircraft was turning left onto the downwind leg at approximately 8.3 nautical miles from the extended runway centerline, the AO waypoint was inserted using the DIR TO function. Twenty four seconds later, a new destination from the AO waypoint was inserted into the temporary flight plan. The Investigation believes that the Commander performed both insertions. The Investigation believes that these insertions were made to anticipate and prevent a similar FMS auto-reset issue on the third approach attempt.

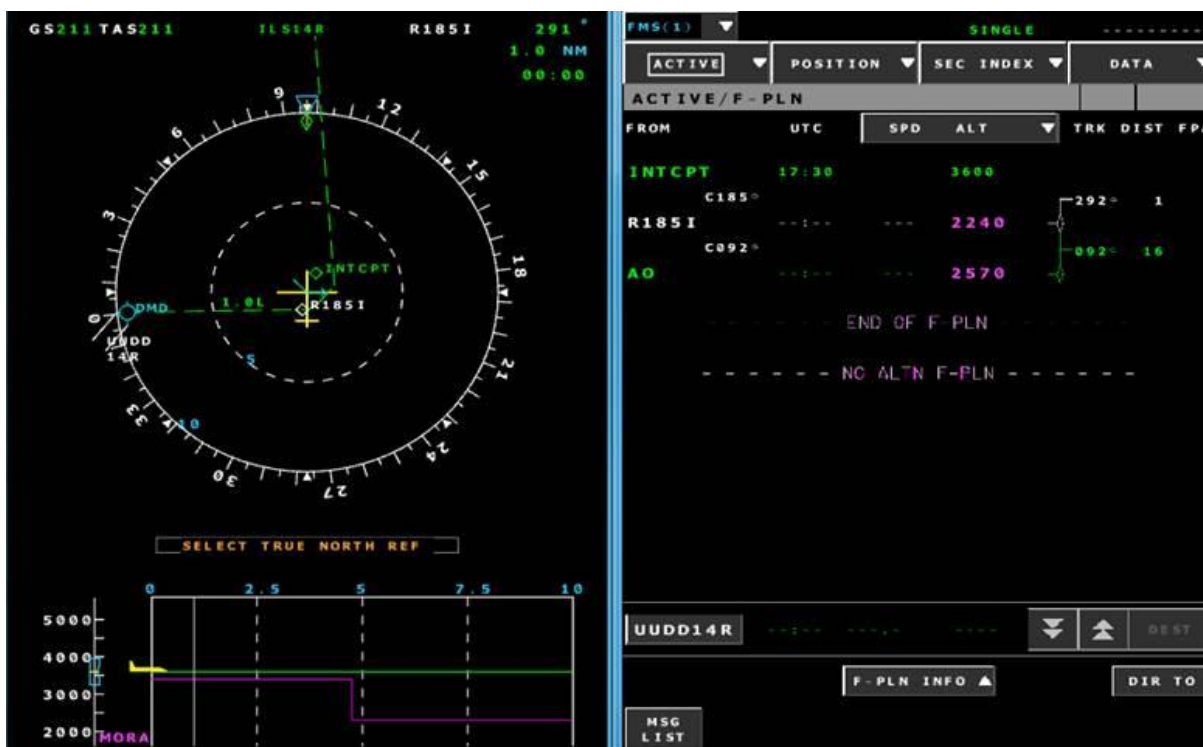
Figure A1.7 – Illustration of FMS flight plan displays on MFD and ND after multi-waypoint sequencing on Co-pilot side and after FMS 1 (FMC-A) recovery on Commander side

The figure A1.7 below illustrates the displayed FMS flight plan on the ND and MFD after the multi-waypoint sequencing on the Co-pilot side, and after FMS 1 (FMC-A) recovery on the Commander side.
