AIRCRAFT ACCIDENT REPORT AND EXECUTIVE SUMMARY

Reference:	CA18/2/3/9655		
Aircraft Registration	ZS-ELS	Date of Accident	13 October 2017		Time of Accident	1420Z	
Type of Aircraft	Piper 28-235		Type of Operation		Private (Part 91)		
Pilot-in-command Licence Type		Private Pilot	Age	57	Licence Valid	Yes	
Pilot-in-command Flying Experience		Total Flying Hours	297.3		Hours on Type	50.3	
Last point of departure		Wonderboom Airport (FAWB): Gauteng Province					
Next point of intended landing		Florence Guest Farm near Chrissiesmeer: Mpumalanga Province					
Location of the accident site with reference to easily defined geographical points (GPS readings if possible)							
Tevreden Pan between Chrissiesmeer and Carolina (GPS S 26° 12' 07.04" E 030° 10'20, 29") elevation 5749 ft.							
Meteorological Information		Wind direction:070°/11kts Broken Cloud 600feet Temperature 09°C					
Number of people on board		1+1	No. of people injured		0	No. of people killed	2

Name of Owner /Operator : ZS-ELS Partnership
Manufacturer : Piper Aircraft Corporation
Model : PA-28-235
Nationality : South African
Registration Marks : ZS-ELS
Place : Tevreden Pan near Chrissiesmeer
Date : 13 October 2017
Time : 1420

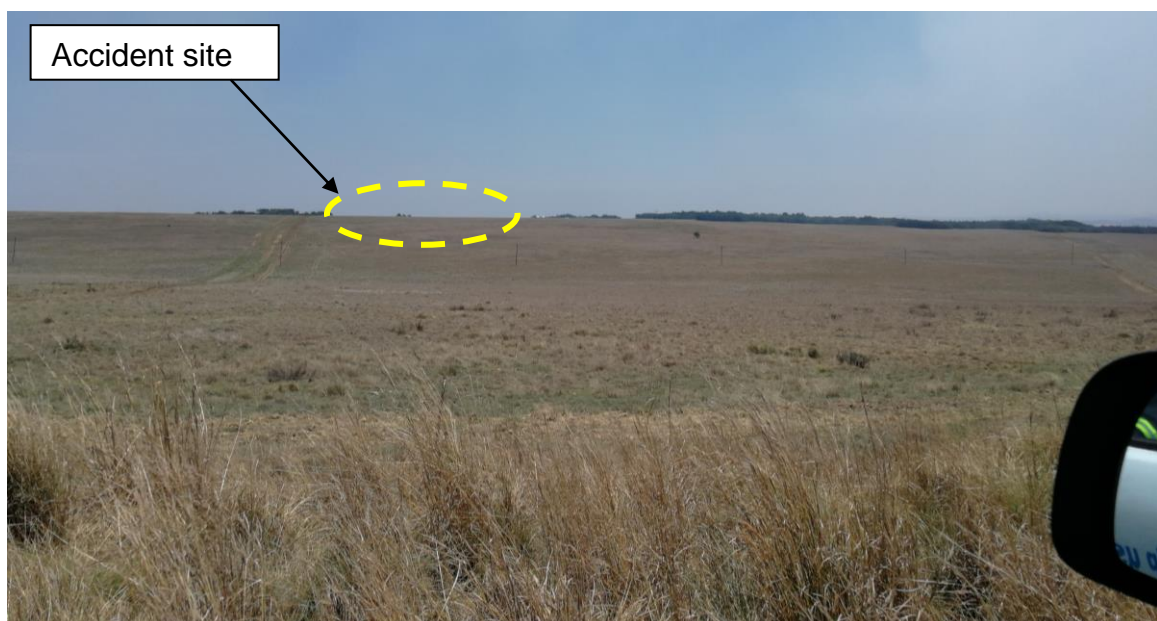
- 1.1.5 One of the guests then traced the location of the passenger's phone using Apple's find my phone App and showed the farm owner the location. The farm owner informed South African Police Services (SAPS) at Chrissiesmeer and requested the police officers to escort him and some guests to the phone's location. The location was at Tevreden Pan between Chrissiesmeer and Carolina. The farm owner also contacted the owners of the farm where the phone was located. At 1645Z they all drove to the location of the cell phone and found the wreckage but due to thick mist they could only see the burning wreckage, grass and fire. The wreckage was found on flat ground above a hill at approximately 11 km to the north west of the lodge.

Figure 1 Photograph showing the accident site

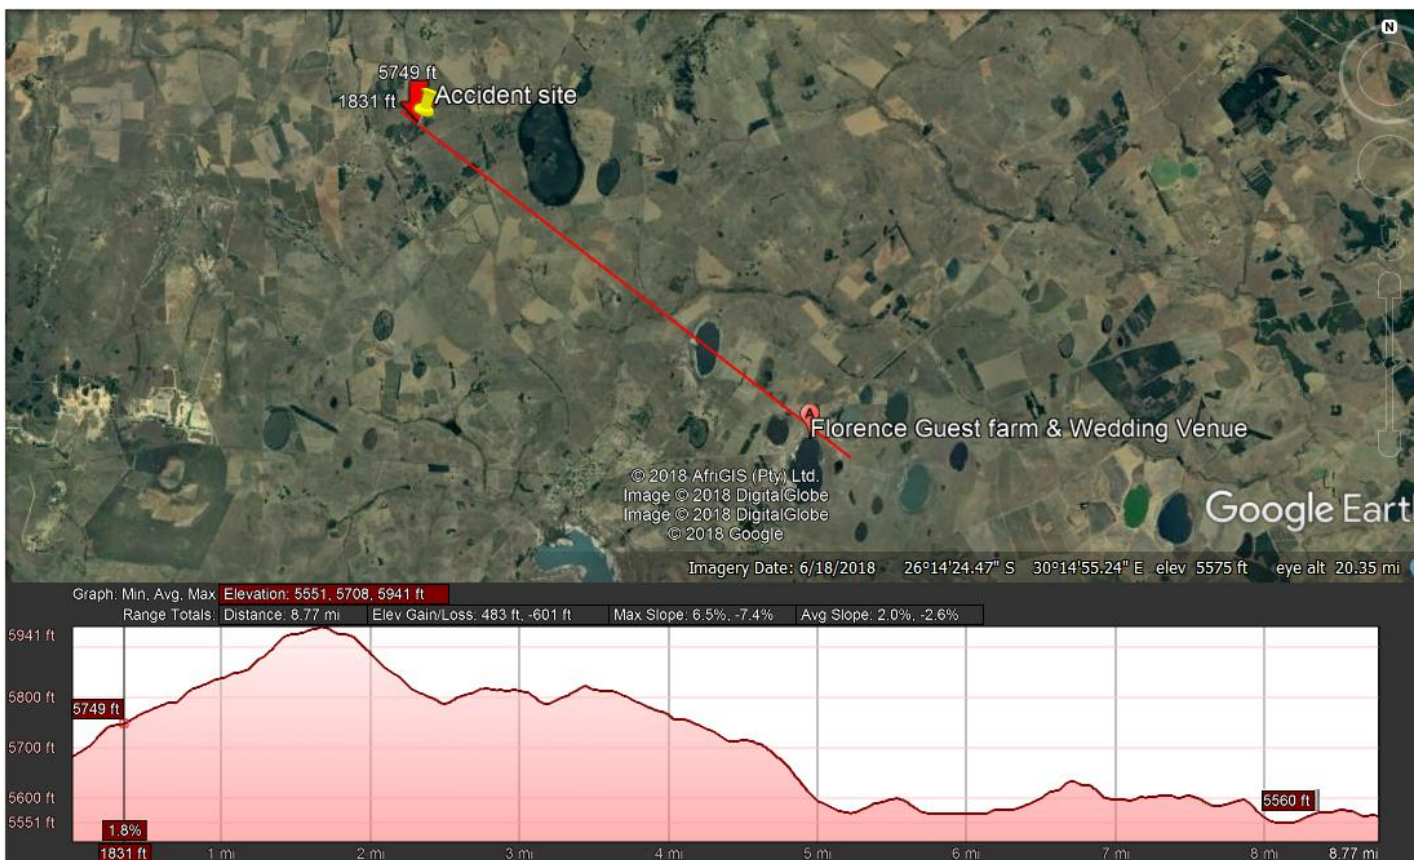
Figure 2: Google maps image showing the profile of the terrain and the red line in the upper part of the picture showing the flight path of ZS-ELS the crash site elevation is 5749 ft and the lodge elevation is 5560ft.

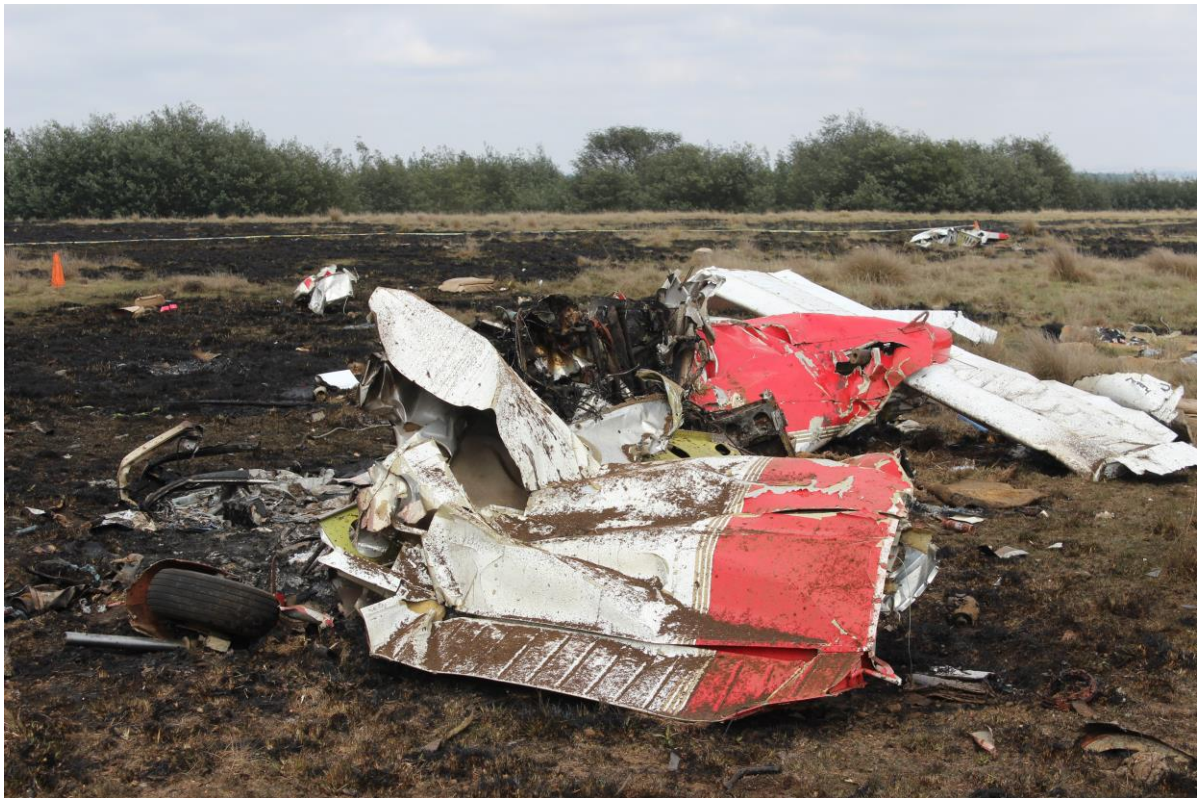
1.3.1 The aircraft was destroyed.

Figure 3 Photo of the damaged aircraft.

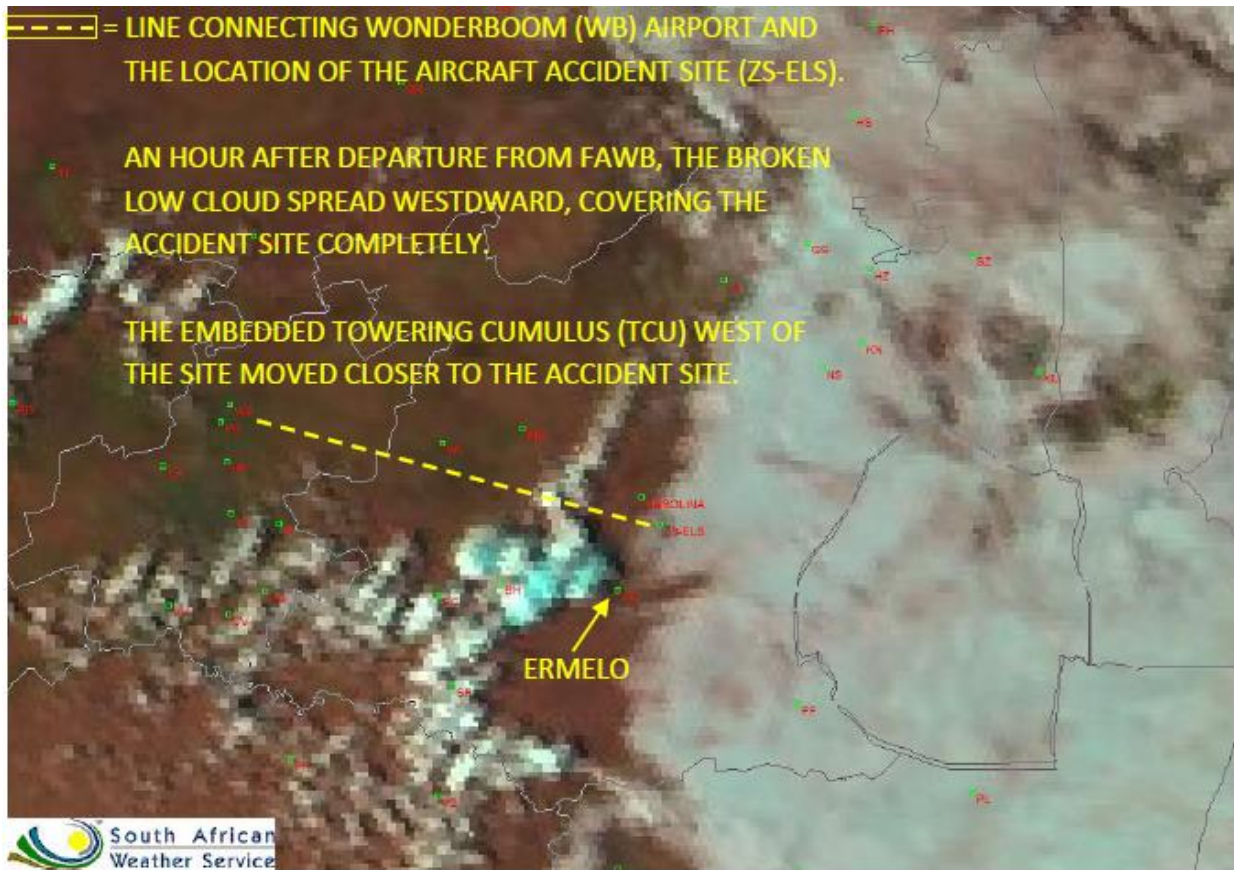
1.7.2 There were Altocumulus clouds and towering cumulus clouds en-route to the south east of Witbank. At 1315Z the accident site was on the western edges of a mass of low cloud which was widely spread to the east and continued encroach to the west parts of Mpumalanga. On the other hand the Alto cumulus cloud on the south east was moving to an easterly direction. The images show a Towering cumulus cloud that moved directly over head the accident site. While low cloud continued to spread westwards towards sunset, covering the accident site completely. See page 6 of 9 of the weather report below Appendices 5.2.

Figure 4 Image showing a Towering cumulus cloud that moved directly over head the accident site

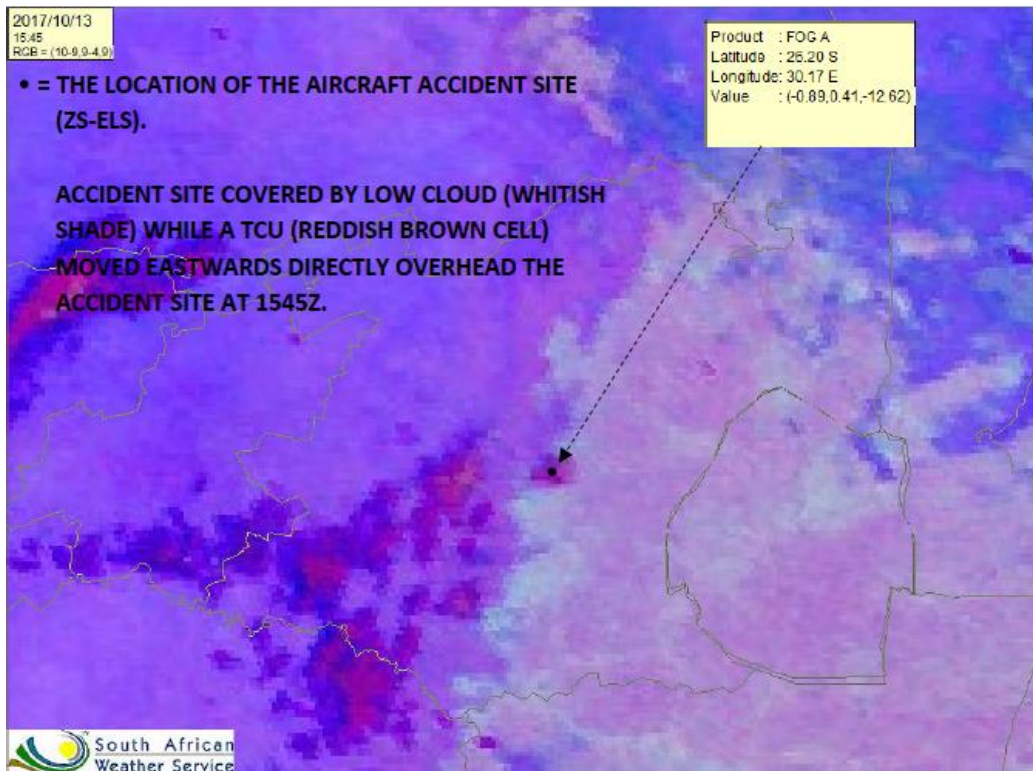
1.7.3 The accident site covered by low clouds (whitish shade) while TCU (reddish brown cell) moved eastwards directly overhead the accident site see figure 5 below.

Figure 5 The image showing the accident site covered by low clouds

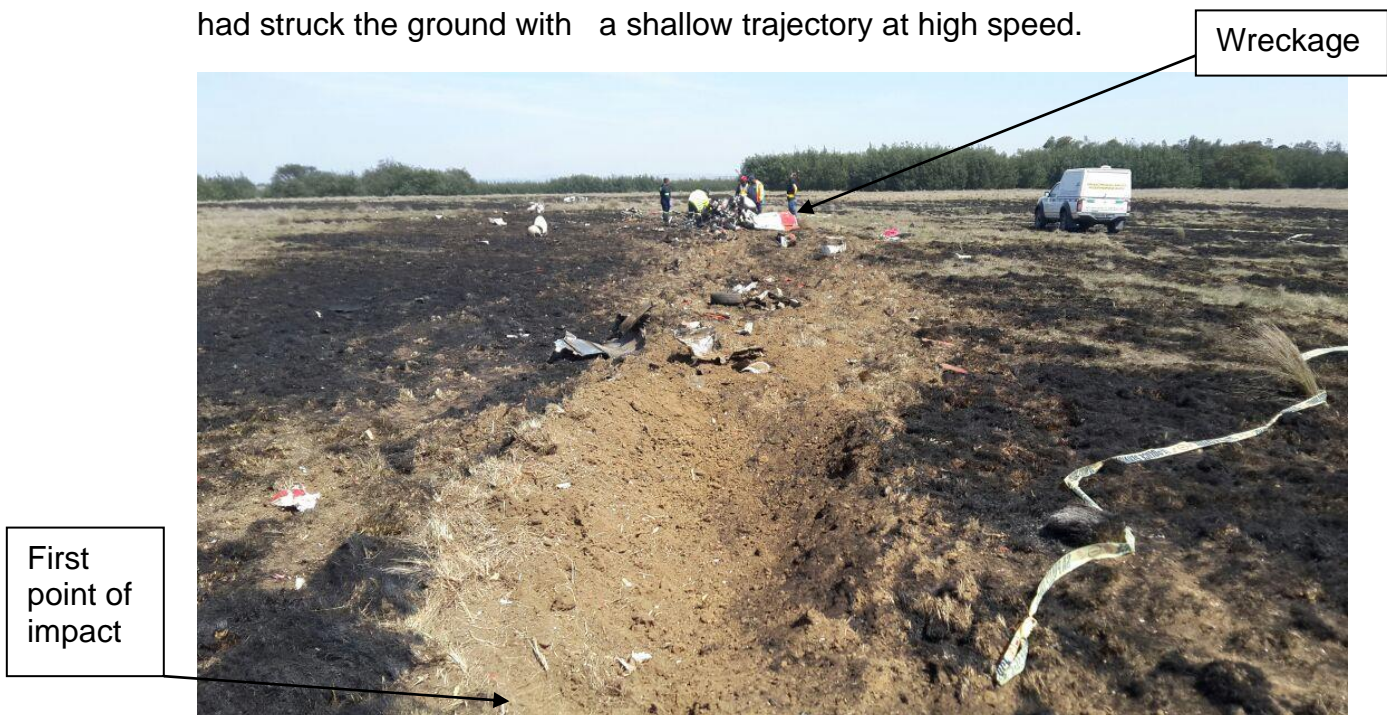
1.12.2 The aircraft crashed nose first and left a 4m long trough in the ground see figure 6. The wreckage trail was approximately 72 m. Parts of all the aircraft’s primary structures were accounted for at the accident site. The completeness and proximity of the main wreckage and the depth of the impact mark, suggested that the aircraft had struck the ground with a shallow trajectory at high speed.

Figure 6 Image of the crater in the ground

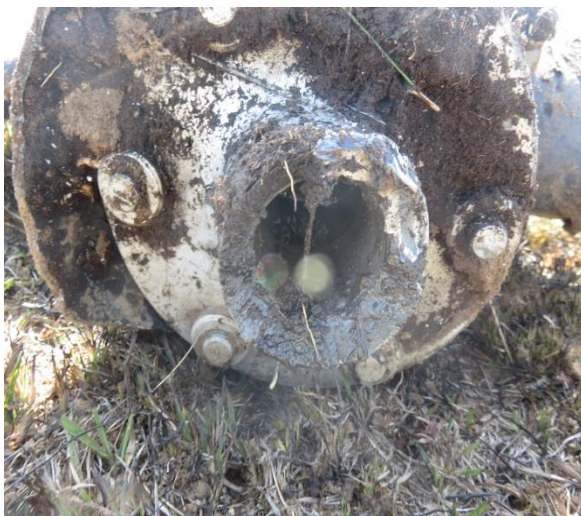
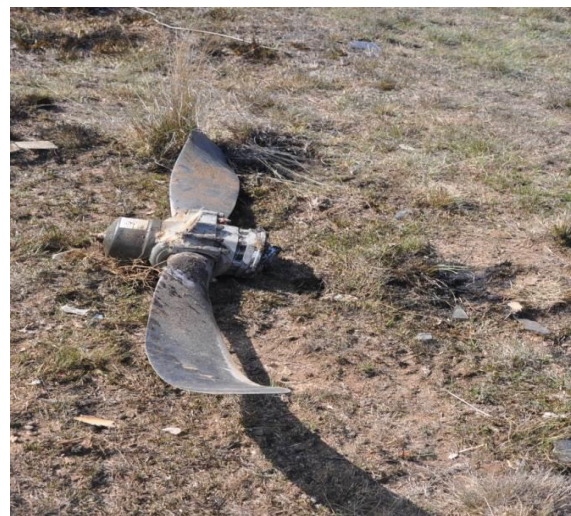
1.12.4 The propeller hub separated from the crank shaft. The separation features on the crankshaft were conical; in appearance with a 45° shear lip around the entire radius of the break, see figure 7 and 8. There was extensive fire damage in the cockpit area with little useful information remaining on the instruments. The throttle control was found pushed fully forward at full power position. The aircraft flight folio couldn't be found during the on-site investigation.

Figure 7/8: Pictures showing a broken engine crankshaft (L) and the propeller (R)

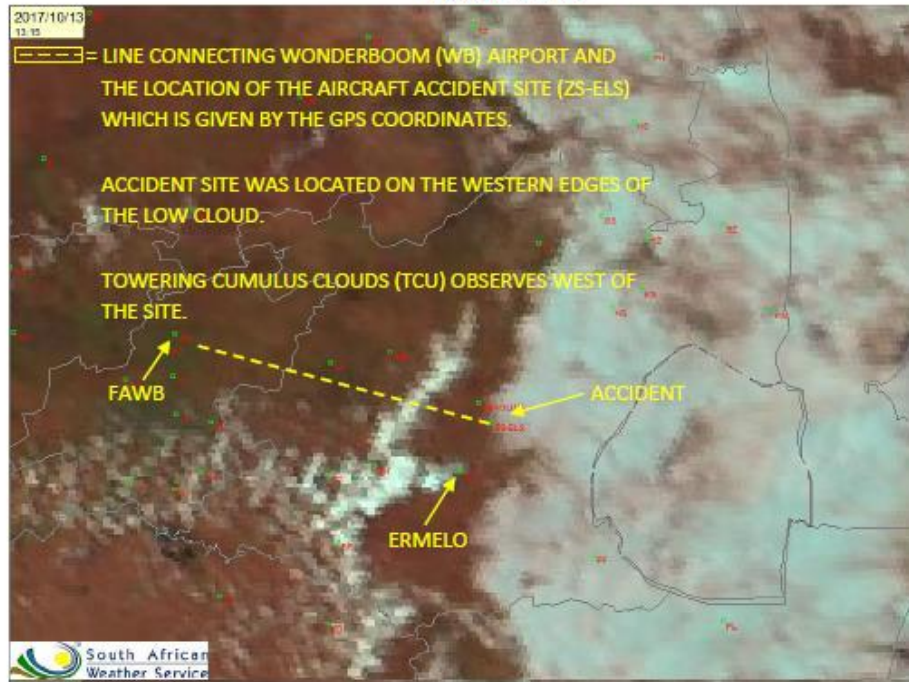
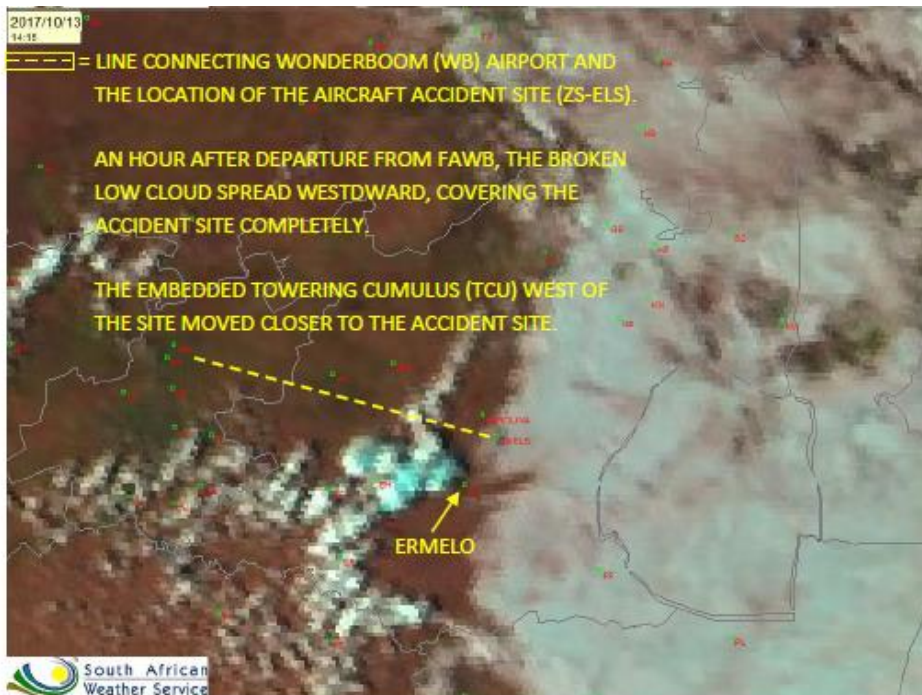
Attachment A1

Satellite images showing observed clouds within the period of the flight under investigation, 1315 – 1800Z, are included as Attachments A1-2. The images recorded no clouds over the Wonderboom (FAWB) at the specified time of departure, but scattered clouds in the form of Alto cumulus (Ac) and high based Towering cumulus clouds (TCu) enroute to the south and east of Witbank. At this time, 1315Z, the accident site was located at the western edges of a mass of low cloud, which was widely spread to the east, and continued to encroach the western parts of Mpumalanga. On the other hand, the Ac cloud that was reported lying over the southwestern parts earlier in the text, was moving into an easterly direction. The mages also show a TCu that moved directly overhead the coordinates of the accident site at 1545Z. While the low cloud continued to spread westwards towards sunset, covering the accident site completely (overcast conditions), the mid-level cloud together with the TCu dissipated were dissipating (see 1800Z night microphysics satellite composite in Attachment A2).
