DANSK UL-FLYVER UNION  
DANISH ULTRALIGHT FLYING ASSOCIATION

# ACCIDENT WITH OY- 9479 VL-3 EVOLUTION

16.October.2017

Location: AUDEBO, NORTH OF EKHK (HOLBÆK), DENMARK

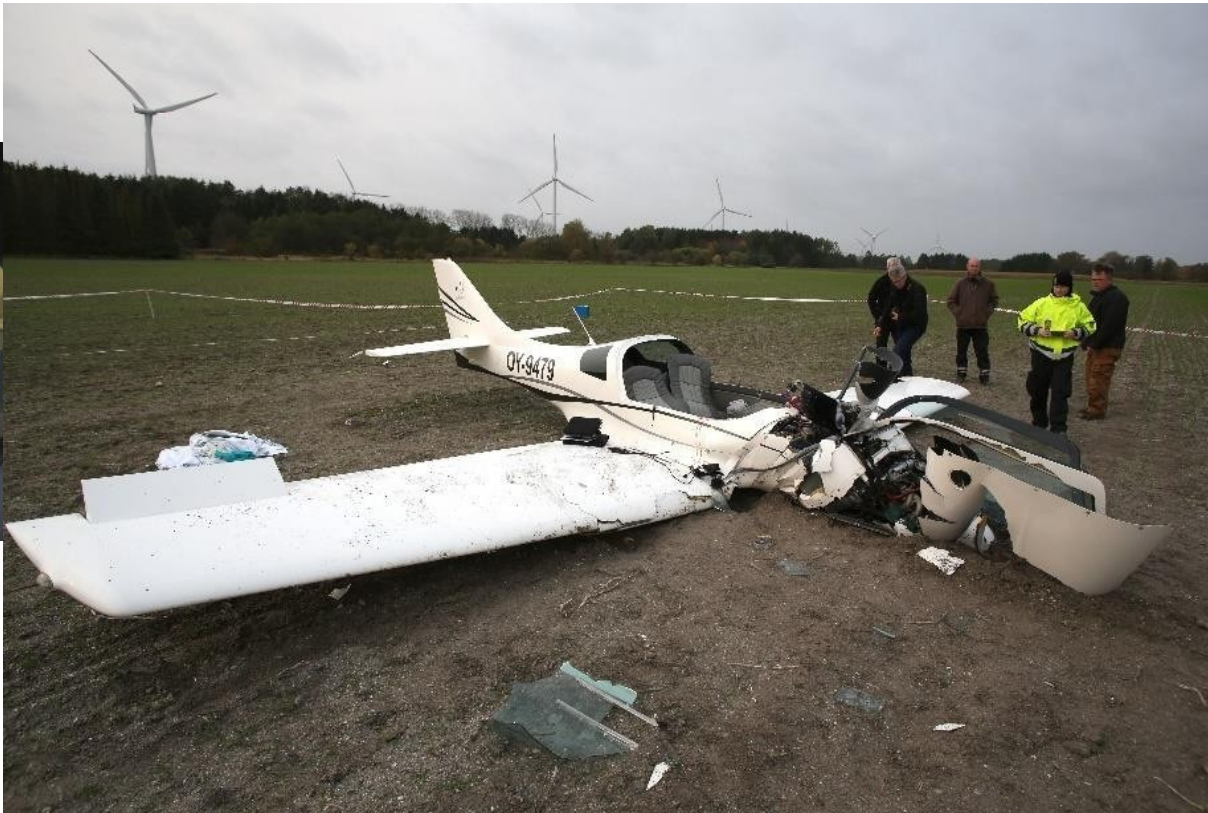
At impact both elevator bobweights broke away. The right one is located below the elevator and

the left approximately 4 meters rear of the aircraft.

If the bobweights have broken away from the aircraft as the tail hits the ground, or by severe oscillation of the control column, can not be determined.

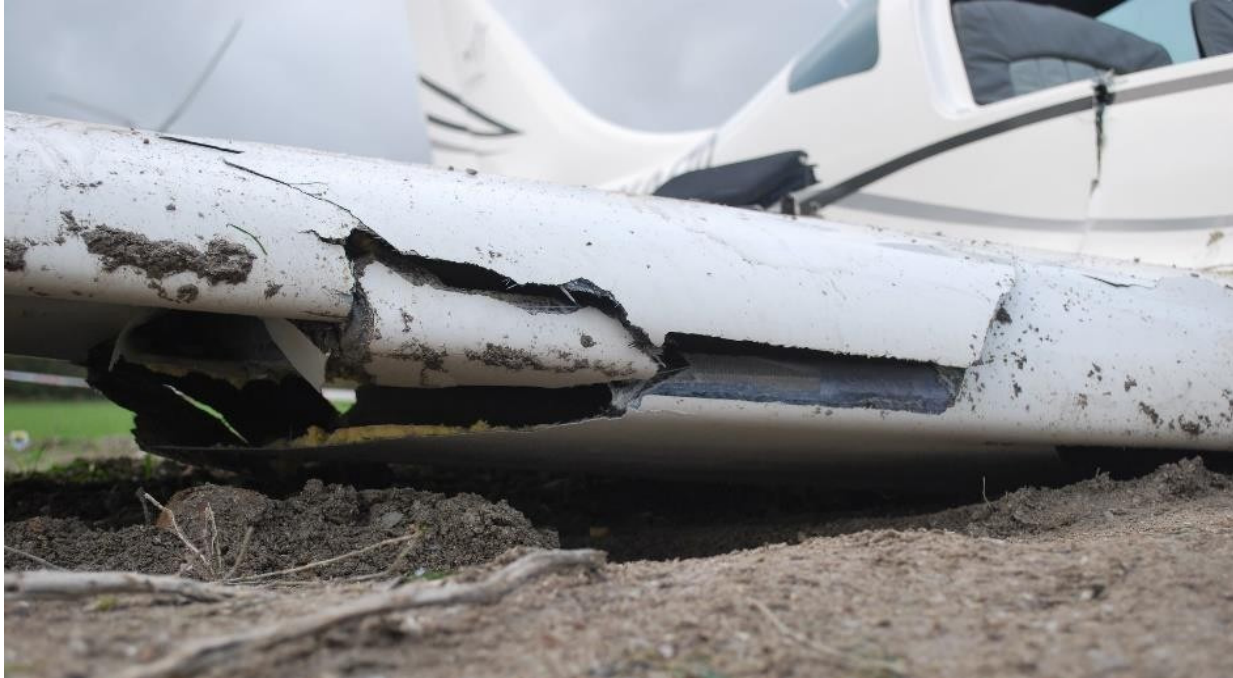
At impact both the internal wing mounted, integral fuel tanks ruptured at their lowest point and the fuel runs to the ground.

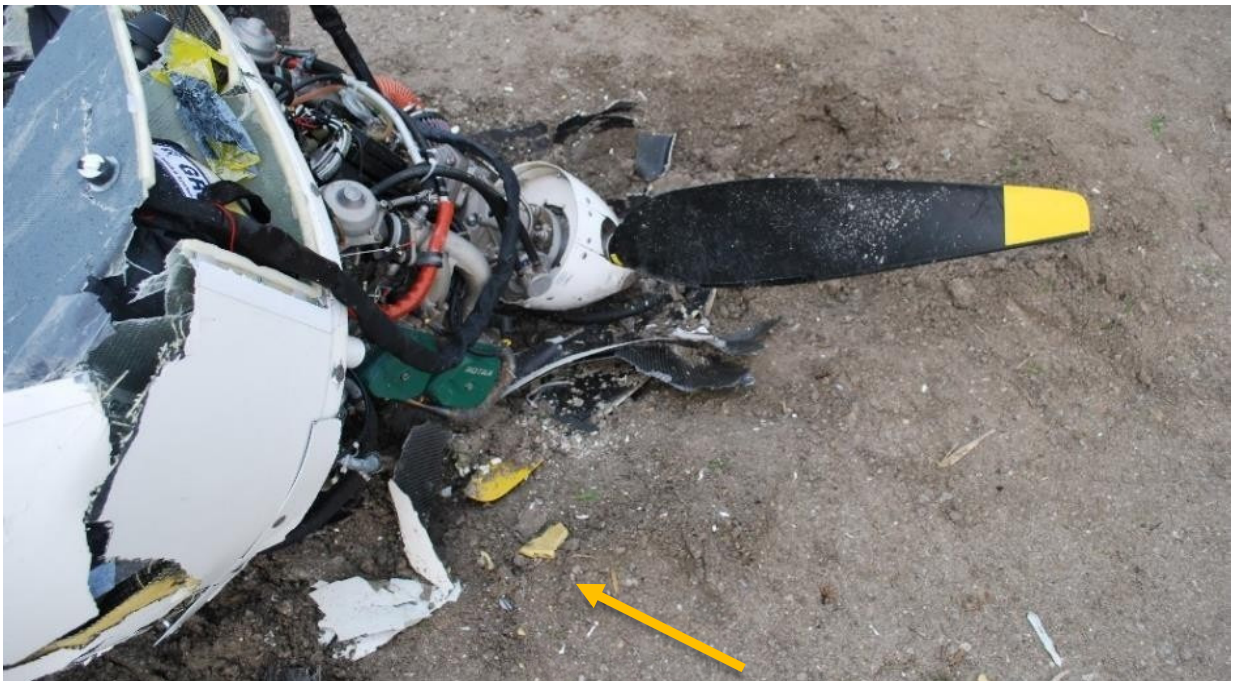
A propeller blade is severed at impact and is subsequently located under the aircraft on the starboard side (underneath the co-pilots rudder pedals). The second blade remains intact and attached to the propeller hub, pointing to starboard relative to the aircraft.

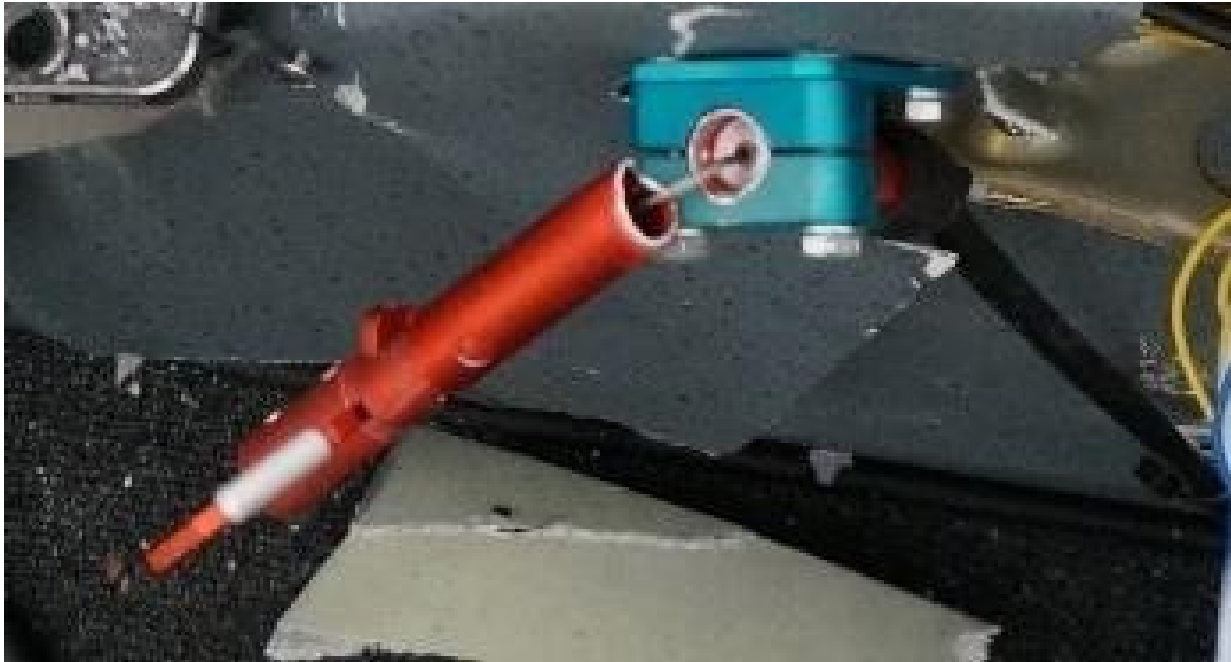
The release mechanism for the Rescue Parachute has severed from its attachment bracket box and has not been released. The Security Pin was removed.

The Accident Investigation Group recommend that when control of the aircraft is lost and cannot be regained, the parachute must/should be, deployed. An item in "The Before Start Checklist" should makes it mandatory for the Pilot-in-Command to declare vocally when and under what circumstances the parachute will be deployed, thus facilitating mental awareness of the subject..

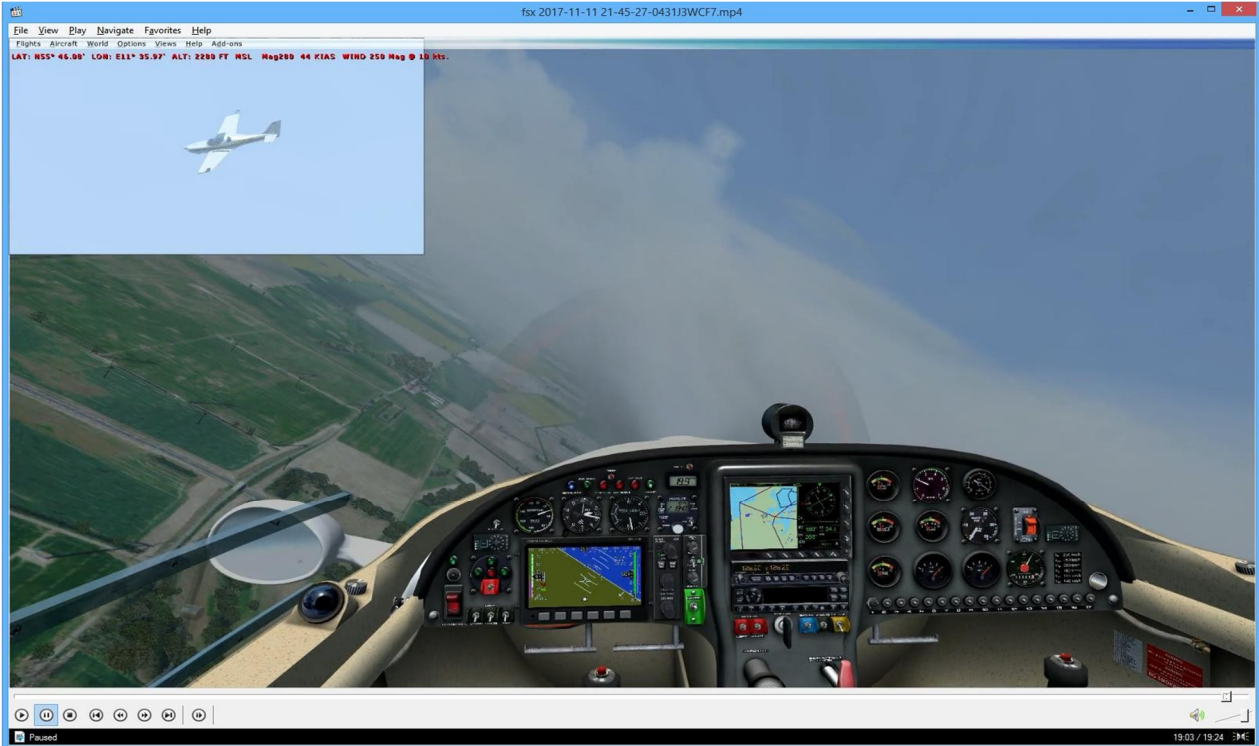
The exercise is repeated and shows that the left wing drops. In this exercise it seems like the correction is rather abrupt, resulting in a right wing down condition.

35° wingdrop

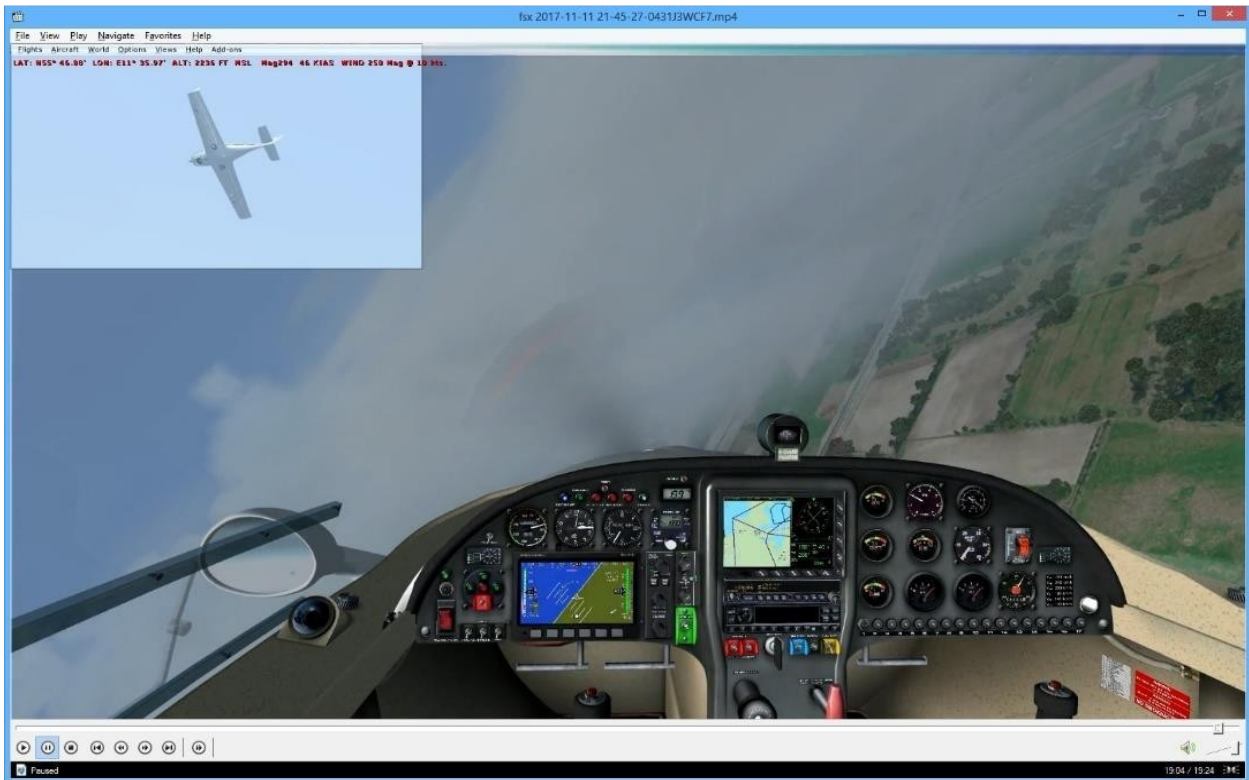
Right wing drop

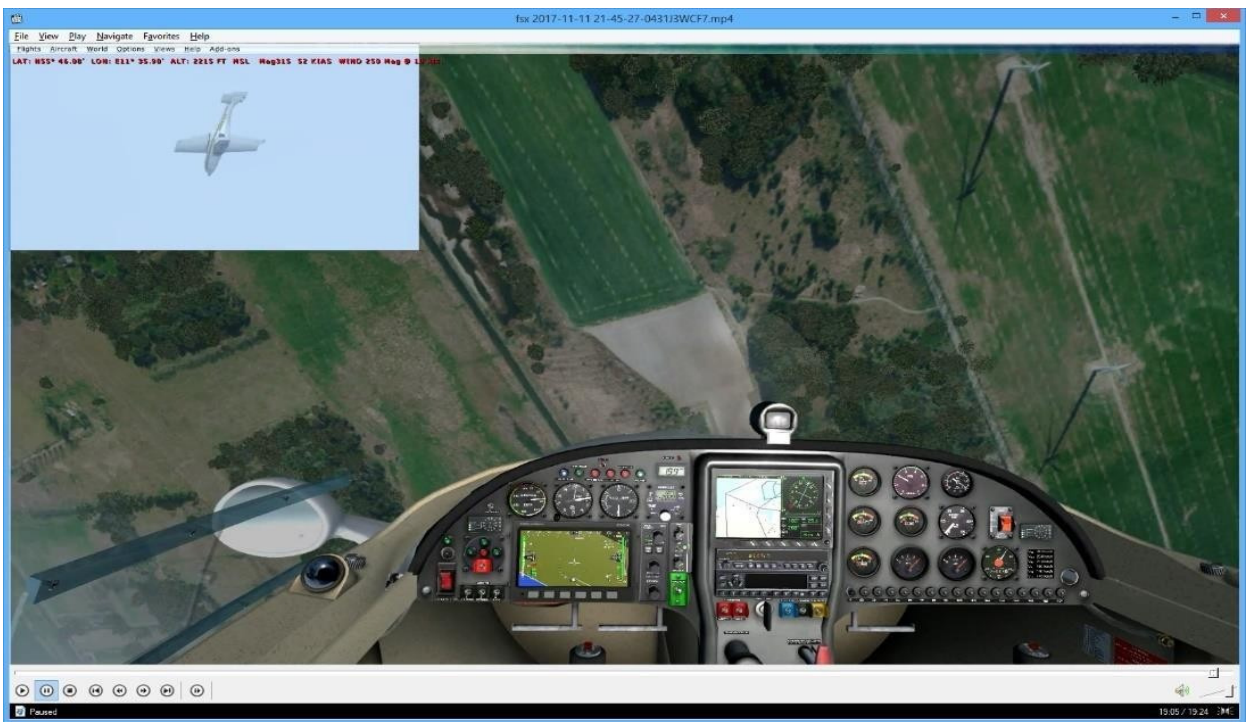
Thereafter the aircraft is in a fully developed stall and the aircraft rotates 8,5 times to the right.

Upside down

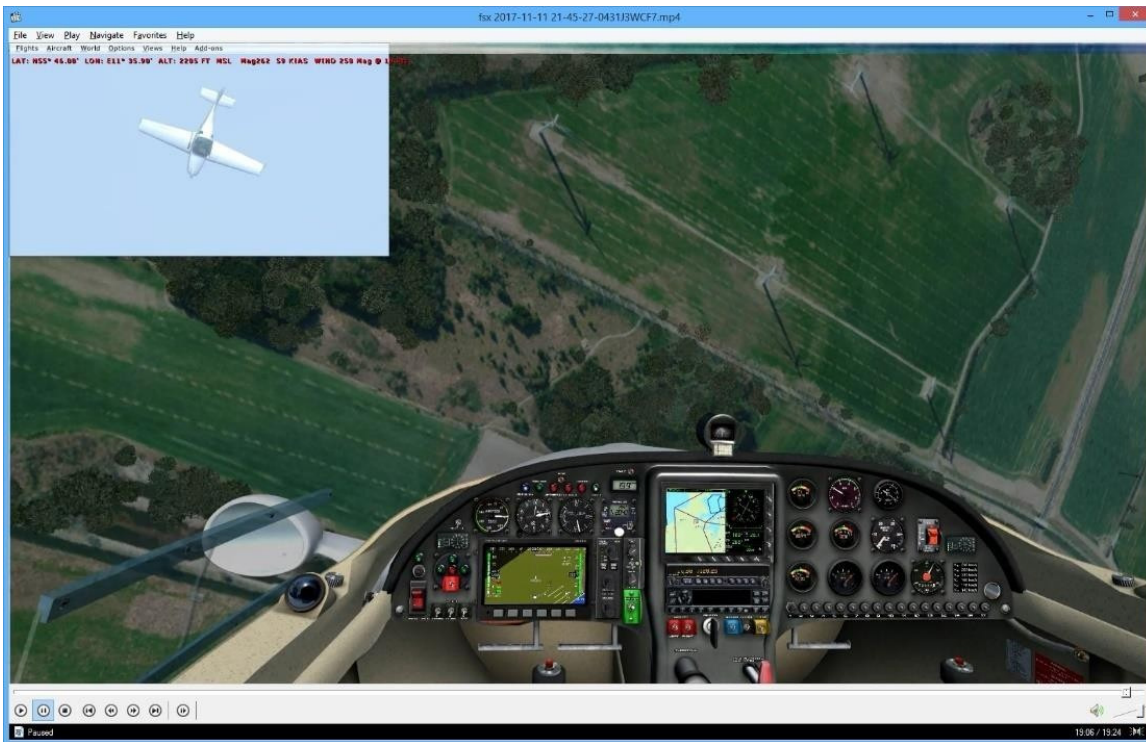
Spinning

After having rotated 8,5 times it appears that the pilots are able to halt the rotation to the right at approximately 600 feet. Unfortunately the automatic logging of parameters stops at this time. The Accident Investigation Committees assumption concerning this, is that the aircraft has stopped rotating, but continues its descent in a state of a high-speed stall, until impact.
