AIRCRAFT ACCIDENT INVESTIGATION

FINAL ACCIDENT REPORT

HELICOPTER AS350 B3

REGISTRATION 5Y-NMJ

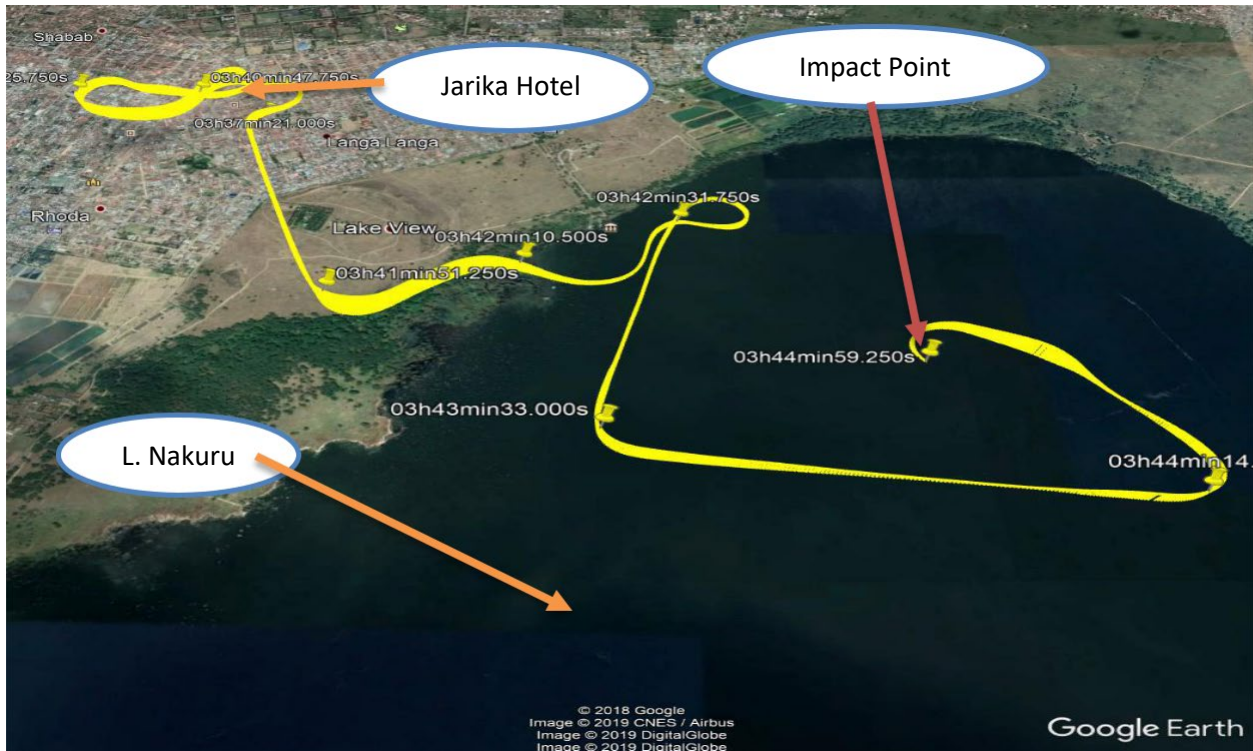
According to the GPS download obtained from the laboratory, the helicopter was flown at a very low level altitude between 0339 hours and 0344 hours. For instance at 0340 hours, the helicopter was captured flying at 357ft above ground level. At 0341 hours it was at 861ft above the lake. At 0344 hours it was captured at 69ft above the water level of the lake.

Figure 1: GPS Google map track showing the flight path taken by the helicopter before crash

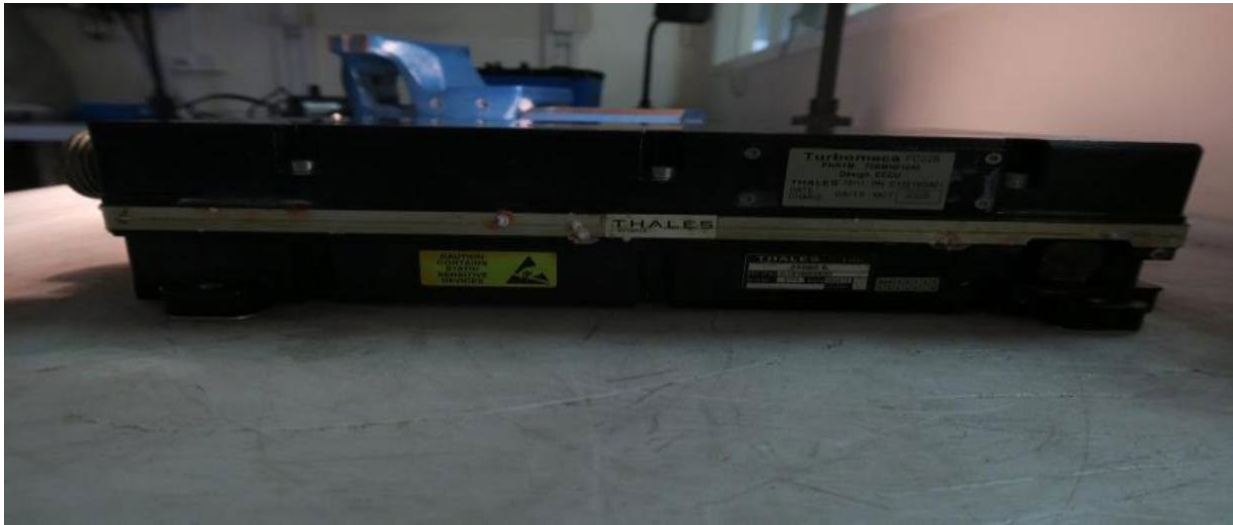
Figure 3: Photograph showing FADEC

At the BEA laboratory the FADEC was found with traces of damaged rust. It was opened and the two electronic boards with the six memory components visually inspected. The six memory components were wet but in good condition. They were dried for more than 48 hours at 90°C. The six memory components were unsoldered using an unsoldering machine under temperature monitoring. They were cleaned, electrically characterized and read out using the BEA memory reader. The reading of two of the six memories was unsuccessful.

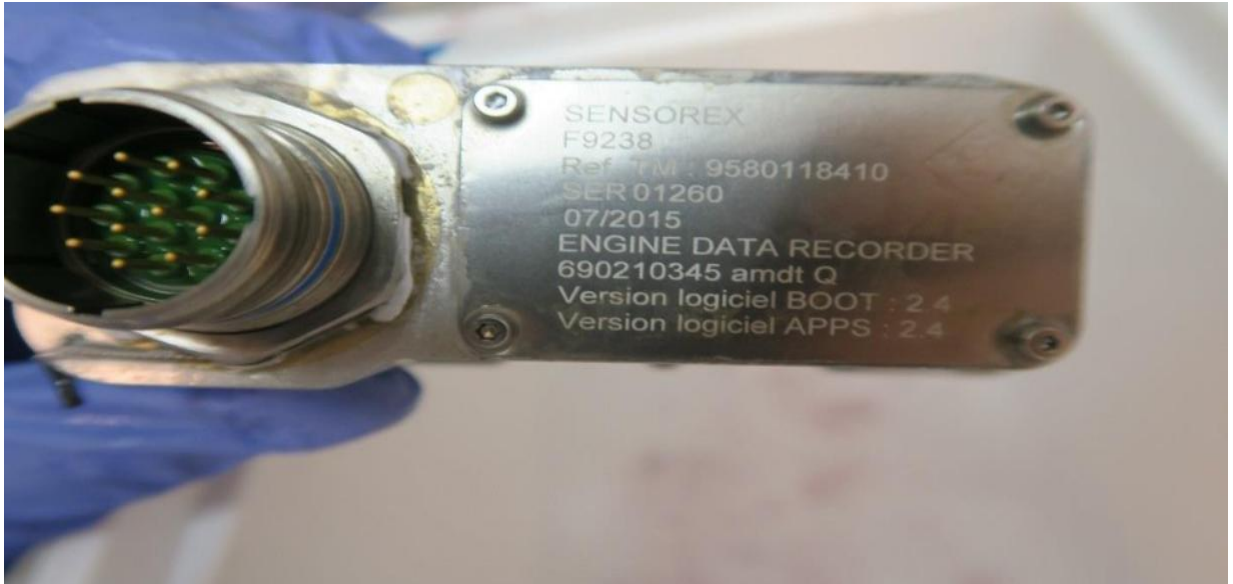
Figure 4; Photograph showing Engine Data Recorder

The EDR was wet with traces of rust. It was opened and dried for more than 48 hours at 90°C. The EDR was reassembled and connected to a computer for downloading. The download was unsuccessful probably due to the long exposure to water.

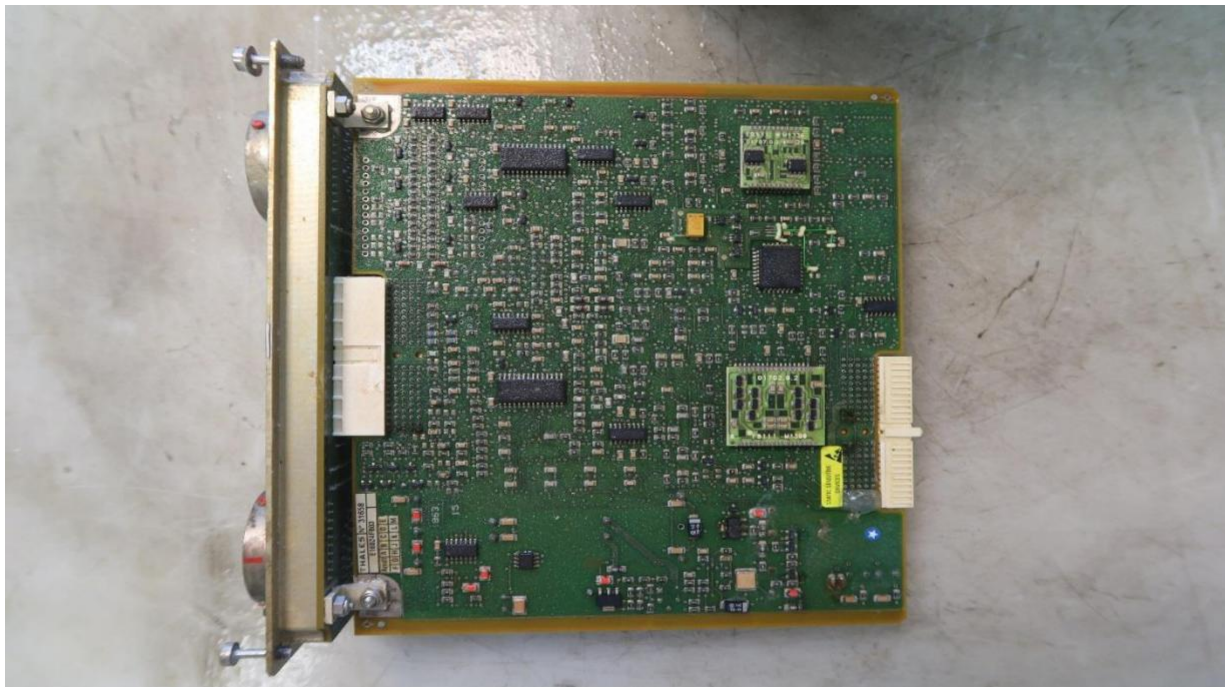
Figure 5; Photograph showing the VEMD electronic circuit board

The VEMD was found wet with traces of rust. The VEMD has 2 electronic boards which were visually inspected and dried. There were traces of rust on it. The main electronic board was dried for more than 48 hours at 90°C. Due to the data retrieved in the other computers (in particular in Vision 1000), it was decided not to do further examination on the VEMD.

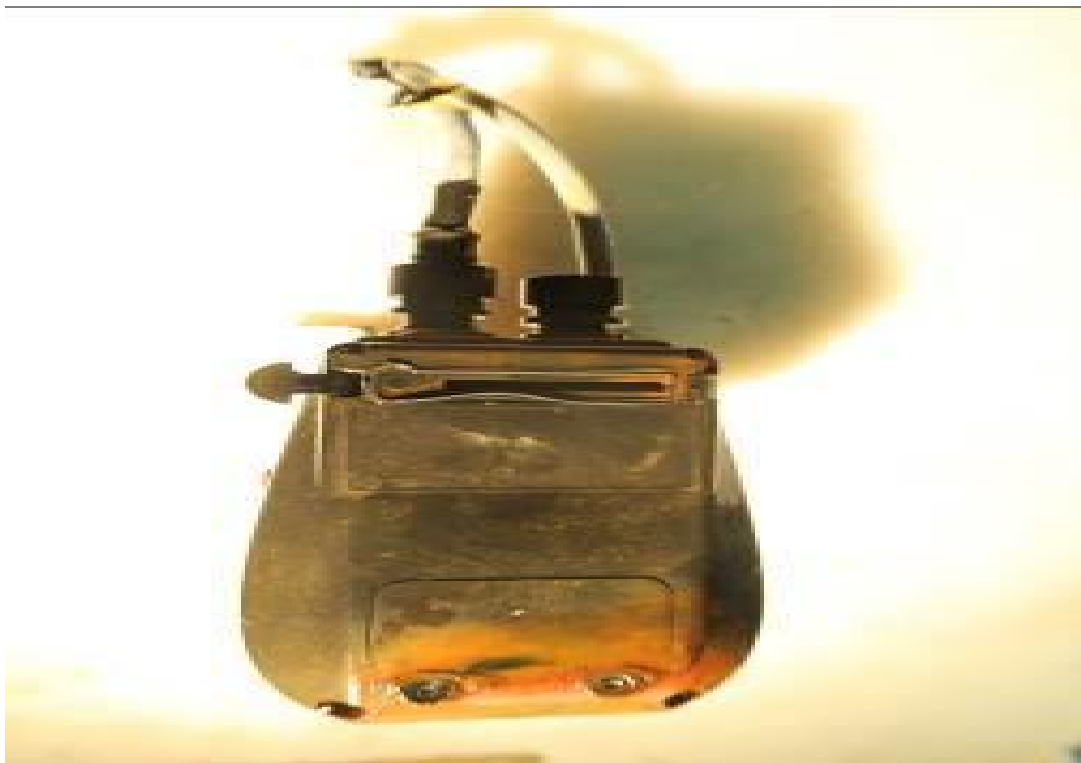
On recovery it was noted that vision 1000 had slight damage with traces of rust. It was opened and the electronic board with the two memory components visually inspected and found with wet traces of rust. The electronic board was dried for more than 48 hours at 90°C. The two memory components were unsoldered using an unsoldering machine under temperature monitoring. They were cleaned, electrically characterized and read out using the BEA NAND memory reader.

Figure 7; Photograph showing Vision 1000 cockpit imaging camera

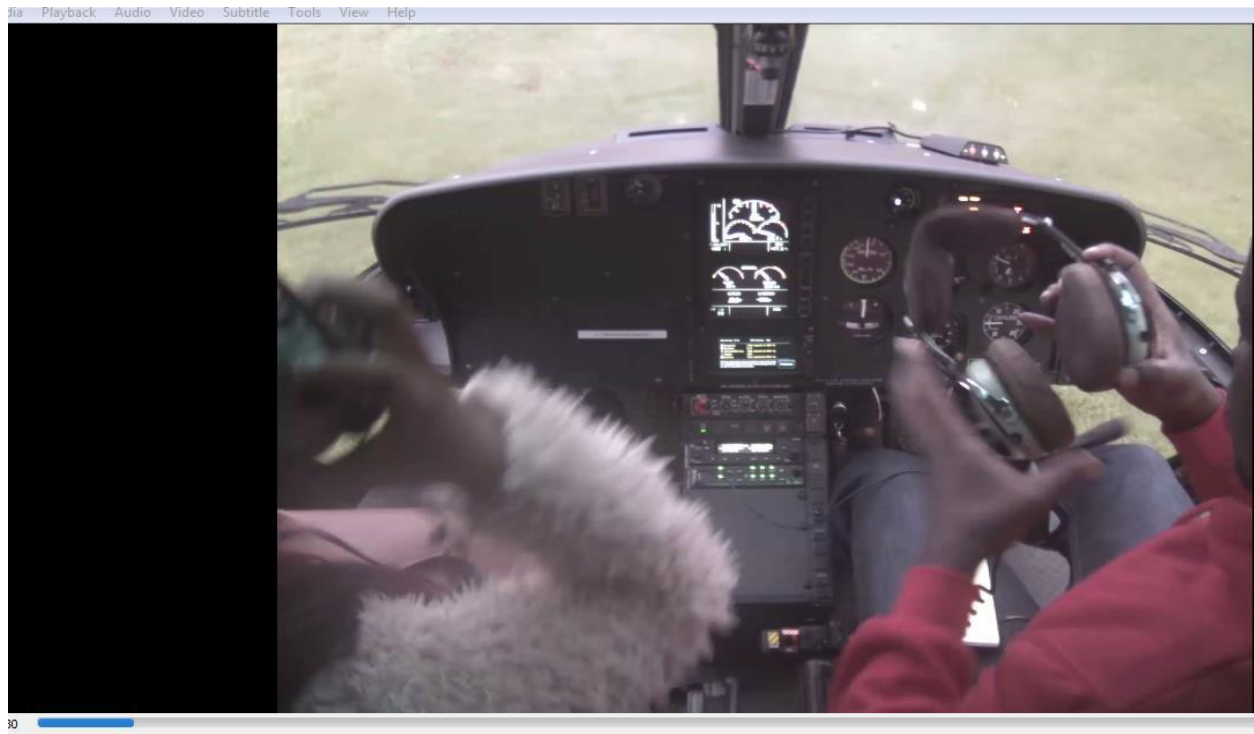
In conclusion according to the video imagery recording captured, the event flight took seven minutes and 38 seconds. During the initial stages the pilot is seen undertaking routine preflight inspection including assisting the female passenger on the front seat fix headset before flight (See figure; 8). On the VEMD the image captured the fuel quantity at more than 400 liters. Before departure the altimeter reading indicated an elevation of 5800ft.

Figure 8: Picture video showing the pilot carrying out preflight check.

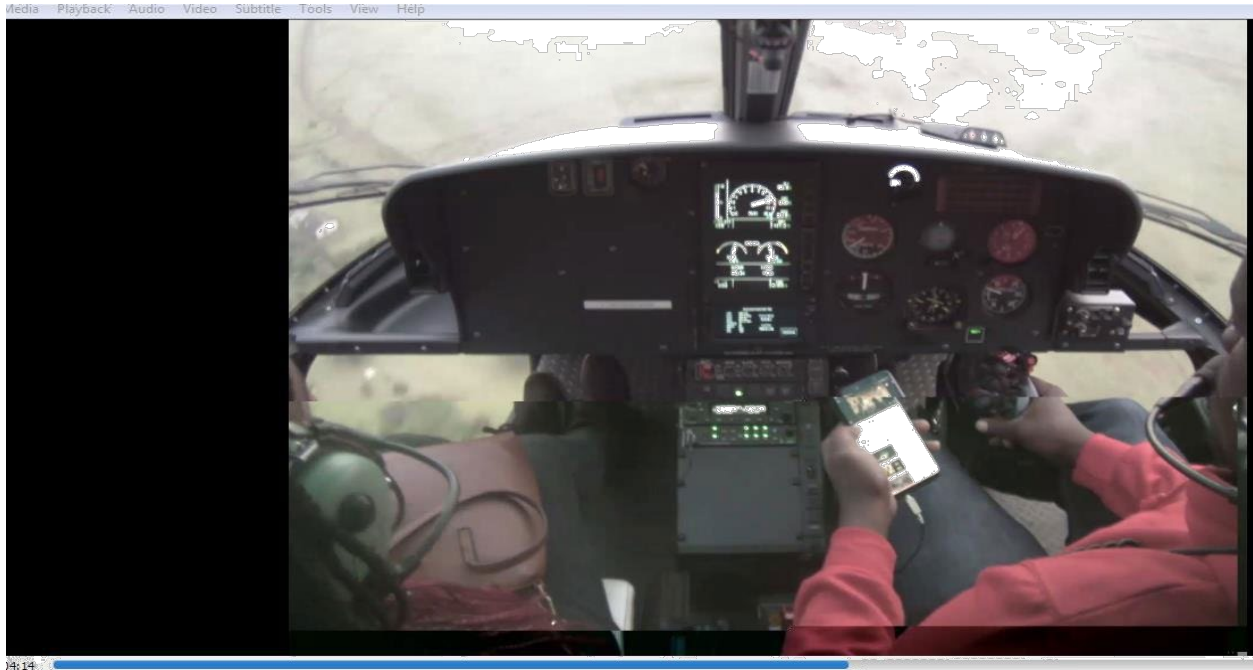
After 4 minutes and 14 seconds of flight the pilot is seen handling his mobile phone while flying (See figure 9) and nothing unusual appear with the flight.

Figure 9: Picture video showing the pilot handling mobile phone while flying.

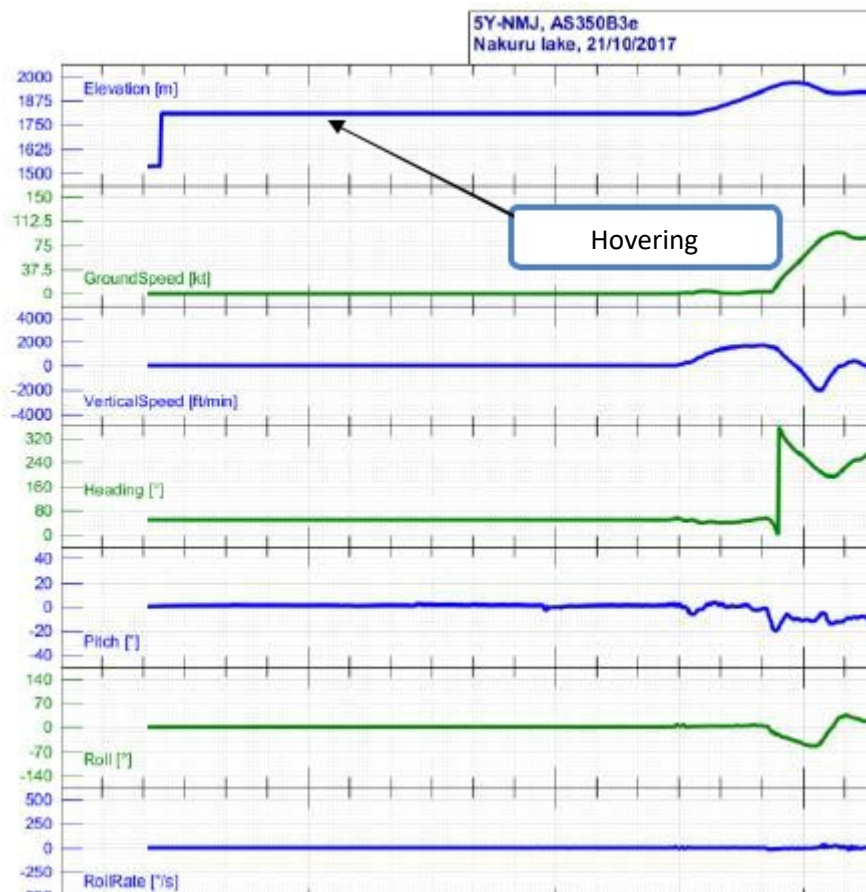
At 03:39:50 he changed course through 360° and flew in the general direction of 120° heading at a ground speed of 110knots.

Between 03:40:00 and 03:45:00 the flight was characterized by consistent change of course, ground speed, altitude and the vertical speed until impact.

Figure 10: Graph showing initial helicopter flight parameters

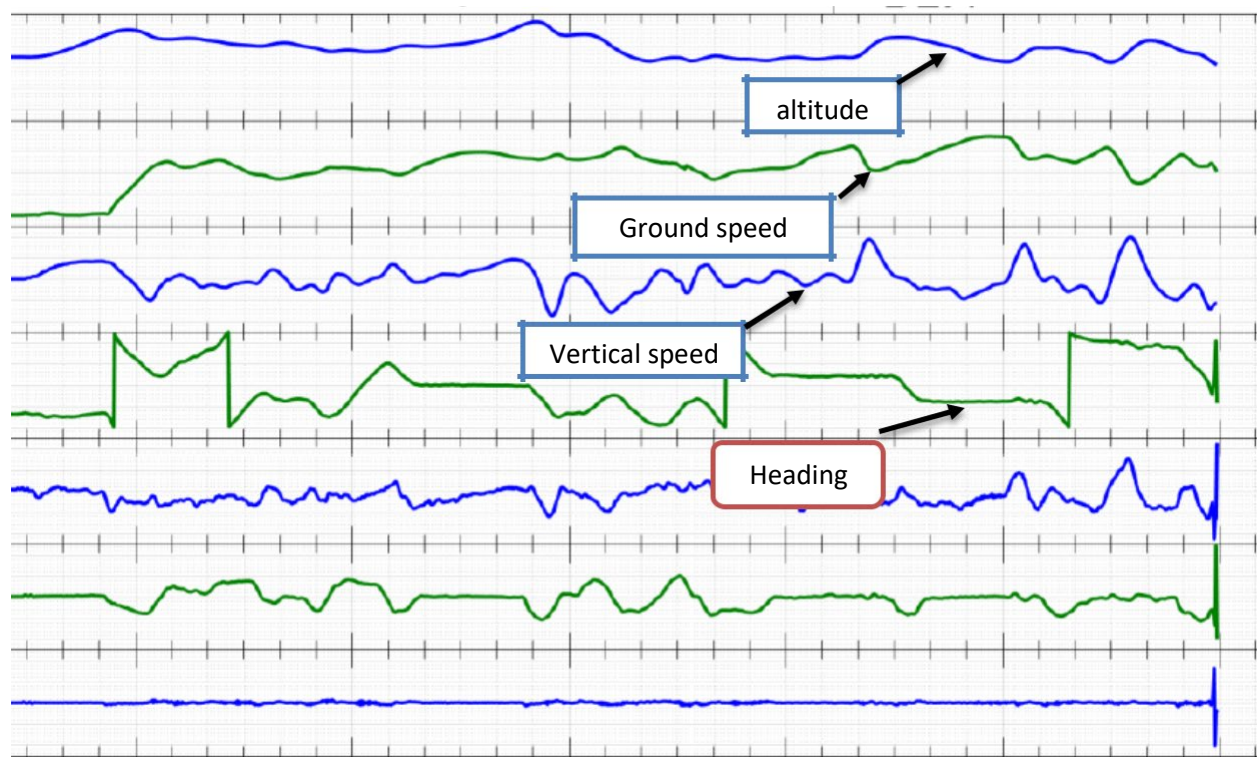
At 03:44:55 the pilot maintained a heading of 200° as he descended considerably.

At 03:44:58 the helicopter was captured at 1762m amsl heading 120° doing a ground speed of 90knots, then suddenly he changed through 90° right to 320° and back to 90° heading and rolls through 140° as pitched up and banked to the left before he plunged into water. There was significant longitudinal acceleration of between -2 to -6 before crash.

Figure 11: Graph showing helicopter flight parameters in the last 30 seconds before impact

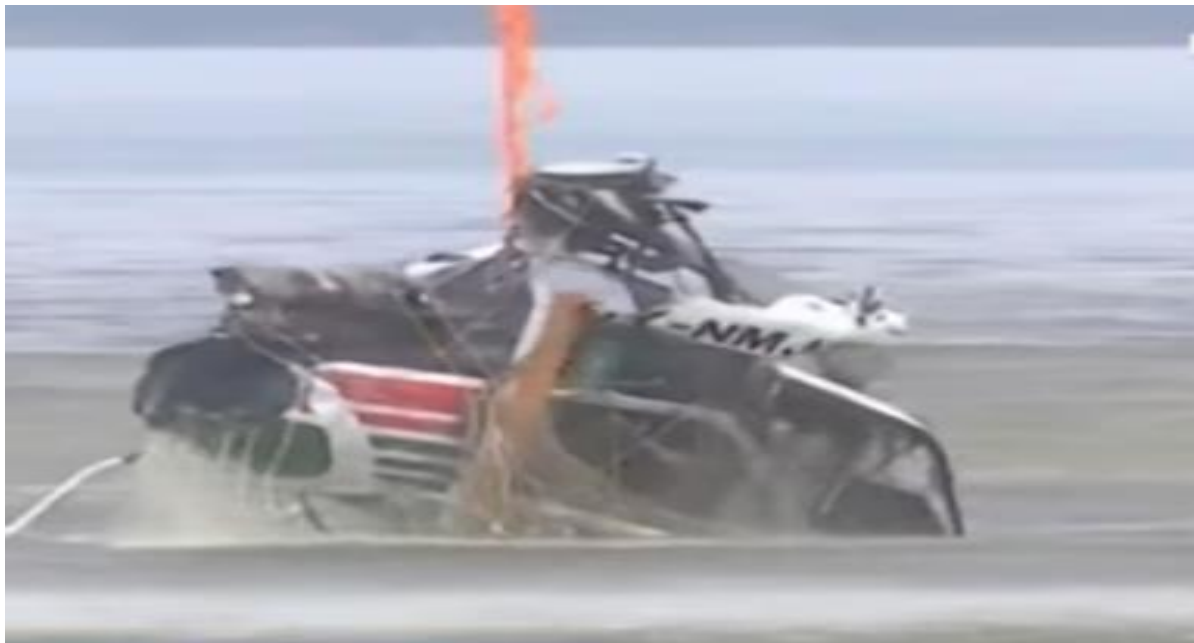
Examination of the wreckage revealed that the helicopter was extensively damaged after impact. The windscreen was broken and bungled, the tail boom broke and separated from main airframe even though it remained less than 5metres from the main wreckage. All the doors were missing except one (front left) where the female passenger was seated, possibly or perhaps that explains why the other bodies were not found within the wreckage. It could be possible the occupants struggled and managed to break the doors as they were trying to escape. The battery was also missing, the main rotor blades were broken but remained still attached to the main rotor shaft. The helicopter cabin was generally dented and bungled in all directions.

Figure 12: Photograph showing the wreckage of the helicopter retrieval from the lake

On impact the helicopter got completely destroyed. Several parts of the fuselage separated and got scattered all over the lake on a stretch of 1km. one back left seat was found at the lake shore 400m from the point impact. Most parts that separated were pushed by the strong water currents. The main fuselage including the tail boom remained at the point of impact.

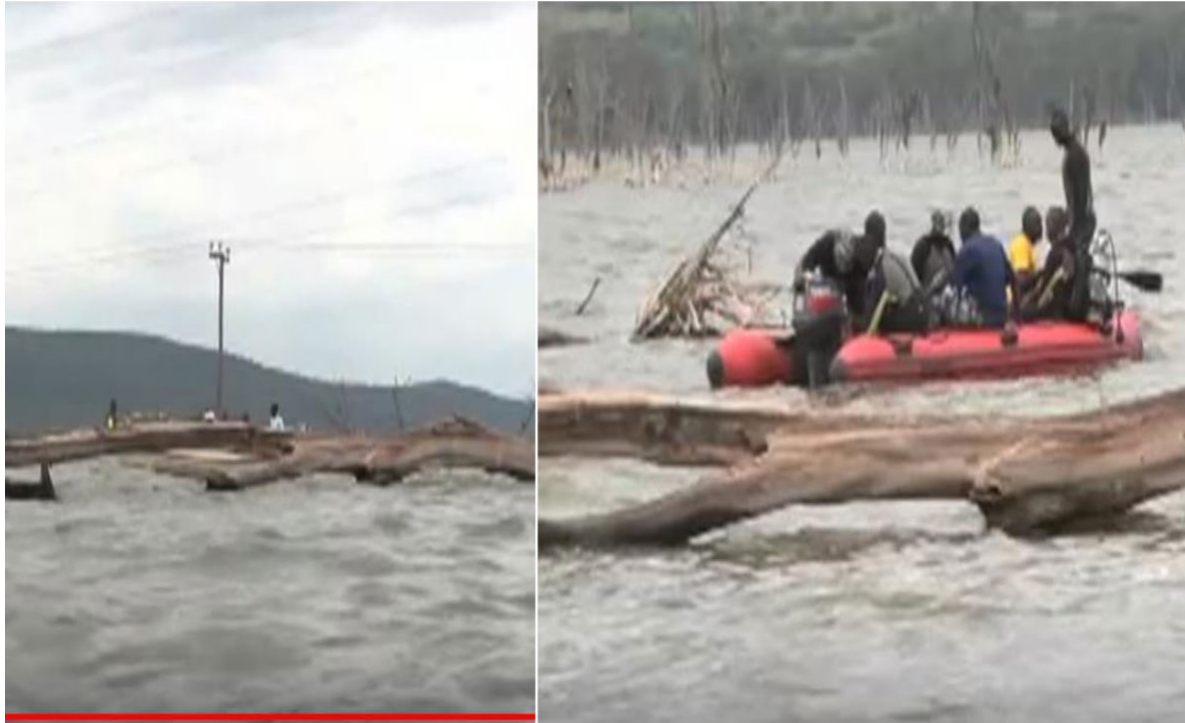
Figure 13: Photograph showing the electric power line and dry acacia trees in the lake

There was heavy presence of dry acacia trees submerged by water on the northern part of the lake even though there was no evidence of collision with the trees and the powerline cutting across the lake.

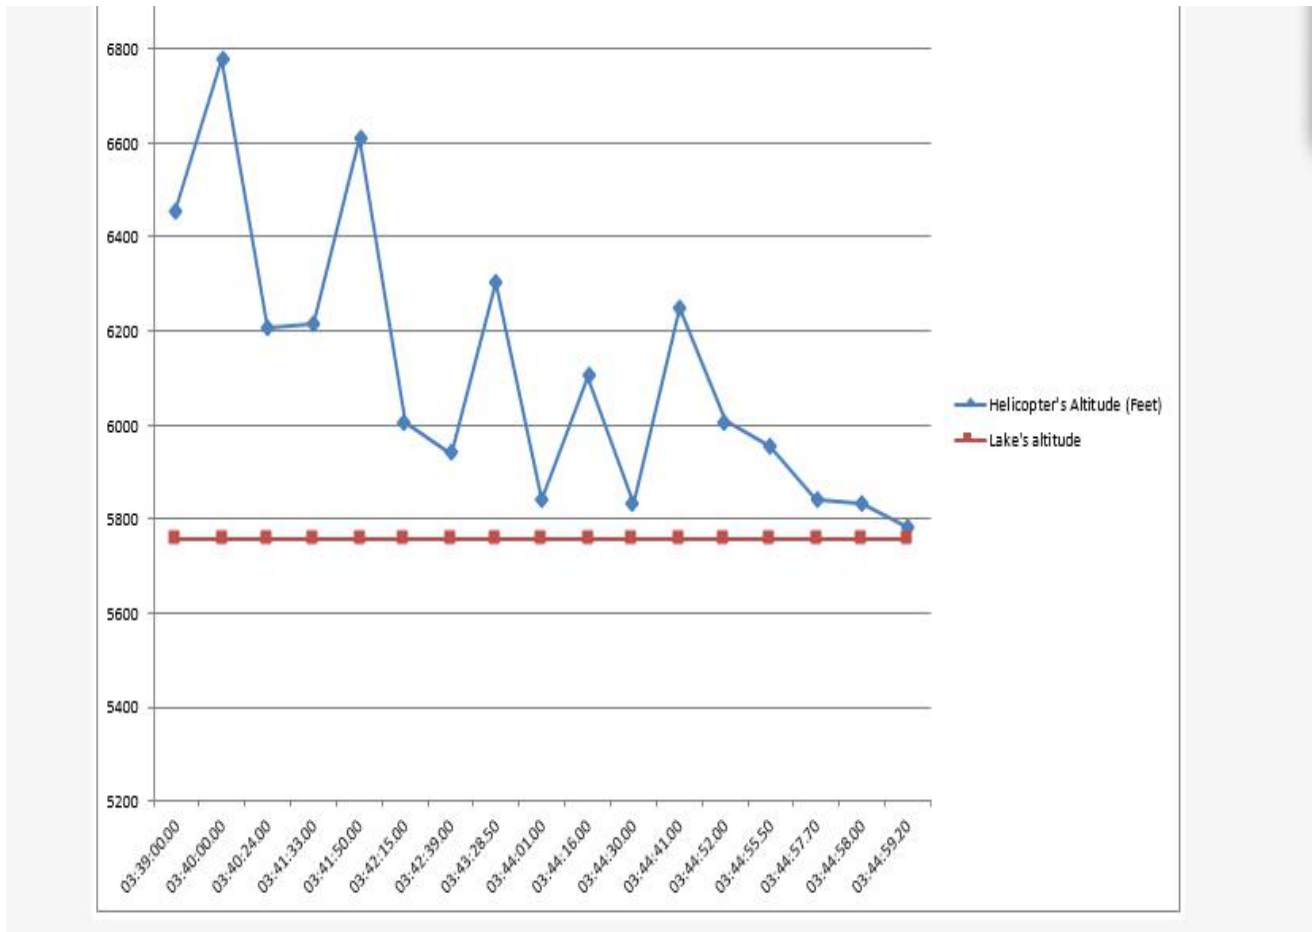
around around the Lake Nakuru for 7 minutes and 38 before it crashed at 03:44:59 hours. Analysis of the flight within the last 5 minutes (See figure 14 below) indicates that the pilot flew at low level to the ground/water with very small safety imagine in the event of loss of control. At one point the pilot was flying as low as 79ft above water.

Figure 14: Graph showing altitude position of the helicopter within 5 minutes before impact
