AIRCRAFT ACCIDENT REPORT AND EXECUTIVE SUMMARY

Reference:	CA18/2/3/9665	
Aircraft Registration	ZU-CIU	Date of Accident	18/11/2017		Time of Accident	1530Z
Type of Aircraft	Windlass Aquila		Type of Operation	Private (Part 94)		
Pilot-in-command Licence Type	National Pilot Licence (NPL)	Age	37		Licence Valid	Yes
Pilot-in-command Flying Experience	Total Flying Hours	108,2		Hours on Type	108,2	
Last point of departure	Potgietersrus Airport (FAQR), Limpopo Province					
Next point of intended landing	Microland airport, Gauteng Province					
Location of the accident site with reference to easily defined geographical points (GPS readings if possible)						
On the Mokopane mountains 7,8 nm from Mokopane town at the following GPS co-ordinates: S 24° 08' 31.3" E028° 52' 42.9" elevation 5655 ft						
Meteorological Information	Wind direction: 320°, wind speed: 05 kts, temperature 27,6 °C, dew point: 5.5 °C, visibility: 10 km					
Number of people on board	1+1	No. of people injured	1	No. of people killed	1

Name of Owner /Operator : Daniels N.R.J.
Manufacturer : Solo Wings CC
Model : Windlass Aquilla
Nationality : South African
Registration Marks : ZU-CIU
Place : Mokopane, Limpopo Province
Dat

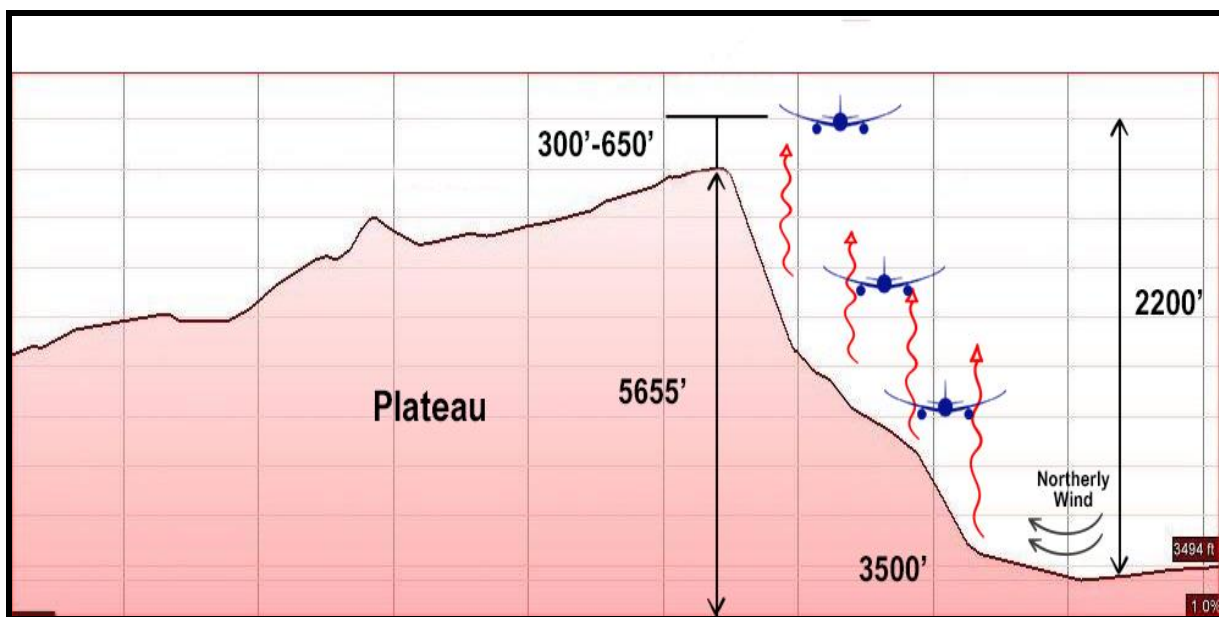
1.12.1 Both ZU-ICI and ZU-CIU flew in a northerly direction and in loose formation towards Mokopane Mountains. They climbed along a mountain ridge with ZU-CIU ahead and lower than ZU-ICI, at about 500 ft. ZU-ICI had turned left to the west earlier; ZU-CIU continued along the ridge and turned left, heading to the west through a valley. The ZU-ICI pilot then observed ZU-CIU aircraft losing height and impacting the mountain in a nose-down attitude. There was no communication from ZU-CIU to indicate whether they had a problem pulling out of danger until the aircraft impacted the mountains. The main wreckage remained intact and there was no post-impact fire.

Figure 2: Altitude levels, thermals and wind direction on the mountain before the accident occurred. The three aircraft illustrate an aircraft climbing along the mountain ridge.

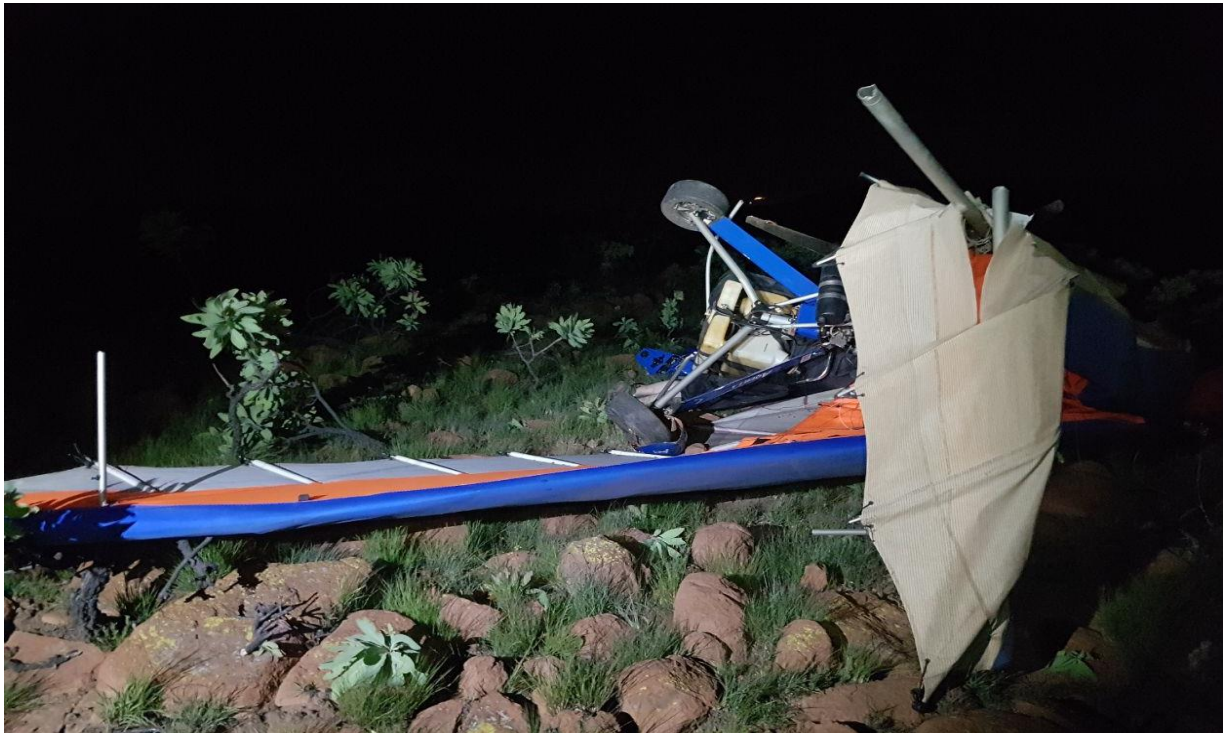
1.12.3 The left wing sustained damage due to impact with the mountain and right wing sustained minor damage. The left wheel was still intact with no damage, the right wheel and nose wheel sustained damage due to impact with the mountain. The engine was still intact and the propeller blades had sustained damage at the tips.

Figure 3: Damage sustained by the aircraft.

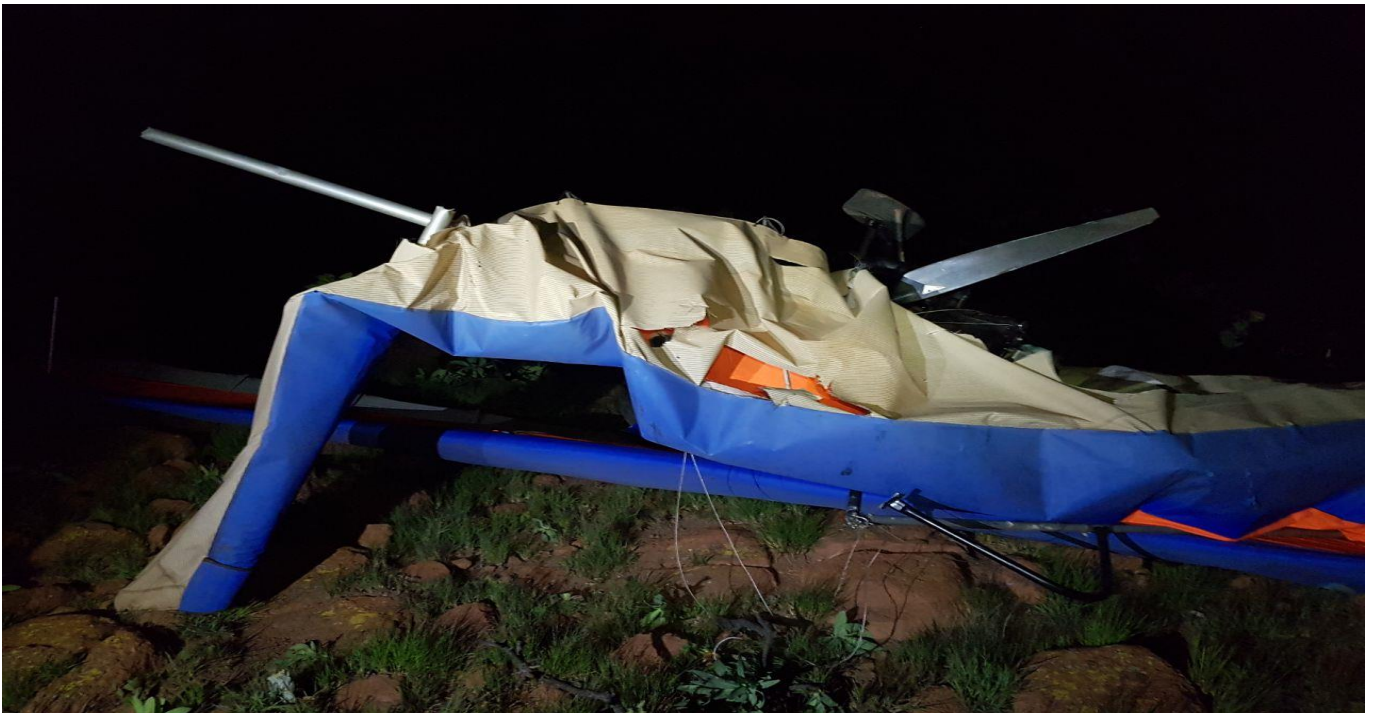
Figure 4: Damage to the left-hand side of the wing

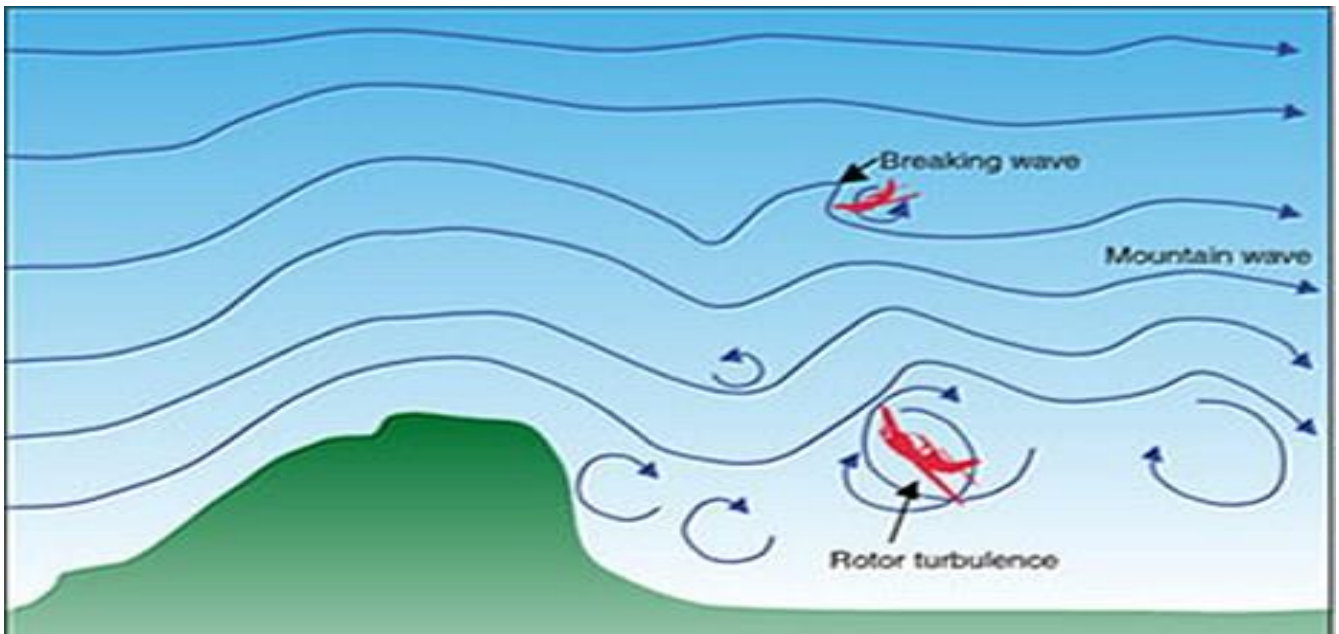
Figure 5: Aircraft encountering rotor turbulence

- 2.4 ZU-CIU made a left turn towards the lee side of the mountain and encountered downward forces from rotors created by the northerly wind. ZU-CIU was probably caught by surprise, since the same conditions that were favourable to them earlier were now the complete opposite. The wind was now pushing down against the aircraft, and if the pilot had tried to lift the nose to get out of that situation, the aircraft would have stalled because of the low airspeed. The only possible solution was to keep the nose pointed down and increase speed, but that option was not available to them since they were too close to the mountain side.

- 2.5 The investigation revealed that the aircraft could not overcome the rotor turbulence, since the engine was at reduced power and it would have taken some time before the power available was greater than the downward rotors encountered.
