Safety Investigation Report

Ref.:
AAIU-2017-11-19-01

**ACCIDENT
ULTRALIGHT ESQUAL VM 1C
AT LANDEGEM
ON 19 NOVEMBER 2017**

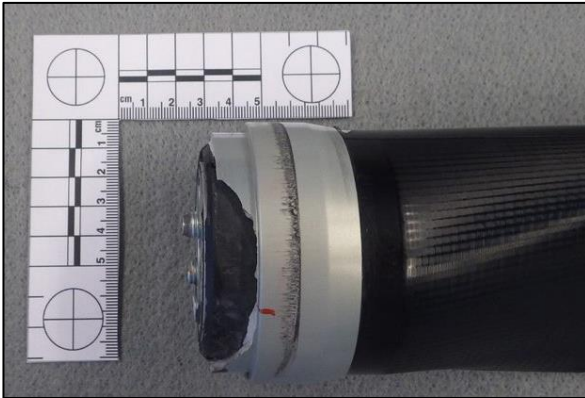
Figure 10 : root of the lost propeller blade

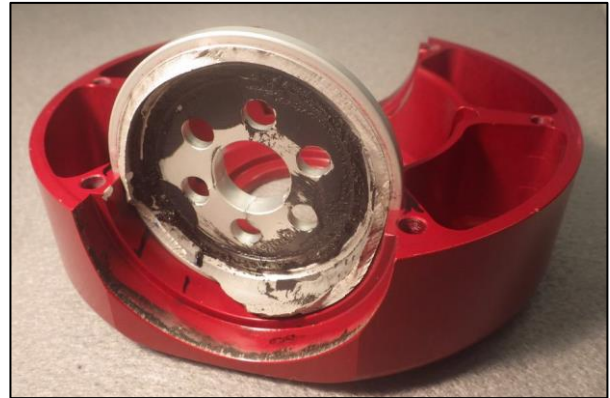
Figure 11 : broken part of the blade root left in the hub

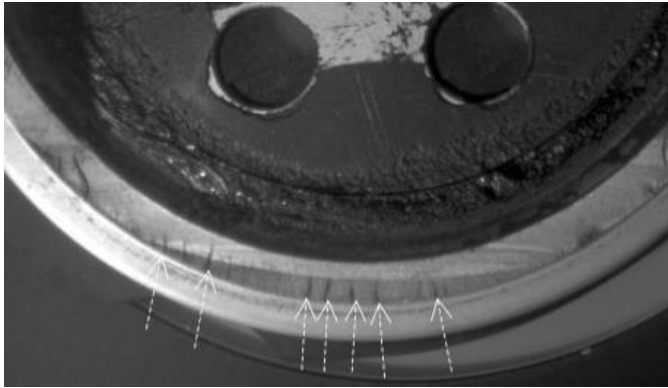
Figure 13 : detail of zone 1a with presence of beach marks; white arrows indicate multiple initiation points of the fatigue crack

As indicated on Figure 13, zone 1a shows small terraces, which indicate multiple initiation points of the fatigue phenomenon; therefore it is very likely that the stress loading to the crack was rather high. This is also in agreement with the location of the crack in the shouldering of the ring. At this location there is presence of a large stress concentration, which is very probably the cause of the crack initiation. Because of the high stress level, the fatigue phenomenon can be classified as low cycle fatigue, leading to the inevitable overload failure.

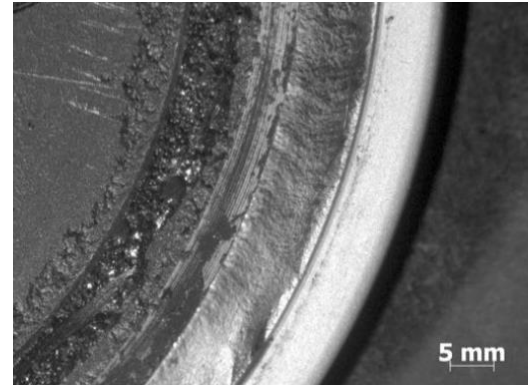
Figure 14 : detail of overload zone 2b

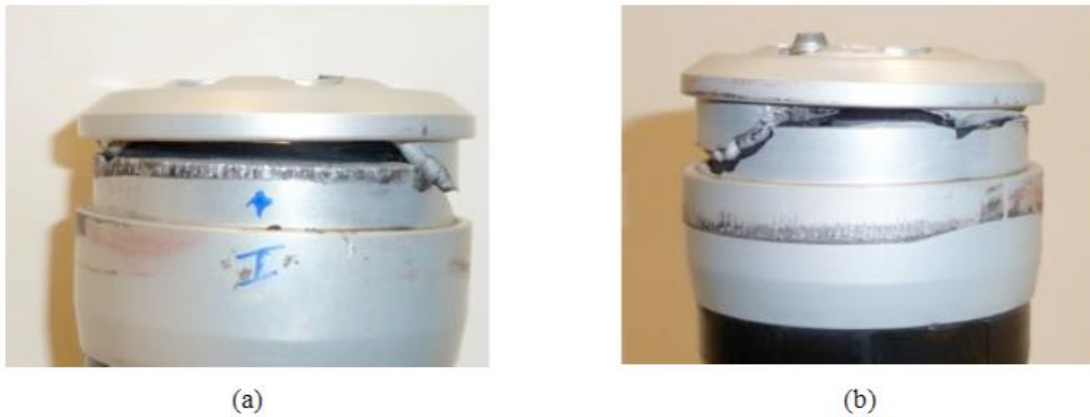
Figure 3 (a) and (b) give a global view on the two complementary fractured parts of the failed propeller fixation ring. On both pictures one clearly sees surface grooves parallel to the propeller axis. As will become clear from the rest of current analysis, these grooves were created after the primary fracture of the fixation ring by centrifugal projection of the propeller blade from its position between the hub halves. The observed grooves indeed correspond to those observed on the interior surface of both hub halves (see figures 15 and 16).

Figure 3: both complementary parts of the fractured fixation ring have been put together; they exhibit perfectly axial surface grooves caused by centrifugal projection of the blade after primary failure of the fixation ring

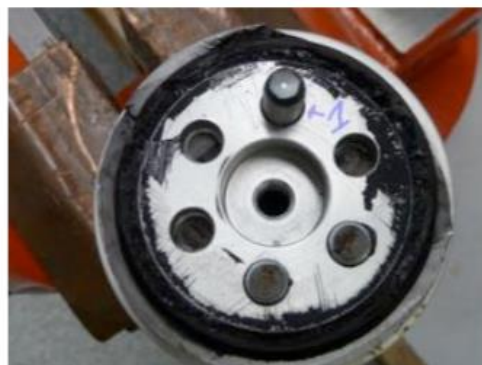
The black material between the outer remnants of the fixation ring and the inner metallic insert has been identified as the carbon fibre/resin composite material. The metallic insert is still properly fixed within the propeller body.

Figure 4: fragment of the fixation ring that remained fixed to the propeller blade (lower part on figure 3); fragments from the broken bolts are still present in the bore holes. Bolt 1 is identified with blue marker. The black material between the outer remnants of the fixation ring and the inner metallic insert are the carbon fibre/resin composite material.

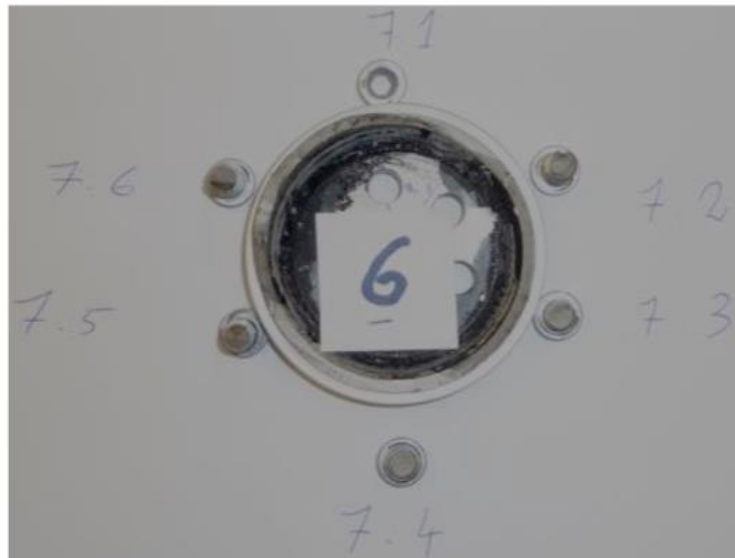
Figure 5: complementary part of the fixation ring (upper part on figure 3), together with the fragments of the broken bolts (see also figure 4). Bolt fragments have been numbered for detailed analysis

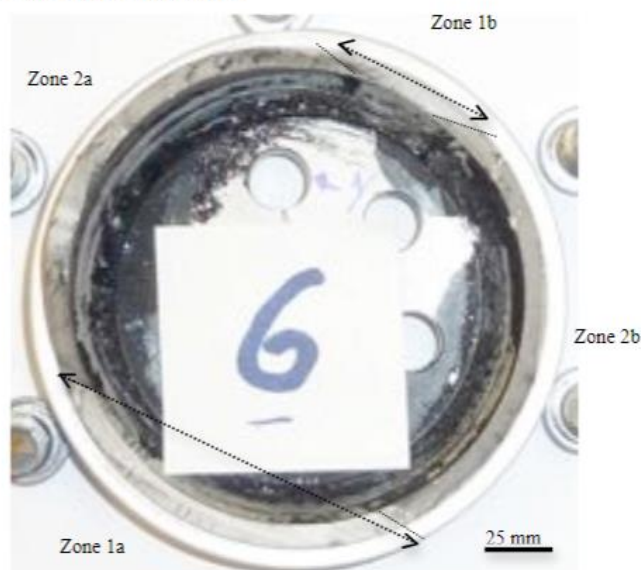
Figure 6 shows the latter part at higher magnification. Four zones have been identified:

- zone 1a (indicated by the larger double arrow): exhibits a very smooth aspect with very clear beach marks; these beach marks indicate presence of a fatigue phenomenon;
- zone 1b (indicated by the smaller double arrow): has an aspect similar to that of zone 1a but is smaller; this zone also shows beach marks indicating presence of fatigue;
- zone 2a and 2b: these zones make up the rest of the fracture surface between the zones 1a and 1b. They correspond to the overload fracture

Figure 6: fracture surface of the fixation ring of propeller blade 2; indication of particular zones. Zones 1a and 1b correspond to the propagation of a fatigue crack; zones 2a and 2b correspond to the overload fracture of the ring. For further explanation, see text.

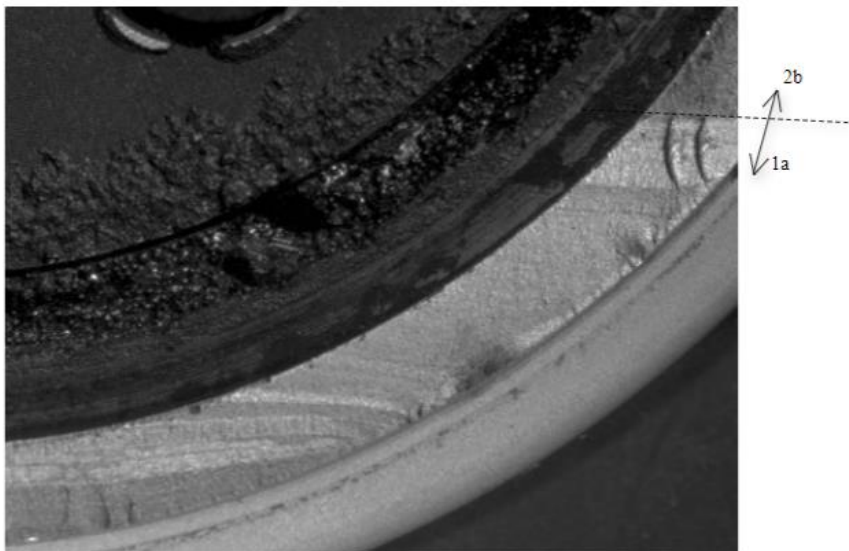
Figure 8: detail of zone 1a with indication of the transition of the fatigue zone towards the overload zone 2b

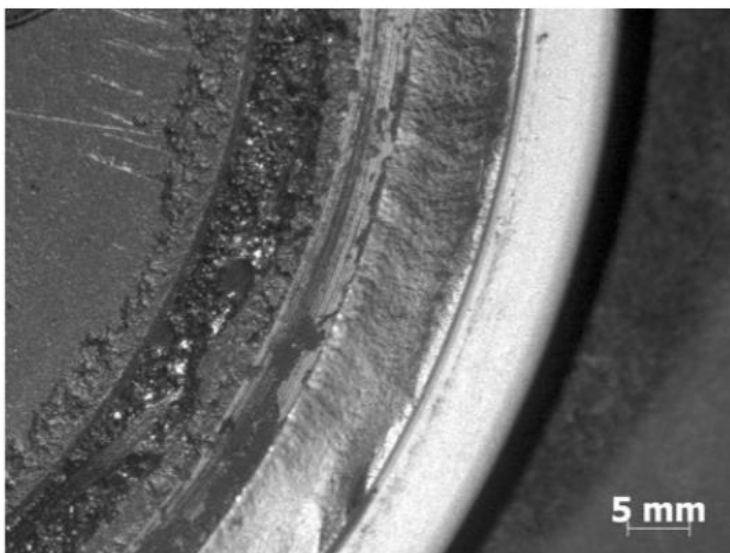
Figure 9: detail of overload zone 2b

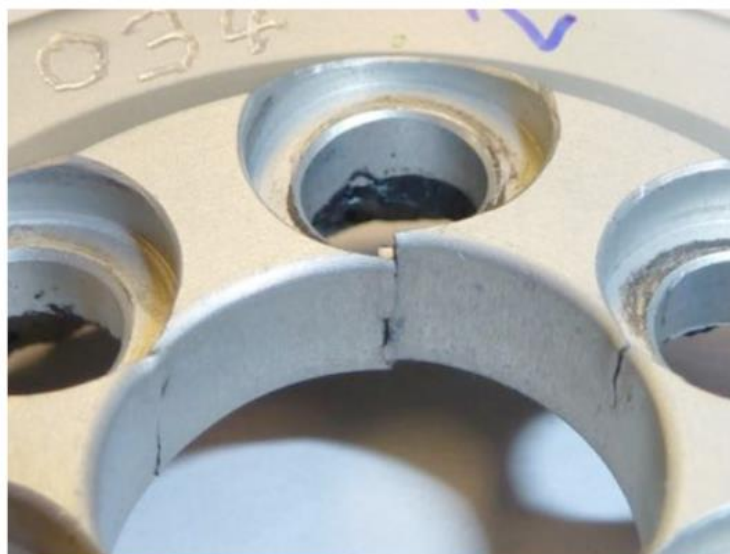
Figure 11: detail of the crack near hole No. 1, as indicated on figure 10

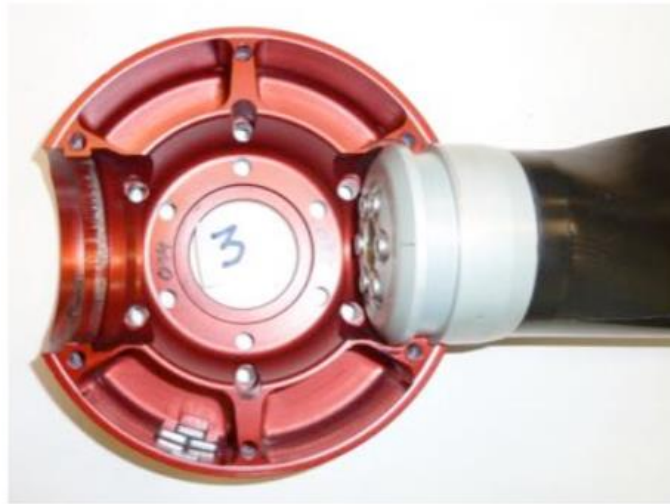
Both hub halves are intact, except for axial grooves (in the direction of the propeller blade) as can be noticed on figure 15 and 16. This indicates that the grooves were created during the axial movement during and immediately after breaking of the fixation ring of the propeller blade 2.

Figure 16: view on both hub halves, showing sliding grooves created by failure of propeller blade 2; no significant traces have been observed on the location for undamaged propeller blade 1

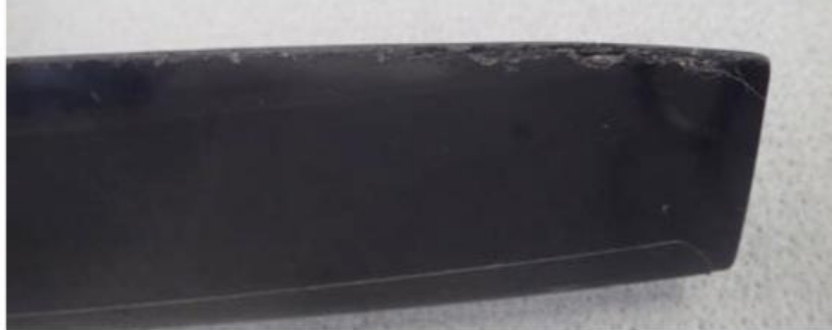
Two organic particles have been found on the damaged trailing edge of propeller blade. These particles are very probably small chunks of wood with contaminants. There are no indications that these particles and the damage of the blade are at the origin of an accidental load having caused initiation of the fatigue crack.

Figure 17 shows the trailing edge of the extremity of blade 2; two particles have been found (see figure 18(a) and (b)). Both particles have a brownish colour and a fibrous texture. The EDX spectrum of particle 1 (see figure 19) reveals carbon and oxygen (hydrogen is not visible using EDX) and a variety of elements between Na and Cu. Particle 2 has a similar spectrum. Both particles are organic, probably wood, with small contaminations of other elements.

Figure 17: extremity of blade with damage on the trailing edge

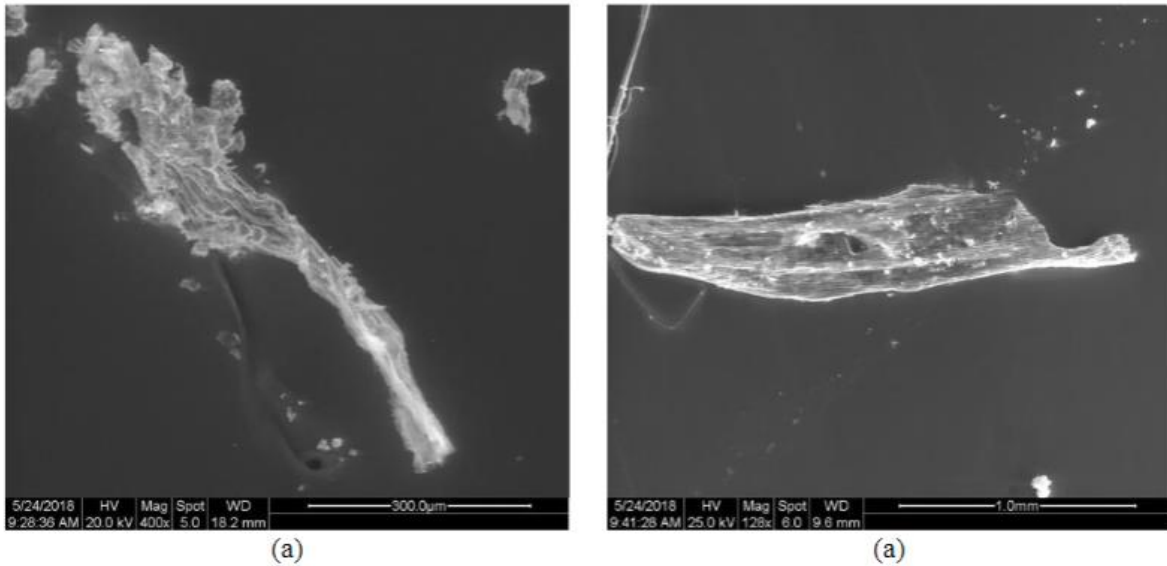
Figure 18: two particles with fibrous texture found in the damaged zone of the blade extremity
