HELICOPTER ACCIDENT REPORT AND EXECUTIVE SUMMARY

Reference:	CA18/2/3/9675	
Aircraft Registration	ZS-HLI	Date of Accident	21 December 2017		Time of Accident	1100Z	
Type of Aircraft	UH-1H		Type of Operation	Private (Part 91)			
Pilot-in-command Licence Type		Commercial Pilot Licence		Age	57	Licence Valid	Yes
Pilot-in-command Flying Experience		Total Flying Hours	3599		Hours on Type	1005	
Last Point of Departure		Bredasdorp Fire Station, Bredasdorp, Western Cape Province					
Next Point of Intended Landing		Bredasdorp Fire Station, Bredasdorp, Western Cape Province					
Location of the accident site with reference to easily defined geographical points (GPS readings if possible)							
Bredasdorp is 79.2nm south-east of Cape Town at GPS co-ordinates 34° 32' 11.10" S; 20°2' 55.31" E; elevation 157ft							
Meteorological Information		Wind: 130°/15kts gusting 25kts, Temperature: 20°C Clouds: BKN 2000ft AGL					
Number of people on-board	1+0	No. of People Injured	0	No. of People Killed	0

Reference Number : CA18/2/3/9675
Name of Owner : FFA Aviation
Name of Operator : Kishugu Aviation
Manufacturer : Richards Heavy Lift Helo Inc
Model : UH-1H
Nationality : South African
Registration Marks

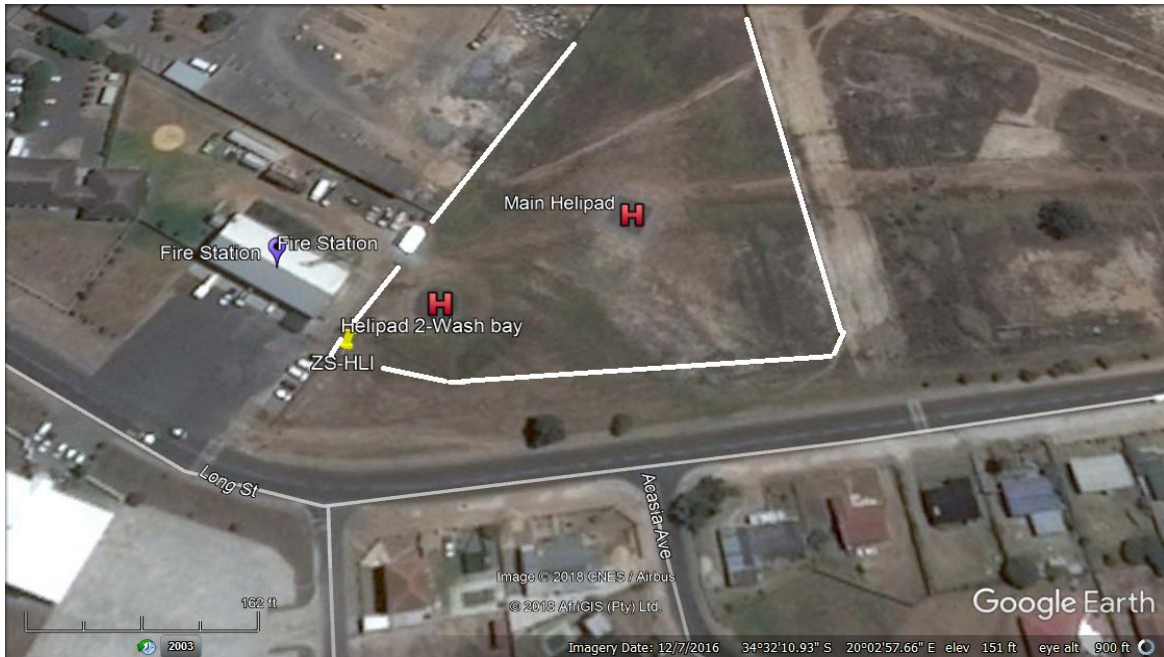
Figure 1: Overlay of the location of the two helipads and the wreckage on Google Earth

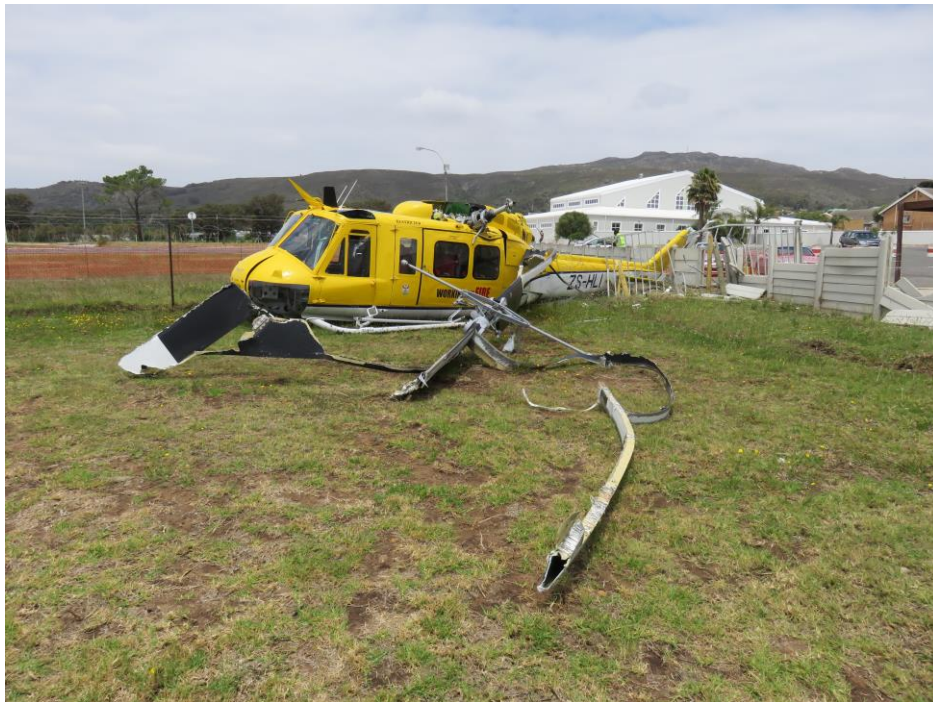
1.3.1 The helicopter was substantially damaged.

Figure 2: The helicopter at the accident site.

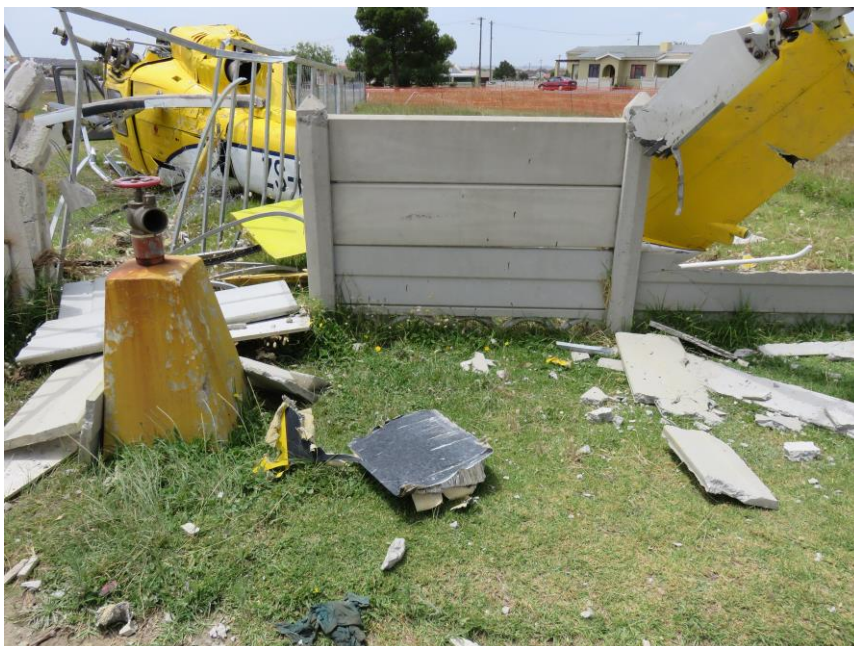
1.4.1 The concrete perimeter fence, wire fence and a large metal gate were damaged. There was also damage to several vehicles that were parked near the helipad and several windows of the fire station building were shattered.

Figure 3: Damage to the concrete perimeter fence, wire fence and gate.

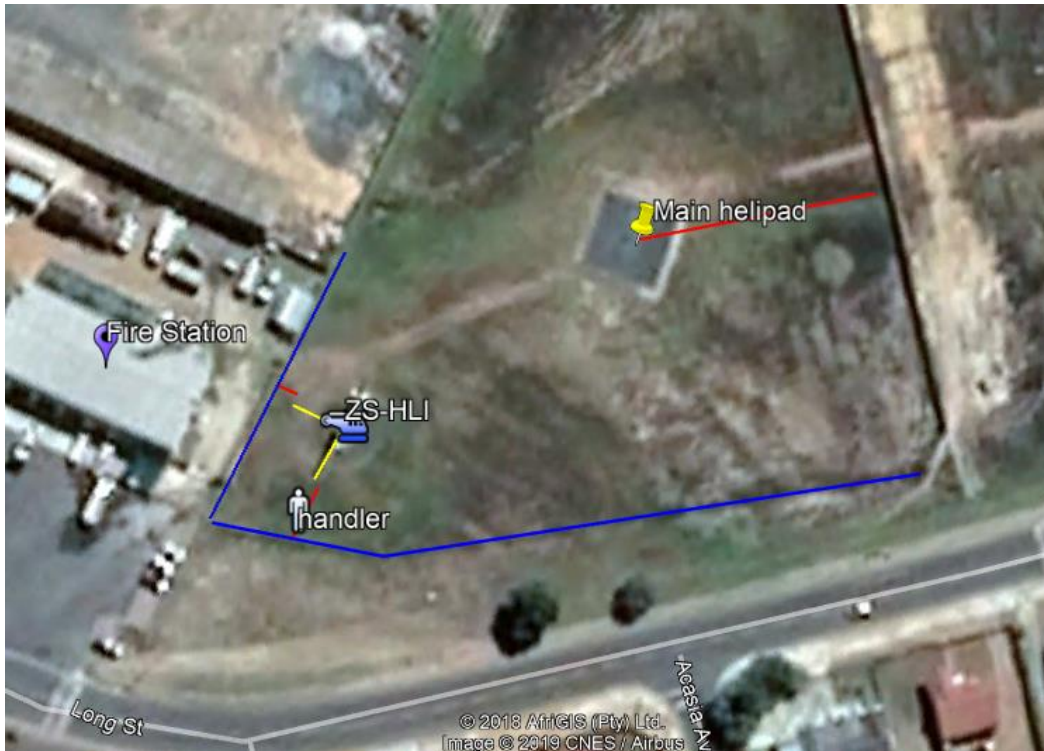
Figure 4: Yellow lines depict rotor blades which have a radius of 7.5m. The marshal stands approximately 11m from the helicopter. The space to the right of the helicopter was approximately 4m long from the blade tip. On the main helipad, the shortest distance to any object or obstacle is approximately 43m.

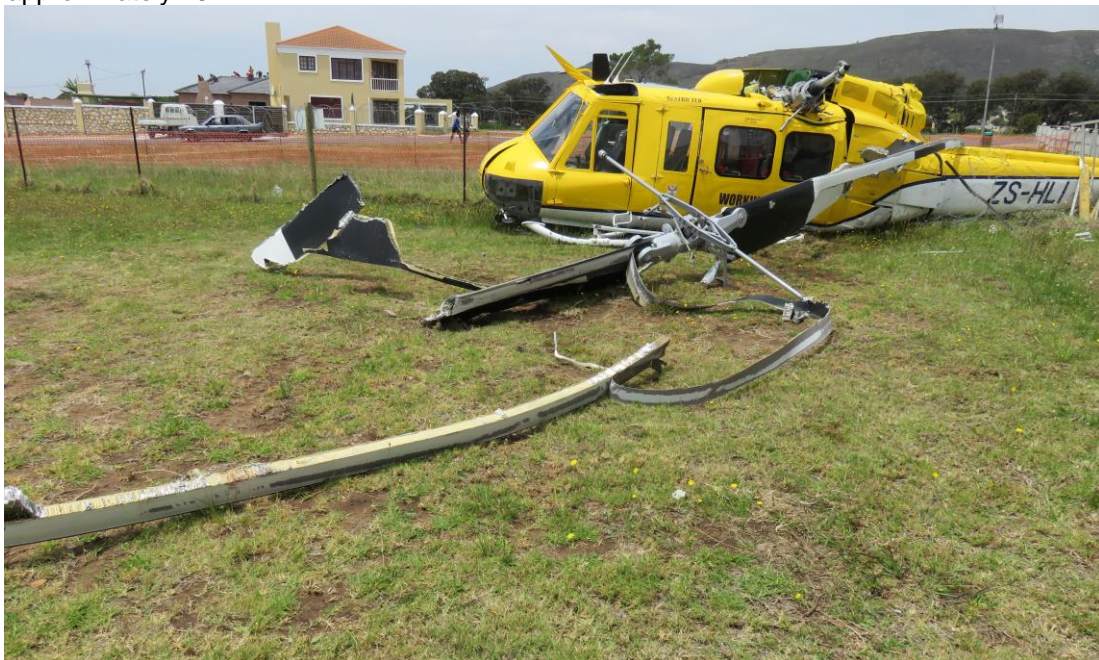
1.12.2 The helicopter came to rest on its belly facing south; the fuselage of the helicopter remained intact. The main gearbox separated from the mounting attachments, slanting to the left. The main rotor blades were destroyed; and the main rotor hub was separated from the rotor mast. A portion of the main rotor spar, approximately 1.2m, penetrated the roof tiles of a neighbouring house, landing inside the house and no one was inside the house. The house was approximately 145m to the south-easterly direction from where the wreckage was located.

1.12.3 The tail boom was bent near the airframe and showed signs of right yaw caused by impact with the ground. The tail rotor blades were destroyed during impact with the fence. The tail rotor gearbox was ripped out of its mounts; it had cracked vertically and was leaning to the left of its normal position.

Figure 5: The substantially damaged helicopter at the accident site.

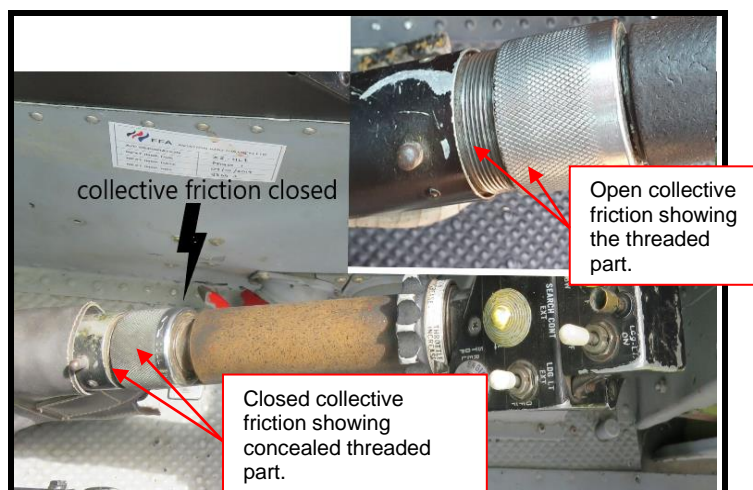
1.16.2 The collective friction on accident aircraft was close to the limit as indicated on Figure 6 with the inset showing a fully open collective friction.

Figure 6: The main photo shows the closed collective friction. The inset shows an open collective friction.

2.2.4 The investigation revealed that the pilot's loss of control was likely caused by the pilot's induced vertical oscillation due to incorrect tightening of the collective friction which was less than the required 7 pounds (hand tight), subsequently leading to the crash.

- *Relax pressure on collective. (Do not 'stiff arm' the collective)*
- *Make a significant collective application either up or down*
- *Increase collective friction*
