<b>AIRCRAFT INCIDENT SHORT REPORT</b>
---------------------------------------

**CA18/3/2/1192: ZU-CIA Student lost control during touch and go**

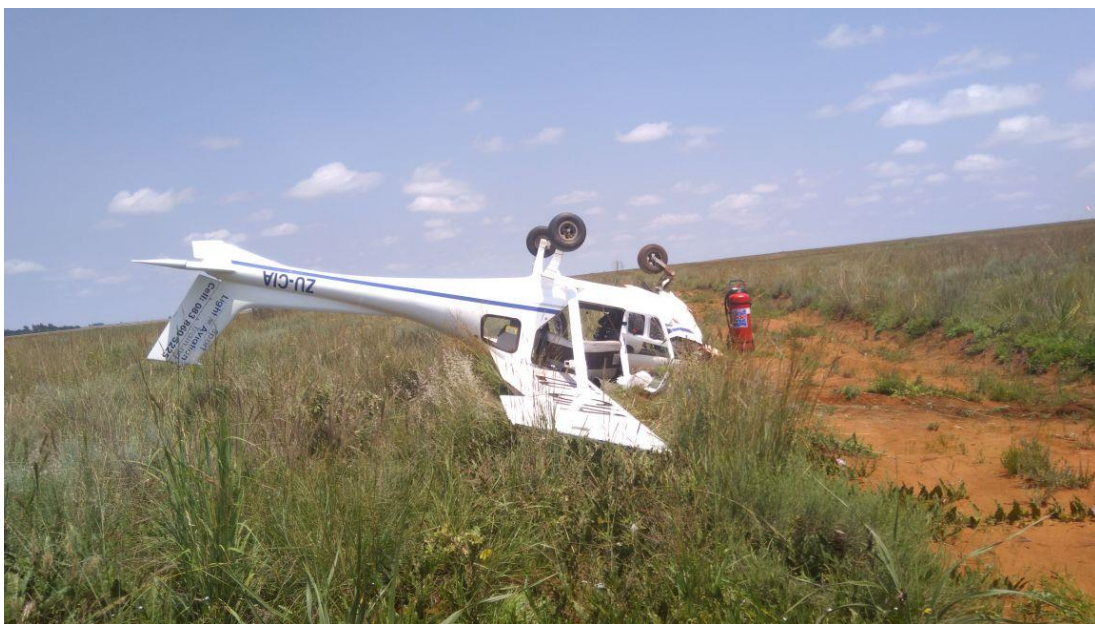
Figure 1: The aircraft after coming to rest.

2.4 The pilot sustained no injuries and the aircraft was substantially damaged with damage limited to the undercarriage, front lower engine cowling, wings, propeller and the firewall.

4.1 The student pilot lost control of the aircraft following a bad landing and in an attempt to take off; the aircraft entered a ditch and nosed over.
