**FINAL REPORT ON ACCIDENT**

**CESSNA 152 AIRCRAFT VT-PTD**

**FALCON AVIATION ACADEMY**

**ON 26/04/2018 AT FAIZABAD**

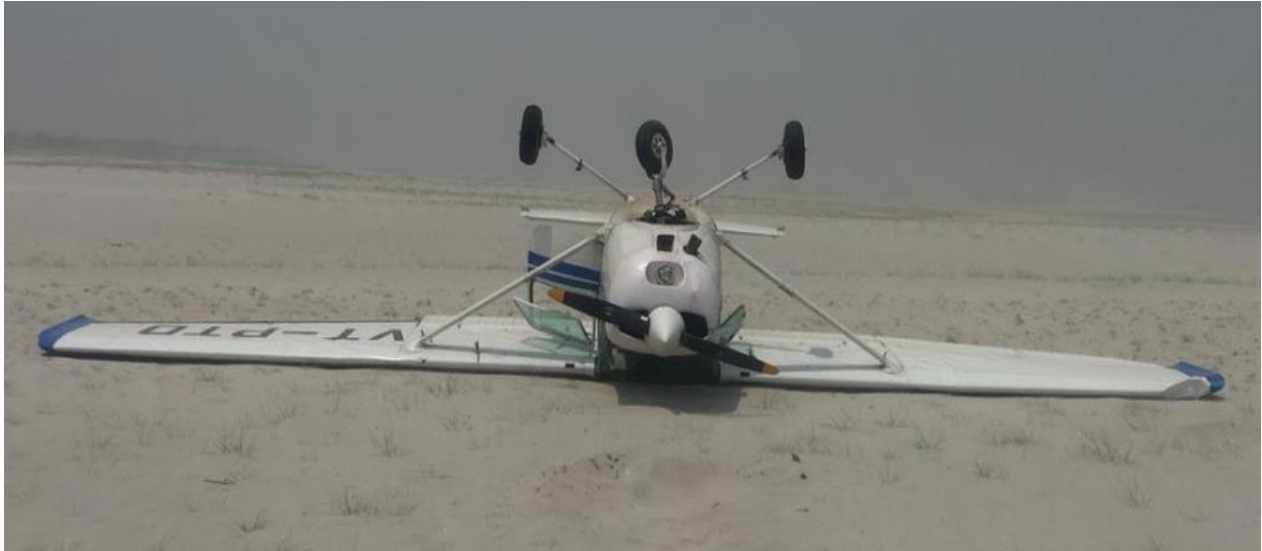
rear wheels touching the sandy ground first. Aircraft kept rolling in this attitude for about 213 feet. As the aircraft lost speed and aircraft weight fell on its wheels, nose wheel also touched the sandy ground. The nose wheel started sinking in the sand which caused the aircraft to topple. Thereafter, the aircraft came to a halt.

Fig 1: Aircraft lying toppled at crash site

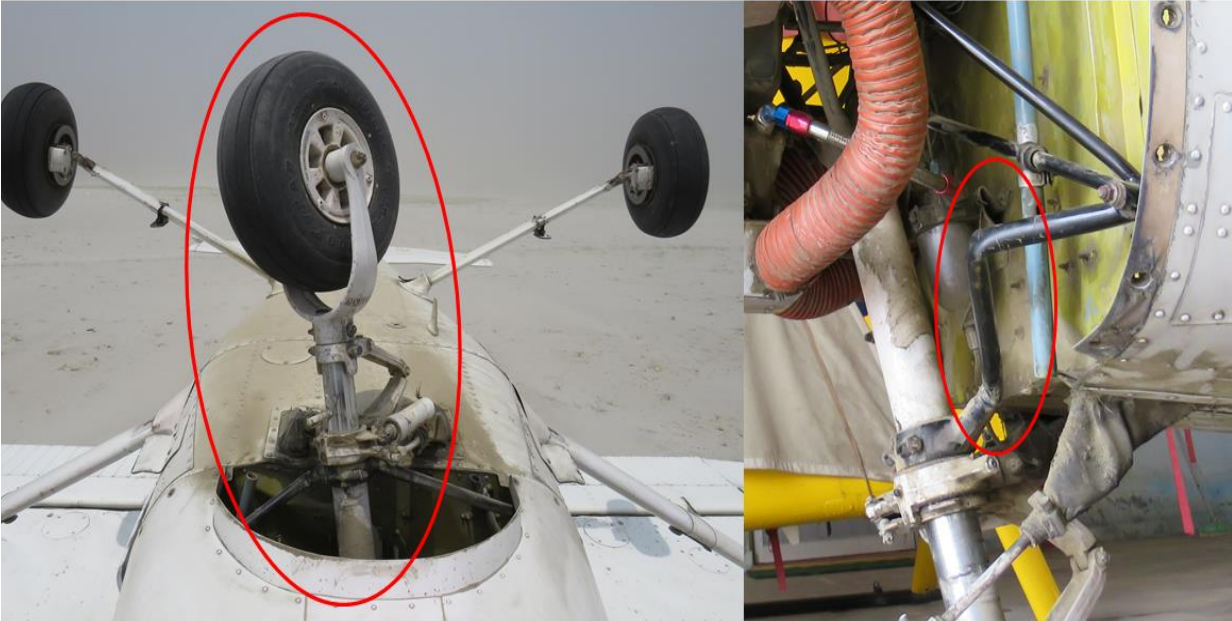
Fig 2: Nose Landing gear bent due to bending of its mounting

Nose cowling of the aircraft received dents and Nose Landing Gear had tilted to one side due to bending of its mounting. Nose wheel right hand steering rod was also broken.

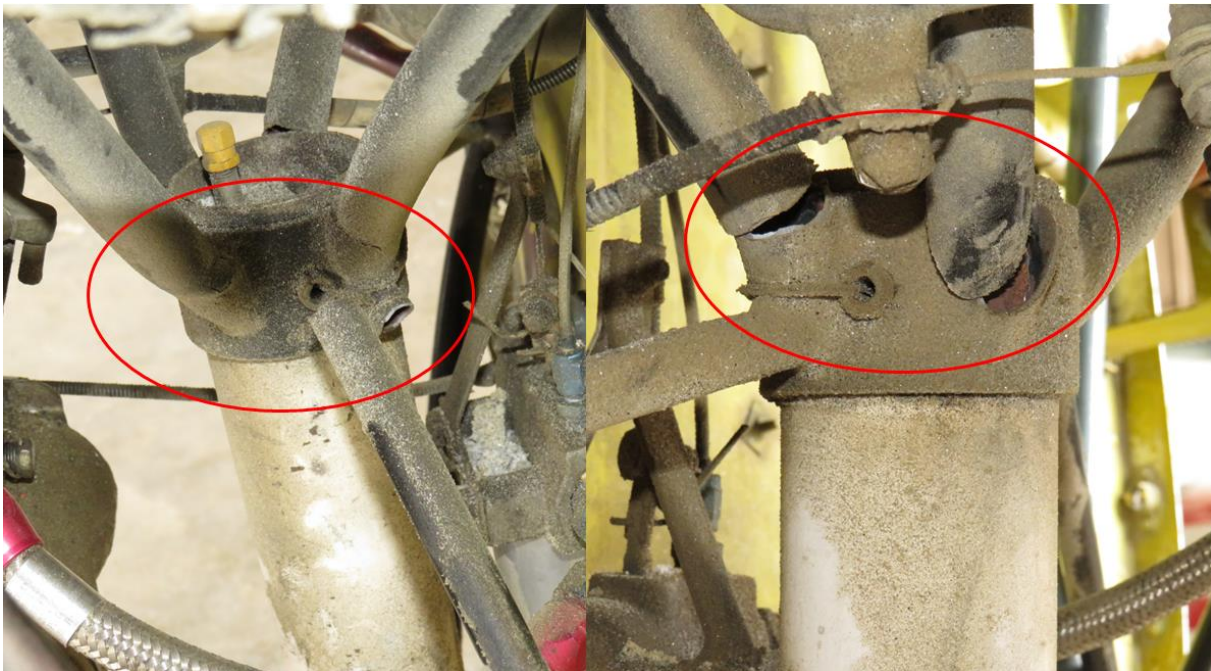
Fig 3: Engine Mounts broken

The engine mount assembly was found broken at three points.

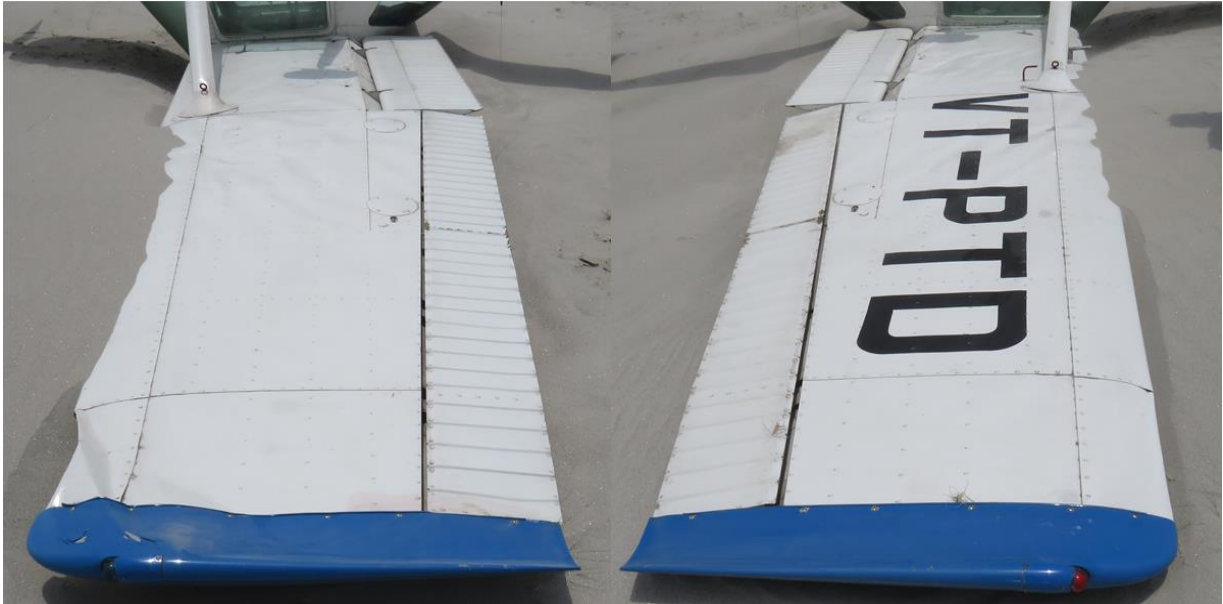
Fig 4: Damages to LH and RH wing

Starboard wing had bulged at L.E near to the tip. Multiple wrinkles were observed on both starboard & port wing on upper as well as lower surface.

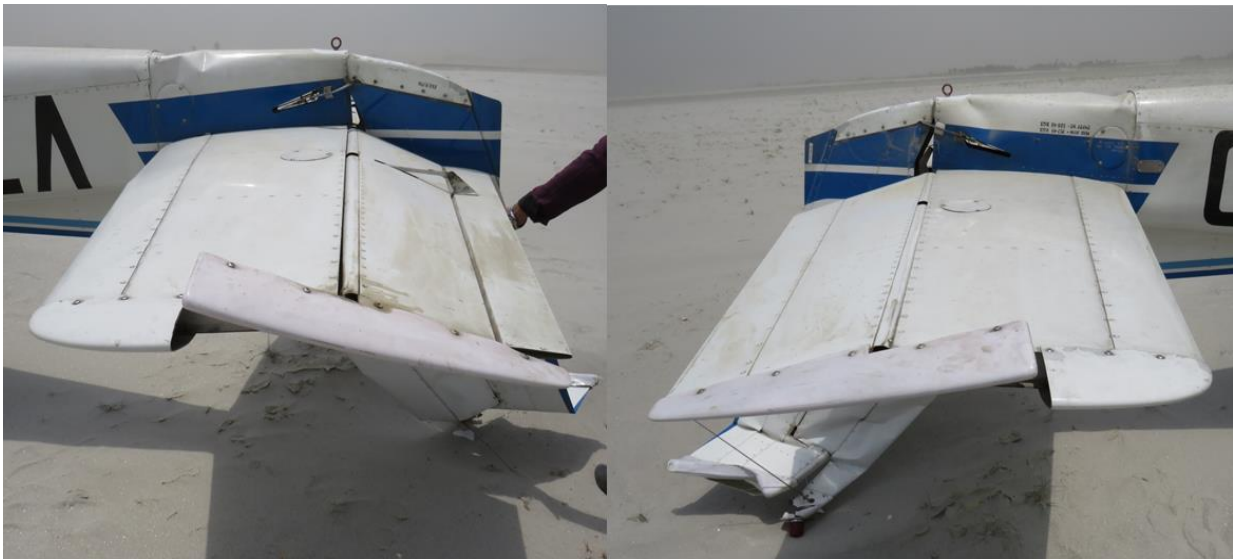
Fig 5: Damages to Tail Fin and Tail Cone

Tail cone had cracked and bulged at two places approximately 2 feet from rudder trailing edge. Tail fin was also severely damaged at approximately 1 foot from the top.

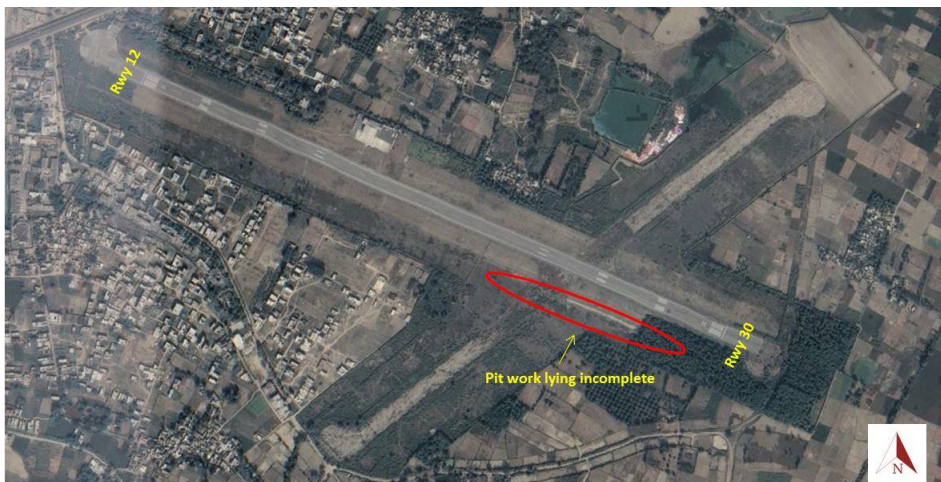
Fig 7: Layout of Faizabad Airport with incomplete mud pit highlighted

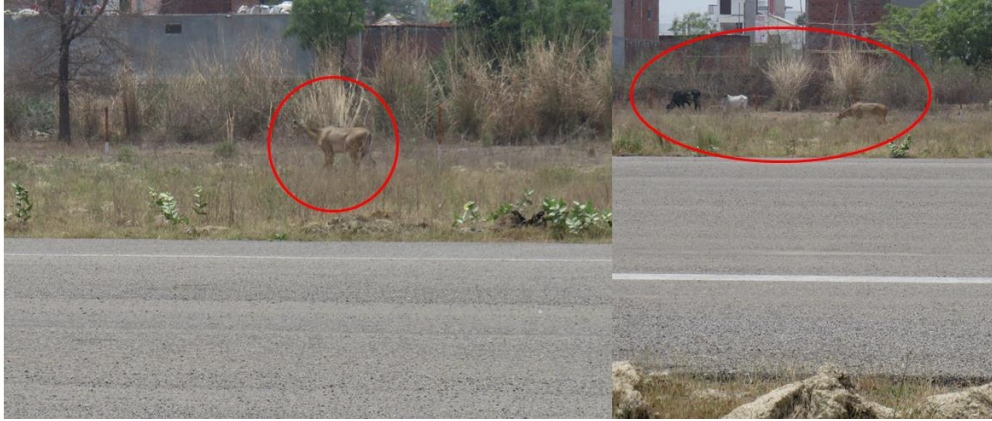
Fig 8: Incursion of stray cattle and wild animals on the Runway

During visit of Investigation team to Faizabad airport, it was observed that the airport premises is not properly secured. Stray cattle and wild animals were seen grazing in the vicinity of the runway. A barbed wire had been put up on both sides of the runway strip to prevent incursion by the cattle and wild animals, but had proven adequate as is evident from the pictures above (Fig 8). Alternately, a pit was being dug on the side of runway to prevent stray cattle from approaching the runway, but the work was lying incomplete.

The airport premises is not properly secured and stray cattle and wild animals are able to approach the runway. A barbed wire fence installed by the operator was not an adequate deterrent and could be crossed by the cattle and wild animals. The work for a pit to prevent animals from approaching the runway was lying incomplete. The hazards present at airport were not a contributory factor in the accident but could pose a serious threat to flights operating from the Faizabad airport.

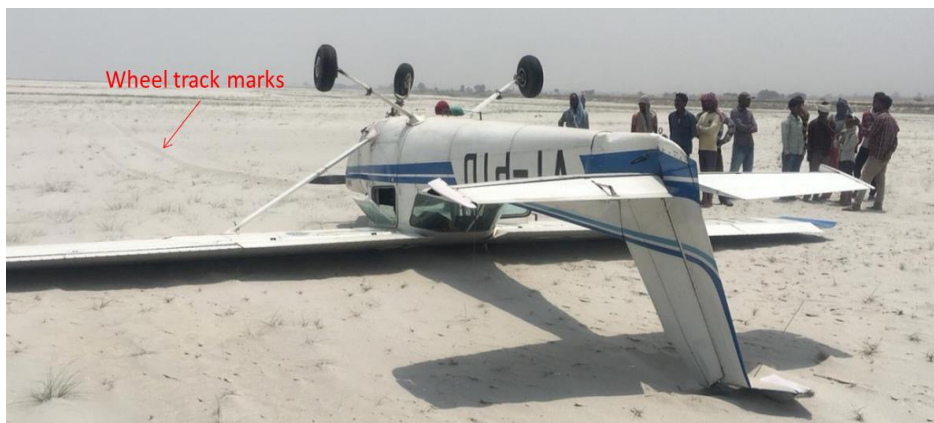
Aircraft forced landed on the bed of Saryu river and had travelled a distance of 213 feet approximately on main landing gear before it got toppled. The marks of tyre track could be seen in the picture taken immediately after the accident.

Fig 9: Wheel track marks

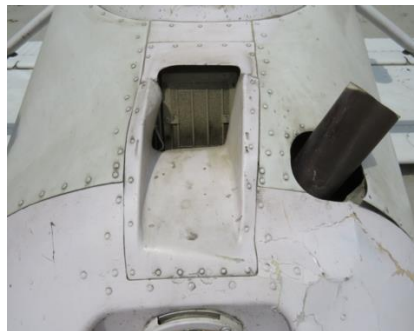
1. Dent was found on the engine cowling near nose section. One rivet of cowling at nose section was found missing.
2. Exhaust stag was found damaged. (Figure10)

Fig 10: Damage to the nose cowling and exhaust stag

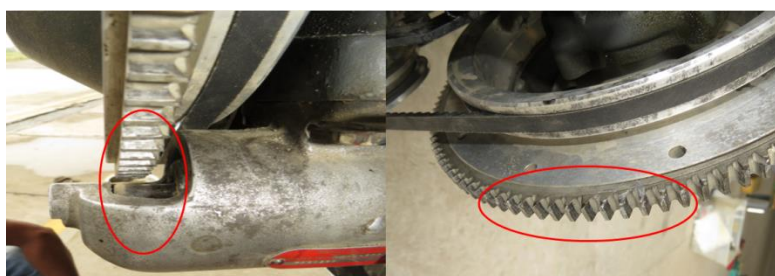
3. Starter drive gear was found broken. (Figure 11)

Fig 11: Broken Starter Gear and Ring Gear teeth

4. Starter ring gear teeth were found damaged at different places and rubbing marks were present on the back of the ring gear. (Figure 11)
5. Air intake filter was found clogged with sand. (Figure 12)

The condition of Starter Motor and Spark plugs hinted at poor maintenance practices. The vibrations and loss of power during the accident flight was caused by fouling of the spark plugs. Crew was unable to re-start the engine as the starter gear teeth had broken possibly during last start up on ground.

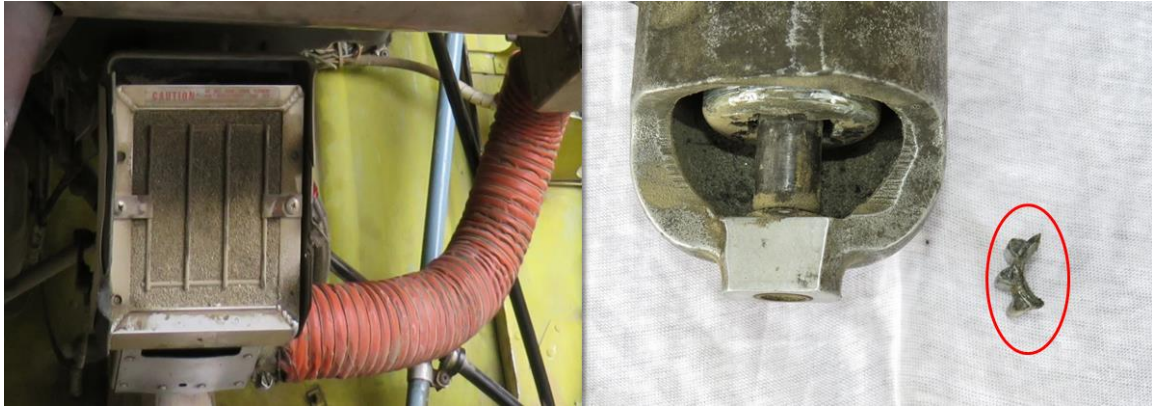
Fig 12: Air intake filter and broken piece of starter gear

6. All gears of the starter were found broken and only one fourth of gear was present. (Figure 12)
7. Cracks were found on both sides of starter mounting points. (Figure 17)
8. All sparks plug from all the Cylinder heads were uninstalled for inspection and found intact. Blue colour deposit was observed on electrodes of top spark plug for Cylinder No. 1 and 3. Bottom spark plugs of cylinder No. 1 & 2 had yellow colour deposits on its electrodes. (Figure 13)

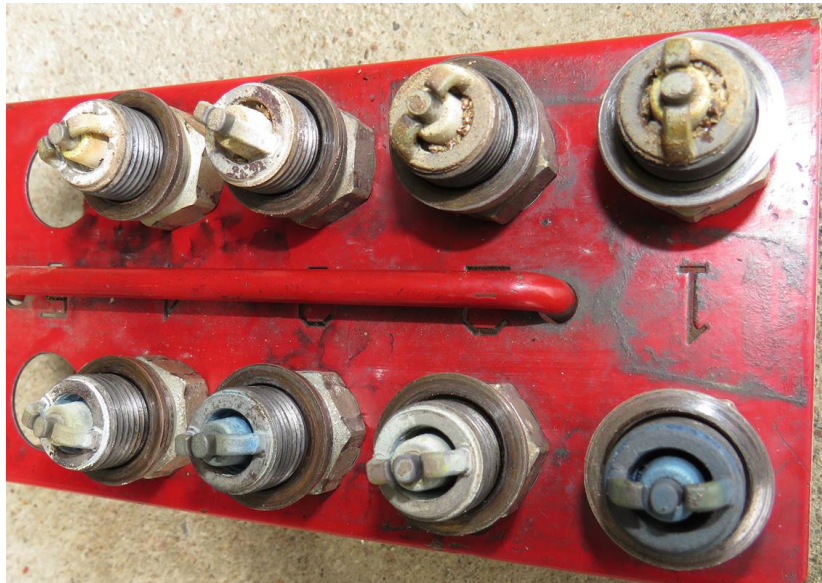
Fig 13: Spark Plugs

The blue coloured deposit on piston heads and spark plug electrode was due to non-combustion of fuel in the cylinder. It can be safely presumed that the top spark plugs of Cylinder no.1 and 3 having blue deposit were not firing. Bottom Spark plugs of Cylinder no. 1 and 2 too were in poor condition due to excessive lead deposit on its electrodes.

The yellow coloured deposit observed on piston heads is a sign of lead deposit which is normally observed on engines received for overhaul with approximately 700 to 800 Hrs of running. Spark plugs too were found with high content of lead deposit which was indicating towards lack of maintenance during

scheduled inspections. Quantitatively that amount of deposit could not have accumulated in just 32 Hrs of engine running had 200 hrs inspection been properly carried out on 18.04.2018. Alternatively, such high deposits could also be caused because the aircraft was carrying out maximum of flying at low altitude (in local flying area) with rich mixture.

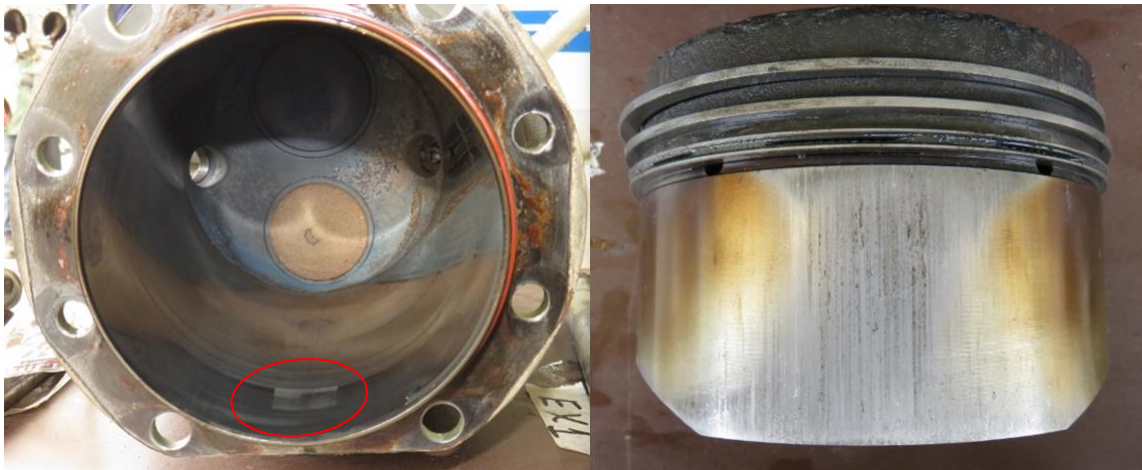
1. Both magnetos, oil filter, R.P.M drive gear and ignition harness were uninstalled from the engine and found satisfactory.
2. Accessory cover was removed and found satisfactory.
3. All induction pipes, oil return lines and oil sump removed and found satisfactory.
4. All cylinders including pistons and connecting rods were dismantled. Scoring marks were observed on cylinder No. 1 inner wall as well as on piston. Rest all the three cylinders were found satisfactory. (Figure 14)

Fig 14: Scoring marks on Cylinder No 1 and its Piston

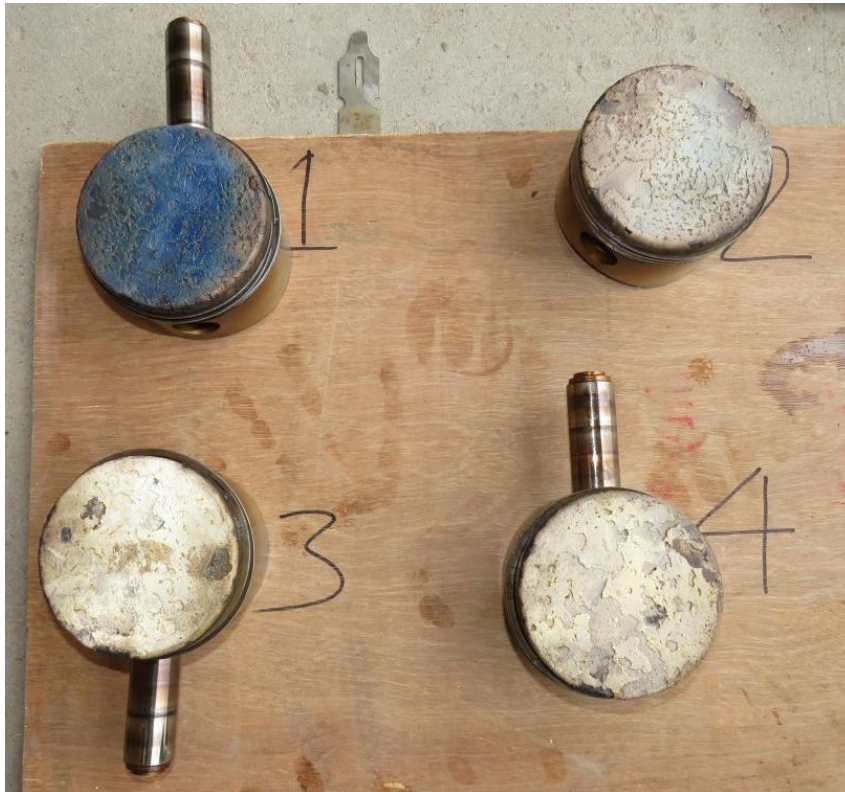
5. Bluish deposit was found on Cylinder no.1 piston head and heavy amount of lead deposit was observed on all the piston heads. (Figure 15)Piston rings, Push rods and connecting rods were dismantled from all cylinders and found satisfactory.

Fig 15: Blue Colour deposit and Lead deposit on the pistons

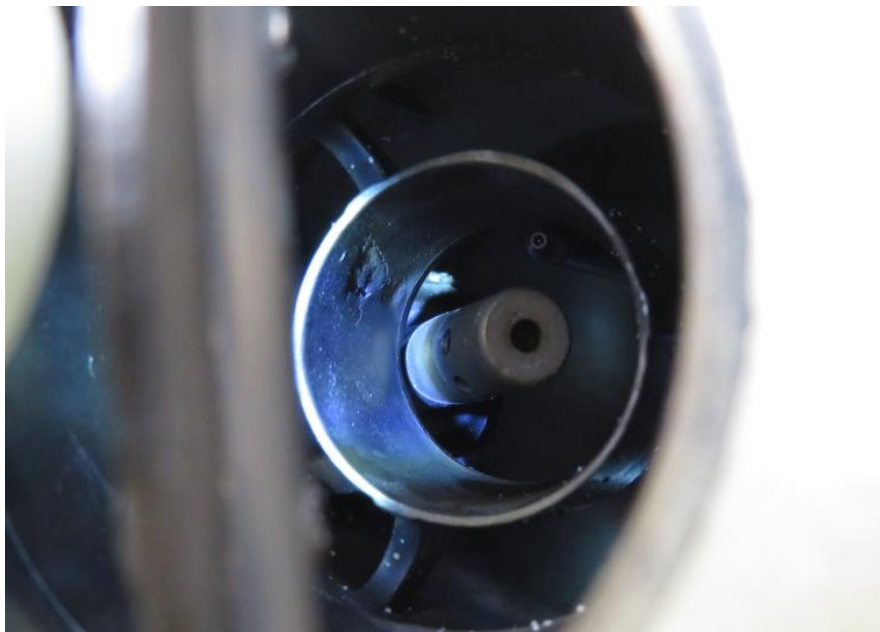
6. Carburettor was removed and inspected. It was found that fuel accelerating jet nozzle was not properly installed in the carburettor which would result into a lower jet pressure than the standard pressure. (Fig 16). The jet nozzle was fitted during the last overhaul and is not inspected in any schedule maintenance checks.

Fig 16: Fuel Accelerating Jet Nozzle

The accelerating fuel jet nozzle was not installed properly at its position which resulted into improper fuel discharge into the venturi and subsequent improper fuel air mixture composition. The effect would have amplified in case of slam opening of throttle.

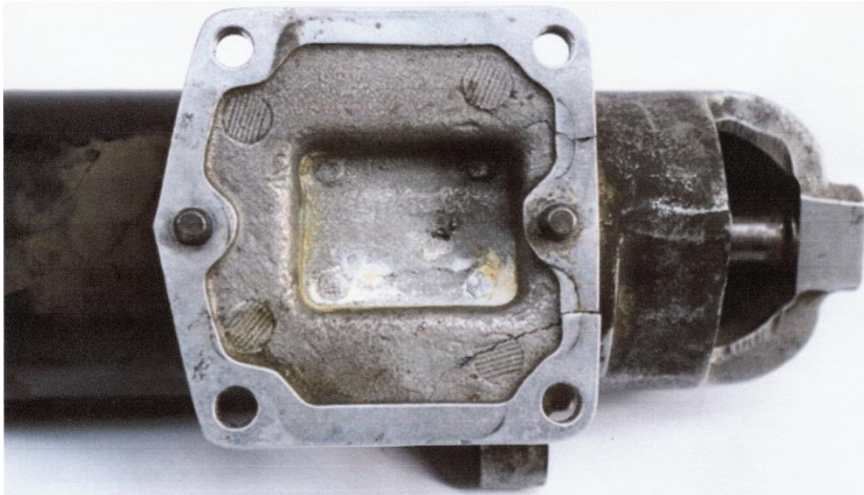
The drive end head assembly removed from the aircraft had visible cracks as is shown in Figure 17.

Fig 17: Drive end head assembly

From the above observations, it is inferred that the base of the assembly had cracked due to corrosion fatigue which resulted from fluctuating load caused by vibration.

The damaged starter and its broken gear were sent to DGCA Lab for examination and as per the result of examination, the base of the assembly had cracked due to corrosion fatigue which resulted from fluctuating load caused by vibration. The vibrational loads were possibly caused due to bending of shaft and improper engagement with the ring drive. It is evident that the crack had progressed over time and was not result of any impact during the accident.

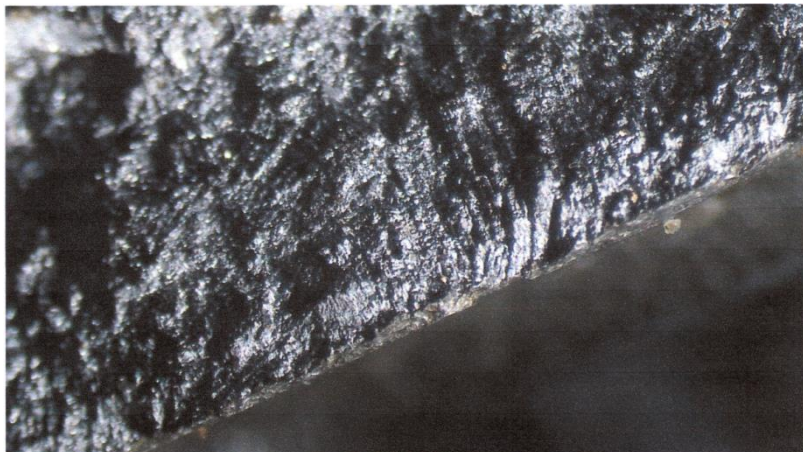
Fig 18: Beach marks on cracked surface

Light beach marks were noticed on the fracture surface. Rubbing Marks were noticed on the fracture surface. Rubbing marks were also noticed on the mounting holes of the head assembly as shown in Figure 19

The presence of light beach marks on the fractured surface and rubbing marks on the holes of head assembly indicated presence of cyclic load due to vibrational stress. Bending of the shaft and signature of corrosion on it indicates that there was some restriction in rotation.

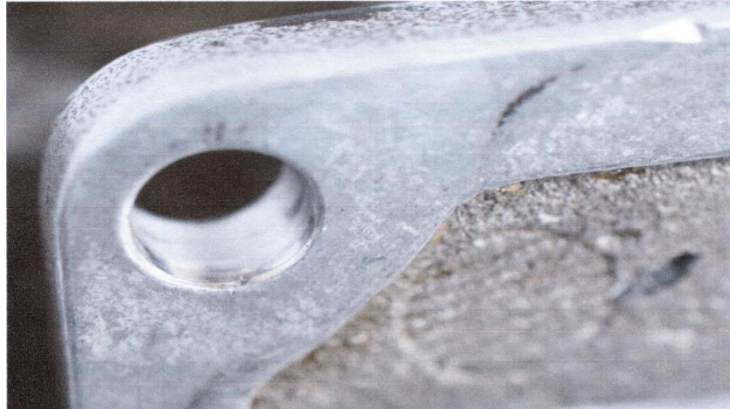
Fig 19: Rubbing marks on mounting holes

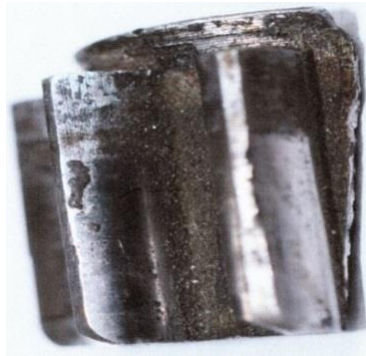
Only small portion of the gear was available for examination. Rest of the portion could have fallen during take-off or in air, after the gear was broken during engine start-up. Pitting was noticed on the gear flank as shown in Fig 20.

Fig 20: Pitting on the gear

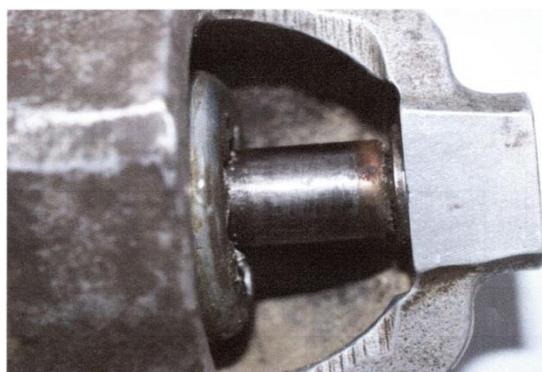
Shaft of the gear was found corroded and slightly bent as shown in Fig 21.

Fig 21: Starter shaft bent and corroded
