DUTCH  
SAFETY BOARD

# Crashed after banner pick-up, Piper PA-25-235 Pawnee

*The Hague, May 2021*

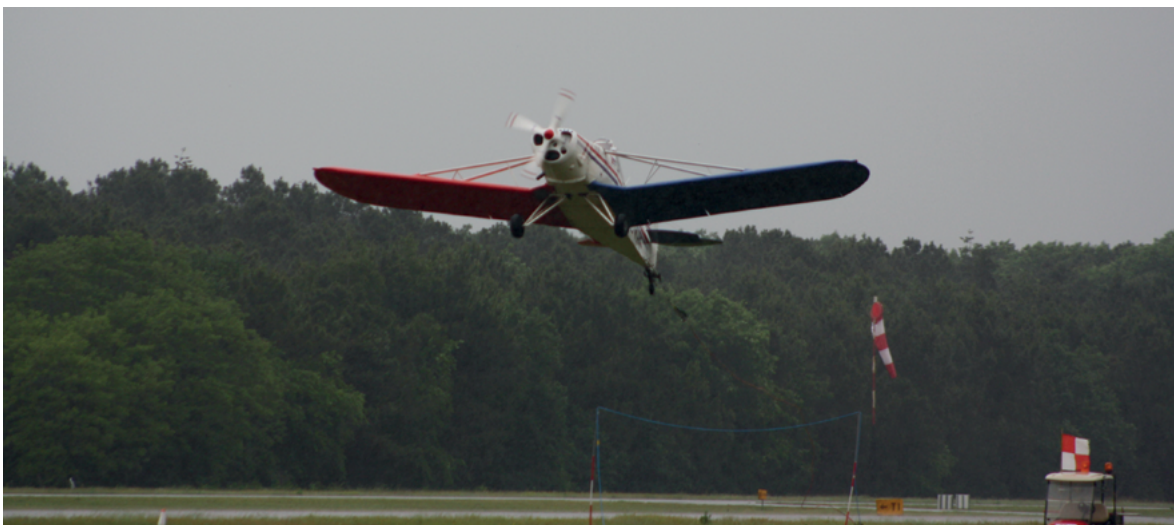
Figure 1: Banner pick-up accident flight. (Source: De Haan)

At 10.58 hours the aeroplane picked up the banner (see Figure 1). During the pick-up, the banner deployed normally. After the pitch up manoeuvre and levelling off, the aeroplane almost immediately began to lose altitude with a wings level and a nose high attitude. This is illustrated by the compilation of video stills in Figure 2. The aeroplane had its flaps in the up position during the pick-up manoeuvre. This is the normal flap setting for the pick-up manoeuvre and climb out. The aeroplane continued to fly in a descending flight path veering slightly to the left, passing over a residence bordering the airport at approximately 100 feet (see Figure 3).

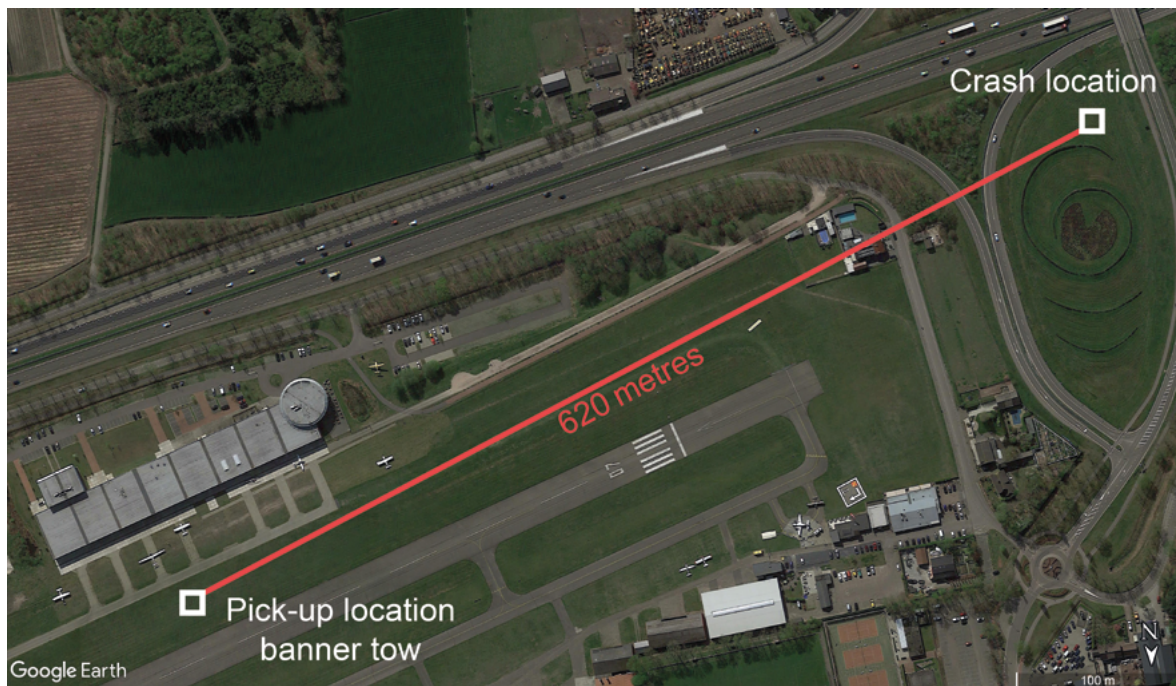
Figure 3: The grass strip, banner pick-up point and the crash location at Breda International Airport. (Source: Google Earth)

The aeroplane crashed on a grass area of a curved ramp leading towards the highway south of the airfield (see Figure 3). The impact with the ground was in a near vertical nose down attitude which caused the wooden propeller blades to completely disintegrate. Many parts of the propeller were found at a distance from the impact point on the grass area. The aeroplane structure was buckled at the cockpit area and distorted by the force of the impact. The banner and towline were found on the airfield boundary and the residential area.

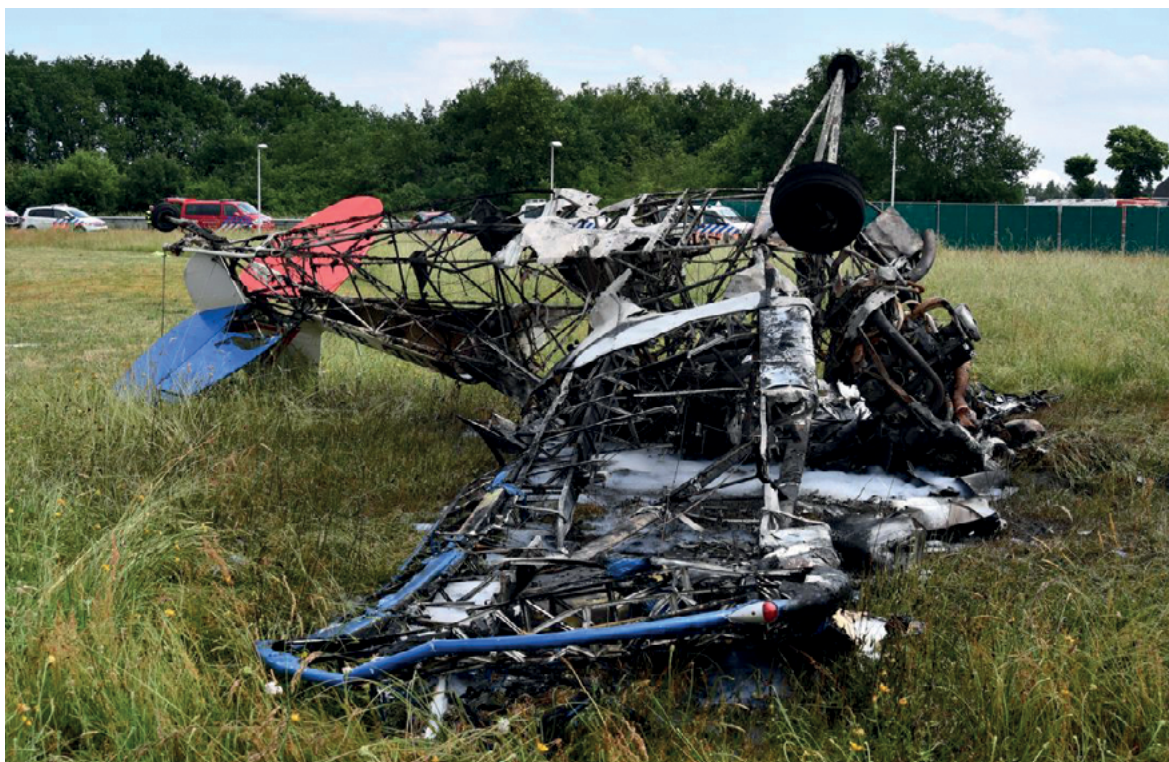
*Figure 4: Wreckage of SE-KHF. (Source: Dutch Aviation Police)*

The aeroplane was destroyed by the impact of the crash and subsequent fire. Although most of the aeroplane was severely damaged, a technical investigation was performed on the engine, cockpit controls, banner tow release system and the propeller. The following findings were made:

- a. The technical state of the engine did not reveal any malfunctions.
- b. The cockpit engine controls were found to be in the following positions: throttle – *full power*, mixture – *rich* and carburettor heating – *cold*.
- c. The aeroplane was equipped with a towing and tow-release installation. The banner release installation was tested and functioned normally.
- d. The wooden propeller blades of the 4-blade propeller were completely fragmented on impact with the ground, only the propeller hub/core was still attached. The fragmentation of the propeller blades showed that the engine was running at high rpm.

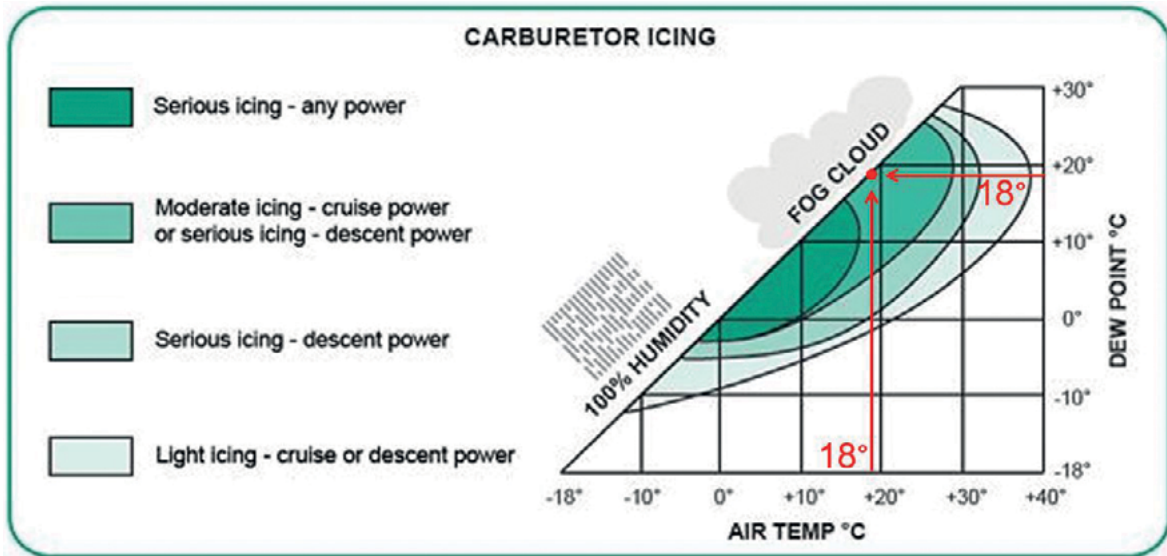
Figure 7: Carburettor icing prediction chart. (Source: Canadian Transportation Safety Board)

The actual carburettor icing conditions at the moment of take-off are notable and should be considered. The outside air temperature at the time of take-off was 18 °C and the dew point temperature was also 18 °C. With these temperatures the red dot in Figure 7 shows that the conditions were favourable for moderate to serious icing during cruise and descent with a low power setting. SE-KHF flew one circuit in the pattern of Breda Airport, before the pick-up of the banner. This is considered similar to a cruise/descent phase of flight. The carburettor heating controls in the cockpit were found in the 'Cold' position; which was the correct position during the pick-up and climb out with a high power setting. From downwind to just before the pick-up, the correct position is "hot", to prevent carburettor icing and guarantee maximum available engine power during the pick-up. It is unknown what the position was during the circuit.

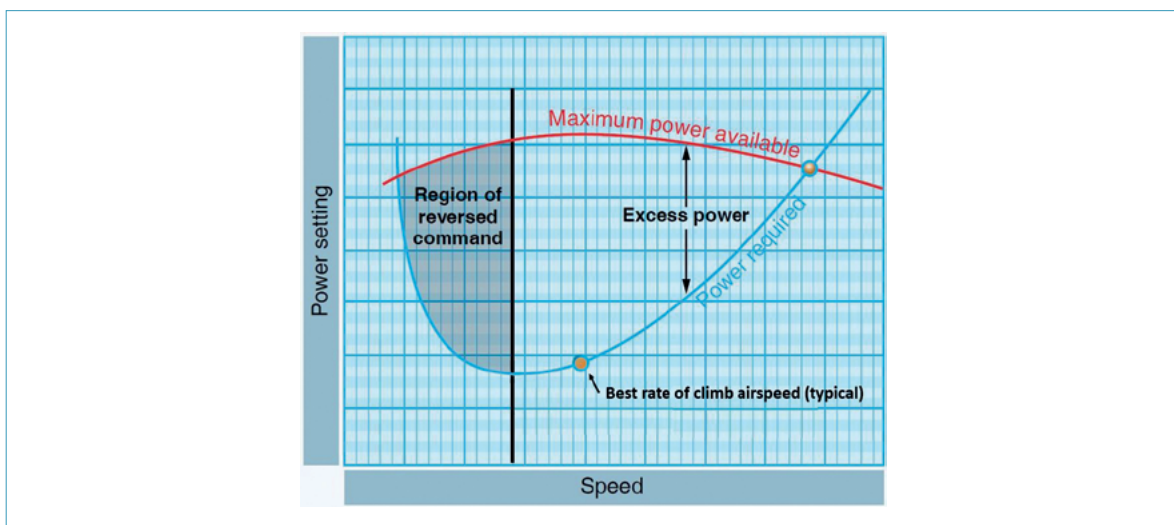
At the calculated average airspeed, the aeroplane was flying in the 'region of reversed command'. Figure 9 illustrates a typical region of reversed command, indicating that when flying at airspeeds below the best rate of climb airspeed, more engine power (thrust) is required to maintain a lower airspeed. This is indicated by the power required curve (blue line) going left and upwards. It also shows that the power required curve on the left side of the graph has a steep rise, indicating that when the thrust deficient situation is not corrected promptly, the decrease in airspeed worsens at an increased rate.

Figure 9: Typical region of reversed command. (Source: FAA, modified by the Dutch Safety Board)

At a certain point after the pick-up, the airspeed had decreased to where the aeroplane was flying in the region of reversed command. This means that flying a lower airspeed required more thrust to maintain that lower airspeed or to accelerate. Hence, the situation worsened as the speed of SE-KHF was decreasing gradually after picking up the banner. This situation could only be resolved by applying sufficient engine power (thrust) and/or by exchanging altitude (nose down) to increase the airspeed. The pilot could do neither of these, having an improper propeller fitted and being too low to the ground.

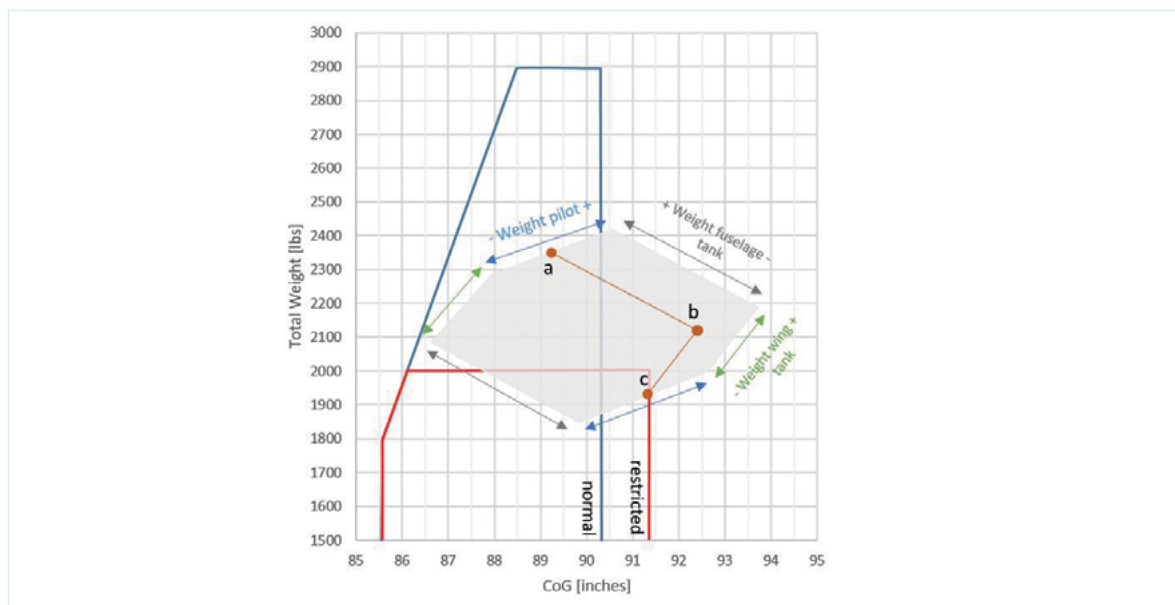
The graph in Figure 10 illustrates the aircraft flight manual weight and balance regions for the normal (blue) and restricted (red) categories.<sup>34</sup> The graph further shows the actual weight and balance region of SE-KHF (grey area). The line 'abc' within the grey area, shows the centre of gravity change as a result of decreasing weight due to fuel consumption.

Figure 10: The centre of gravity limits for the normal and restricted categories (SE-KHF).
