AIRCRAFT ACCIDENT REPORT AND EXECUTIVE SUMMARY

Reference:	CA18/2/3/9715	
Aircraft Registration	ZU-BNH	Date of Accident	11 June 2018		Time of Accident	1221Z
Type of Aircraft	Cozy Fish Eagle		Type of Operation		Private (Part 94)	
Pilot-in-command Licence Type		PPL	Age	56	Licence Valid	Yes
Pilot-in-command Flying Experience		Total Flying Hours	724.55		Hours on Type	158.2
Last point of departure		Port Elizabeth International Airport (FAPE): Eastern Cape				
Next point of intended landing		Port Elizabeth International Airport (FAPE): Eastern Cape				
Location of the accident site with reference to easily defined geographical points (GPS readings if possible)						
Baakens Valley 1nm north east of FAPE GPS coordinates: S 33°58'17.26", E 025°36'46.50"; elevation 123 feet						
Meteorological Information		Wind: 070/9kts, Visibility: >10 km CAVOK, Temperature: 18°, Dew Point: 9°				
Number of people on board	1+0	No. of people injured	0	No. of people killed	1

Name of Owner/Operator : R Burger
Manufacturer : R Burger
Model : Fish Eagle
Nationality : South African
Registration Marks : ZU-BNH
Place : Baakens Valley, 1 nautical mile north of FAPE
Date : 11 June 2018
Time : 1221Z

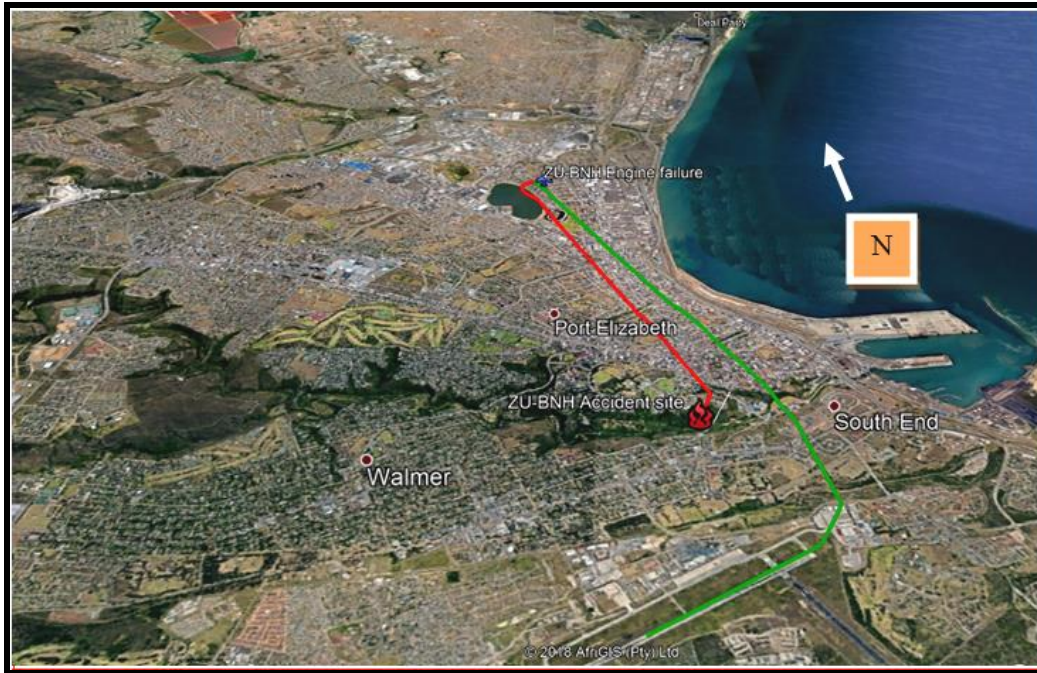
- 1.1.3 The ATS radar recording indicated that after the “Mayday” call the aircraft lost 300 ft in height immediately and continued to lose height until it crashed. Before the accident, the pilot had reported that he was in a valley and it did not look good (as heard from the ATS audio recordings). Another aircraft that took off from FAPE a few minutes after ZU-BNH reported at 1221Z that ZU-BNH had crashed and was on fire. The airport’s fire and rescue team was dispatched to the accident site. On reaching the accident site, the fire was extinguished. However, the fire had destroyed most of the aircraft; only the engine, firewall, main landing gear struts and the one winglet remained. The pilot was fatally injured.

Figure 1: Google Earth image showing the aircraft flight path as seen on radar

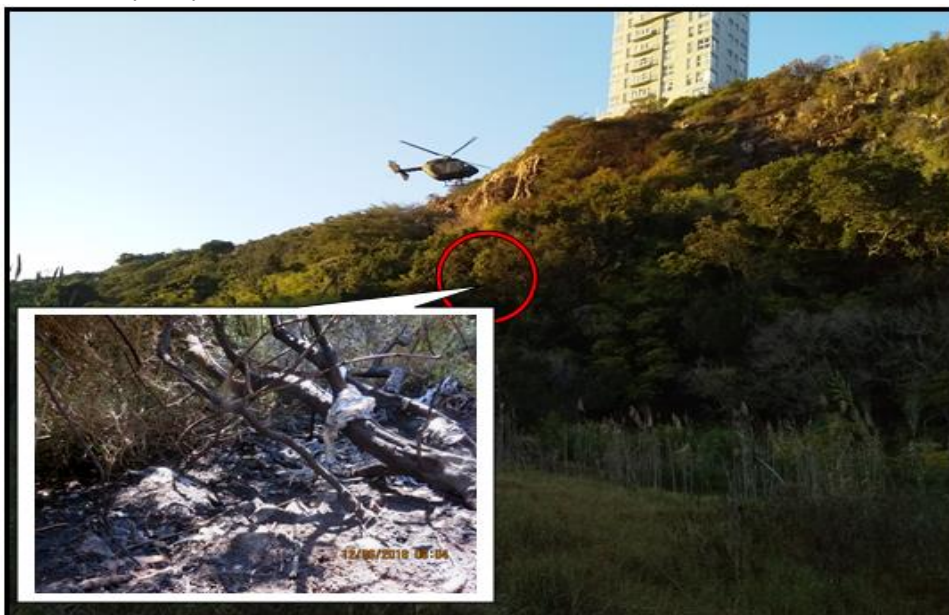
1.3.1 The aircraft was destroyed by the post-impact fire.

Figure 2: The wreckage as found at the accident site. The SANDF helicopter hovering above was assisting with the engine recovery.

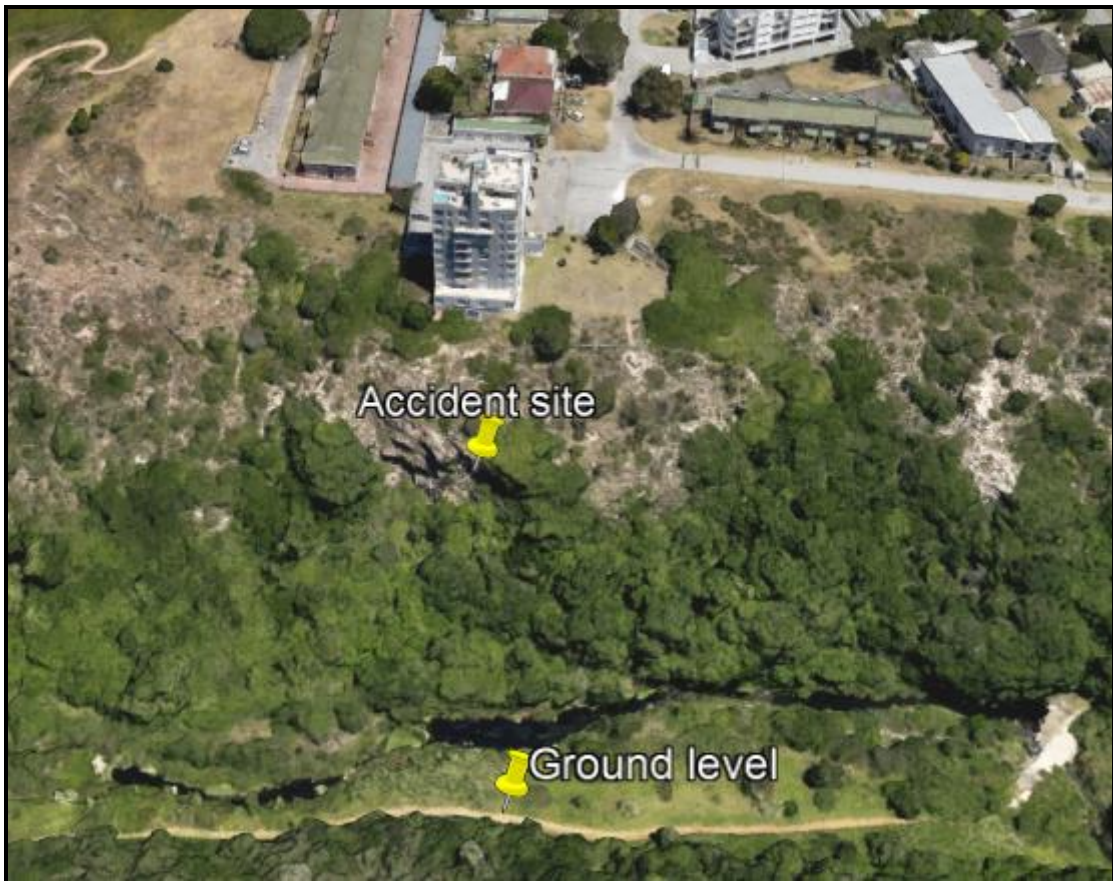
1.12.1 The aircraft accident occurred on an upslope of the valley with a bushy terrain. The accident site is 123 ft AMSL. See Figure 3 below.

Figure 3: View of the area around the accident site

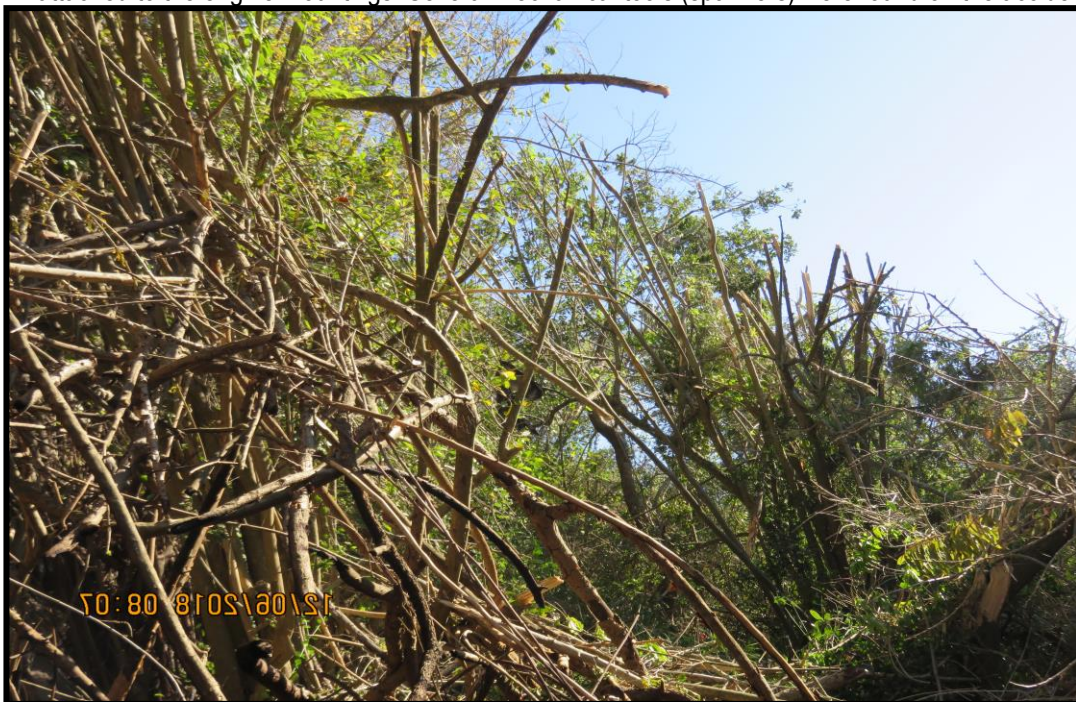
- 1.12.2 The onsite investigation revealed that the aircraft approached the accident site at a steep right-banked angle and high speed. The aircraft was flying in a south-westerly direction when it crashed. This was consistent with the angle at which it went through the bush and cut through the trees. See Figure 4 below.
- 1.12.3 A post impact fire erupted and engulfed most of the aircraft; only a winglet, main gear strut and the engine were left. The engine was burnt and its top covers were melted. The main landing gear struts were burnt and still attached to the engine mountings. Several mechanical tools (spanners) were found on the accident site.

Figure 4: Shows the angle at which the aircraft cut through the trees

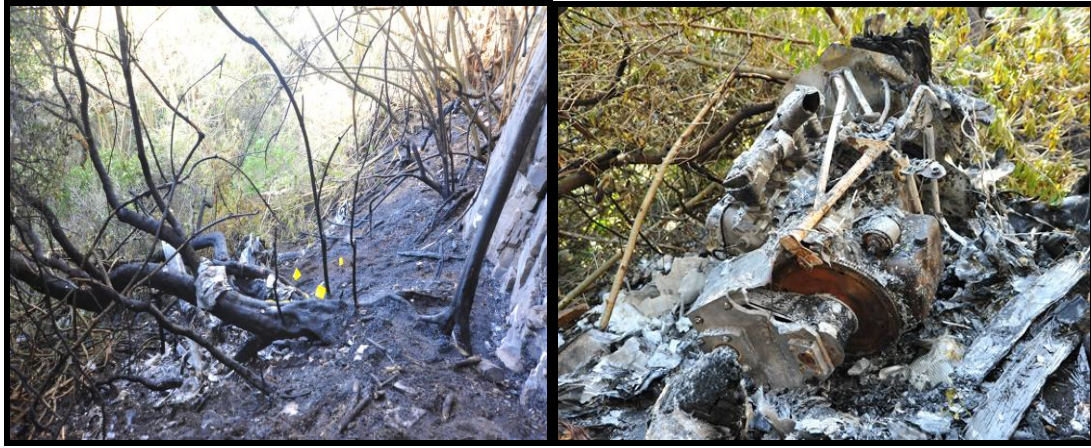
Figure 5: Photo of the accident site and the engine as it was found (photo courtesy of the SAPS crime scene photographer)

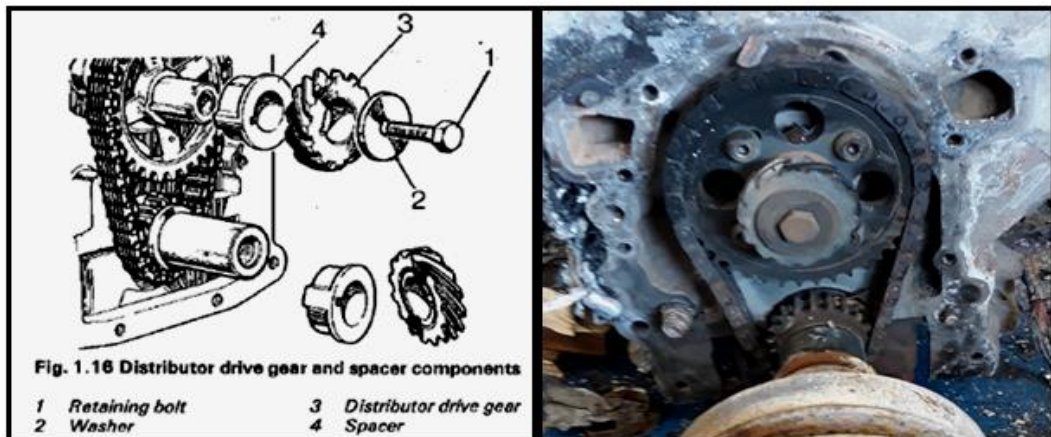
Figure 6: Shows the timing section of the engine type; photo shot during engine tear down inspection

1.16.2 The engine timing is co-ordinated between the crankshaft and the camshaft to synchronise the opening of the valves during four-stroke combustion. Further, a distributor electrical firing box is linked to a timing component through a gear mechanism (distributor driving gear). The size of the gear and its teeth are design to determine the firing sequence of each piston cylinder during engine operation. Each gear tooth co-ordinates the electrical spark according to piston cylinder four-stroke procedures. This also allows the engine to operate normally at certain ranges of revolution per minutes. On a motor vehicle this is indicated by rev-counter indicator instrumentation.

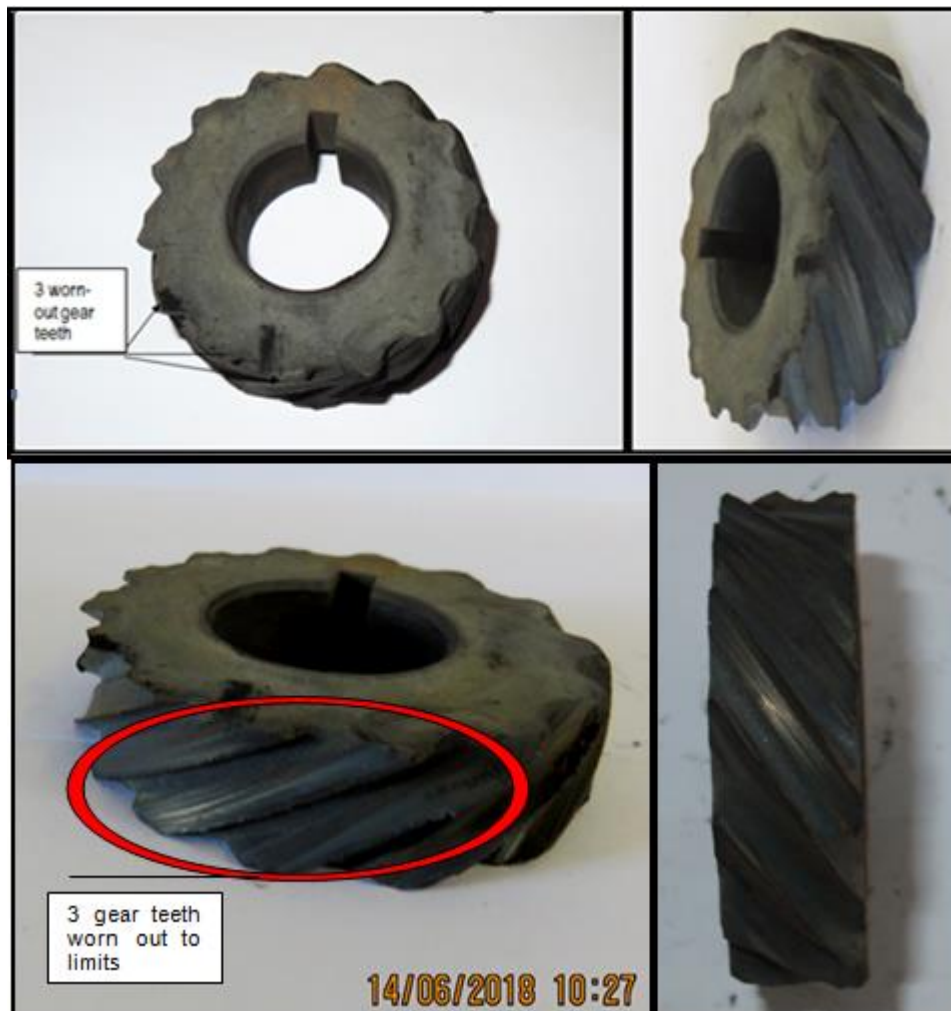
Figure 7 : Shows the worn out distributor driving gear teeth

1.16.3 During engine teardown, the timing components were inspected. The timing chain and timing gear were still intact. However, the distributor driving gear was worn out beyond limits. The general condition of the gear was not good. Three of the gear teeth failed, with the rest having sharp edges, showing signs of them having been worn-out. The damage on the gear was consistent with a component that was loaded and worn over time during operations.

- 3.1.8 The aircraft was equipped with a Rover 3500 V8 engine which was designed for the Rover 1976 to 1987 automobile car type.
- 3.1.9 The engine failed due to failed distributor driving gear; three of the gear teeth were worn out and caused disruption in the engine's ignition timing system.

- 3.2.1 Unsuccessful forced landing following an inflight engine failure as a result of a failed distributor drive gear. The distributor drive gear teeth failed and caused disruption in the engine ignition timing system leading to the engine stoppage.

- 4.1 The regulator (SACAA) should ensure that parts used in NTCA aircraft are aligned to aviation as in this accident it was determined that the engine limits were calculated in kilometres (km) and not flying hours or cycles.

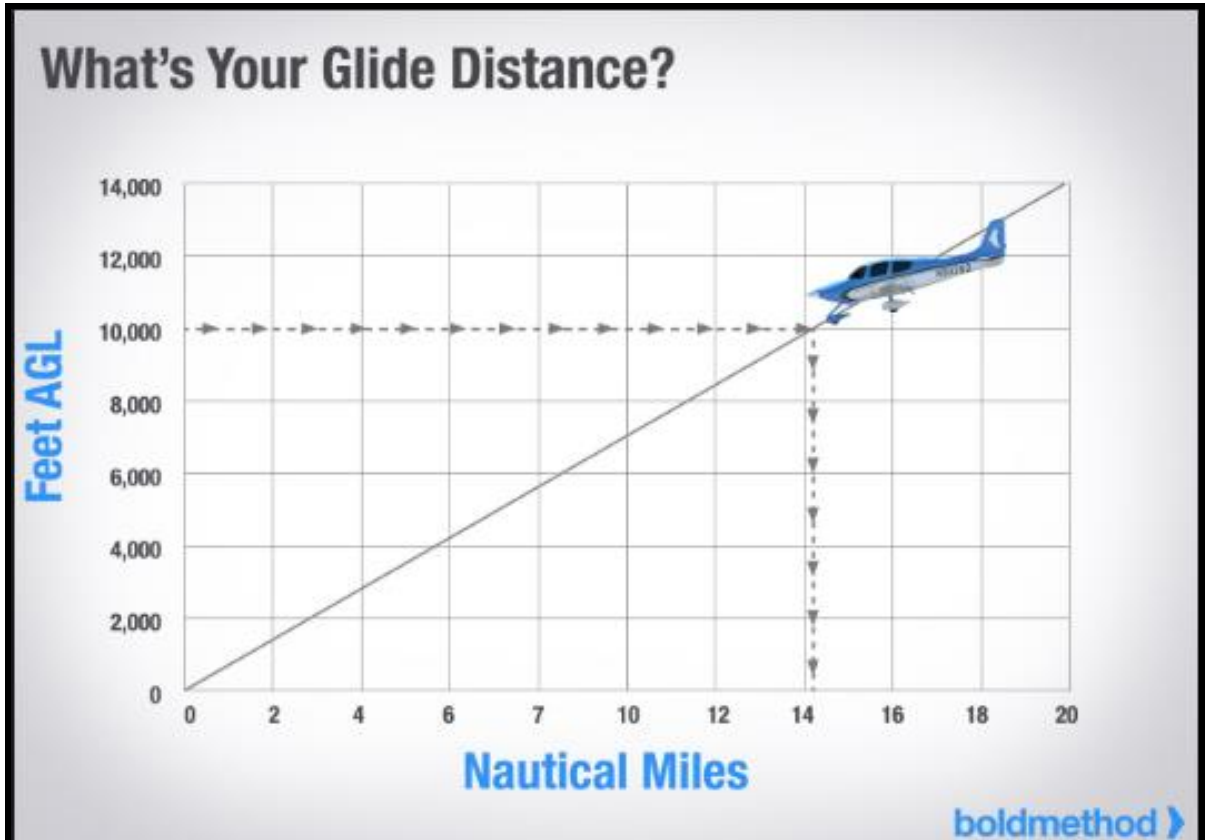
1.18.1 When you lose power and need to do a power-off landing you need to maintain the best glide speed as published in the pilot operating handbook (POH) in order to cover the most glide distance. You can glide 1,5 nm per 1000 ft, for example if you are at 4000 ft you can glide for 6 nm. See the graph below.

Figure 9 Graph showing glide distance

- 3.1.12 The aircraft did not have enough height to glide to the airport as indicated in the glide graph provided above. (Refer to Figure 9.)
- 3.1.13 The pilot knew the performance of the aircraft and he could have made a better judgement and taken a decision to land the aircraft in any of the open areas rather than trying to go to the airport. His knowledge of the aircraft was revealed on his website: <https://zandvleitrust.org.za>.

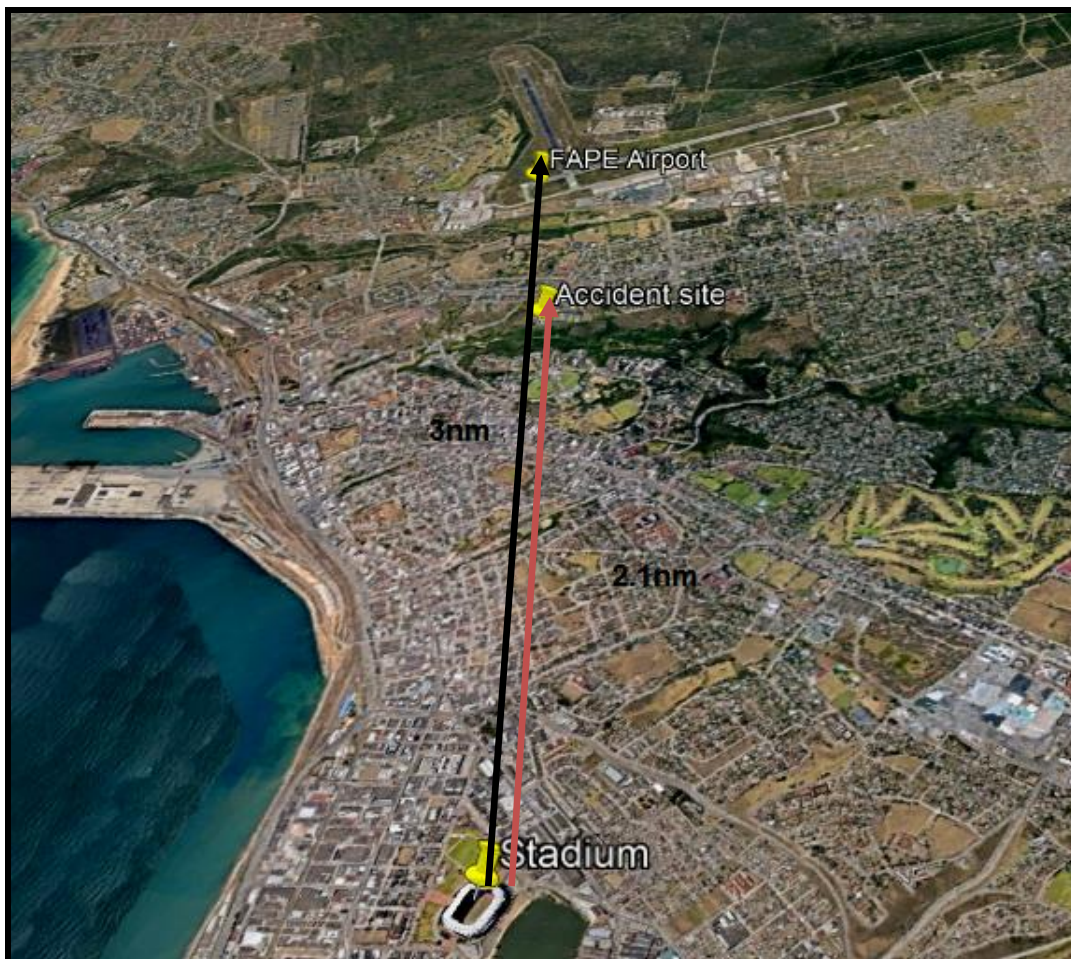
1.18.2 ZU-BNH reported engine failure at 1700 ft and lost 300 ft in height during the turn, so the glide started at 1400 ft. He could only glide for 2.1 nm, which is the distance from the stadium to the accident site indicated by the maroon arrow in Figure 10 below. The pilot reported engine failure overhead the stadium, which is 3 nm north-east of the airport. The pilot needed to be at 2000 ft to glide 3 nm. which is indicated by the black arrow. See the Google Earth image below.

Figure 10 Google Earth images of the stadium, accident site and FAPE
