AIRCRAFT ACCIDENT REPORT AND EXECUTIVE SUMMARY

Reference:	CA18/2/3/9723	
Aircraft Registration	N53757	Date of Accident	16 July 2018		Time of Accident	1216Z
Type of Aircraft	Super Decathlon 8KCAB BL30		Type of Operation	Private (Part 91)		
Pilot-in-command Licence Type	PPL		Age	51	Licence Valid	Yes
Pilot-in-command Flying Experience	Total Flying Hours		1442.25		Hours on Type	133.50
Last point of departure	Mwana Private Airstrip, Limpopo Province					
Next point of intended landing	Brits Airfield (FABS), North West Province					
Location of the accident site with reference to easily defined geographical points (GPS readings if possible)						
Roodekopies Dam with GPS coordinates S25°24'57.66" E027°34'59.36" and a field elevation of 3345ft						
Meteorological Information	Wind Direction: North; Wind Speed: 5-10kt; Air Temperature: 18; Visibility: Good					
Number of People On-board	1 + 0	No. of People Injured	0	No. of People Killed	0	
Synopsis	<p>Two aircrafts with registrations N53757 and ZS-AXX, both with sole occupants, took off from Mwana Game Lodge in Limpopo Province, heading to Brits Airfield (FABS) with the intention to uplift fuel for the intended tour around the North West

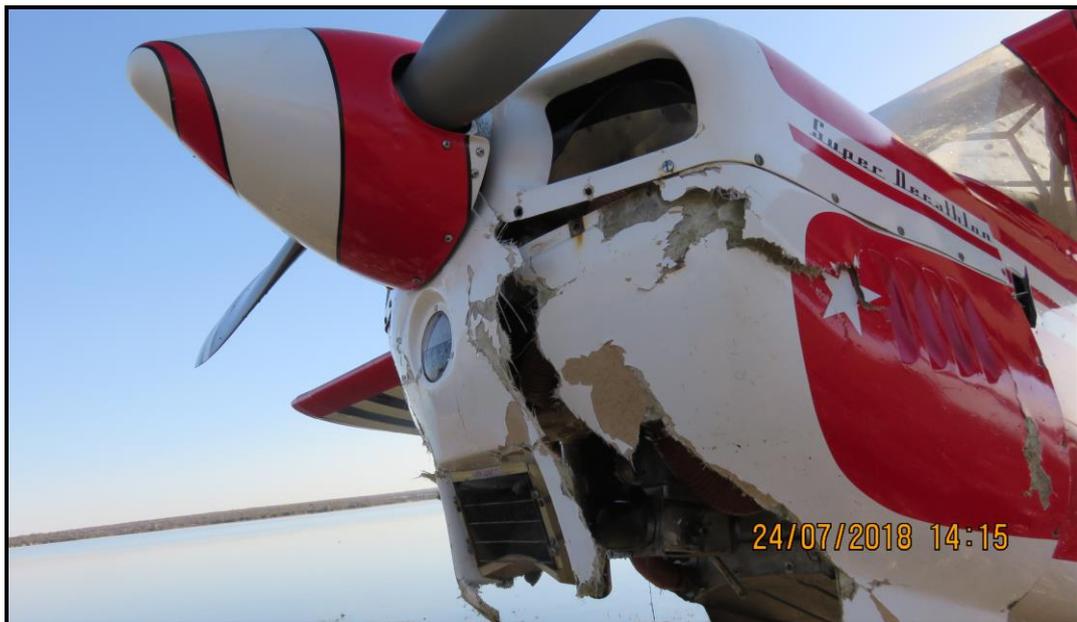
Figure 3: Damaged bottom engine cowlings

1.1.3 According to eyewitnesses who were busy with maintenance work on the northern bank of the dam, two aircrafts approached from the north side of the dam flying at a low height of approximately 100ft above the dam's water level. A red and white aircraft was flying lower than the other. As they were flying, the red and white aircraft began to fly very low towards the middle of the dam on the right-hand side section. Soon after, the eyewitnesses saw high waves from behind the aircraft whereafter, it suddenly raised the tail in an uncontrolled manner. They then spotted the pilot jumping into the water from the right-hand side of the aircraft and began swimming ashore towards the left-hand side of the dam. A local helicopter pilot, who earlier heard about the crisis, came to the accident site and found the pilot at the shore of the dam. He airlifted him to the local hospital for observation. The pilot was not injured during the accident sequence; the aircraft was recovered seven days after the accident. The aircraft sustained damage to the engine bottom cowlings.

1.3.1 The aircraft sustained visible damage to the engine cowling and was submerged in water for seven days.

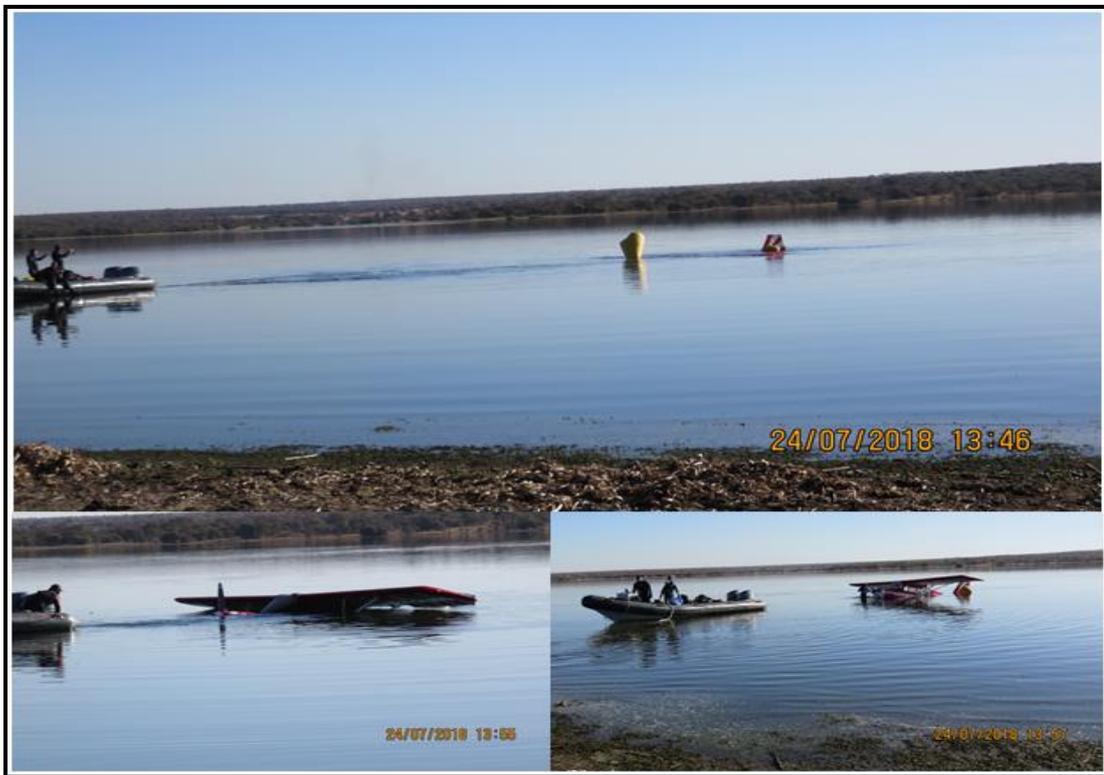
Figure 5: Recovery of the aircraft

1.12.2 On the day of aircraft recovery, it was found at approximately seven metres below the water surface at GPS coordinates S25°24'57.66" E 027°34'59.36". After ditching the aircraft, the pilot had disembarked the aircraft and swam approximately 730m in a 108 degrees direction from the aircraft to the shore. The aircraft was intact and only sustained water and crash damage to the bottom engine cowlings. The damage is consistent with damages caused by impact with water at fairly low speed, as a result of a low forward speed. There was evidence of fuel dripping from the fuel tank at the accident scene during recovery.

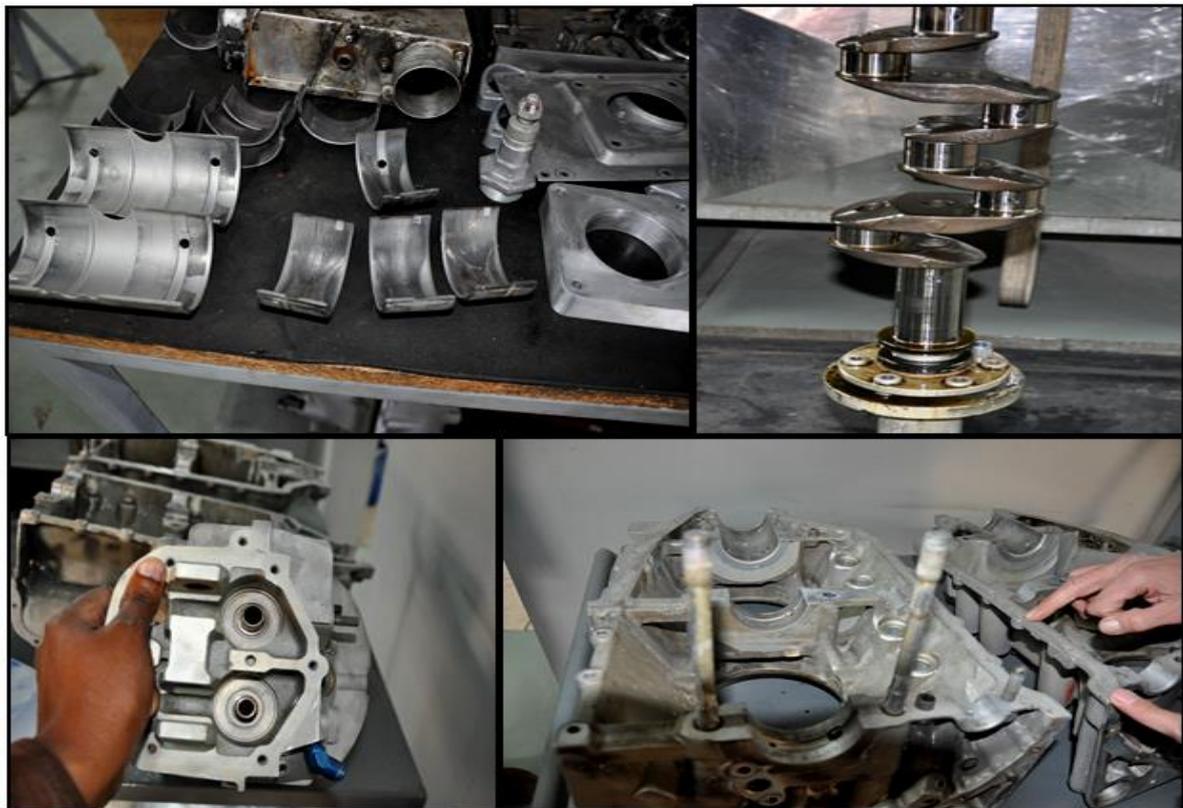
Figure 6: Engine parts as found following the teardown inspection

1.16.2 The investigation team visited the AMO and found the engine dismantled and cleaned. As observed, the engine parts which were reported to have defects that could have led to the reported engine power loss did not show evidence of damage or wear that could have contributed to the engine power loss. Moreover, when asked why did the AMO not involve the investigating team at the time of the engine teardown, the AMO responded that they did not know what procedure to follow.

- 2.8 The engine was recovered for further investigation. No evidence of internal or external damage to the engine was found that could explain the reasons for power loss and engine stopping. The aircraft had enough fuel for the intended flight.
