Final report RL 2019:07e

Accident in Othem, Gotland, on 11 August 2018 involving aircraft D-EHAC of the model Bolkow BO 208 C Junior , operated by a private individual.

File no. L-98/18

6 May 2019

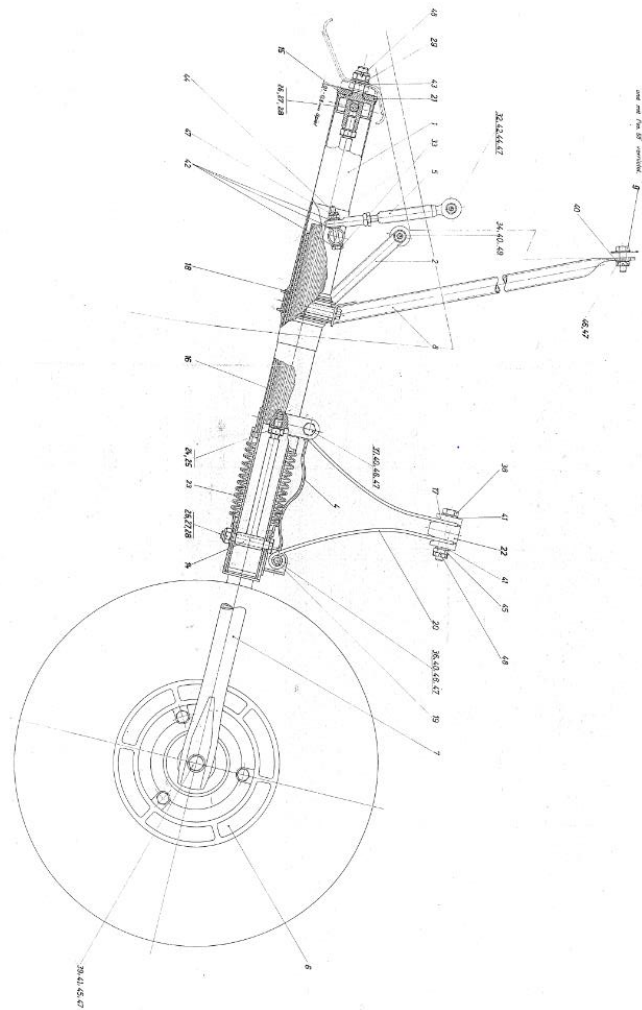
Figure 3. Landing gear leg with internal gas spring. Illustration: Airbus Defence and Space GmbH.

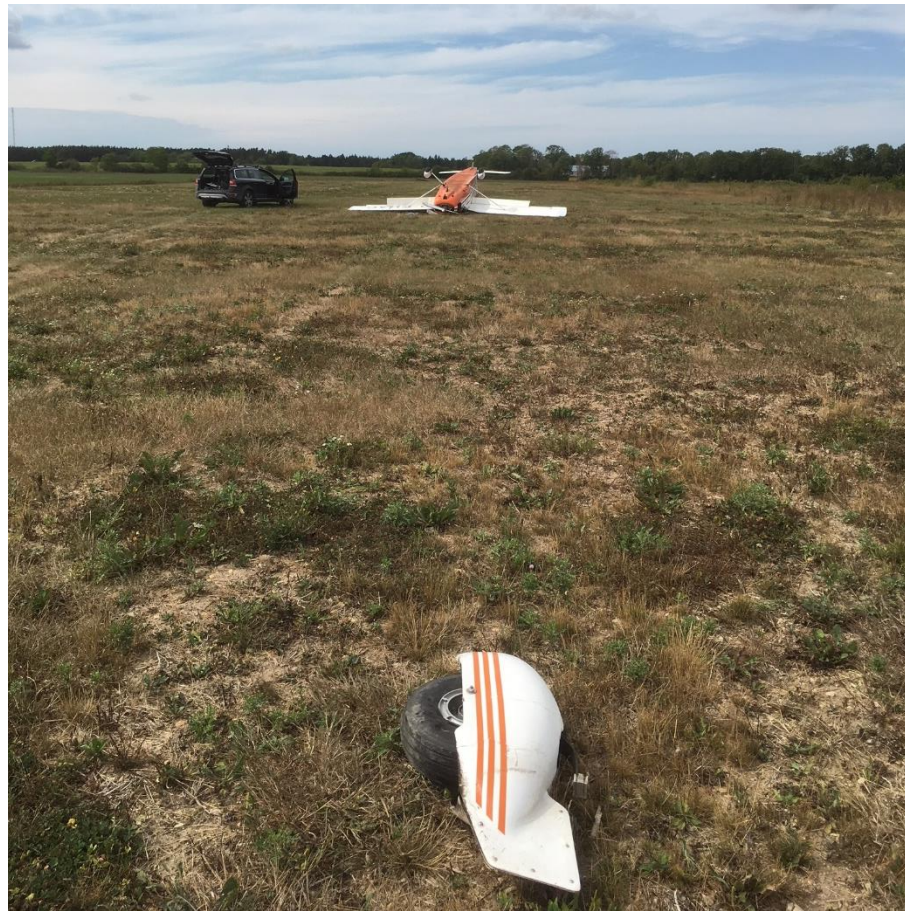
Figure 5. The nosewheel and the aircraft wreckage. The picture is taken in an easterly direction. Photo: Aeroplane owner.

The aircraft ended up on its back. The nosewheel can be seen at the bottom of the image in figure 5.

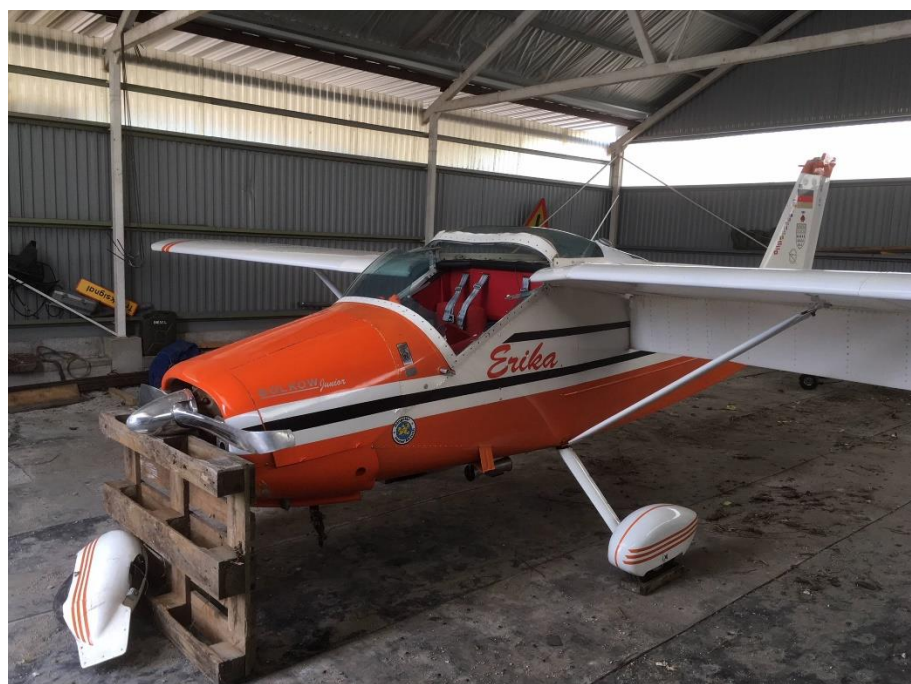
Figure 6. The wreckage after being towed to the hangar.

The aircraft had visible damage to the following components:

- Propeller and spinner
- Engine cowling
- Nose landing gear
- Nosewheel fairing
- Windshield and roll bar
- The rear attachment, tip and flap of the left wing
- The top part of the elevator and the fin
- The tailskid and its attachment

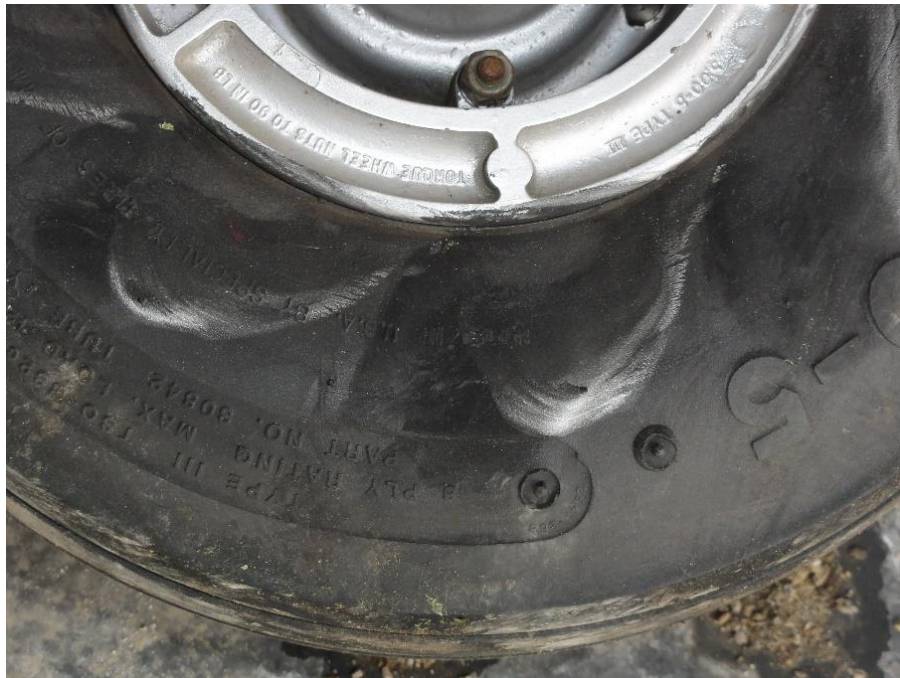
Figure 7. Traces of paint from the wheel fairing on the tyre.

There were also traces of paint on both sides of the nosewheel tyre, which shows that the tyre has come into contact with the wheel fairing (see figure 7).

The investigation of the damages to the nose landing gear (see sections 1.16.2 and 1.16.3) has shown that it was completely compressed during the landing. SHK has calculated that the nose landing gear was subjected to a vertical force equivalent to 3.4 G, which means that it was a very hard landing. In addition, the paint residue on the tyres indicates that there was significant force applied to the nosewheel during landing.

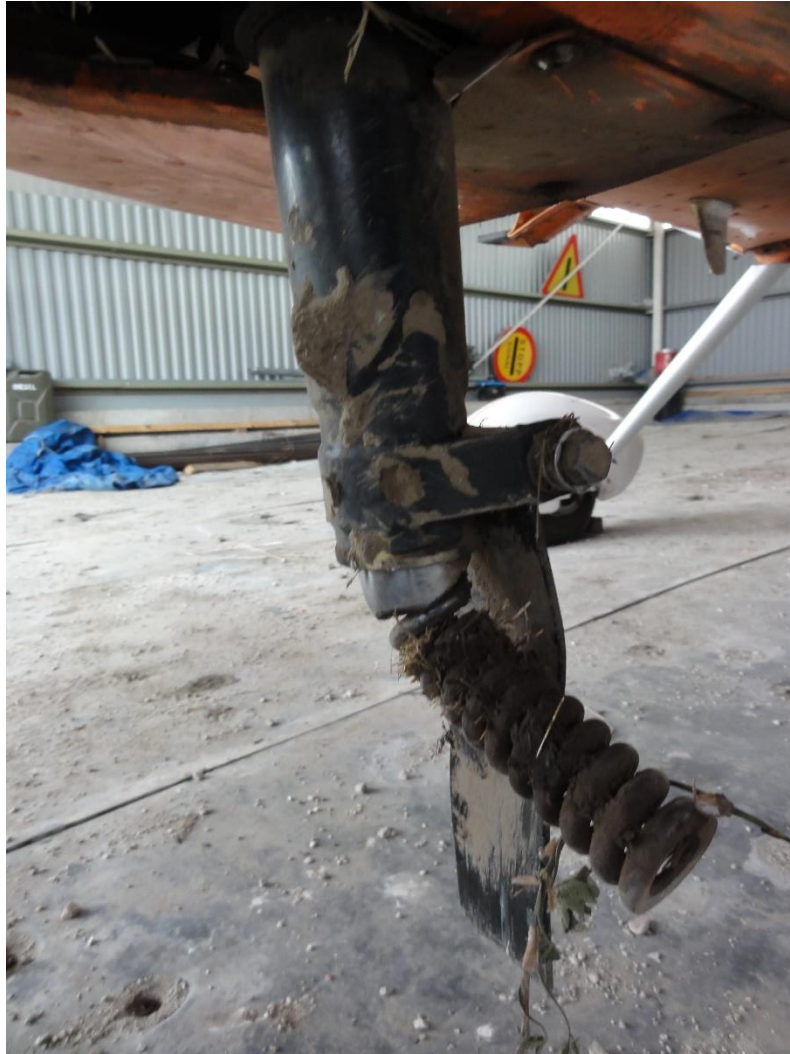
Figure 8. The top part of the nose landing gear.

The bottom part of the nose landing gear had separated from the aircraft, with fracture surfaces on both the piston rod and the leaf spring (see figure 8).

The leaf spring had several fatigue cracks and several surface defects that have given rise to fatigue cracks. The damper piston has ruptured due to overloading, and the fracture surface shows that the nosewheel was oriented in the direction of travel at the time of the rupture.

The lower part of the piston rod had broken off. The remaining part was bent and stuck in the cylinder in the fully compressed position.

The upper leaf spring of the torque link had ruptured close to the rear attachment and was deformed.

SHK believes that the piston rod was fractured first due to overload, and that the leaf spring unit then broke off when the lower part of the nose landing gear bent backwards. This is confirmed by the marks on the back of the landing gear cylinder and by the deformation of the upper leaf spring.

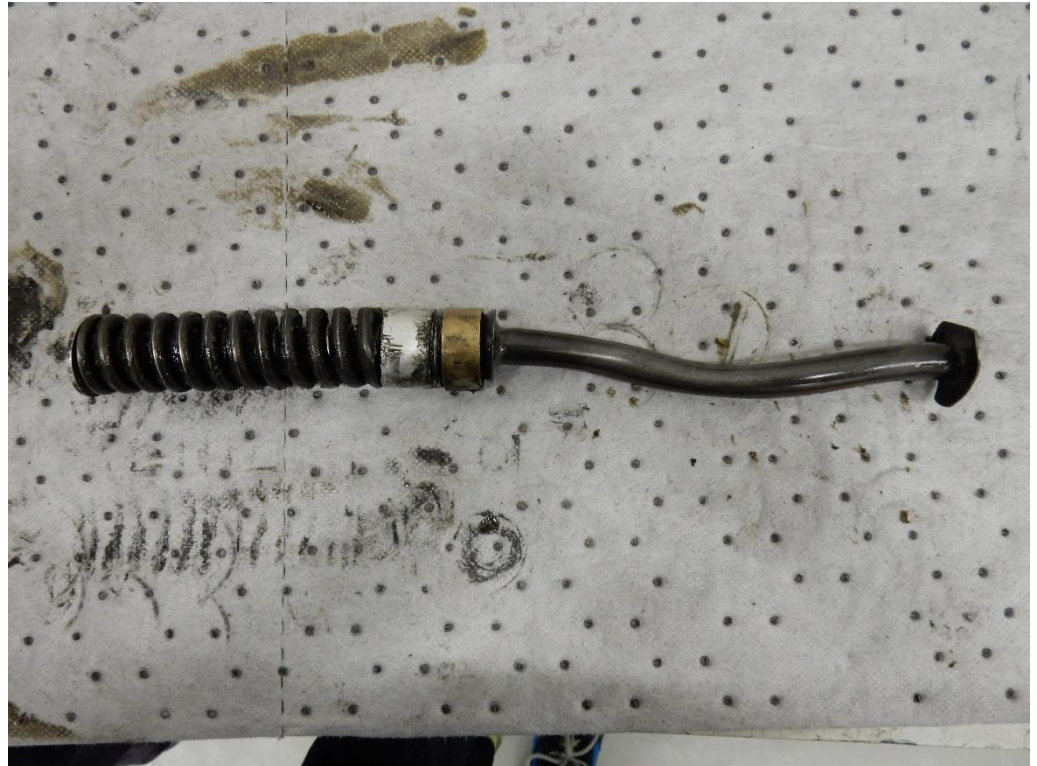
Figure 9. Part of the spring assembly and the deformed metal rod.

The part was similar to the latter model, which normally has an internal gas spring. However, after disassembly, it was discovered that coil springs were installed while the gas spring was missing. There was also a metal rod and a bushing.

The metal bar in the cylinder was deformed (see figure 9). SHK estimates that the bar had been subjected to a buckling load equivalent to a G-force of 3.4 G.

The nose landing gear design was not in accordance with the drawings. The gas spring normally installed in the landing gear cylinder was replaced with a coil spring assembly along with a rod and bushings. It is possible that the internal parts of the landing gear originate from the earlier model.

The incorrect composition of the nose landing gear has led to a complete lack of damping, which has contributed to the aircraft bouncing in conjunction with the landing.
