Final report RL 2019:08e

Serious incident at Linköping/SAAB Airport on 14 August 2018 involving aircraft SE-CFP of the model Douglas DC-3C, operated by Flygande Veteraner.

File no. L-99/18

17 May 2019

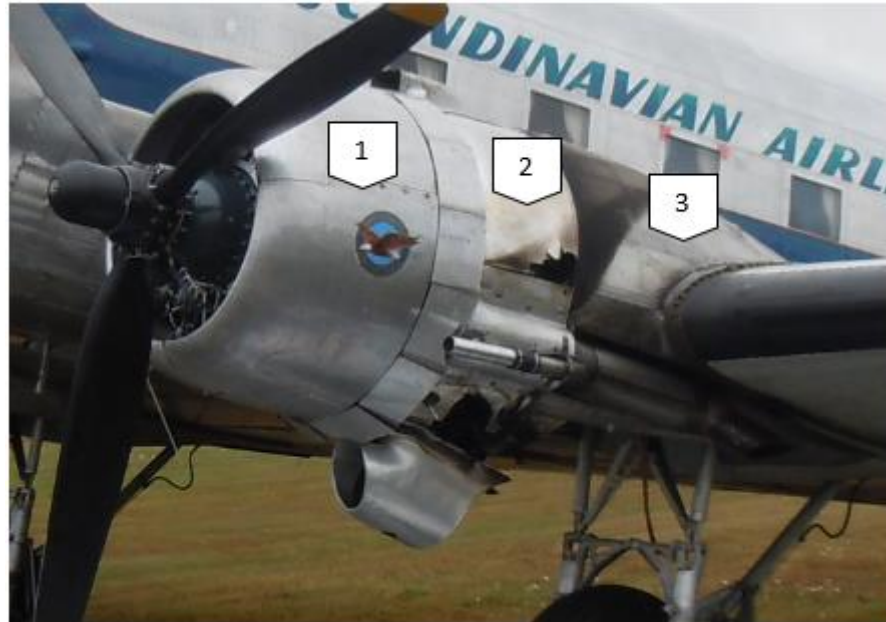
Figure 2. The engine nacelle with its three main sections: zone 1 – engine compartment, zone 2 – accessory compartment and zone 3 – space for oil tank and landing gear. The image also shows soot from the flames and melting damage to the cowling of the accessory compartment.

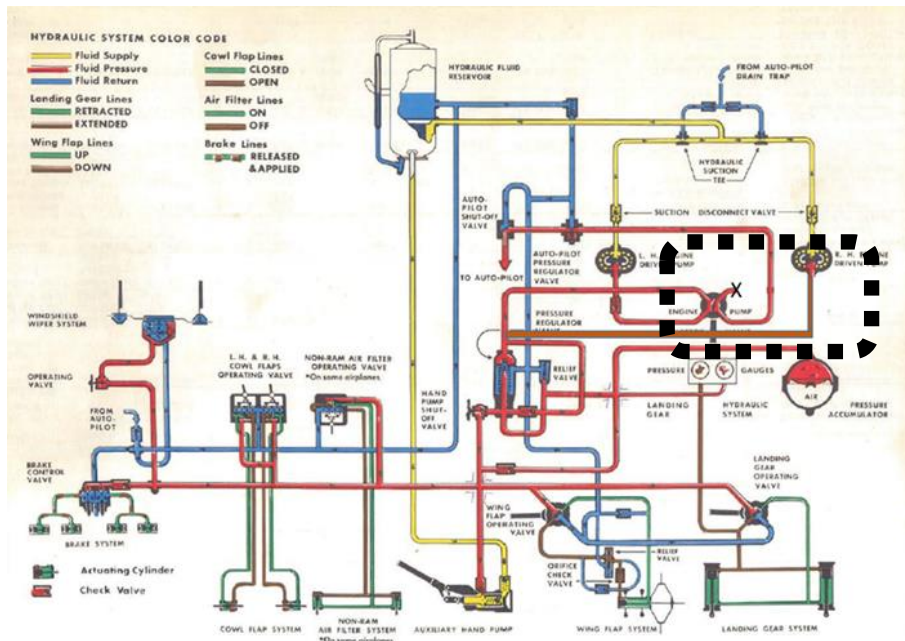
Figure 5. The hydraulic system on the aircraft in question. The shaded rectangle shows the location of the modification. Image: Douglas Maintenance manual modified by SHK. Copyright © Boeing. Reprinted with permission of The Boeing Company.

The modified design (see figure 5) means that the right pump is always connected to the main system. The left pump can be used either to supply the hydraulic pressure for the autopilot or to reinforce the main system. Since the pressure lines of the two pumps are connected, a leakage at either side will empty the entire system.

In case of leakage from the left engine, a shutdown of the pressure line would have been possible if the control had been switched to the position for the left pump to feed the autopilot. However, this is not written in any checklist. The selector valve was also locked in the position for the left pump to reinforce the main system.

With the existing system, the shut-off valve cannot prevent oil leakage in the event of the hydraulic lines in zone 2 being burned off or starting to leak for another reason.

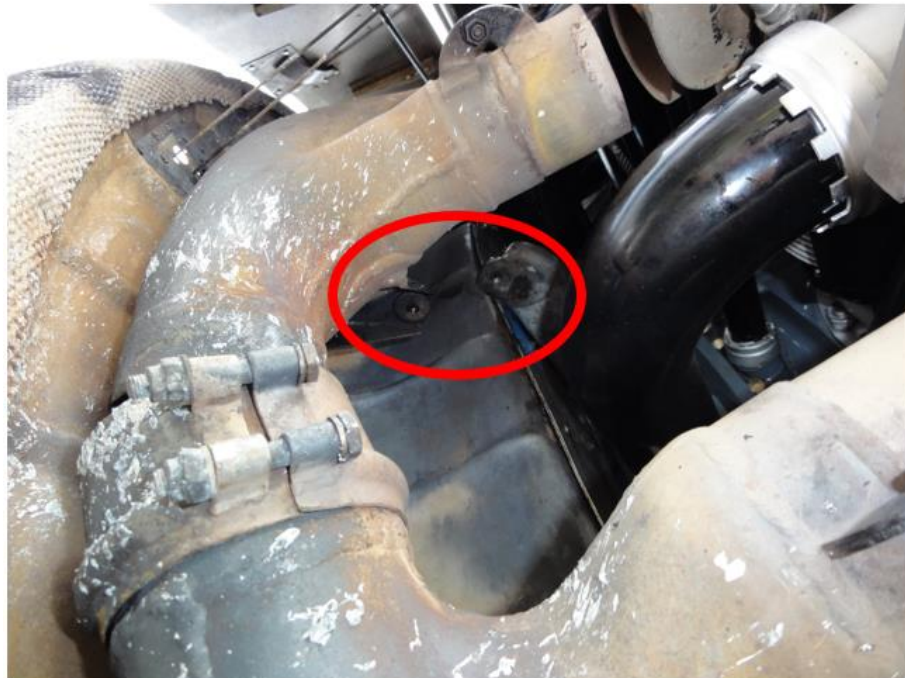
In addition to the fire damage, it was noted that there were screw joints missing on three of the exhaust collector attachments, which contributed to it coming loose from several connections. The screw and bolt were missing completely in these locations (see figure 6). In the other fittings, the screw joints were correctly installed.

Figure 6. One of the three fittings where the screw joints were missing between the exhaust collector and the engine.

The investigation has shown that three screws that are to fixate the exhaust collector were missing. This led to the exhaust collector coming loose from several of the cylinder exhaust pipes.

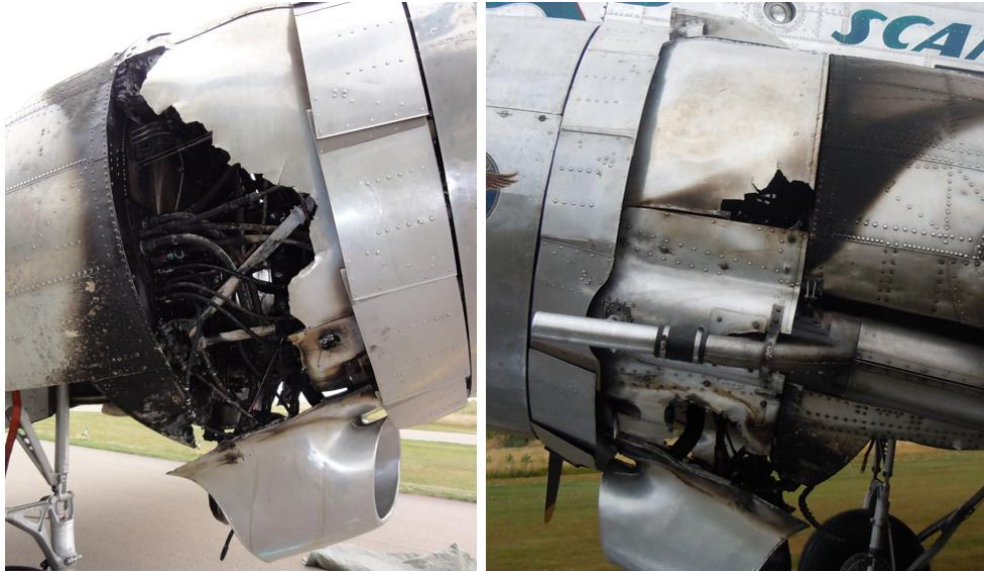
The investigation found fire damage to the cowlings around zone 2 and partial damage to the cowlings around zone 3. The cowling around zone 2 had melted in the area closest to the parts of the exhaust collector that had come loose. There was only soot on the firewall between zones 1 and 2.

Figure 7. Fire damage to the cowling around zone 2 of the left engine. In the cowling behind zone 2, there were some small holes, where the aluminium had melted.

A petrol engine of the type in question has a large fuel surplus in the combustion, which means that a lot of unburned fuel comes out of the exhaust pipe and is ignited upon contact with the air. The exhausts had a temperature of 800 to 1,200 degrees, which is enough to melt the metal of the cowl to zone 2.

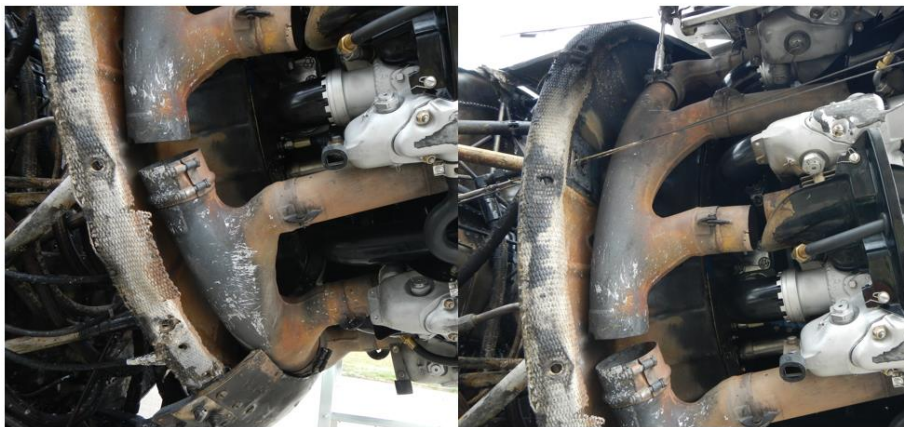
When the cowling was removed, fire damage could be seen on all non-metal parts of zone 2. In zone 1, the exhaust collector had come loose from three of the 14 cylinders. Since the exhaust collector had come loose, the exhausts could flow freely from the cylinders towards the firewall and the cowling behind the engine.

Figure 8. The exhaust collector behind the engine cylinders in zone 1. The light spots on the exhaust collector are assessed to be melted aluminium from the cowling.

There was no fire damage in zone 1, with the exception of a number of stains on the exhaust collector, which are deemed to be melted aluminium. The fire has also affected zone 3, where the fire damage was limited to the paint and a few cables on the firewall.

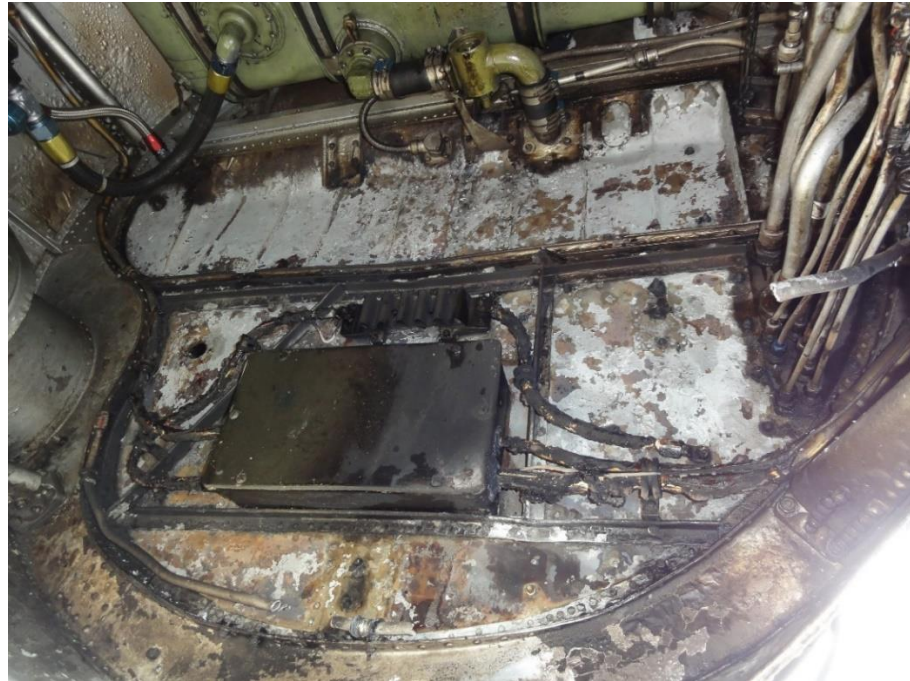
Figure 9. Fire damage in zone 3. Cables on the firewall to the accessory compartment have melted and burned.

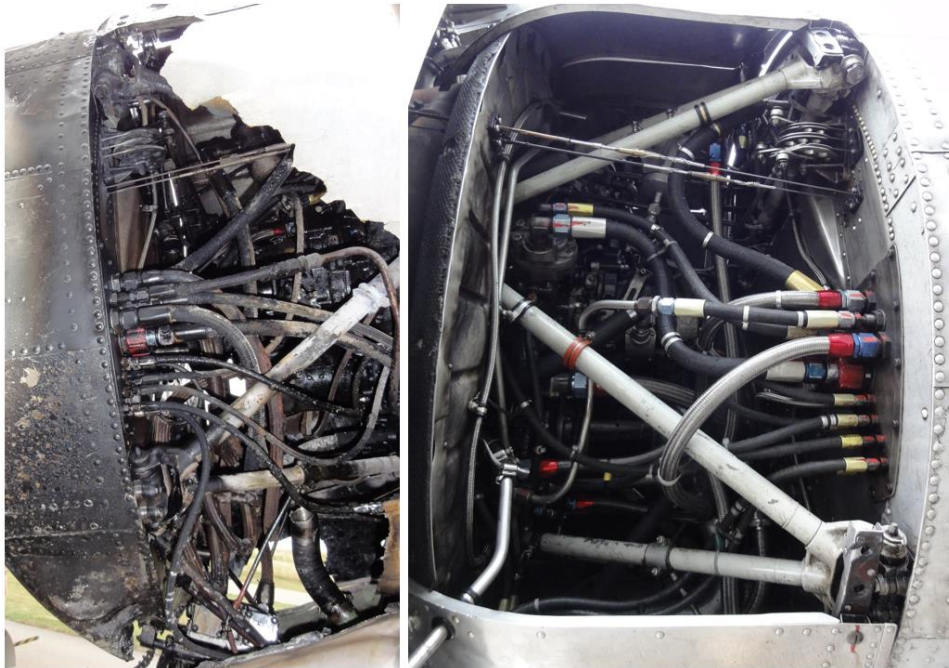
The suction side of the hydraulic system has been turned off after the shut-off valve was closed, but because the lines were burned off, hydraulic oil has leaked from the cowl flap lines and the plugged pressure line of the engine pump.

Figure 10. Some of the damage to zone 2, compared to the right engine.

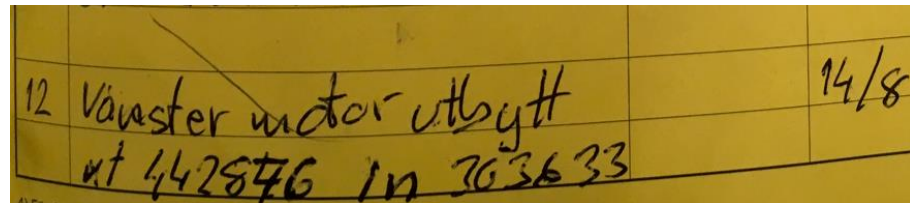
The work was carried out without a work order, i.e. "job card", or other written instruction. After the engine change, no follow-up was done by comparing the removed components to the new components that had been taken from storage and fitted on the engine. The operator's technical staff have not been able afterwards to account for who did what during the work process.

Figure 11. Note of the engine change in the technical and journey log (Left engine replaced, out 442876, in 303633).

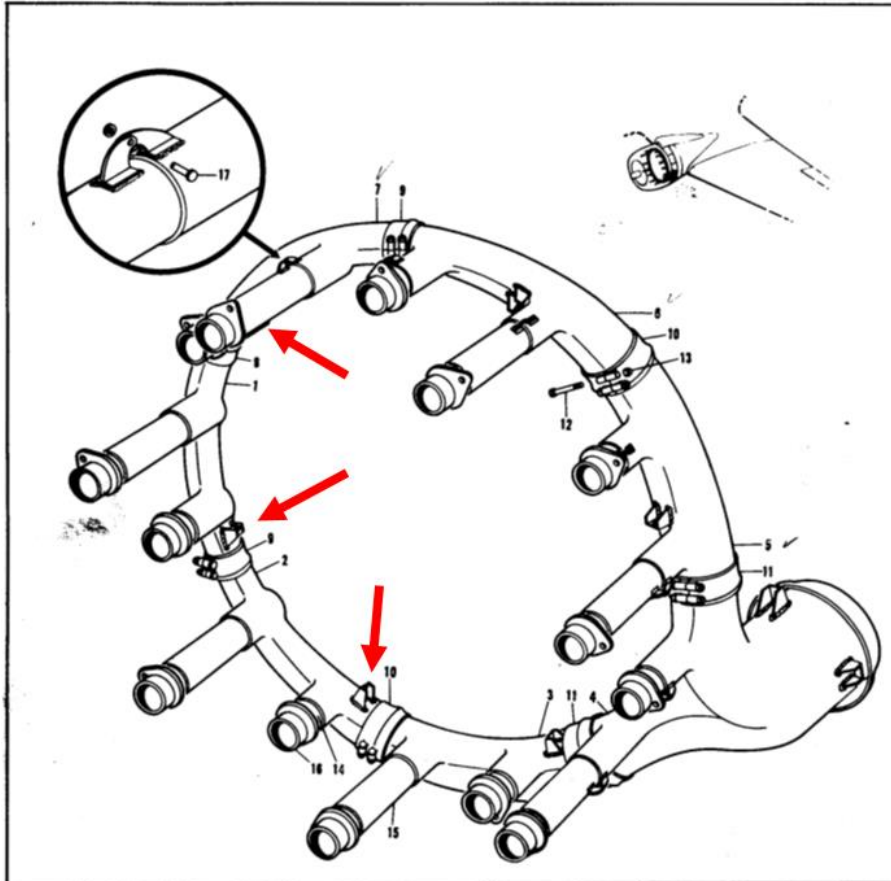
The places where the screws and bolts were missing were difficult to see and reach.

It has not been possible to establish whether the missing screws were never fitted at all, or if they were fitted by hand without being fastened by tool afterwards.

Figure 12. Image from “Illustrated parts catalogue” for DC 3. The arrows indicate the attachments for the exhaust collector that were lacking screw joints. Image: Copyright © Boeing. Reprinted with permission of The Boeing Company.
