## **Safety Investigation Information Report**

**Serious Incident File No. 81-18**

**- MIDAIR COLLISION -**

<b>Date</b>	<b>14.8.2018</b>
<b>Between</b>	
<b>Helicopter</b>	<b>R44 (Robinson)</b>
<b>Registration</b>	<b>4X-BCR</b>
<b>To</b>	
<b>Drone</b>	<b>Phantom 4</b>
<b>Location</b>	<b>Petah Tiqwa</b>

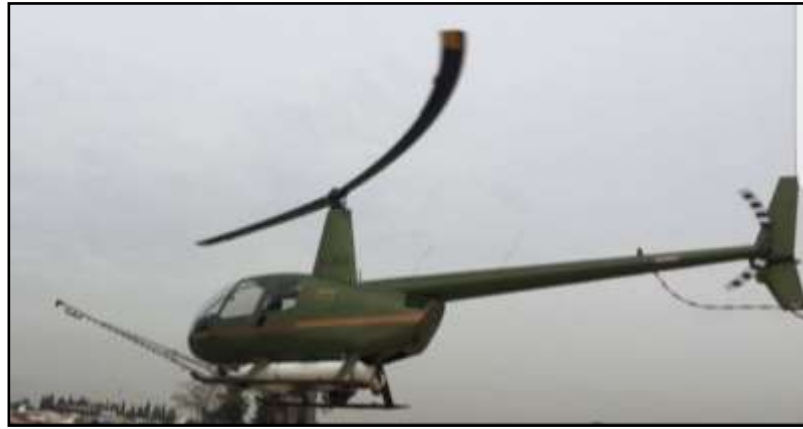
**The helicopter involved**

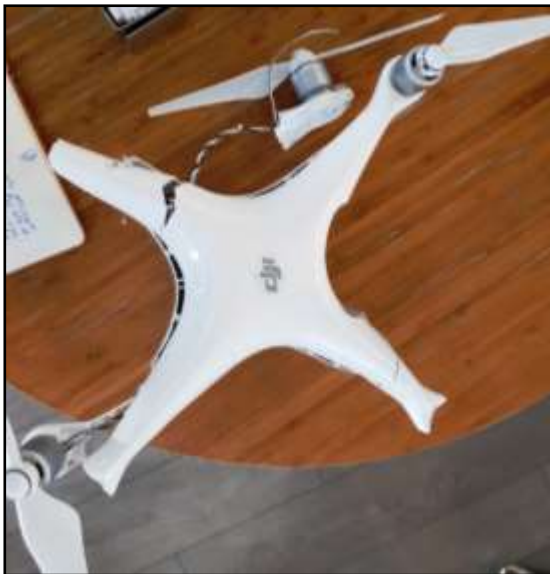
After exiting the helicopter, the pilot assessed visually the helicopter and found the UAS jammed and broken into the lattice spray system.

**The Drone after collision**

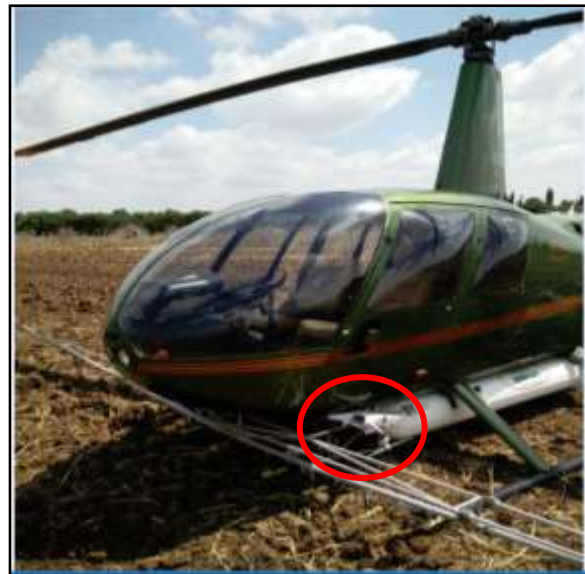
At the same time, the helicopter pilot noticed "a white body at approximately 10 meters on his left side", followed by a "bang" feeling that the pilot heard from his lower left side of the helicopter.

**The drone impact location**
