AIRCRAFT ACCIDENT REPORT AND EXECUTIVE SUMMARY

Reference:	CA18/2/3/9727	
Aircraft registration	ZS-HBP	Date of accident	15 August 2018		Time of accident	0742Z
Type of aircraft	Robinson R22 Beta II		Type of operation		Private (Part 91)	
Pilot-in-command licence type	Commercial	Age	27		Licence valid	Yes
Pilot-in-command flying experience	Total flying hours	3 215.5		Hours on type	703.6	
Last point of departure	Ithala Game Reserve, Eastern Cape Province					
Next point of intended landing	Ithala Game Reserve, Eastern Cape Province					
Location of the accident site with reference to easily defined geographical points (GPS readings if possible)						
Ithala Game Reserve (GPS position: 31°33'11.10" South 026°29'42.90" East) elevation 4 413 feet AMSL						
Meteorological information	Surface wind, Calm; Temperature, 13.6°C; Dew point, 6°C; CAVOK					
Number of people on-board	1 + 1	No. of people injured	1	No. of people killed	1	
Synopsis						
<p>On Tuesday, 14 August 2018, a pilot flew from O.R. Tambo Aerodrome (FAOR) to Port Elizabeth Aerodrome (FAPE) to assist a game capture team to capture 75 antelope (Lechwes) on a private game reserve near Sterkstroom in the Eastern Cape province. Th

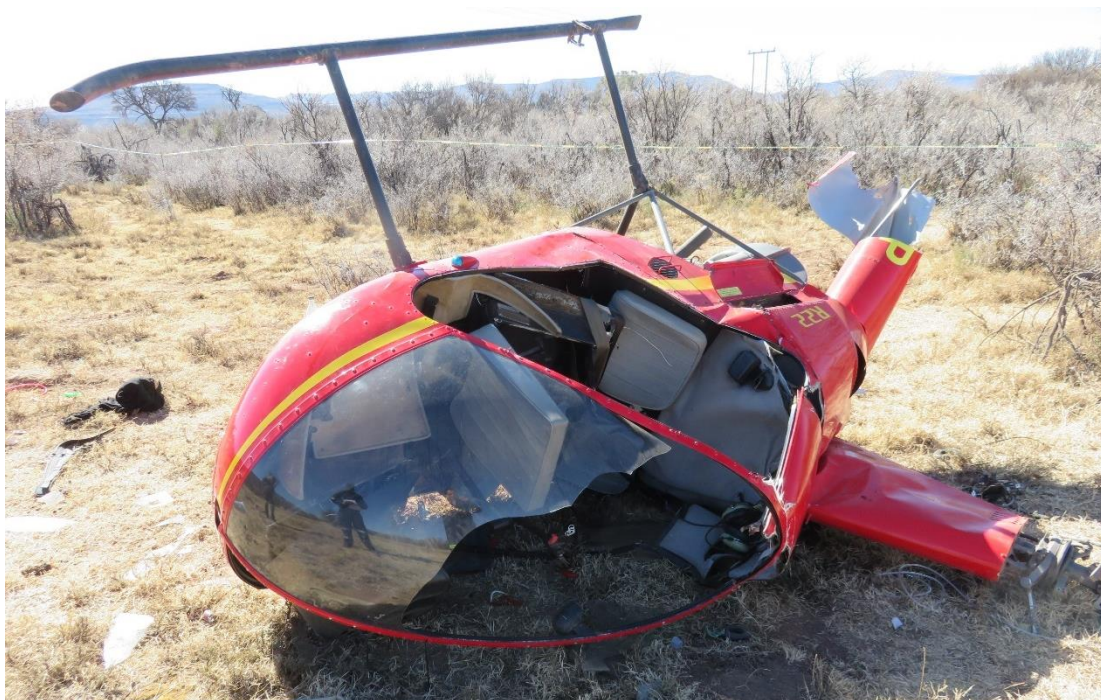
1.3.1 The helicopter was extensively damaged during the accident sequence.

Figure 1: The helicopter as it came to rest.

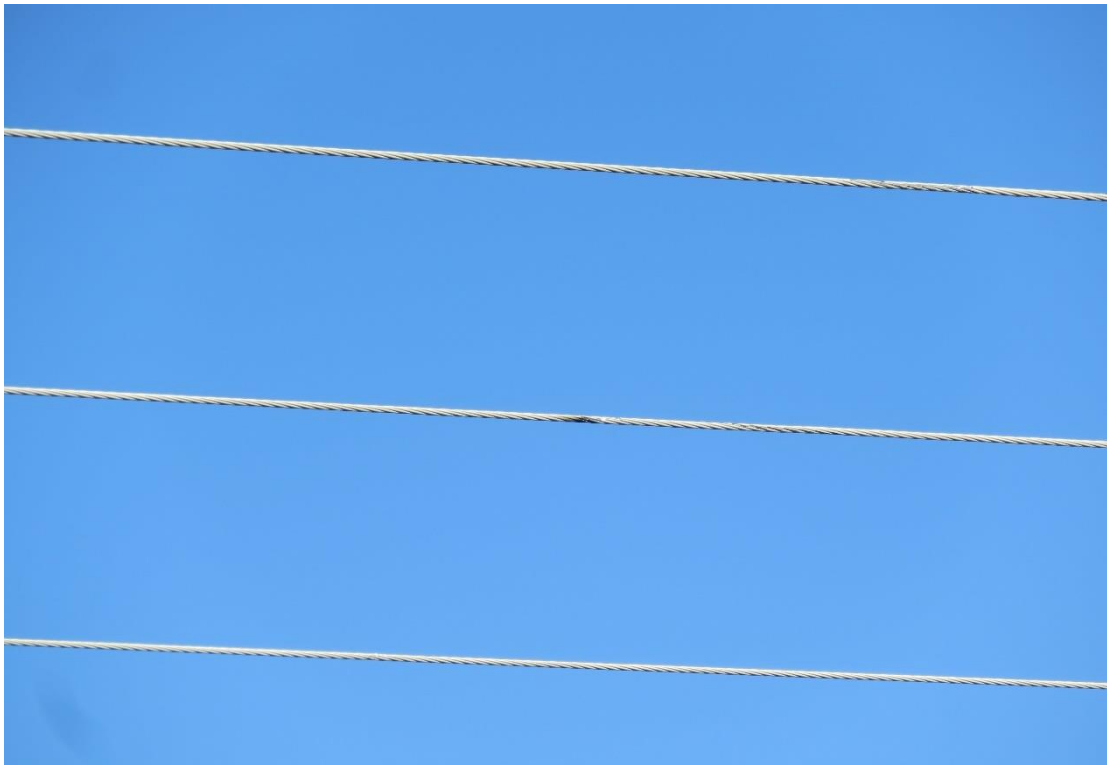
1.4.1 One of the three high-tension power line cables displayed evidence of arcing, but the cable did not appear to have been damaged, nor was there any power failure in the area as a result of contact with the wire.

Figure 2: The high-tension wires, with the centre wire displaying evidence of arcing.

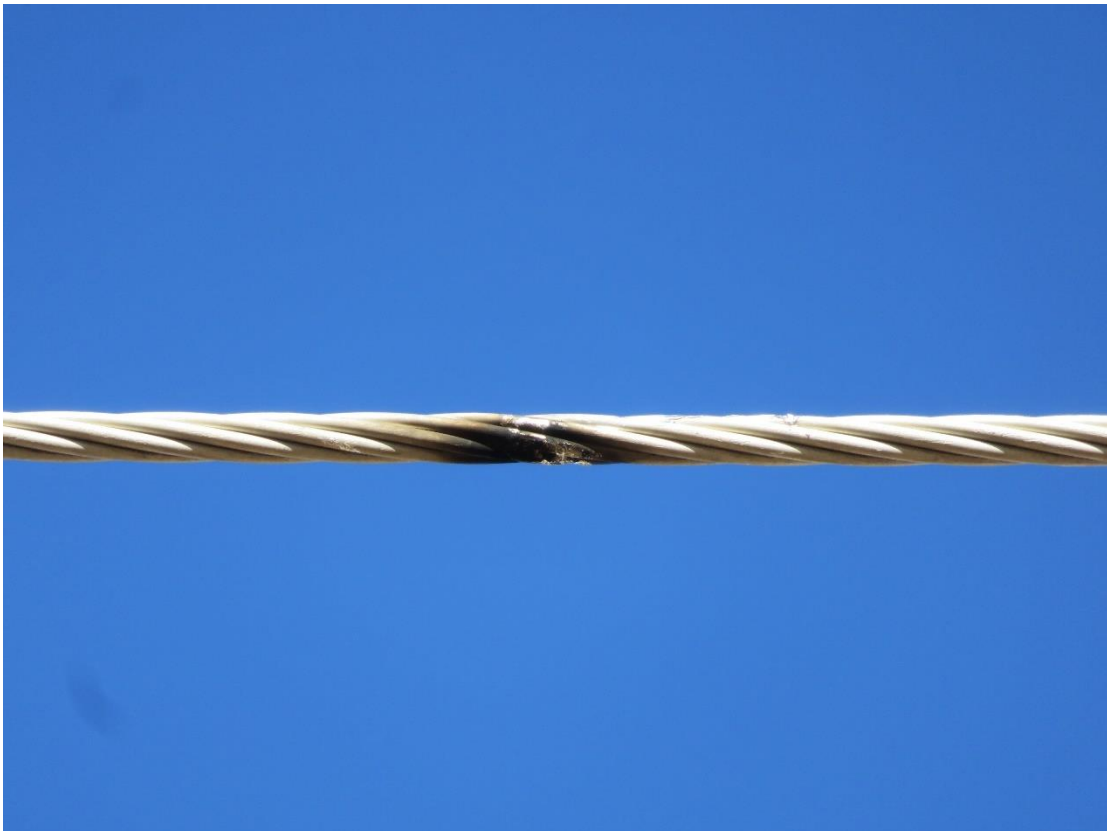
Figure 3: Closer view of the centre wire arcing.

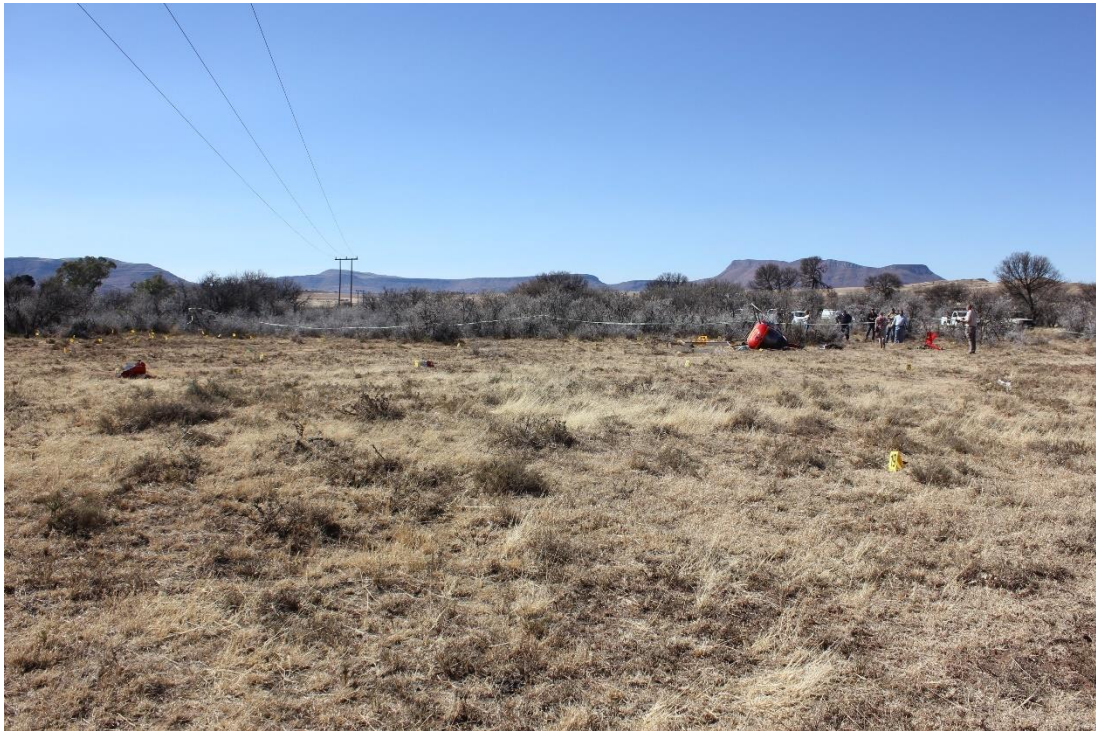
1.12.2 The main wreckage of the helicopter was found lying on its left side 21m from a high-tension power line on a heading of 255°M. The wreckage displayed extensive

damage with the tail boom being severed by the main rotor blades at more than one location. The aft tail boom structure was located approximately 5m from the main wreckage. The vertical stabiliser and tail rotor drive assembly, which consist of the tail rotor gearbox, hub and blades were still secured to the aft tail boom structure and did not display any abnormalities that would have precluded normal operation. The cockpit/cabin area remained intact although slightly distorted during the impact sequence. The passenger was, however, secured by an additional safety harness and was found trapped underneath the helicopter, still secured to his harness.

Figure 5: A general view of the accident site, including the high-tension wires.

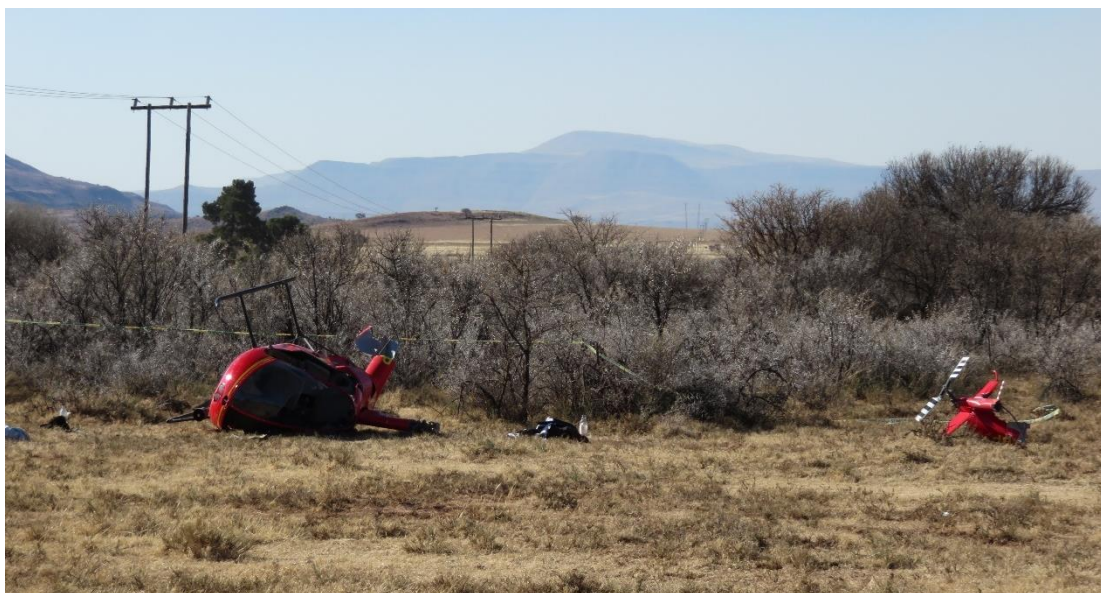
Figure 6: A closer view of the main wreckage and the aft tail rotor assembly.

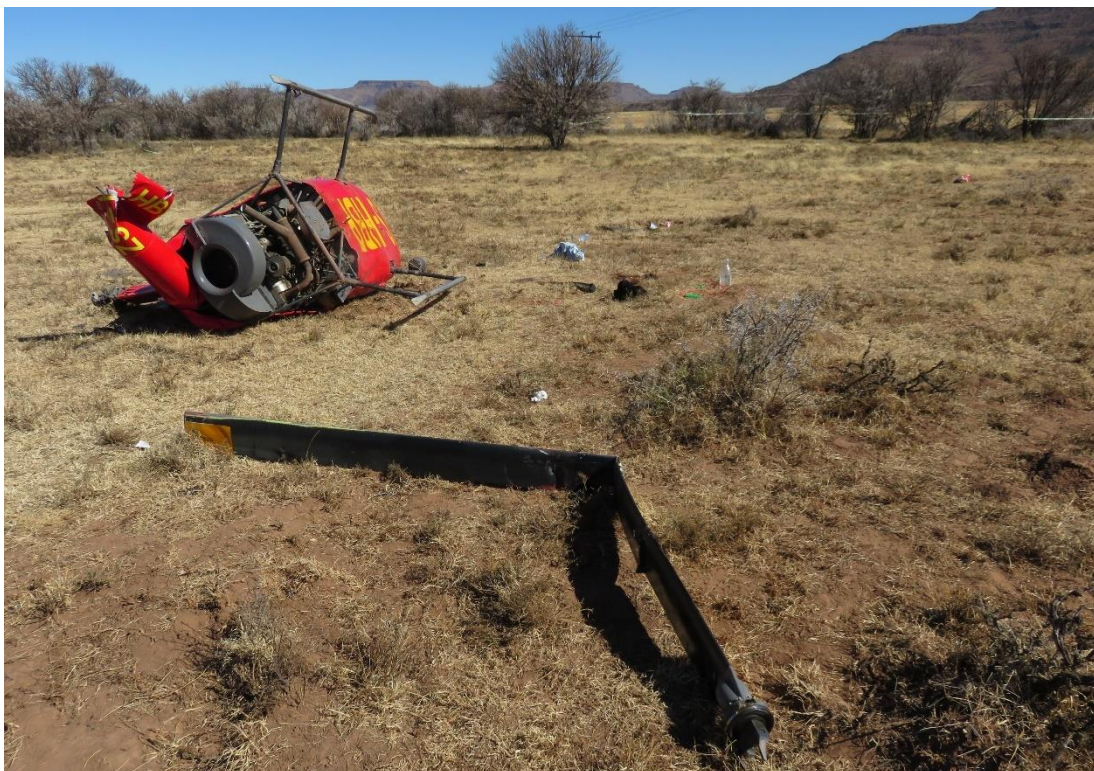
- 1.12.3 Both main rotor blades were found fractured at the main rotor hub assembly during the impact sequence. The blade with serial number 2551 was located 41m from the main wreckage and, although damaged, it remained intact as seen in Figure 8. The blade with serial number 2502 was found in proximity to the main wreckage as seen in Figure 7. The blade had a perforated hole through it, which penetrated the blade from the bottom (black painted surface) and exited at the top (yellow and white painted surface) at a distance that was measured to be 84cm from the blade cuff. The damage observed to the blade raised several questions and the section of the blade was subjected to a forensic examination as discussed in this report. Both main rotor blades presented evidence that it severed the tail boom (red paint markings), which include the tail rotor drive shaft and the tail rotor control rod. The red paint markings at various distances on the two main rotor blades indicated that the tail boom was struck more than once by the main rotor blades; this was consistent with the smaller segments of the tail boom structure that was located at the scene.

Figure 7: The main wreckage and one of the main rotor blades, with serial No. 2502.

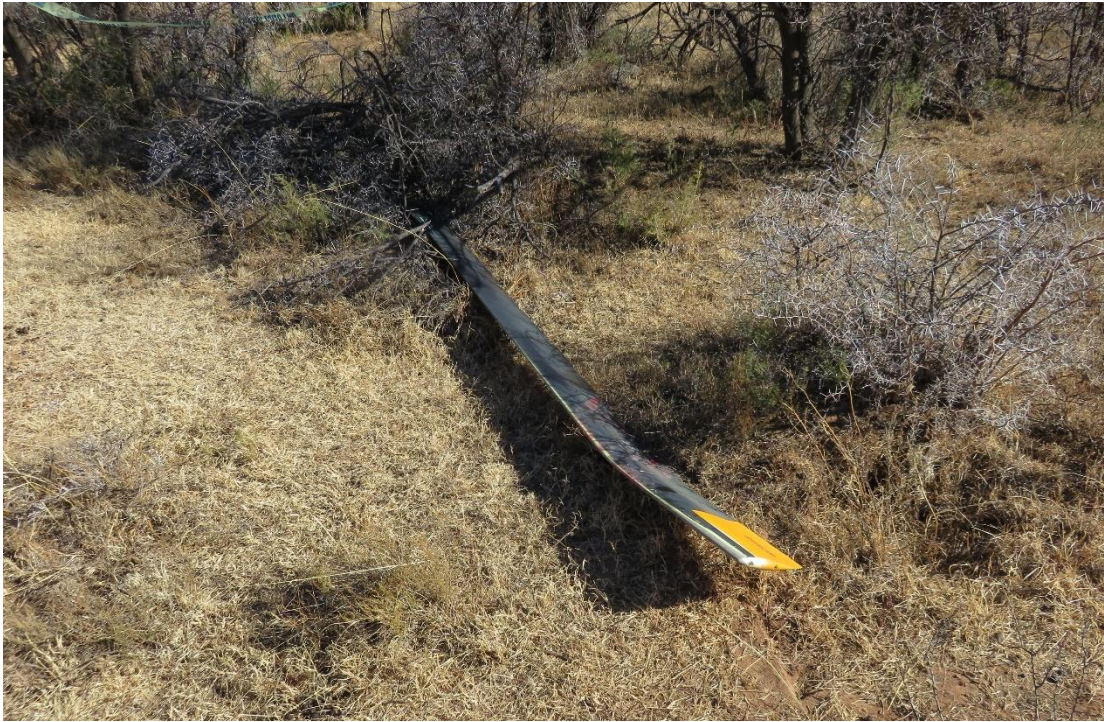
Figure 8: The other main rotor blade, with serial No. 2551.

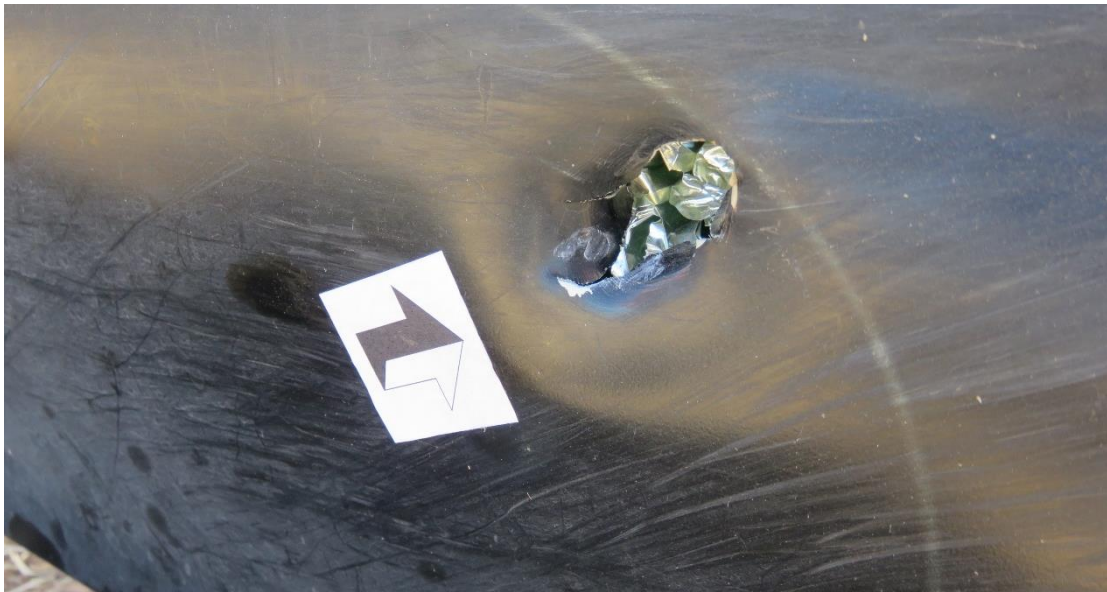
Figure 9: The perforated hole on the bottom surface of the main rotor blade, with serial No. 2502.

The sample comparison tests concluded that the perforated hole in the blade displayed the presence of the same material elements that were present in the SAPS induced bullet hole. With these results, the conclusion can be made that it was highly probable that the perforated hole was caused by a projectile/bullet that was most likely fired from a rifle/gun by a person on the ground.

3.1.19 Both main rotor blades fractured at the main rotor hub assembly. One of the main rotor blades (# 2502) had a perforated hole through the blade, which originated from an external source. The perforated hole met the material specifications of a bullet/projectile.

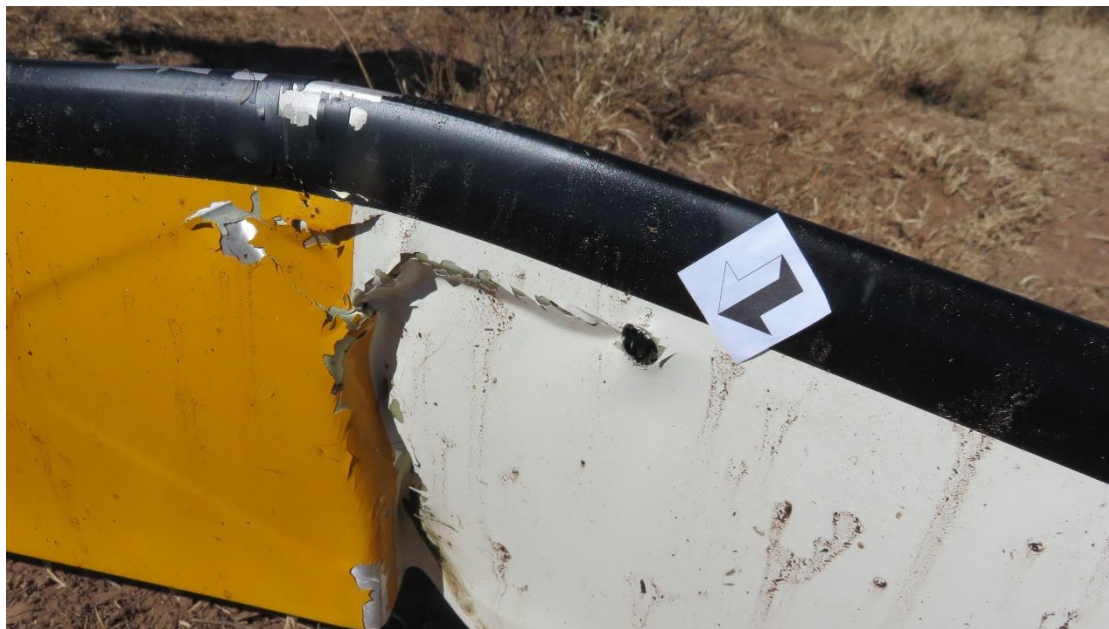
Figure 10: The perforated hole (exit point) on the top surface of the main rotor blade, with serial No. 2502.

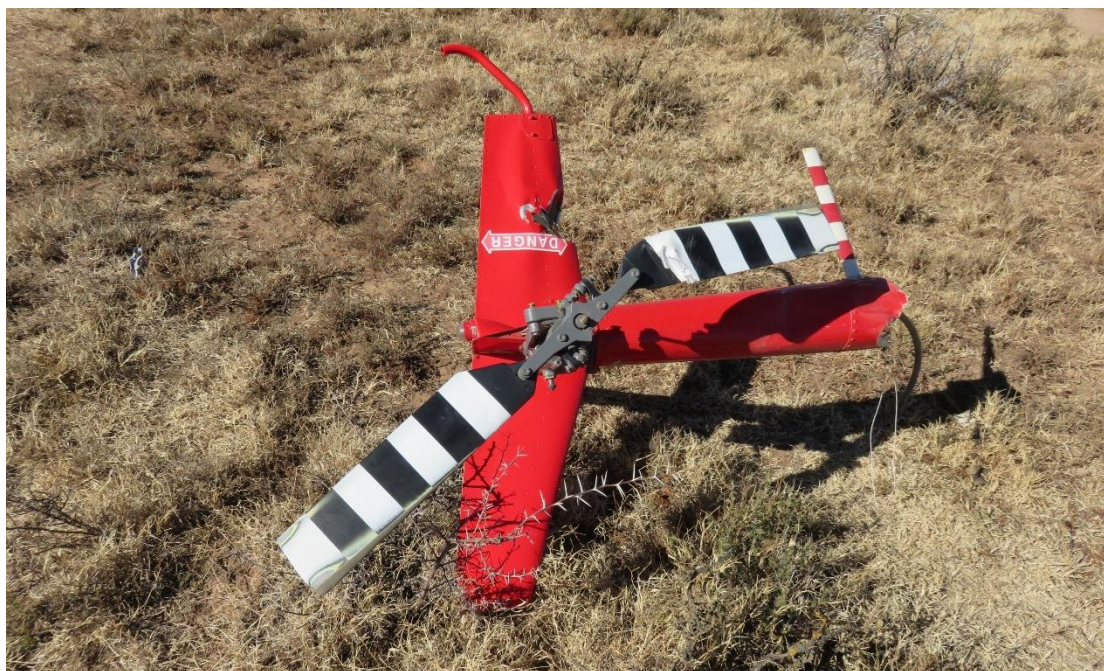
1.12.5 The aft tail rotor assembly with the tail rotor gearbox, hub and tail rotor blades still secured to the tail boom structure were located approximately 8m from the main wreckage as seen in Figure 6. No evidence of overheating was noted on the tail rotor gearbox teletemp (heat sensor strips). The tail rotor gearbox and associated components were found to be rotating freely. One of the tail rotor blades was slightly bent towards the tail boom, which was attributed to ground impact after the tail boom structure was severed by the main rotor blades.

Figure 11: The aft tail rotor assembly with linkages still intact and secured.

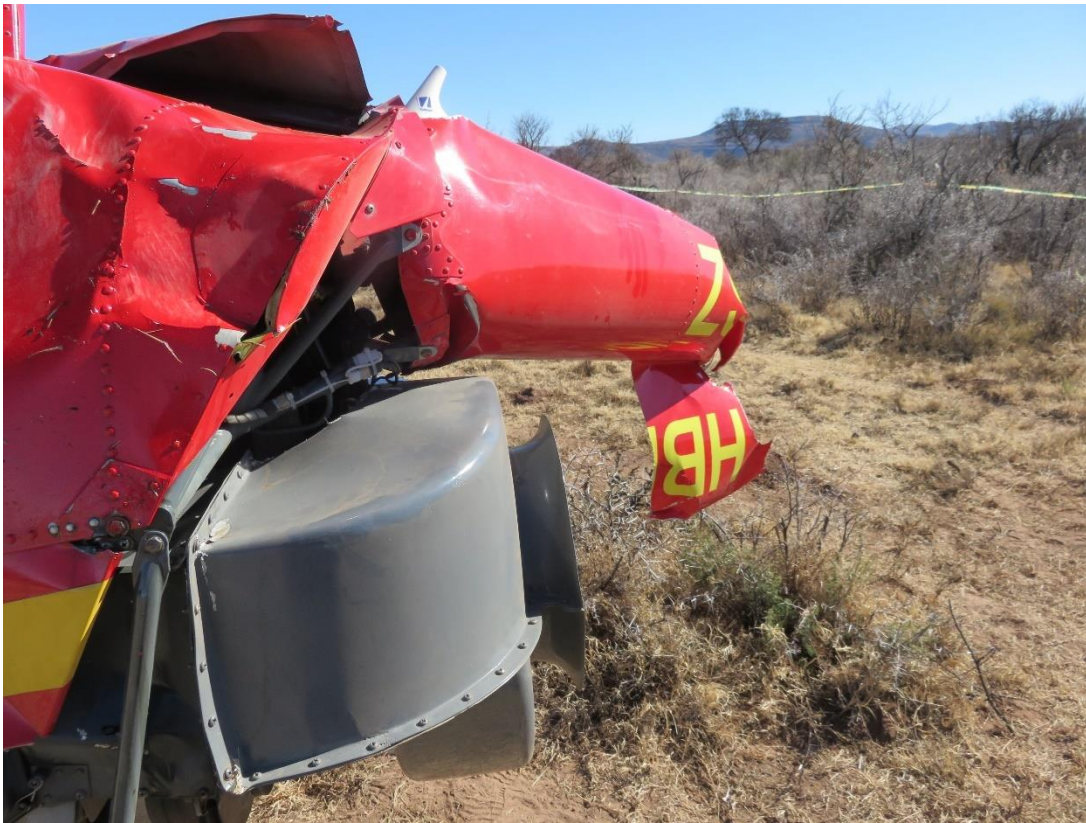
Figure 12: Tail boom was severed near the centre fuselage (helicopter was turned upright).

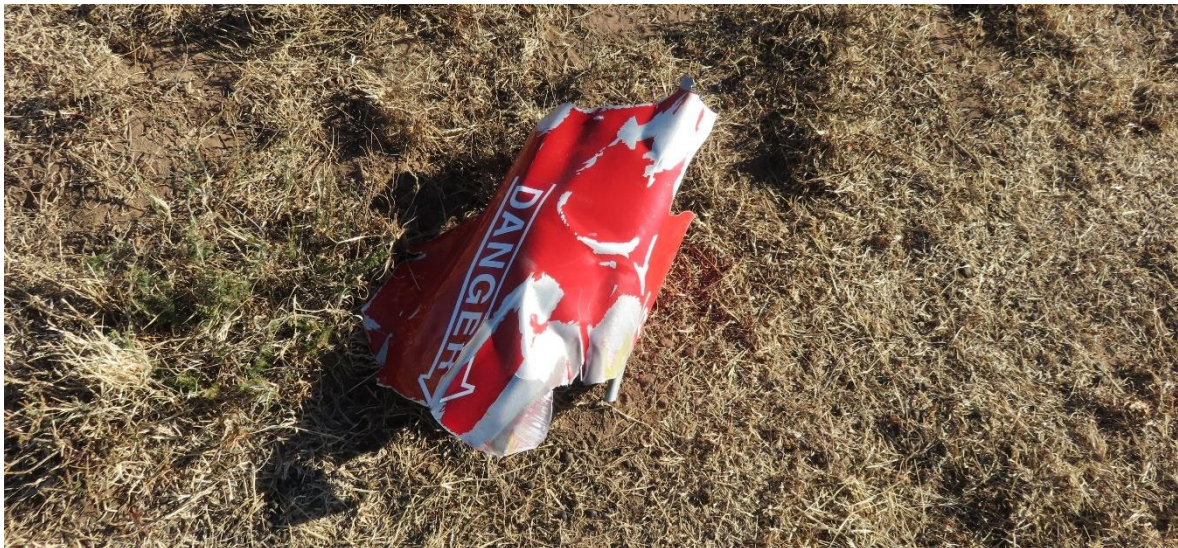
Figure 13: Smaller section of the tail boom structure.

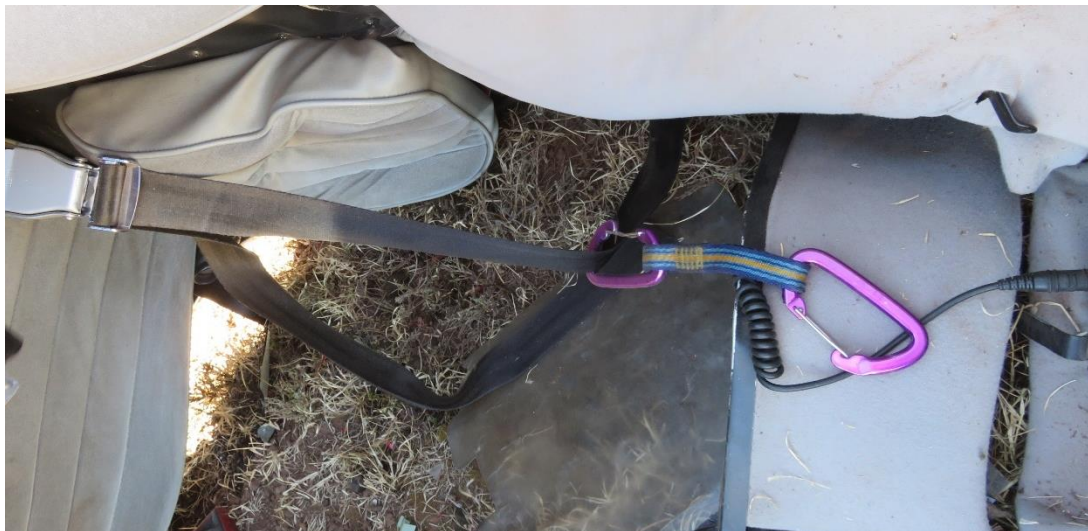
1.15.2 The veterinarian was not strapped onto the seat by means of the helicopter-equipped safety harness. Due to the nature of the operation, he made use of his personal safety harness (monkey chain), which he secured to the helicopter safety harness by means of a carabiner as shown in Figure 14. The safety harness, as per Figure 15, was secured to the second carabiner.

Figure 14: The carabiner secured to the helicopter safety harness (left seat).

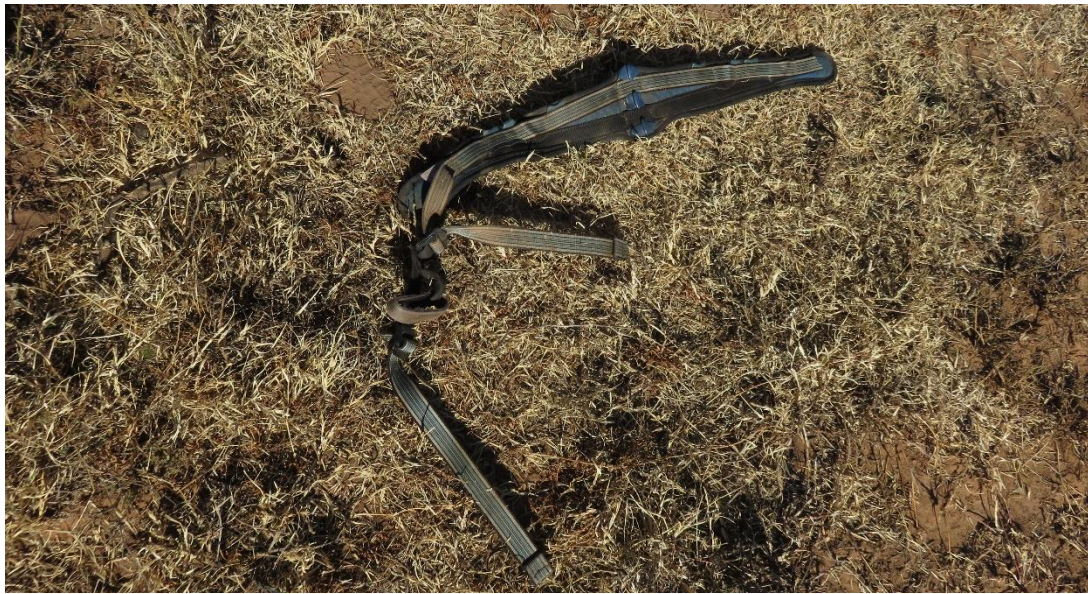
Figure 15: The safety harness that was around the veterinarian's waist.

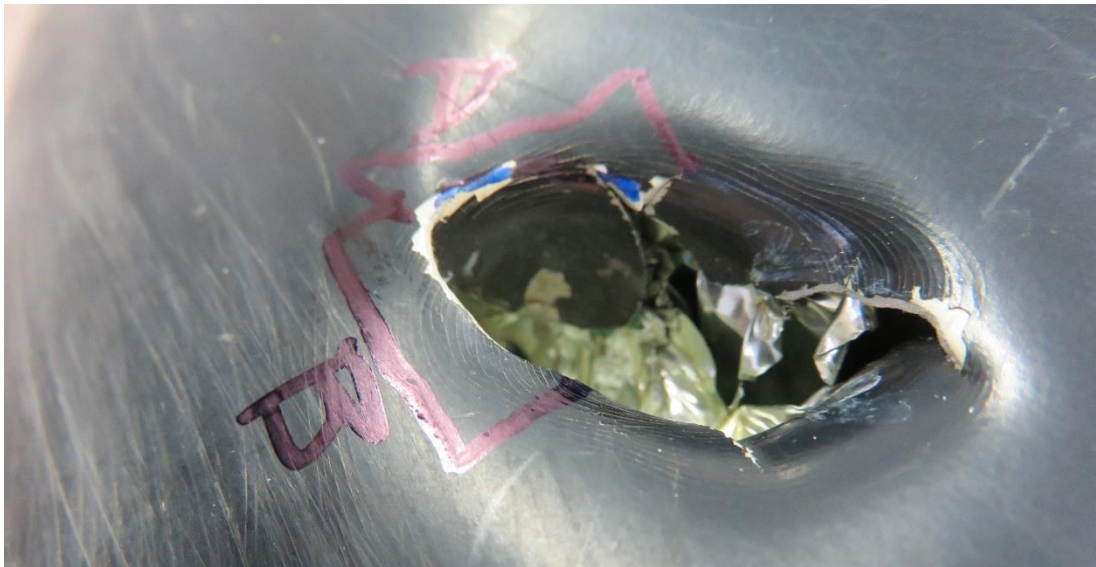
Figure 28: The perforated hole (lower blade surface) from where the two samples were taken.

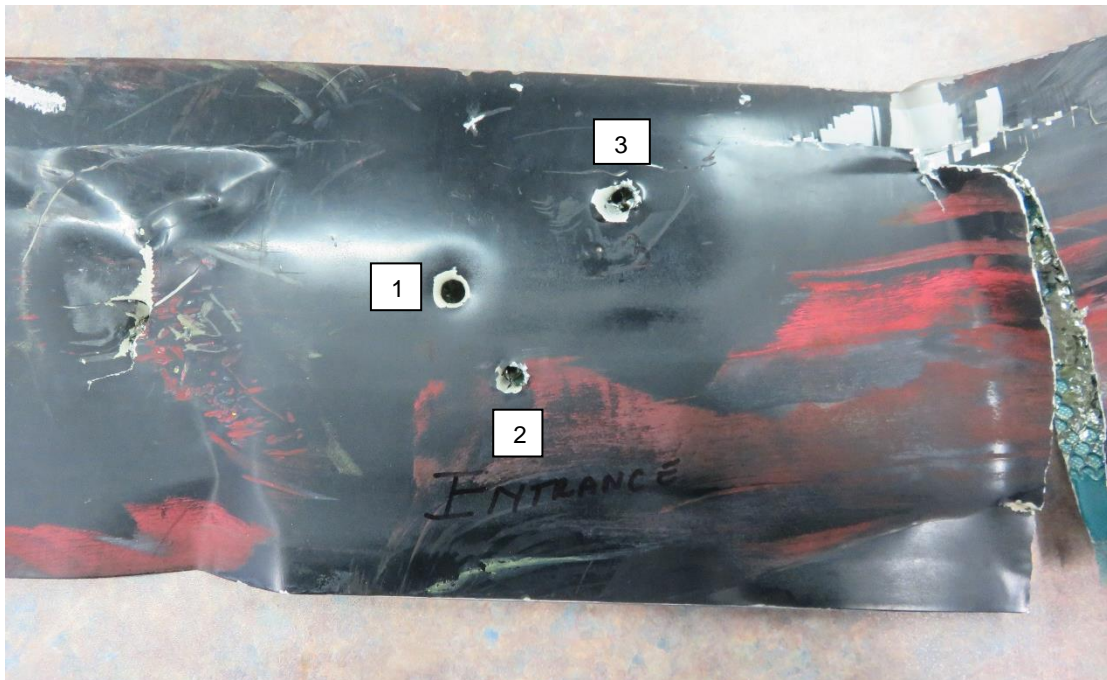
The section of the main rotor blade depicted in Figure 31 was submitted to the forensic laboratory. It should be noted that this section of the main rotor blade formed part of the blade with serial No. 2502, which was the same blade that had the perforated hole. The three holes, marked 1, 2 and 3 in Figure 31 came about during the static ballistic test that the police conducted, where they had fired three bullets at the blade. A material sample of hole 1 as illustrated in Figure 31 where the bullet entered the blade surface was cut out (see Figure 32) and was subjected to a FEGSEM analysis at an accredited microscopic laboratory.

Figure 31: Section of the main rotor blade with three bullet holes.

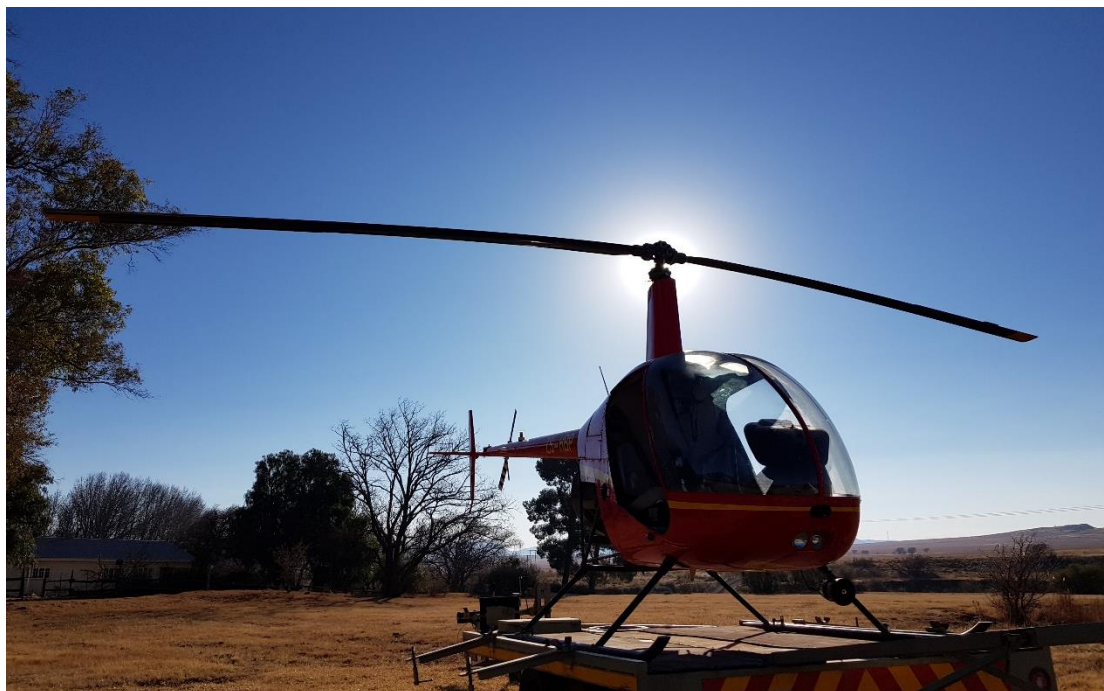
The focus from the family was on the main rotor blade that was pointing to the left (towards the tree) when looking at the photograph in Figure 33. The photograph was enlarged by the family member, and several comparisons were drawn with photographs that were shared with them (source unknown to the writer) that were taken at the scene of the accident after it occurred. These reference photographs could be seen in Figures 34, 35 and 36, respectively. The resolution of the photographs received via email was of poor quality, therefore, the SAPS official requested to obtain the photographs with maximum resolution from the cellphone of the passenger.

Figure 33: One of the photographs that was on the cellphone. This is a 3.5MB resolution photograph. (Source: passenger's cellphone)

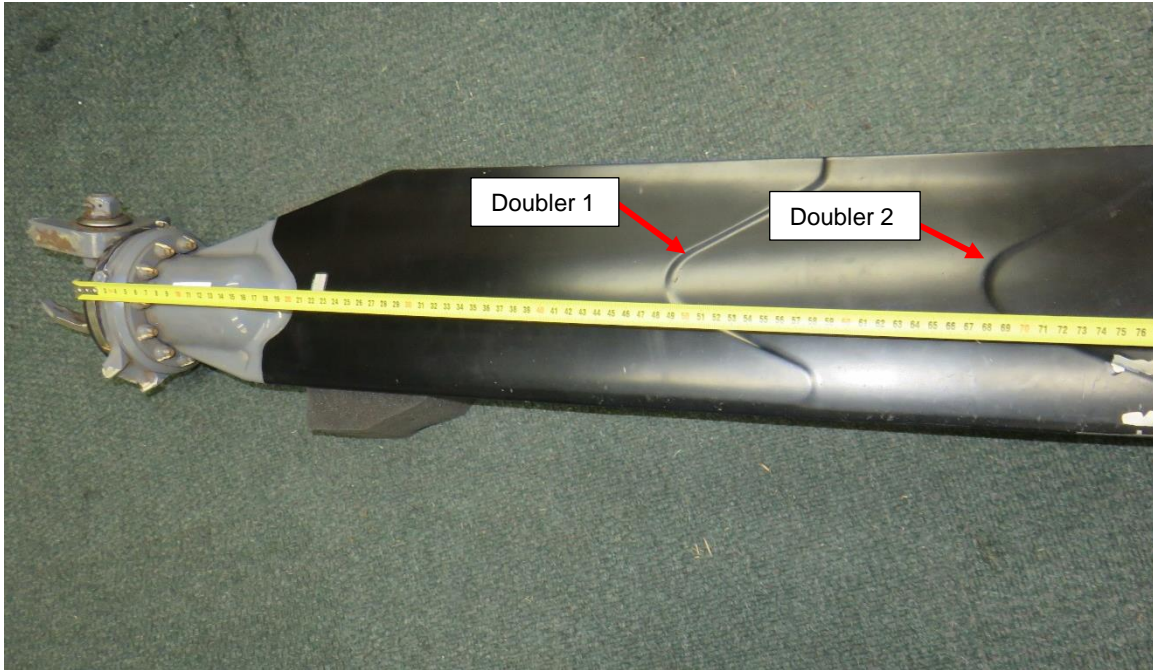
Figure 37: The two *doubler* transitions, indicated by red arrows on the actual main rotor blade in question.

Following the email that was received from a family member on 17 August 2019, no evidence could be found that either of the two main rotor blades sustained any damage on the lower blade skin in the surface area from *doubler 1* towards *doubler 2* and further outwards, towards the blade tip.

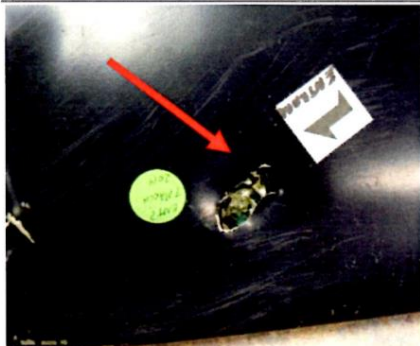
Photo 3: Foreign Object Impact damage, as received (Digital)

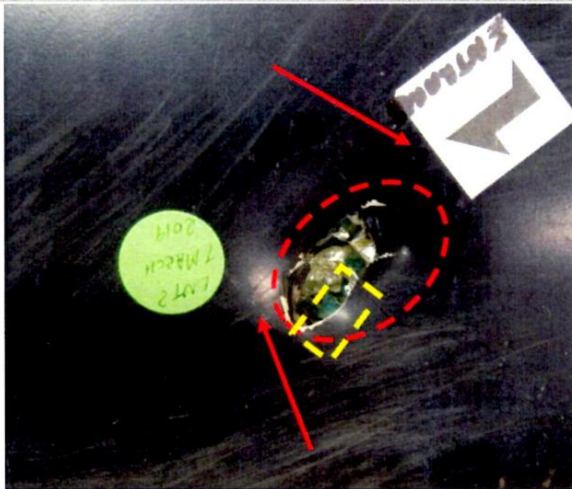
The qualitative EDS analysis results obtained from the FOD (entry-end) contact surface (Photo 4, yellow dashed square) revealed clear, and comparable to the SAPS reference sample, indications of fragments originating from a source with a high copper content (EDS Map Result 2, Pictures (a), (b) and (d), yellow arrows; Method B). Point and ID (Method A) analysis of the noted particulates confirmed the copper (Cu) content of **39.65 Wt% - 55.7 Wt%** to be exceedingly higher (EDS Results 1, 2 and 3; Method A) and thus *partially* unrelated to the expected **3.8 Wt% - 4.9 Wt%** copper (Cu) content of the AISI 2024 substrate alloy composition (Extract 1).

Photo 4: FOD, entry side (digital)

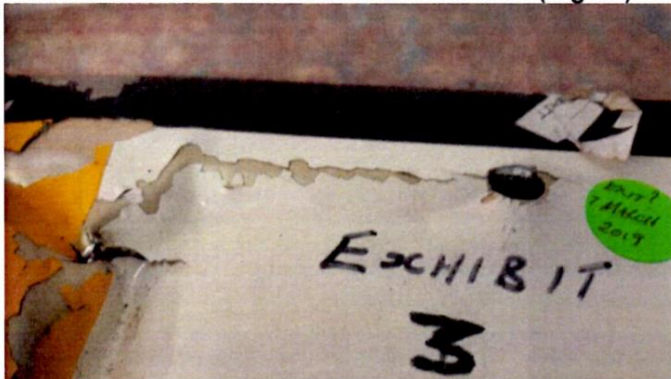
Photo 8: FOD, exit side, MR Top surface (digital)

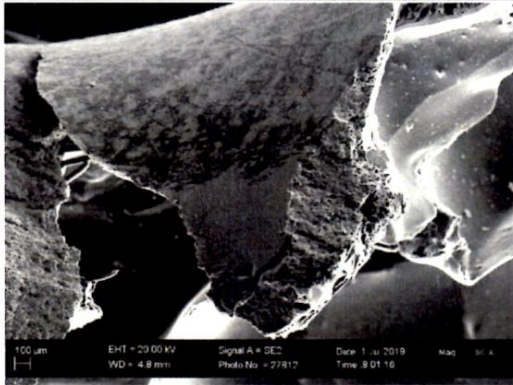
Fractograph 2: SAPS reference sample, point of entry fracture surfaces (86X, 20kV, SE, FEGSEM)

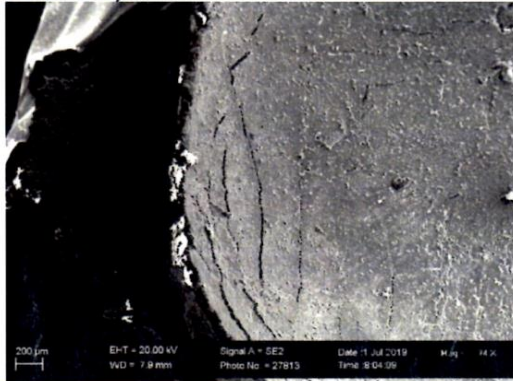
Fractograph 3: FOD sample, point of entry fracture surfaces (74X, 20kV, SE, FEGSEM)

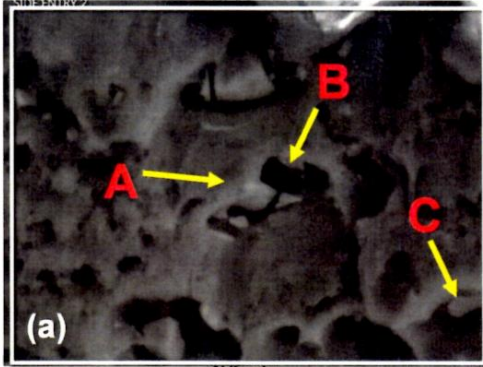
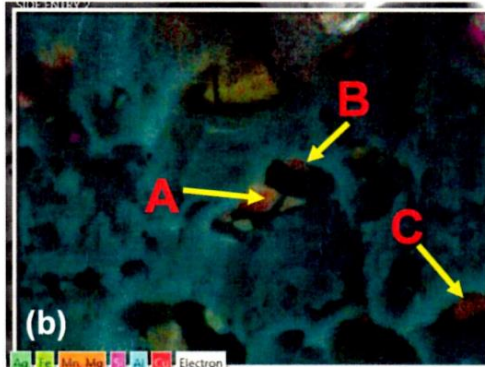
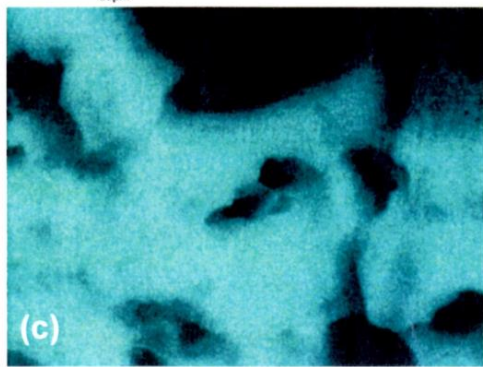
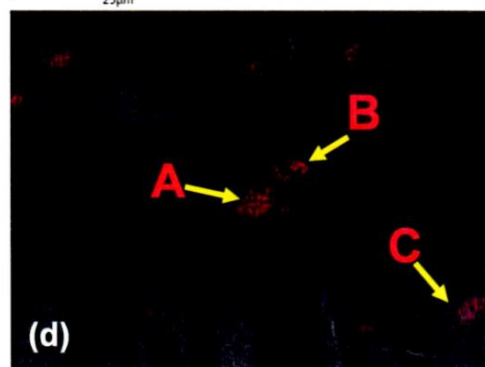
Element	Wt%	Wt% Sigma	Atomic %
Mg	1.27	0.02	1.49
Al	88.02	0.08	93.45
Si	0.70	0.02	0.72
Mn	0.92	0.03	0.48
Fe	0.90	0.03	0.46
Cu	6.60	0.06	2.98
Ag	1.58	0.04	0.42
Total:	100.00		100.00

EDS Map Result 2: Contact area selection, FOD sampleⁱⁱ
