Accident Investigation Coordinating Committee

Report 2018/02

Final Report on the Serious Incident to
Airbus, A320-251 (VT-EXL)
Velana International Airport, Maldives
7 September 2018

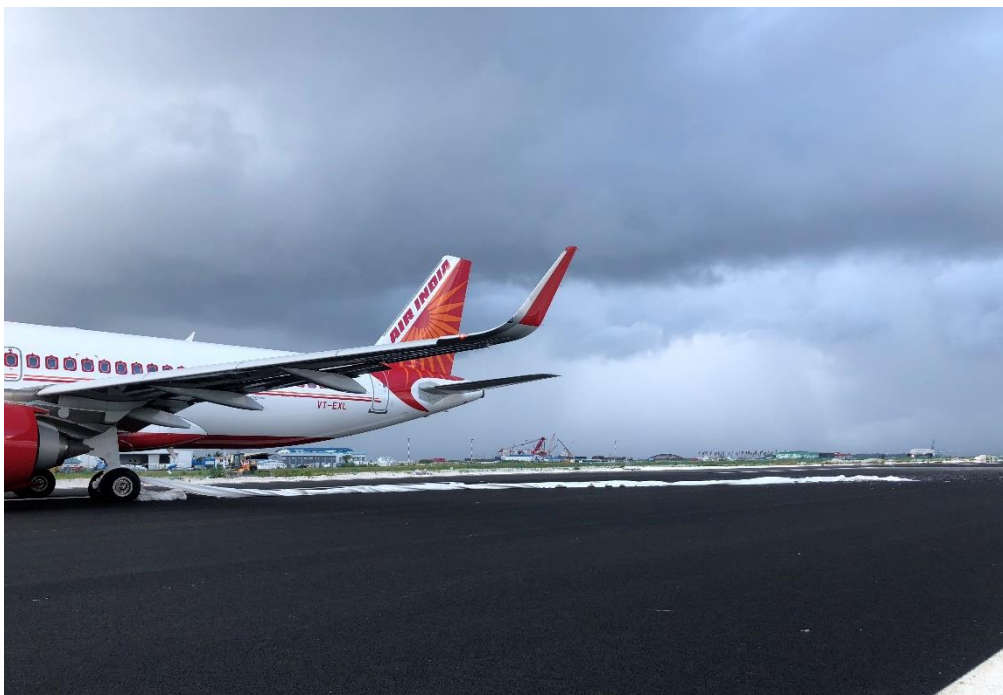
1 Aircraft with white clothing

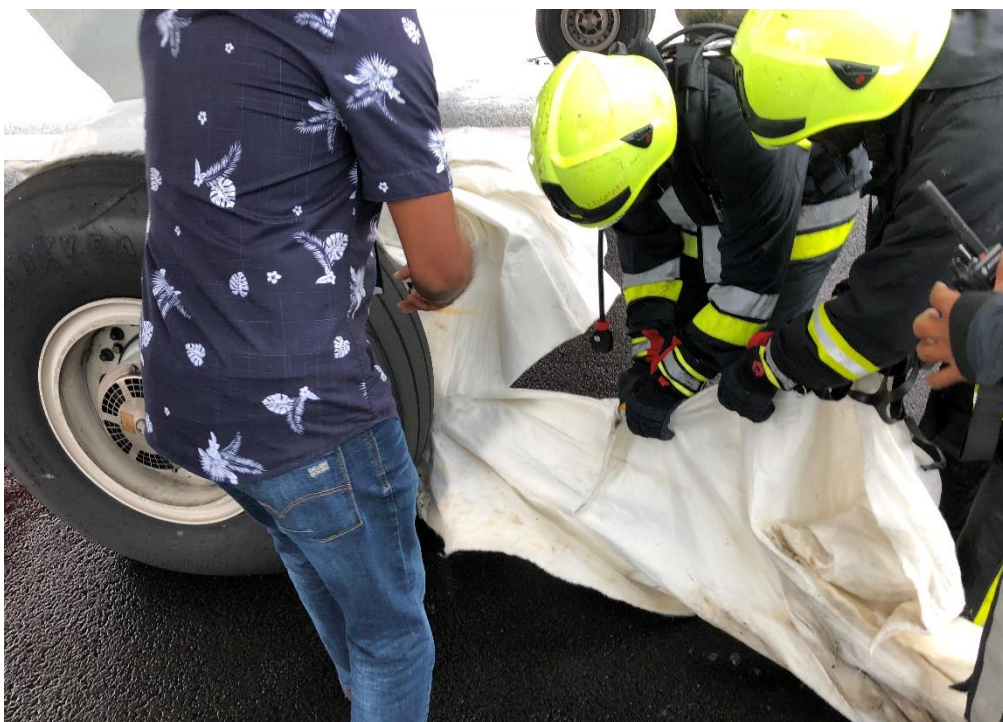
White Clothing on tyre

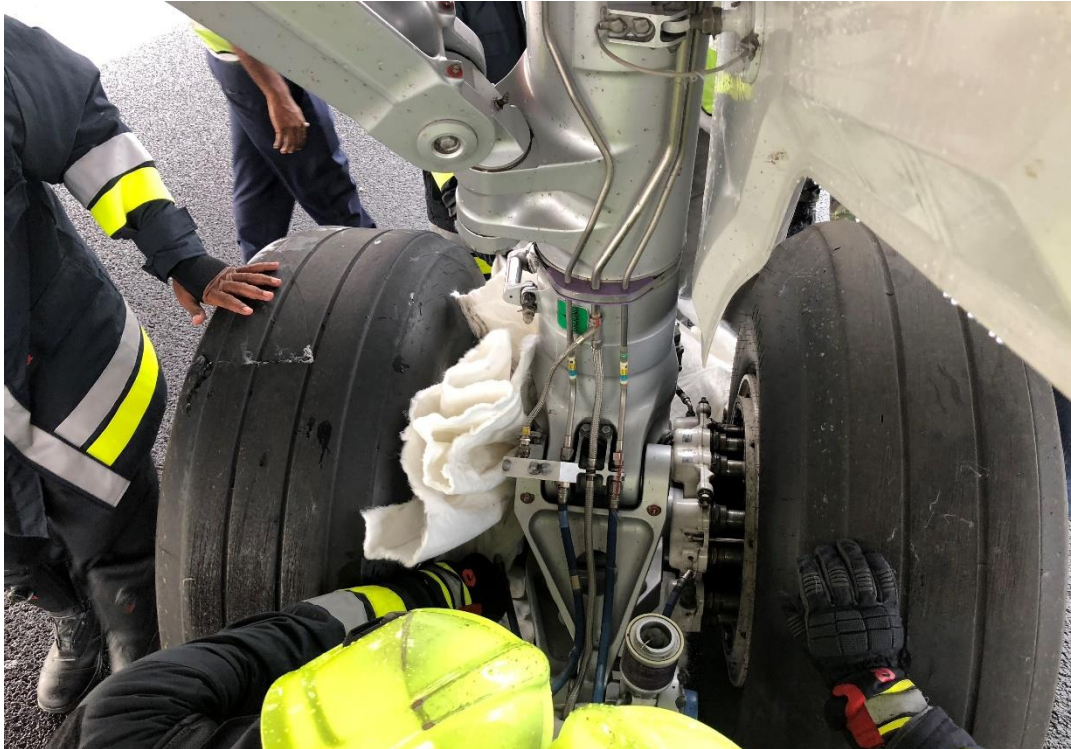
In process of removing the clothing

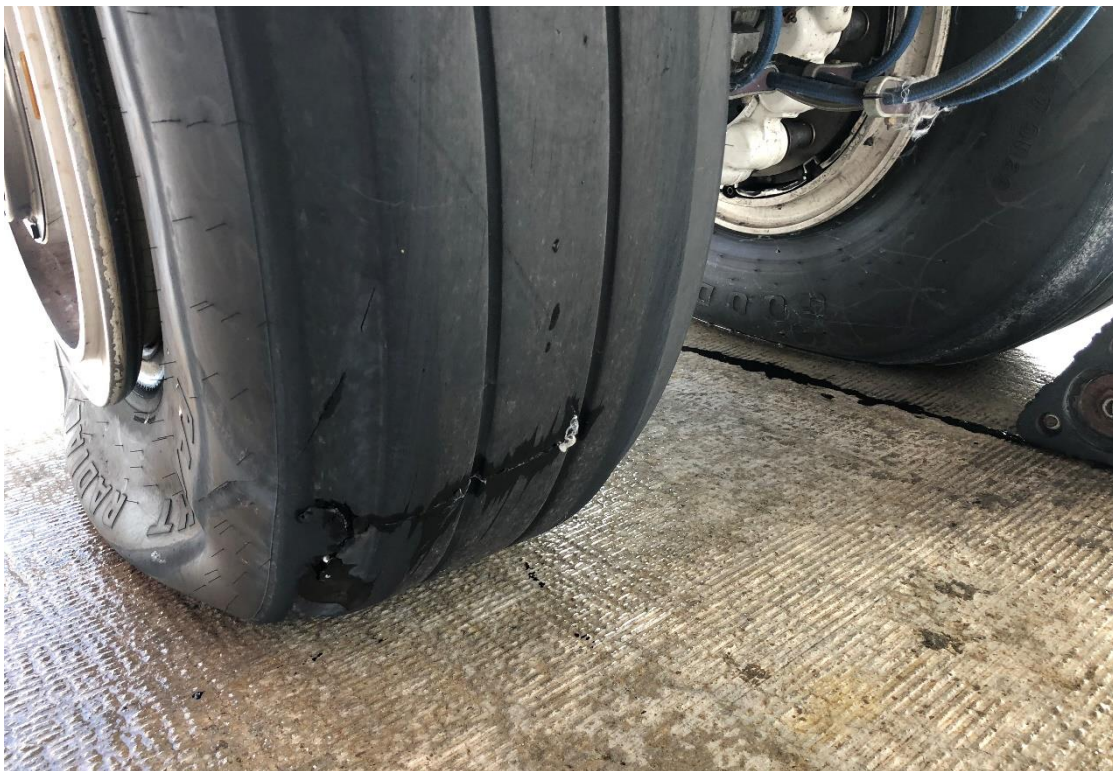
The LH main landing gear tyre was damaged.

Damage to Tyre

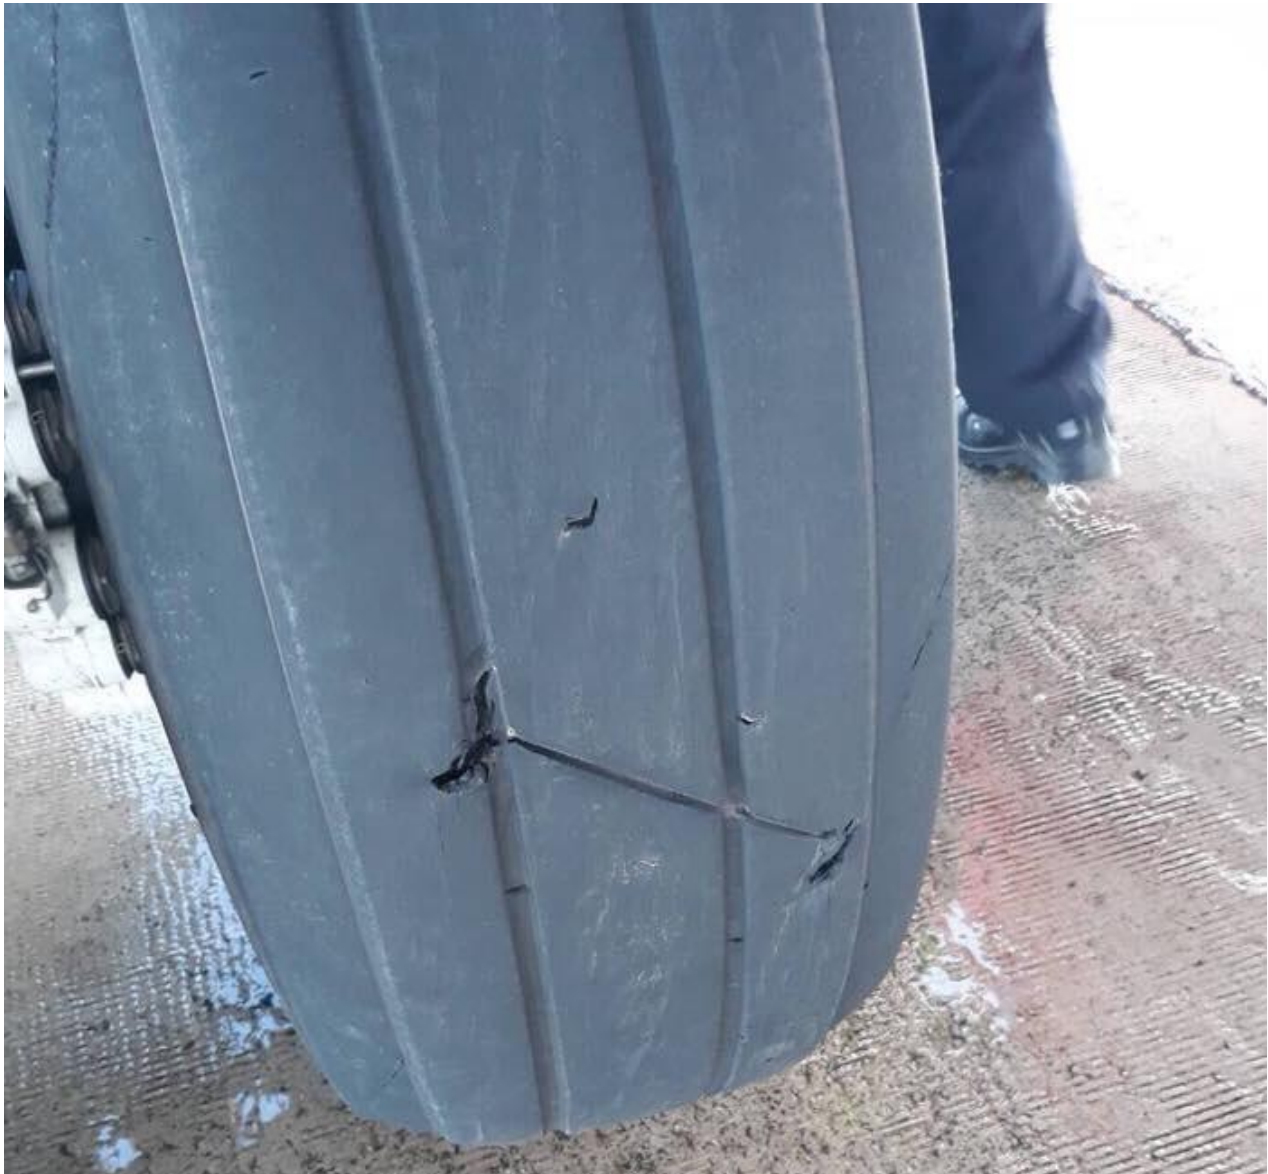
Damage to Tyre
