Final report RL 2019:10e

Serious incident at Trollhättan/Vänersborg airport on 9 October 2018 involving the aircraft YL-RAI of the model ATR-72-202, operated by RAF-AVIA.

File no. L-145/18

5 September 2019

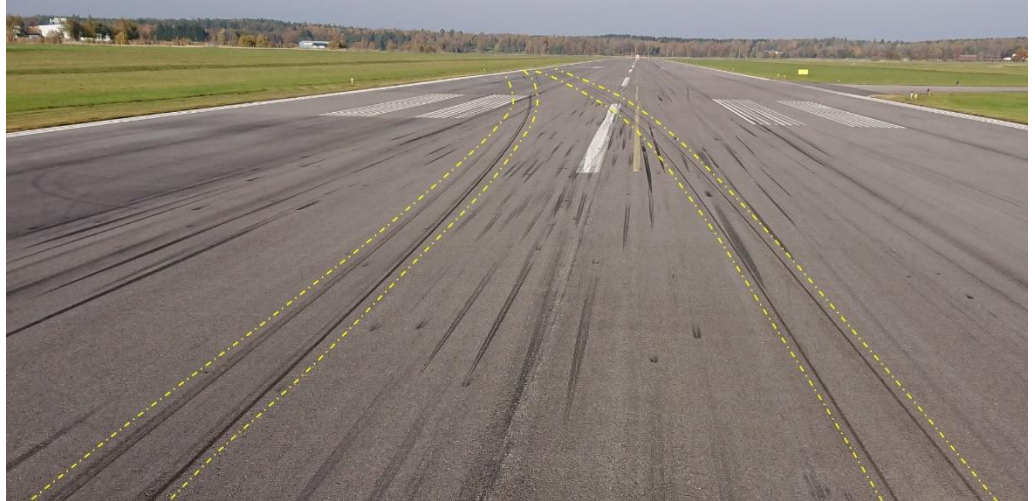
Figure 1. Tyre tracks in the landing direction towards the left edge of the runway.
Photo: Trollhättan/Vänersborg airport.

The ground clearance for the aircraft model at the nose landing gear doors and the underside of the fuselage is approximately 40 cm, and the runway edge light is 50 cm high. Considering the placement of the tyre tracks in relation to the runway edge light, SHK considers it established that the light was damaged in conjunction with the excursion.

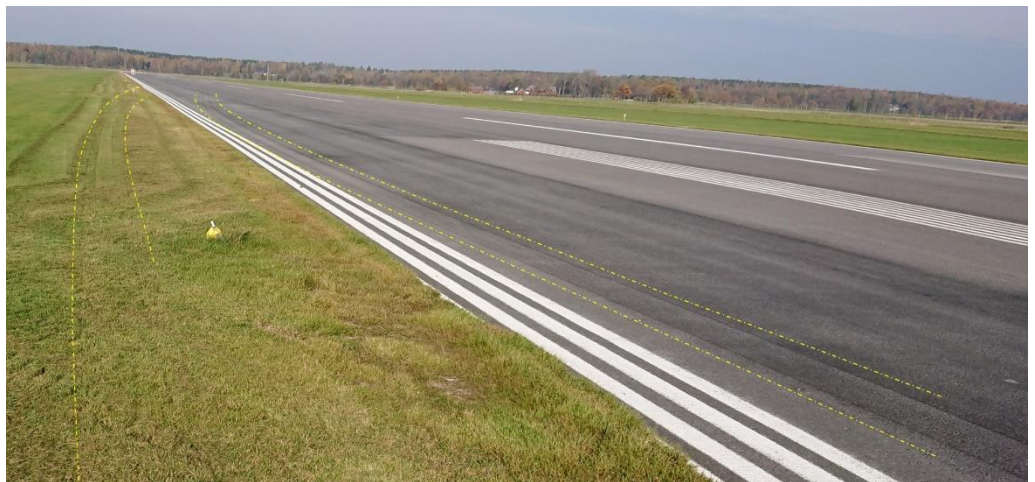
Figure 2. Tyre tracks going past the hit runway edge light and back onto the runway.
Photo: Trollhättan/Vänersborg airport.

In conclusion, SHK makes the assessment that the aircraft YL-RAI came off the runway during the landing, damaged the edge light and thereafter rolled back onto the runway.
