HELICOPTER ACCIDENT REPORT AND EXECUTIVE SUMMARY

Reference:	CA18/2/3/9738	
Helicopter Registration	ZS-HLP	Date of Accident	23 October 2018		Time of Accident	0730Z
Type of Helicopter	Bell Richard's Heavy Lift UH-H1 Huey		Type of Operation		Commercial Part 127	
Pilot-in-command Licence Type		Commercial Pilot	Age	70	Licence Valid	Yes
Pilot-in-command Flying Experience		Total Flying Hours	12350		Hours on Type	Unknown
Last Point of Departure		Dedicated Landing Zone, Vermaaklikheid, Western Cape				
Next Point of Intended Landing		Dedicated Landing Zone, Vermaaklikheid, Western Cape				
Location of the accident site with reference to easily defined geographical points (GPS readings if possible)						
At Vermaaklikheid, Western Cape, on a farm with GPS co-ordinates (S 34°19'30.88", E 0 21° 2'23.58") and a field elevation of 454ft above mean sea level						
Meteorological Information		Wind direction:350° ; Wind speed:20kt ; Air temperature:32°C ; Visibility: CAVOK; Dew-point: 04°C;

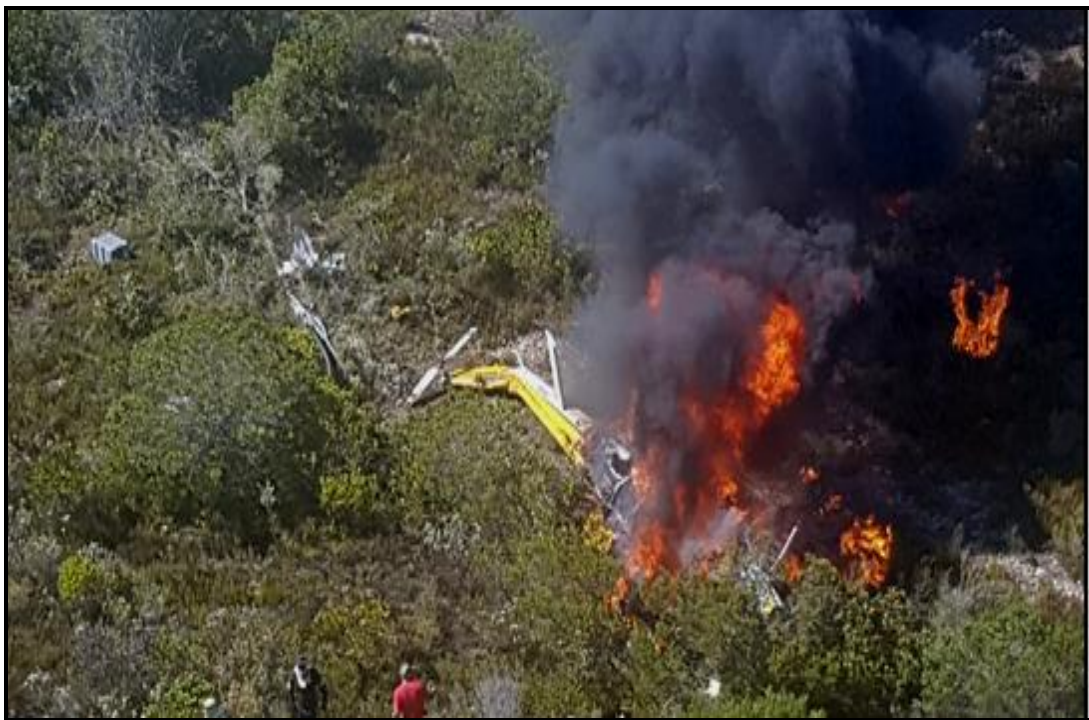
Figure 1: The helicopter engulfed in flames.

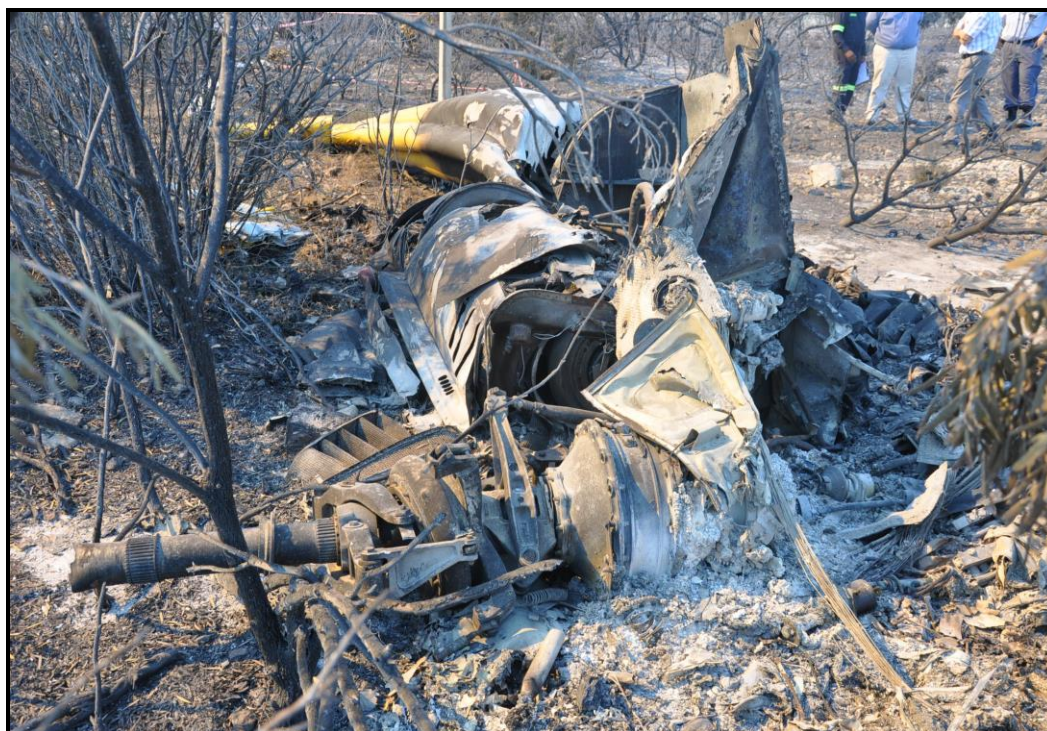
1.3.1 The helicopter was destroyed by impact forces, post-impact fire and, later, the veld fire, refer Figure 2..

Figure 2: The helicopter wreckage post fire.

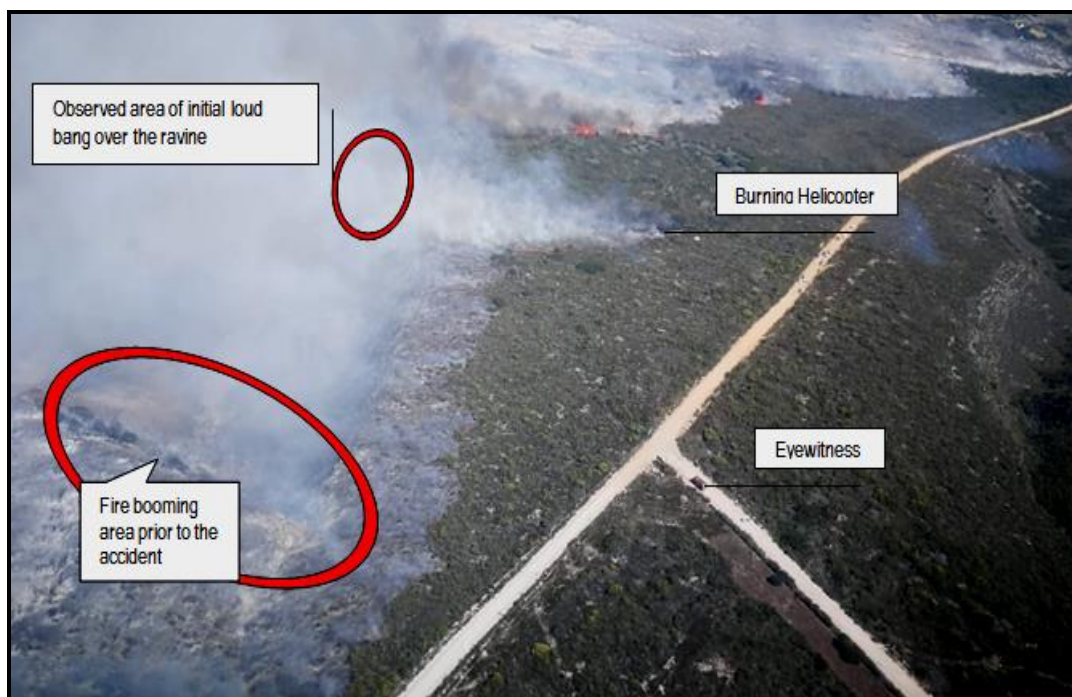
Figure 6: Aerial view of the accident site after the accident.

- The direction of the airflow was indicated by smoke direction, which also indicated high rising smoke over the ravine, which is consistent with high rising strong turbulence.

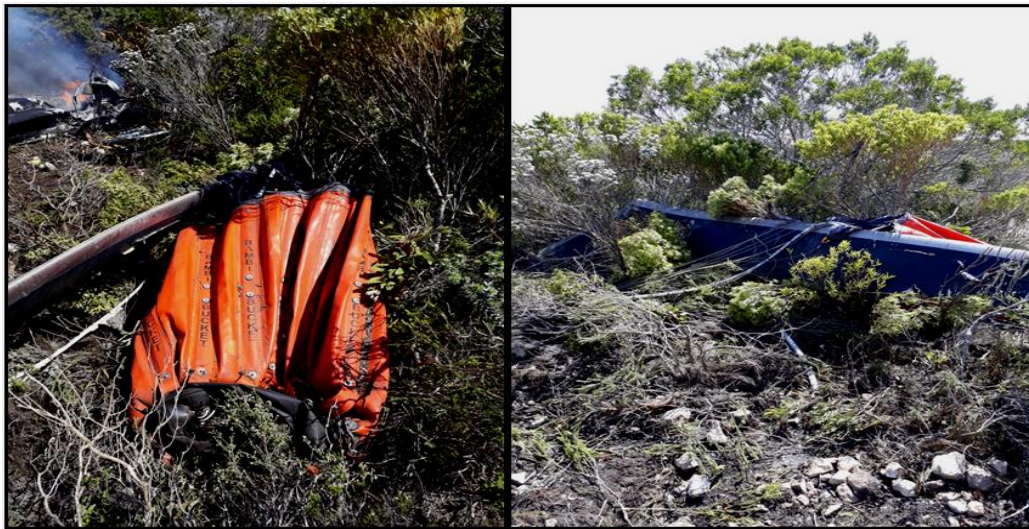
Figures 7 and 8: The Bambi Bucket on the main rotor blade before it was burned by veld fire.

- The second blade followed through and impacted the ground; however, the rotational energy was not severed as with the first blade. About 1.6m of the outer part of the main rotor blade was bent and the composite material separated and was flung around. This resulted in the main rotor completely stopping. The Bambi Bucket remained hooked over the second rotor blade during the impact sequence, while the main rotor head separated from the main wreckage and was found as demonstrated in Figures 7 and 8.

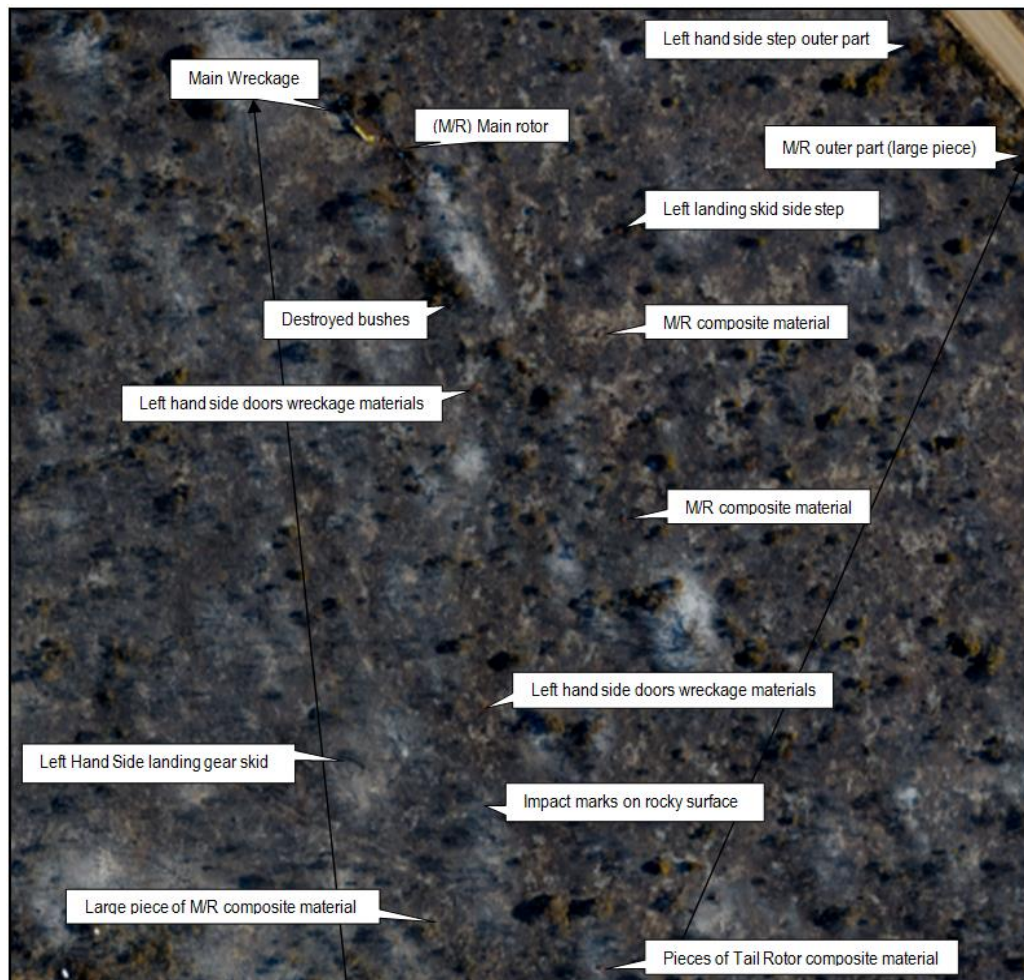
- The investigation team found the accident site as shown in Figure 9. The wreckage distribution was located approximately 150m from the ravine edge in the direction north-north westerly. The wreckage pattern was indicative of an in-flight break-up at low height to the ground surface. Although the site was burned overnight due to the veld fire, some of the trees were bent in the direction towards where the main wreckage was found lying on its right side with the fuselage burnt to ashes and facing north west.

Figure 9: The accident site and the wreckage spread pattern.

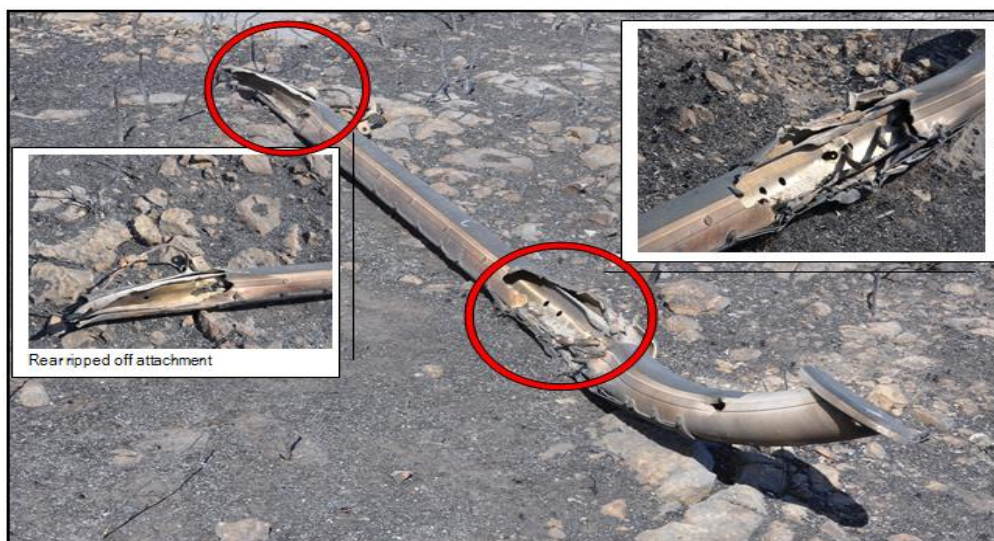
Figure 11: Damaged left skid gear caused by a cable.

- Next to scar marks at approximately 12m from the wreckage, the left skid gear was found facing in a north-easterly direction. It had some scar marks associated with an object that was ripped from both mounting attachments. The marks are indicative of damage caused by a strong metal cable at high-tension force.
- The left-hand side doors of the helicopter were also found near this section, bent, as if they were pulled towards the back from their assembly position.
- About 75m from the main wreckage, broken bush trees were observed along the route path of the wreckage, bending towards it. Along the path, parts of the fuselage pieces were also found.

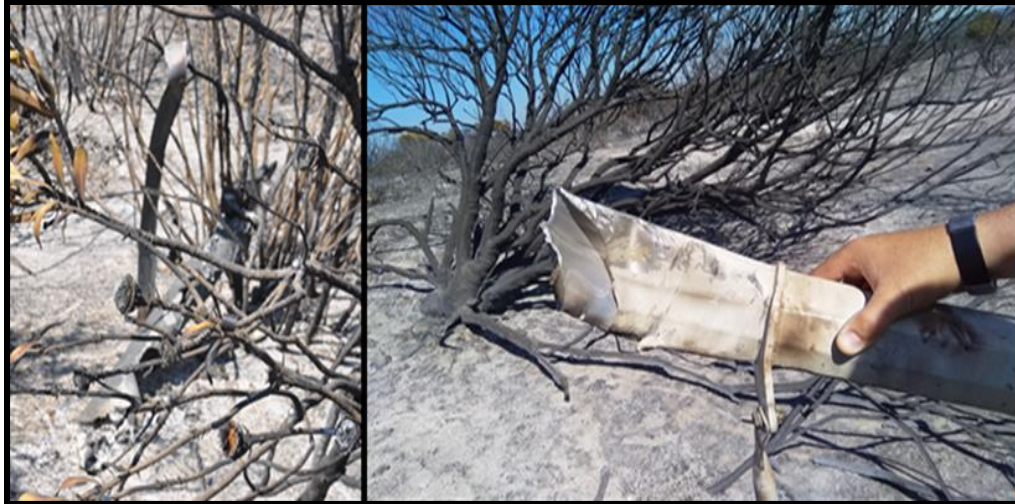
Figures 12 and 13: The main rotor blade piece and the left-hand side step.

- With reference to the main wreckage position, at approximately 100m near the road, a large piece of the main rotor leading edge was found hanging on some trees. Next to it was a short front part piece of the left-hand side step. The remaining large piece of the left-hand side step was found about 50m from the right-hand side of the main wreckage. The two pieces were compared for separation damage. The damage was also associated with objects cut off by a cable.

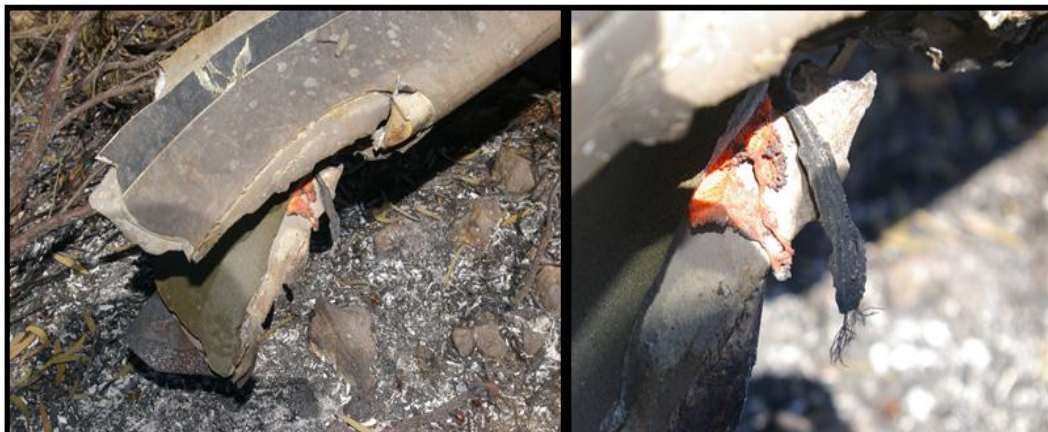
- The Bambi Bucket was found lying over the main rotor. Both main rotor blades composite material were disintegrated. One of the main rotors was missing a part, a rotor leading edge outer piece of approximately 1.5m, which was found next to the road hanging on a tree. The damage that contributed to the separation of the main rotor piece is associated with hard contact with the ground. Further observation revealed that the same rotor blade had lost most of the composite material, which was found along the wreckage trail marks. The other main rotor blade was bent at approximately the same point where the other piece had separated.

Figures 14 and 15: The main rotor blade that has a missing piece of the outer part with a sling strap cover and an electrical wire.

- The Figures 14 and 15 show evidence of the Bambi Bucket sling connecting strap cover with the bucket electric wires for the release mechanism found at the edge of the damaged piece. The main rotor blades damage is consistent with hard impact with the ground at high rotational energy, resulting in them breaking off. At the time of this impact, more rotational energy was absorbed. The second main rotor blade (Refer to Figure 8) impacted the ground, however, the rotational energy was not as severe, thus, it was only bent. The ground impact with each main rotor blade resulted in disintegration of composite material, which was spread along the wreckage distribution.

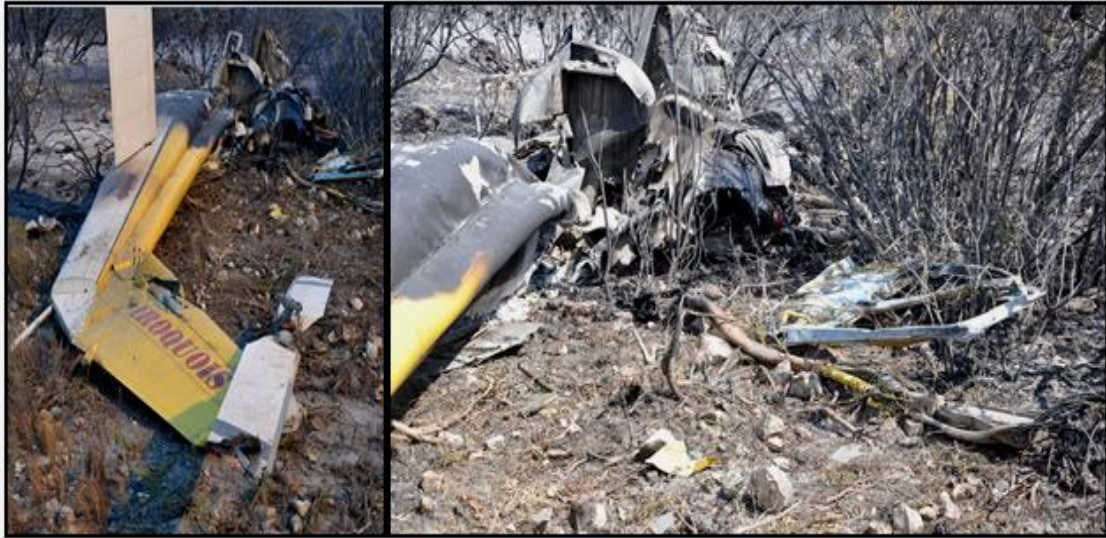
Figure 16: The remaining large piece of a tail boom and the Bambi Bucket connecting strap.

- A large piece of the tail boom was found damaged near the fuselage. The damage was indicative of an object that was ripped by a strong cable at high tensile force. A sling strap that connected the Bambi Bucket was found lying on the ground as shown in Figure 16. More damage was observed on the tail rotor tips and the tail rotor fin as illustrated in Figure 17. Composite materials were found around the area where witnesses stated that they heard a loud bang when the Ch-Papa helicopter turned left. The tips of both tail rotor blades were damaged. More composite material was found within the tail fin faring cover, which was also damaged. (The tail rotor blades had damaged the tail faring cover). The tail rotor blades had damage associated with forced bending near the blade root neck.

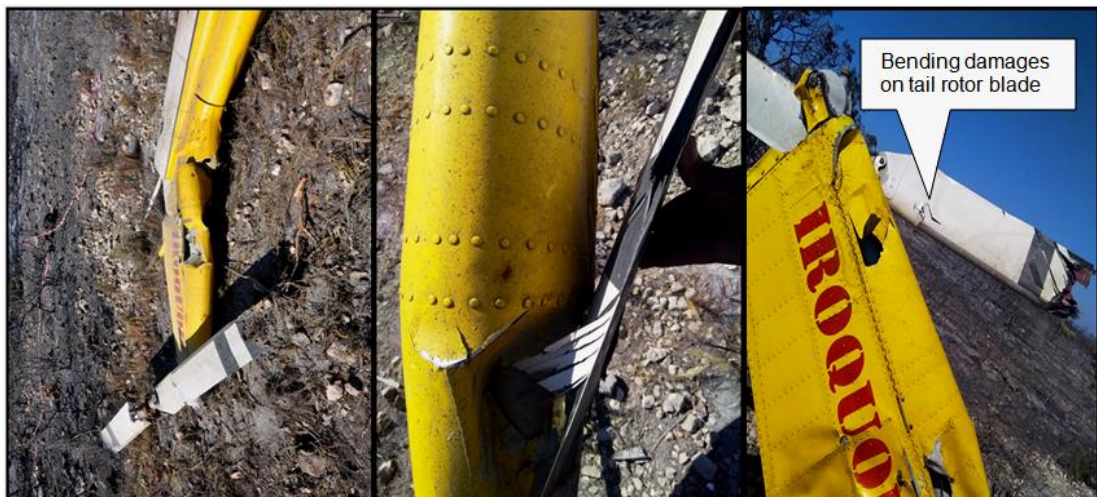
Figure 17: The damaged tail rotor blades and the tail rotor drive shaft faring cover.

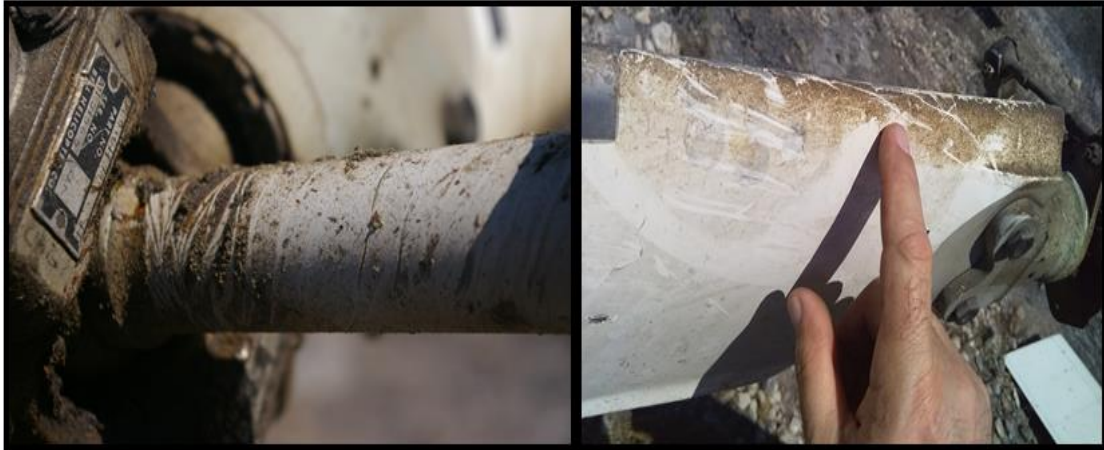
Figures 18 and 19: The damaged tail rotor drive shaft and tail rotor blades.

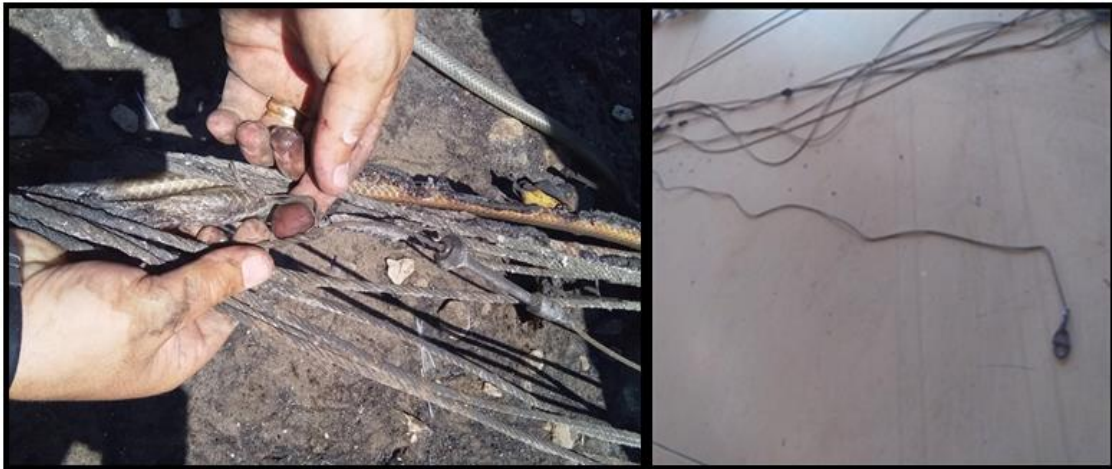
Figures 20: Damaged water-release cable and the Bambi Bucket holing cables.

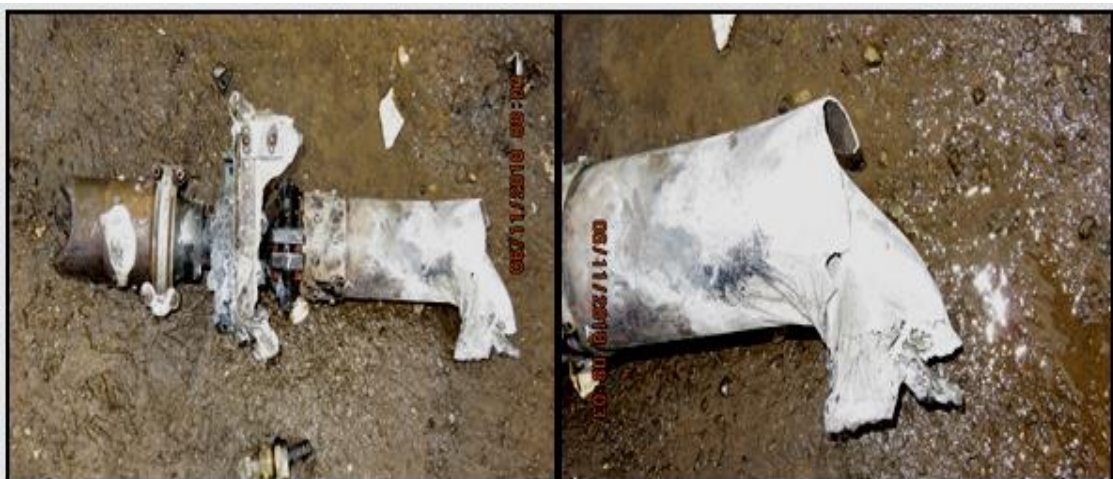
- The tail rotor drive shaft had broken. More evidence of the damaged tail rotor shaft was observed near the engine-connecting coupling, which had a twisted deformation. This damage is associated with drive shaft twisting after the tail rotor impacted an object when the shaft was turning at high engine-driven power.

Figures 21 and 22: The damaged tail rotor drive shaft due to a sudden stop (interruption) caused by a foreign object in the tail rotor.

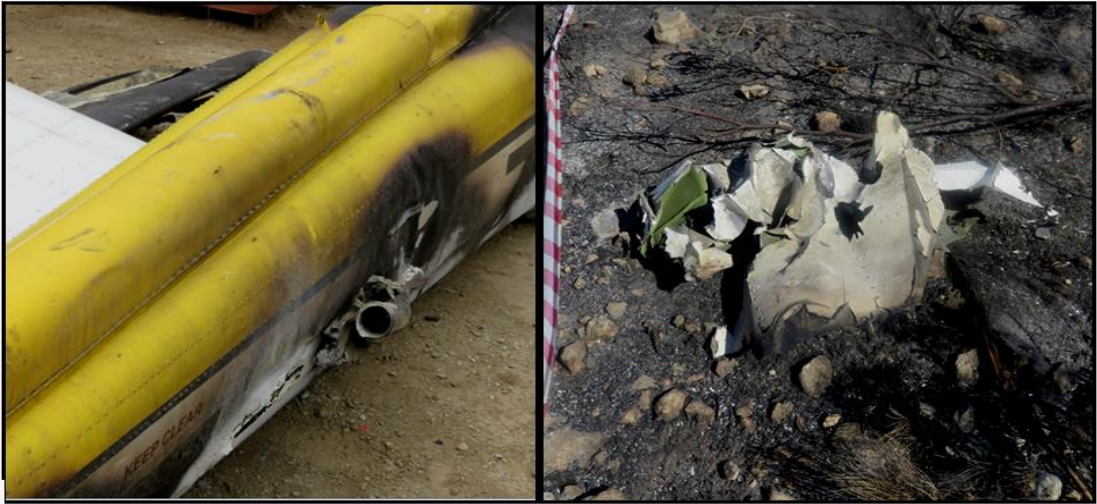
Figures 23 and 24: The right-hand side elevator mounting position and the damaged elevator.

- The right-hand side synchronised elevator was damaged. Part of the outer elevator section had damage which demonstrated that it was ripped from the inner part of the trailing edge through cross-section towards the outer part of the leading edge and by impact forces during the accident sequence.

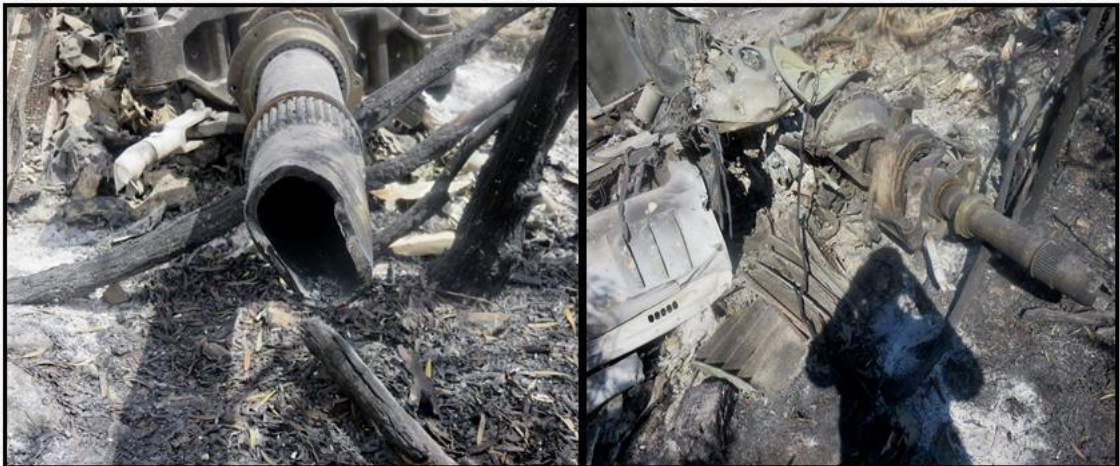
Figures 25 and 26: The mast assembly connecting point of the main rotor head.

- The mast assembly damage at the point where the main rotor head connects to the assembly was broken off and separated. This damage is consistent with mast bumping, which occurred at a high main rotor rotational energy. All other main rotor connecting links were damaged and broken off during the accident sequence.
