AIRCRAFT ACCIDENT REPORT AND EXECUTIVE SUMMARY
--	---

Reference:	CA18/2/3/9755	
Aircraft Registration	ZU-JPA	Date of Accident	25 November 2018		Time of Accident	0530Z
Type of Aircraft	Kitfox Super Sport 7		Type of Operation	Private (Part 94)		
Pilot-in-command Licence Type	PPL (A)		Age	55	Licence Valid	Yes
Pilot-in-command Flying Experience	Total Flying Hours		1876.4		Hours on Type	24.5
Last Point of Departure	Falstaff Private Strip in Hilton, Eastern Cape					
Next Point of Intended Landing	Falstaff Private Strip in Hilton, Eastern Cape					
Location of the accident site with reference to easily defined geographical points (GPS readings if possible)						
Falstaff Farm in Hilton, 15nm south of Queenstown Airfield (FAQT) GPS position: S32°11'16.5" E026°56'46.1" at an elevation of 4090ft						
Meteorological Information	Wind: 305° 9kts gusting 10kts; temperature: 14°C; CAVOK					
Number of People On Board	1 + 1	No. of People Injured	1	No. of People Killed	1

Reference Number : CA18/2/3/9755
Name of Owner/Operator : Scheepers PJ
Manufacturer : Skystar Aircraft Company
Model : Kitfox VII SS
Nationality : South African
Registration Marks : ZU-JPA
Place : Falstaff Private Airstrip in H

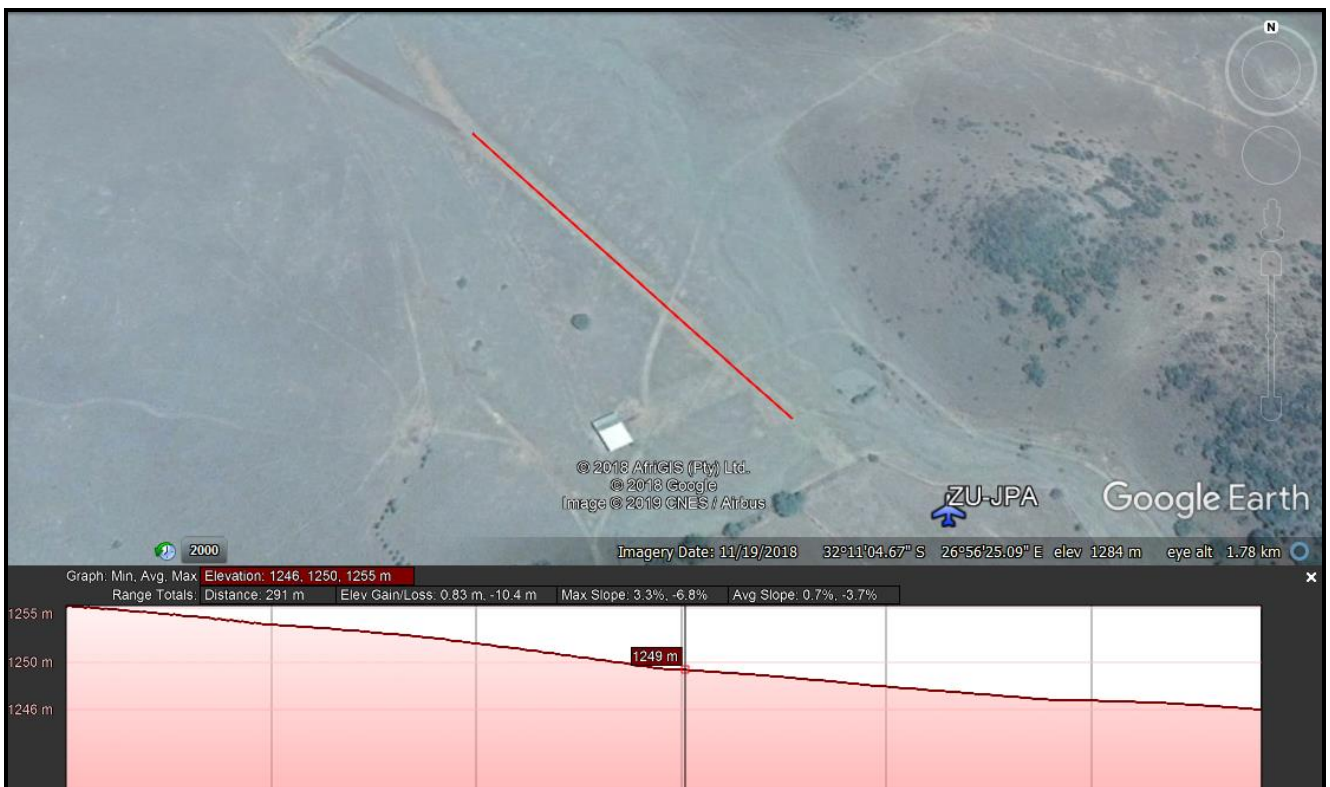
Figure 1: Runway 14 has a downward slope at an average of 3.7% and is 290m (951 feet) long.

The Kitfox Super Sport 7 requires a take-off distance roll of 88m (290ft) on a non-sloping runway. The accident aircraft took off on a 3.7% down sloping runway with a 9kts tailwind. This configuration will increase the aircraft's take-off distance roll by 24%, therefore, the required distance for the time of the accident would have been 109m (358ft).

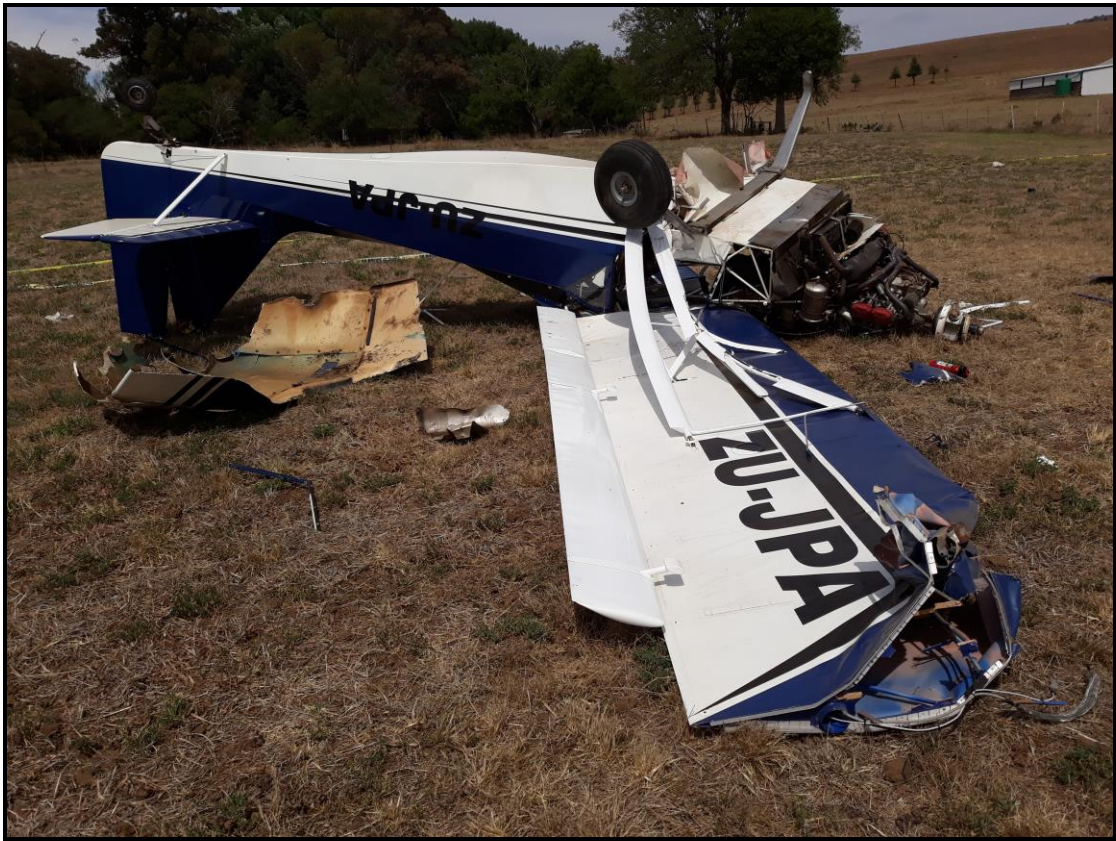
Figure 2: The aircraft as it came to rest post-accident.

1.12.1 The aircraft could not achieve a positive rate of climb and lost height before the right main landing gear impacted a rocky embankment. The right main wheel and brake assembly separated and were found 90m south-east of the wreckage (see Figure 4 and 5). The aircraft rotated through its vertical axis to the right before it impacted with a parameter fence along the extended centre line of Runway 14 at a distance of 40m. All three propeller blades broke off from the propeller hub during the accident sequence (see Figure 6). The aircraft came to rest in an inverted attitude 95m from the threshold of Runway 32 after flipping over (see Figure 2).

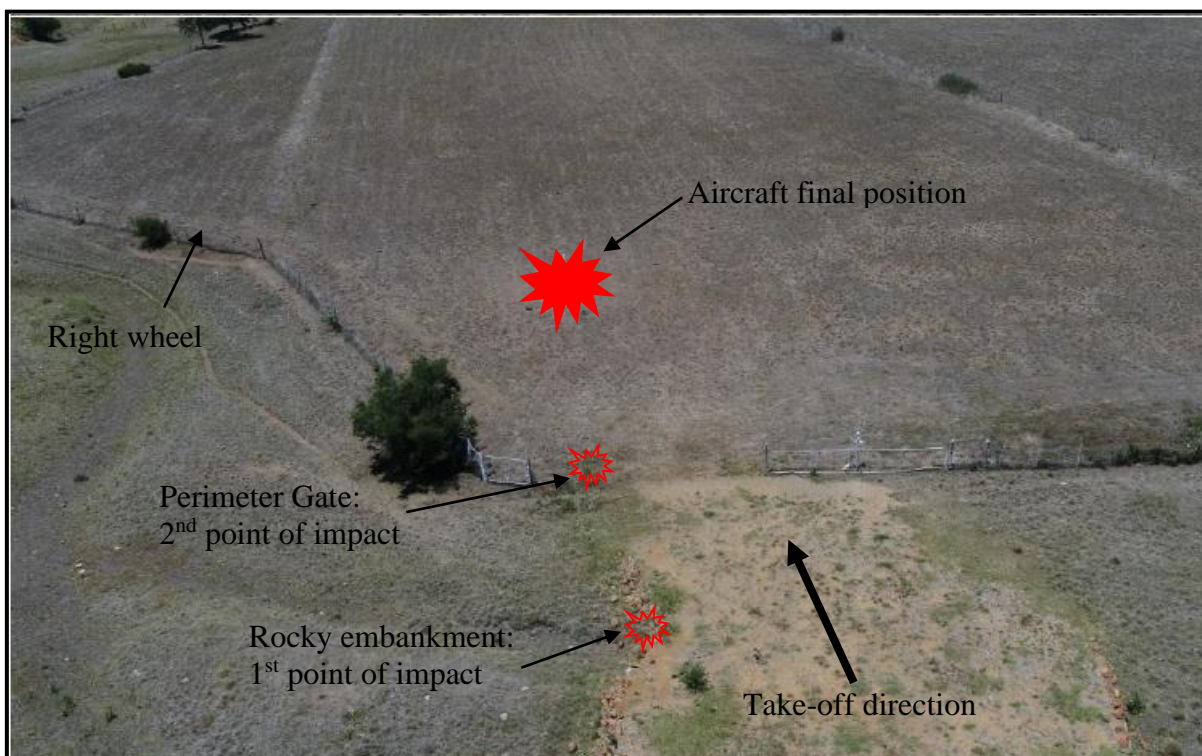
Figure 3: Aerial view of impact sequence.

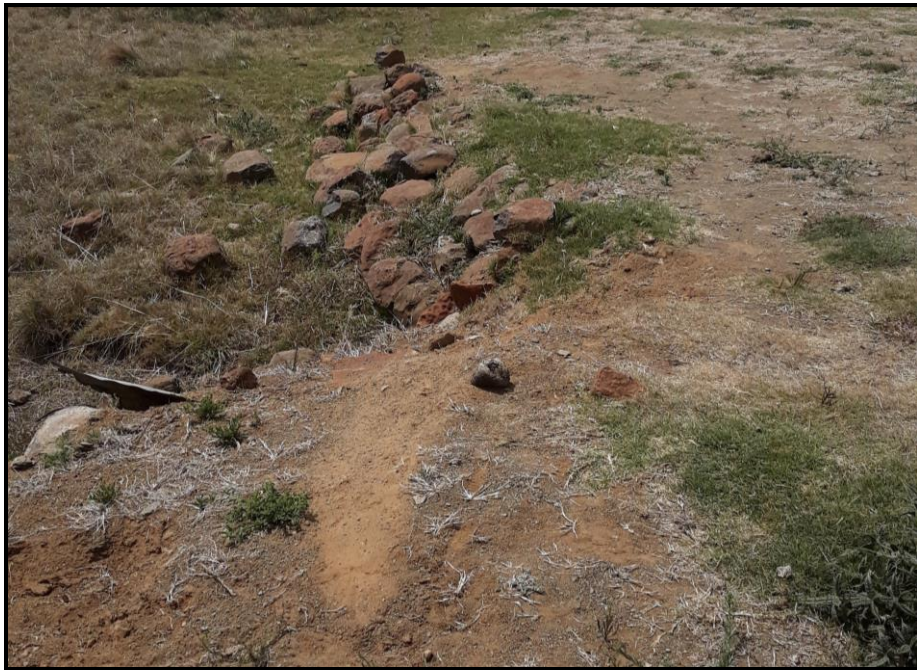
Figure 4: Rocky embankment and first point of impact.

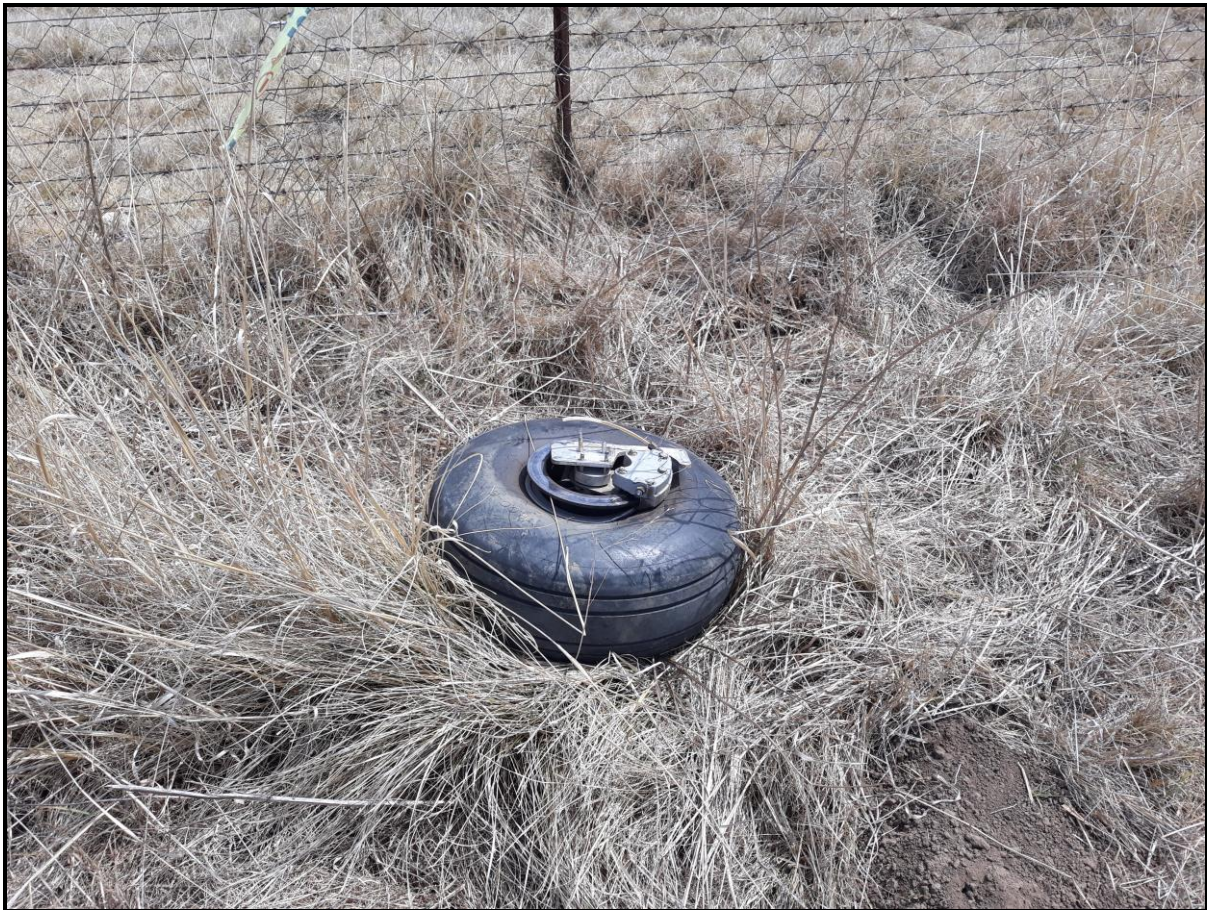
Figure 5: Right wheel and brake assembly.

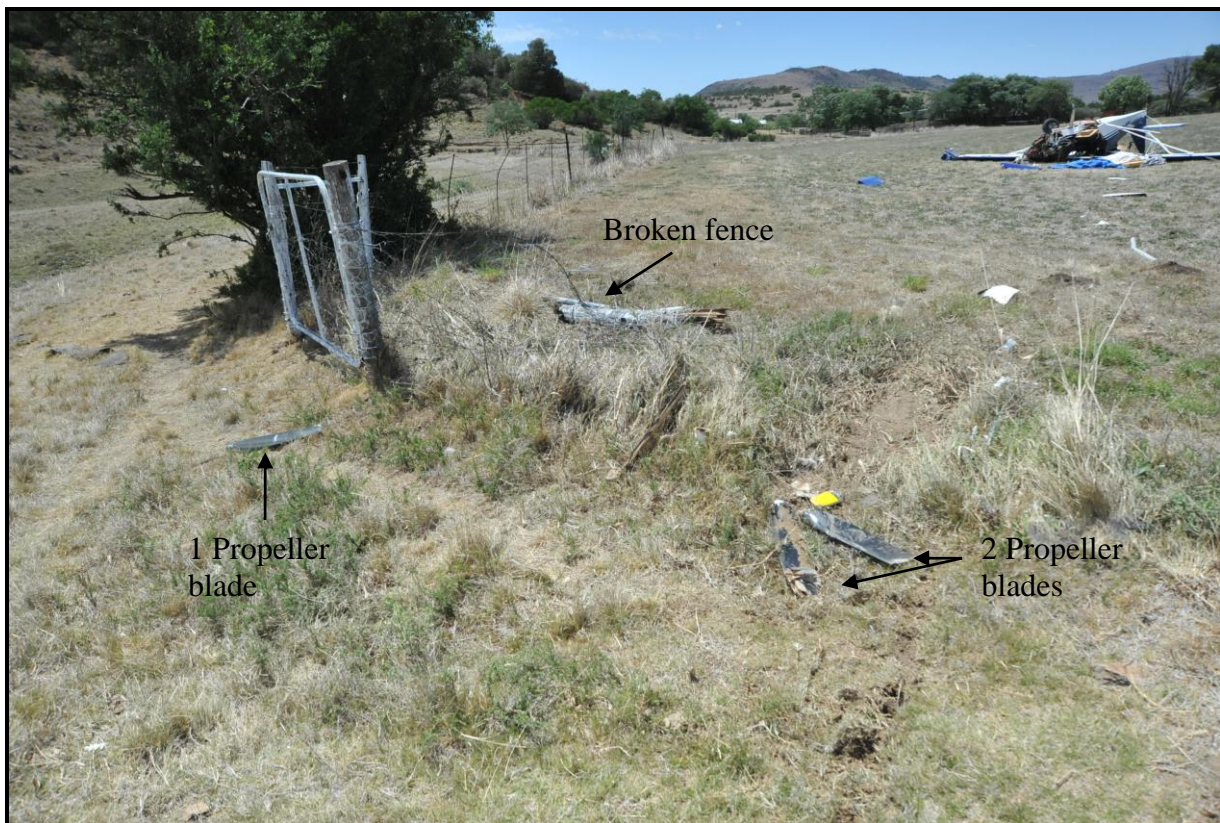
1.4.1 Perimeter gate and fence situated 40m from Runway 32 threshold (See Figure 6).

The propeller blades showed evidence of the engine being under power prior to the accident. During the impact, all three propeller blades separated from the hub. The damage to the propeller indicated that the engine had power at impact.

Figure 6: Damaged parameter fence, propeller blades and the wreckage.
