AIRCRAFT ACCIDENT REPORT AND EXECUTIVE SUMMARY

Reference:	CA18/2/3/9703	
Aircraft Registration	ZS-DIV	Date of Accident	29 November 2018		Time of Accident	1503Z
Type of Aircraft	Cessna U206D (Aeroplane)		Type of Operation		Private (Part 91)	
Pilot-in-command Licence Type	PPL Validation	Age	49		Licence Valid	Yes
Pilot-in-command Flying Experience	Total Flying Hours	175.0		Hours on Type	7	
Last Point of Departure	Nelspruit Aerodrome (FANS), Mpumalanga Province					
Next Point of Intended Landing	Wonderboom Aerodrome (FAWB), Gauteng Province					
Location of the accident site with reference to easily defined geographical points (GPS readings if possible)						
Machadodorp Sappi forestry at GPS co-ordinates S25°28'36.47" E30°37'.01.22" at an elevation of 4 697ft above mean sea level (AMSL).						
Meteorological Information	Wind: 90°/4 knots; Temperature: 17°C; Dew Point: 11°C; Visibility: Overcast, Clouds; 1500 ft					
Number of People on-board	2 + 3	No. of People Injured	4		No. of People Killed	1

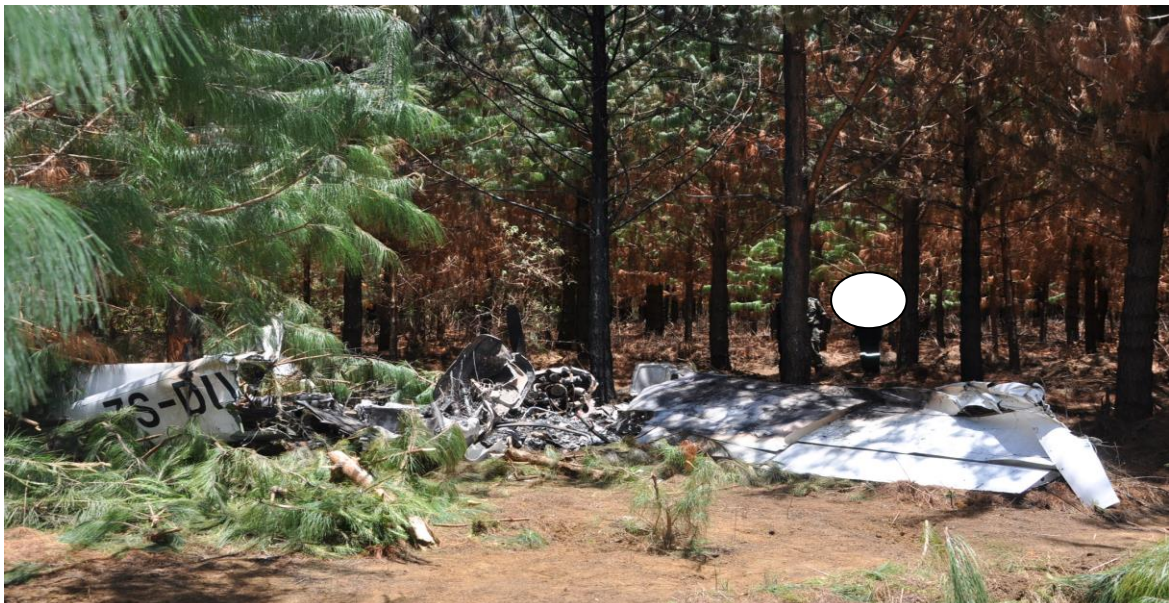
1.3.1 The aircraft was destroyed by impact forces and a post impact fire that ensued after the crash.

Figure 2: The condition of the wreckage as found at the accident site.

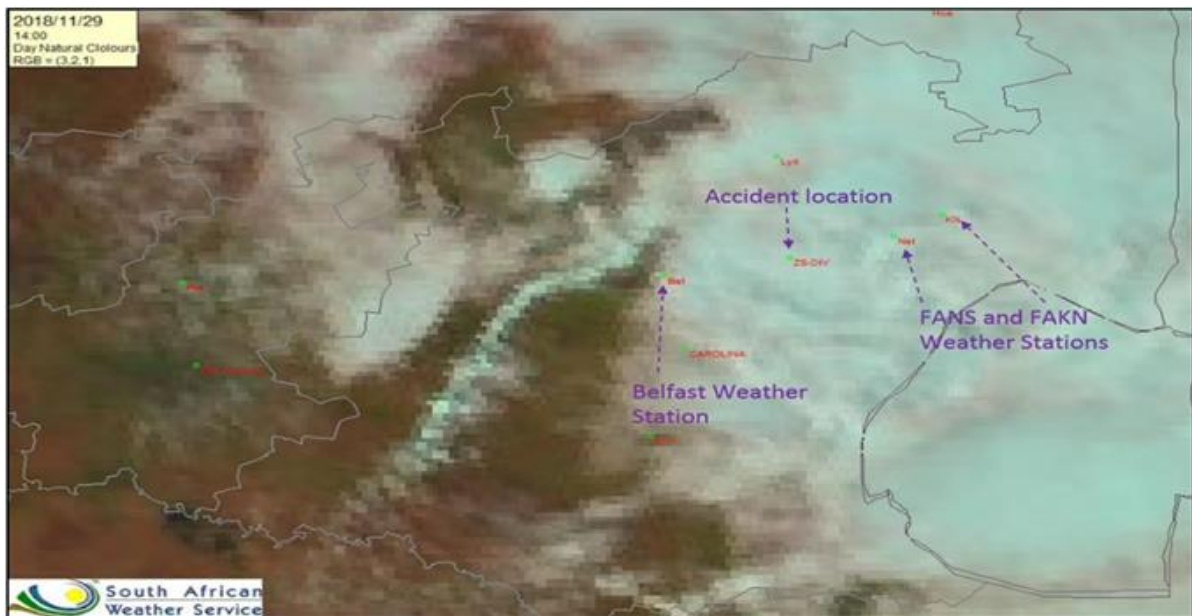
NOTE: The satellite image recorded overcast low-level clouds around the accident time between Nelspruit and Belfast (see Figure 4). Clouds on the satellite image have a whitish appearance with the land surface depicted in a brown shade; the vegetated areas green.

Figure 4: The satellite image recorded by the SAWS on 29 November 2018.

- 2.2.5 The satellite image from the South African Weather Service (SAWS) showed low-level clouds around the accident area between Nelspruit and Belfast with reported overcast conditions around the accident site.

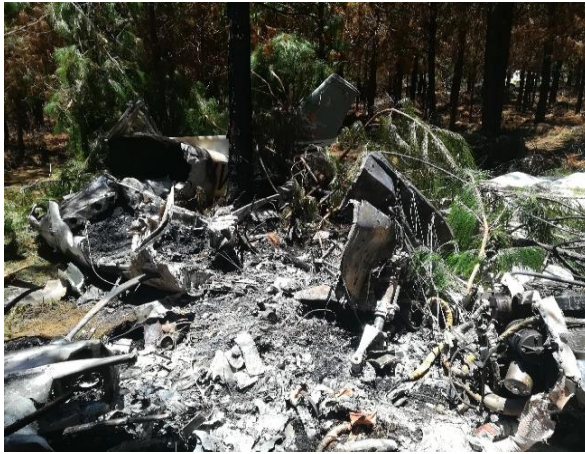
Figure 6: Flaps position after the accident. post-accident.

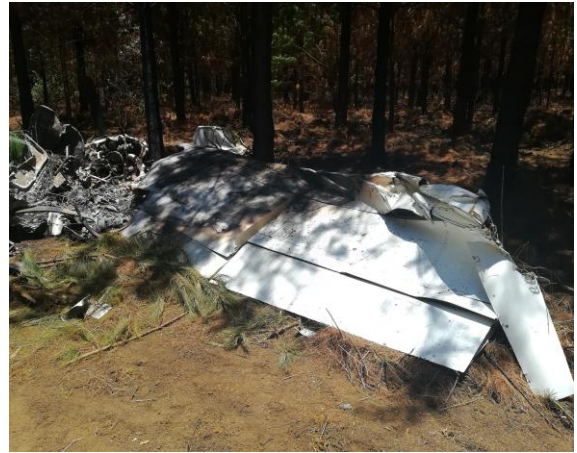
1.12.1 Examination of the wreckage at the accident site revealed that damage to the aircraft and the surrounding trees was consistent with the aircraft approaching the crash site with its wings-level and nose-up attitude. The entire aircraft and all control surfaces were located at the main wreckage site. Control continuity was established for all flight controls. The flaps were in a retracted position prior to impact. The empennage survived the fire. The landing gear broke and all three tires were

Figure 5: The remains of the landing gear.

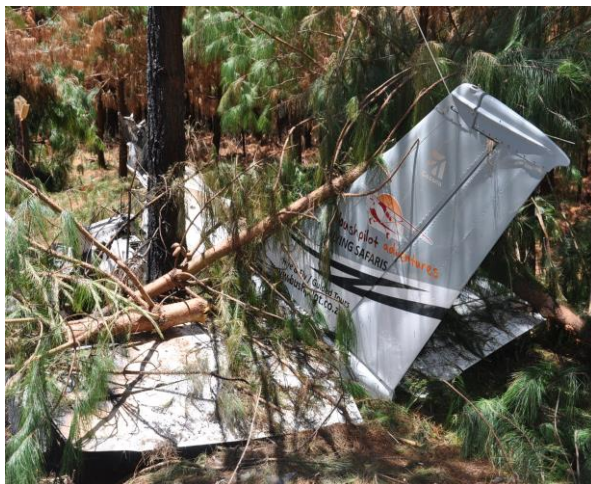
Figure 7: The aircraft tail section after the accident.

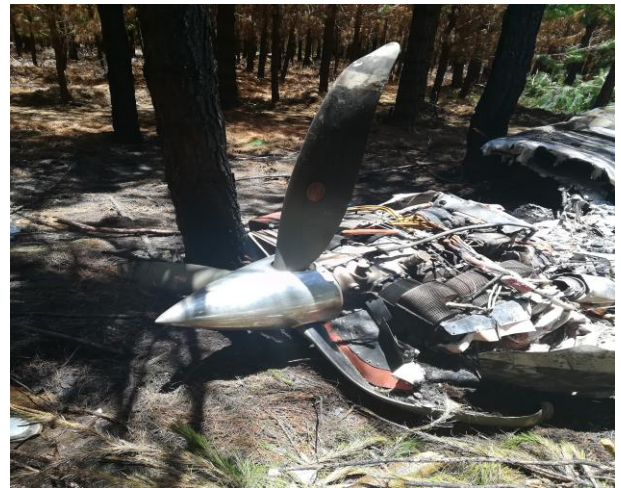
burned. The engine had evidence of an engine producing a substantial amount of power before the accident occurred. The engine remained attached to the airframe with its tubular mount. The engine-driven fuel pump remained attached to the engine. The hose from the pump to the carburettor was separated at the carburettor fuel inlet fitting and fuel was expelled from the hose as the engine was rotated. Both magnetos remained attached to the engine and no damage was noted.

Figure 8: The engine and propeller after the accident.
