<b>AIRCRAFT ACCIDENT SHORT REPORT</b>
---------------------------------------

**CA18/2/3/9758**, ZS-RLV, Unsuccessful forced landing following a decay in main rotor RPM while flying at low level

**Date and time** : 3 December 2018, 1530Z  
**Location** : Farm Potgietersleger, Ventersburg district, Free State Province  
**Occurrence type** : Accident  
**Aircraft registration** : ZS-RLV  
**Aircraft manufacturer and model** : Robinson Helicopter Company, R22 Beta  
**Last point of departure** : Farm Erfenis  
**Next point of intended landing** : Farm Erfenis  
**Location of accident site with reference to easily defined geographical points (GPS readings if possible)** : Farm Potgietersleger, 28°08'01.58" South 027°19'29.29" East  
**Meteorological information** : Surface wind: 240°/11 kt gusting 20 kt, temperature: 33°C, CAVOK  
**Type of operation** : Commercial (Part 127)  
**Persons on board** : 1 + 1  
**Injuries** : None  
**Damage to aircraft** : Substantial

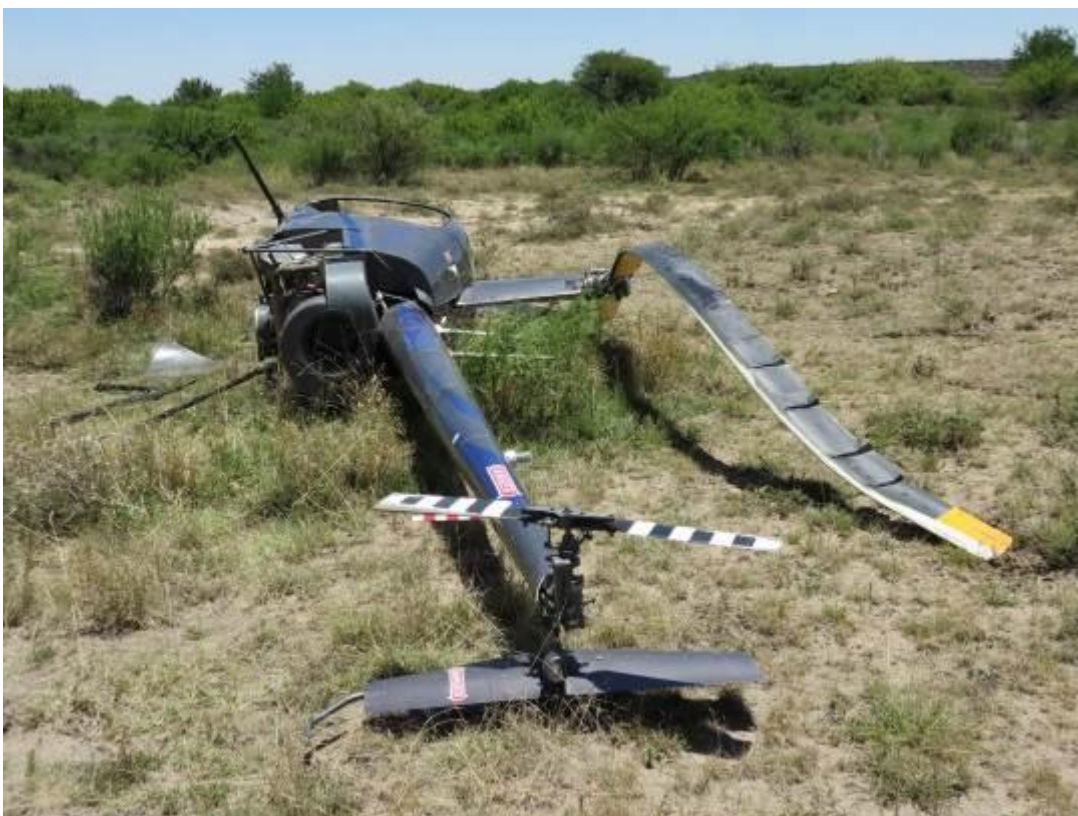
The helicopter came to rest on its right side on a heading of 300°M. Several main rotor blade strike markings were evident in the hard dry soil next to the wreckage where it came to rest, despite the fact that the main rotor blades remained attached to the main rotor hub assembly (though severely deformed). The tail boom as well as the tail rotor control assembly remained attached to the fuselage. No damage was visible to the tail rotor assembly, as can be seen in Figure 4. Apart from the left windshield, which broke during impact, the cockpit/cabin area remained intact, including the instrument cluster (Figure 5). The skid gear broke off during the impact sequence and was lying in close proximity to the main wreckage, with the right skid trapped underneath the helicopter (on the pilot's side) (Figure 5). The pilot indicated that he had closed the fuel shut-off valve after they had evacuated the cabin area. Figure 6 shows the densely vegetated terrain they were flying over when they encountered the sudden gust of wind from behind. The pilot stated that he was afraid that they were going to collide with an embankment and was trying to clear it in order to mitigate the risk of injury, when they impacted with level ground.

**Figure 2:** The helicopter as it came to rest

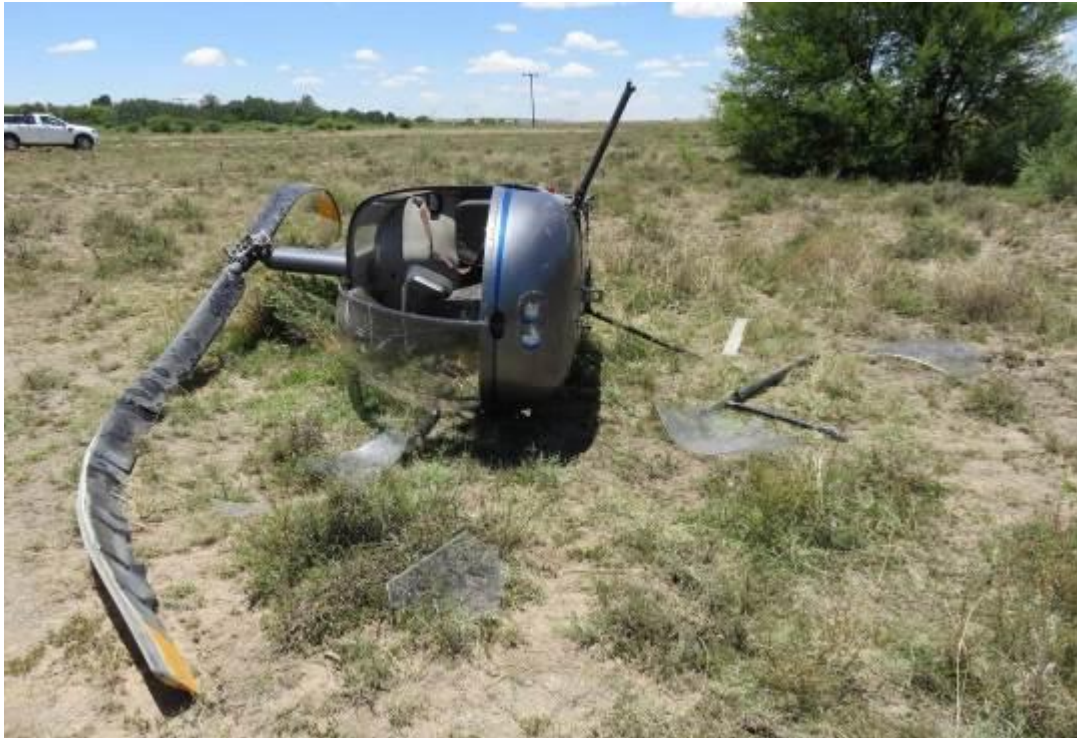
**Figure 3:** A front view of the helicopter as it came to rest

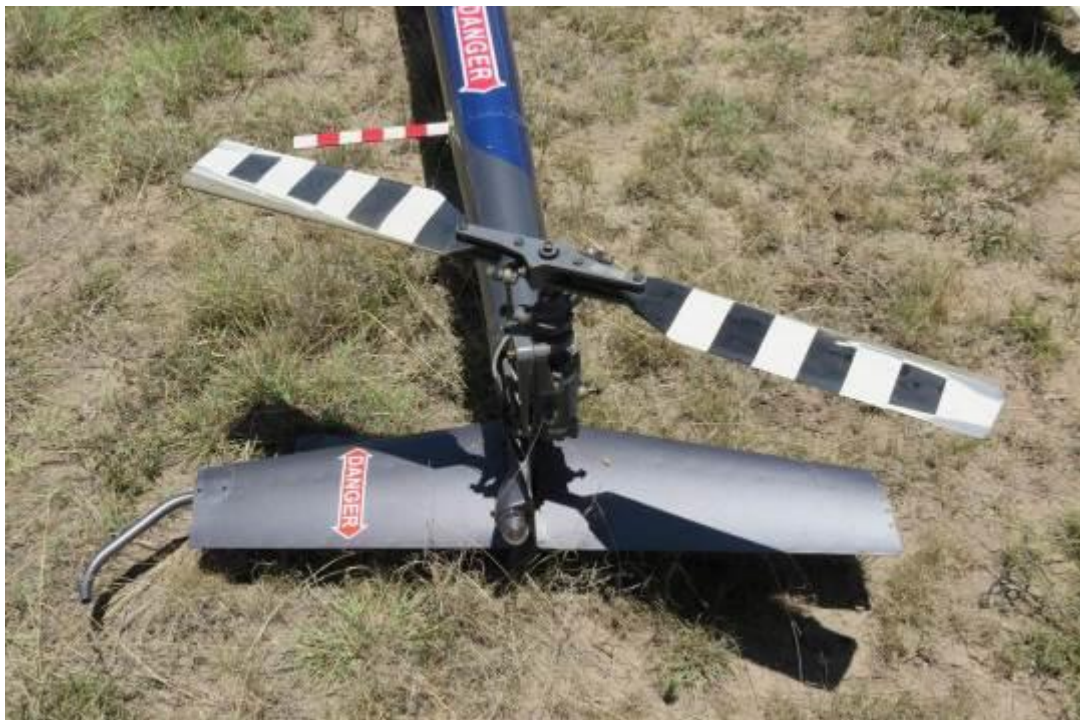
**Figure 4:** A view of the tail rotor assembly, which did not sustain any damage

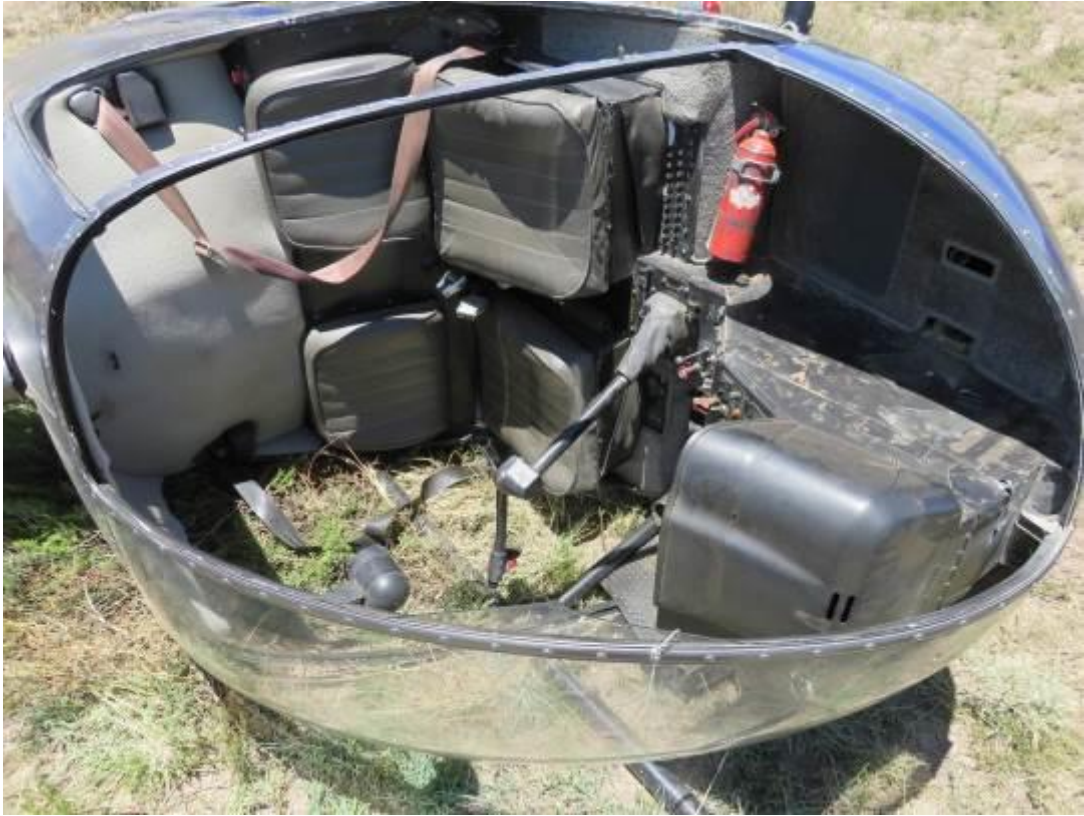
**Figure 5:** A view of the cockpit/cabin area, which remained intact apart from the left windshield that broke

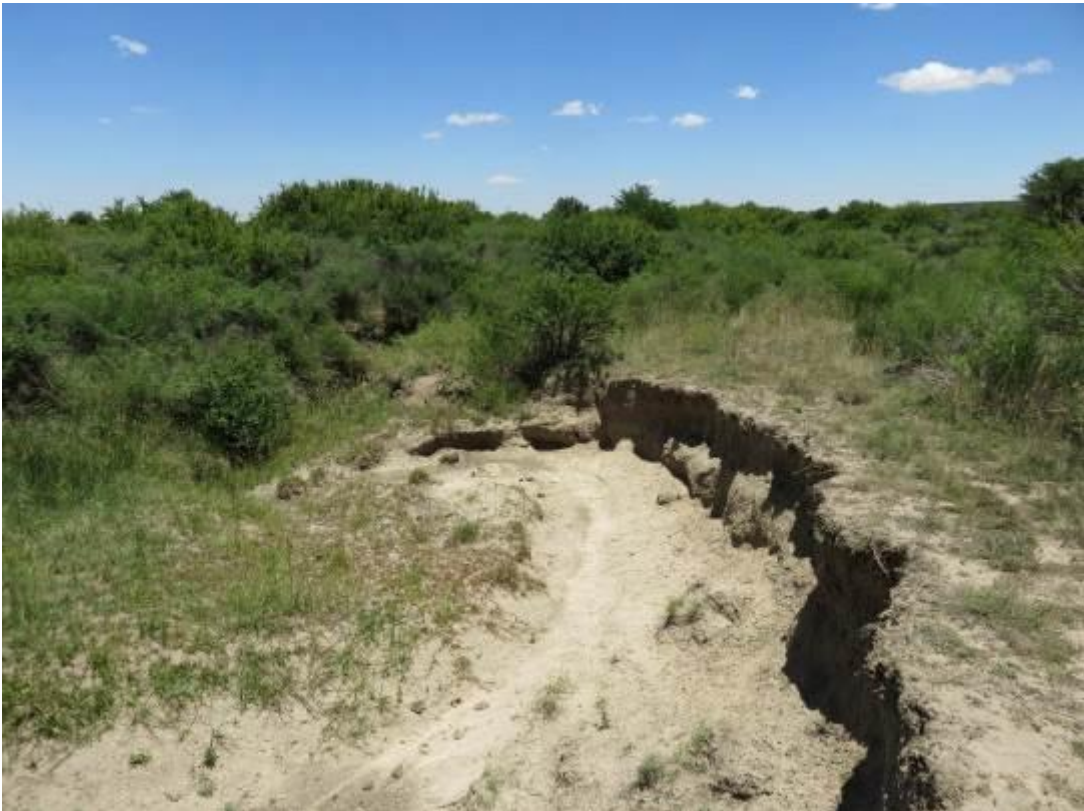
**Figure 6:** A view of the eroded terrain/embankment the pilot had to clear
