Islamic Republic Of Iran
Civil Aviation Organization
Aircraft Accident Investigation Board

Final Report

Aircraft Model: A310-300

Registration: EP-MNV

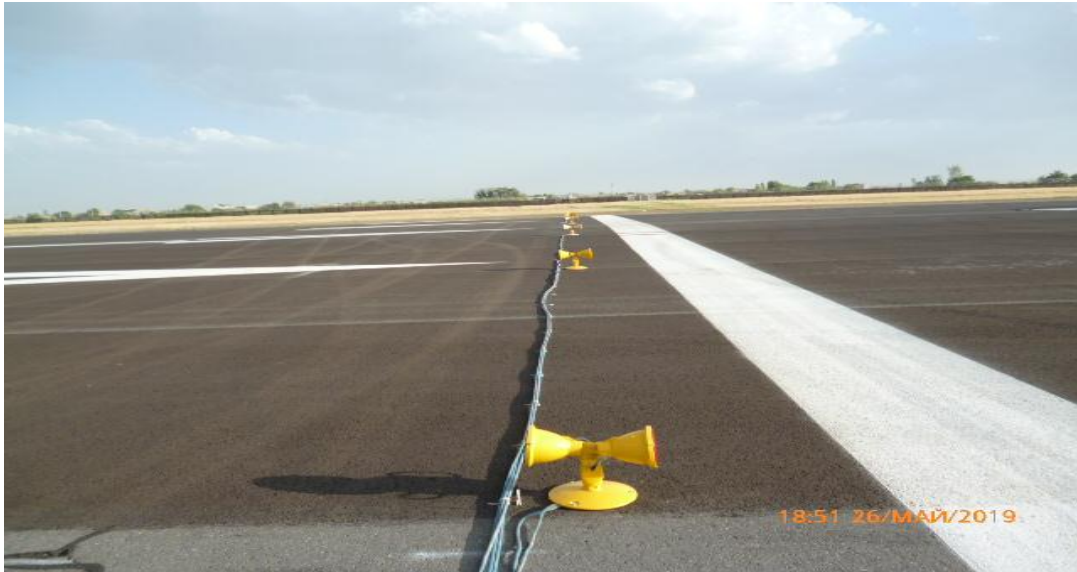
ZVARTNOTS International Airport (UDYZ/EVN) located 10 km west from city of Yerevan. RWY Dimension is 3850×56 m/ Asphalt. At the time of incident, the available RWY length was 2400m (3850 meters excluding displaced threshold 1450m from beginning of RWY 27). There was white arrow marking as well as lined threshold sign marking with elevated lights on the displaced threshold.

In accordance with NOTAM A0058/19 RWY declared distance are as below: RWY 09: TORA 2400M TODA 2850M ASDA 2850M LDA 2400M

RWY 27: TORA 2400M TODA 2850M ASDA 2800M LDA 2400M

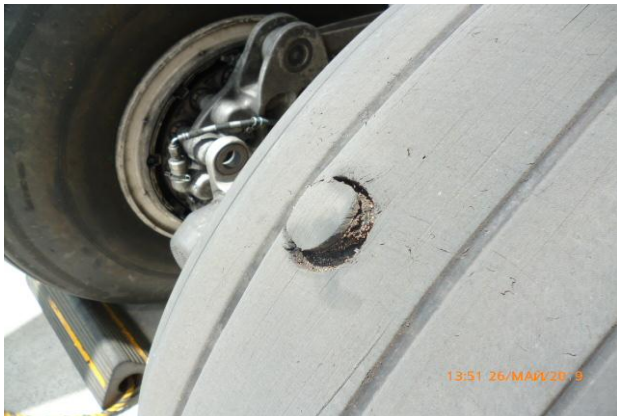
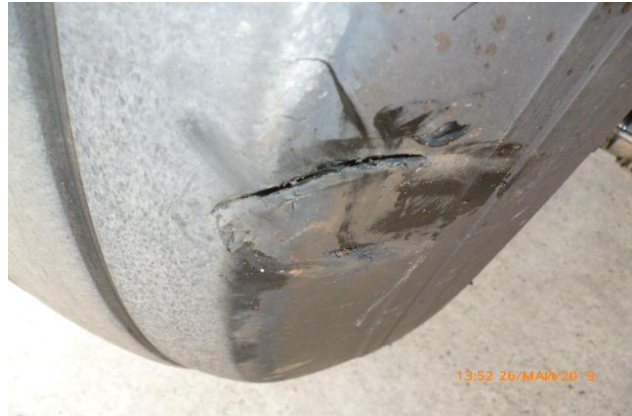
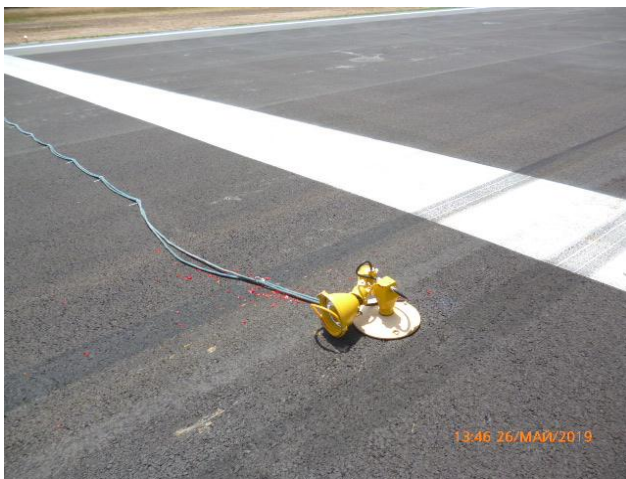
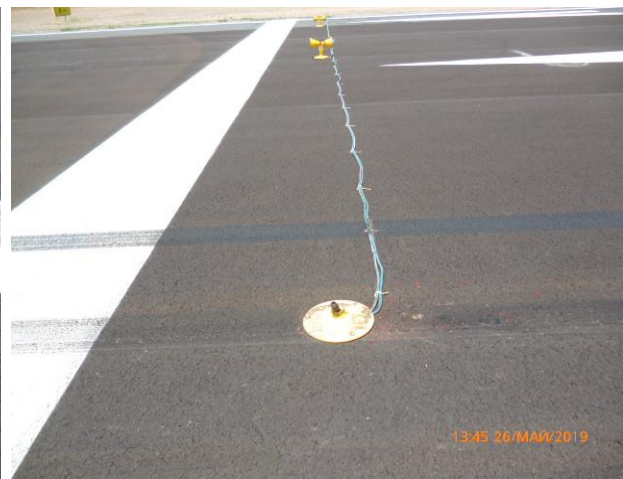
- There was not any deflection on the airframe and control surfaces.
- There were signs of impact of elevated threshold light as well as deep cuts on the main landing gear tires which did not permit the aircraft to continue more flights.

- The elevated lights across the runway as a RWY end light caused a hazard for the flight which caused damage on the aircraft tires.

Due to serious damage of No.5 and No.6 tires by a deep cut, the aircraft grounded at Zvartnots INTL Airport and tires were changed by the new serviceable ones and aircraft was released and returned to Imam Khomeini INTL Airport/Tehran safely.
