National Transportation Safety Board Aviation Accident Final Report

Location:	Uvalde, TX	Accident Number:	CEN19LA054
Date & Time:	01/12/2019, 1130 CST	Registration:	N813WT
Aircraft:	Canadair CL 600 2A12	Aircraft Damage:	Substantial
Defining Event:	Hard landing	Injuries:	9 None
Flight Conducted Under:	Part 91: General Aviation - Business

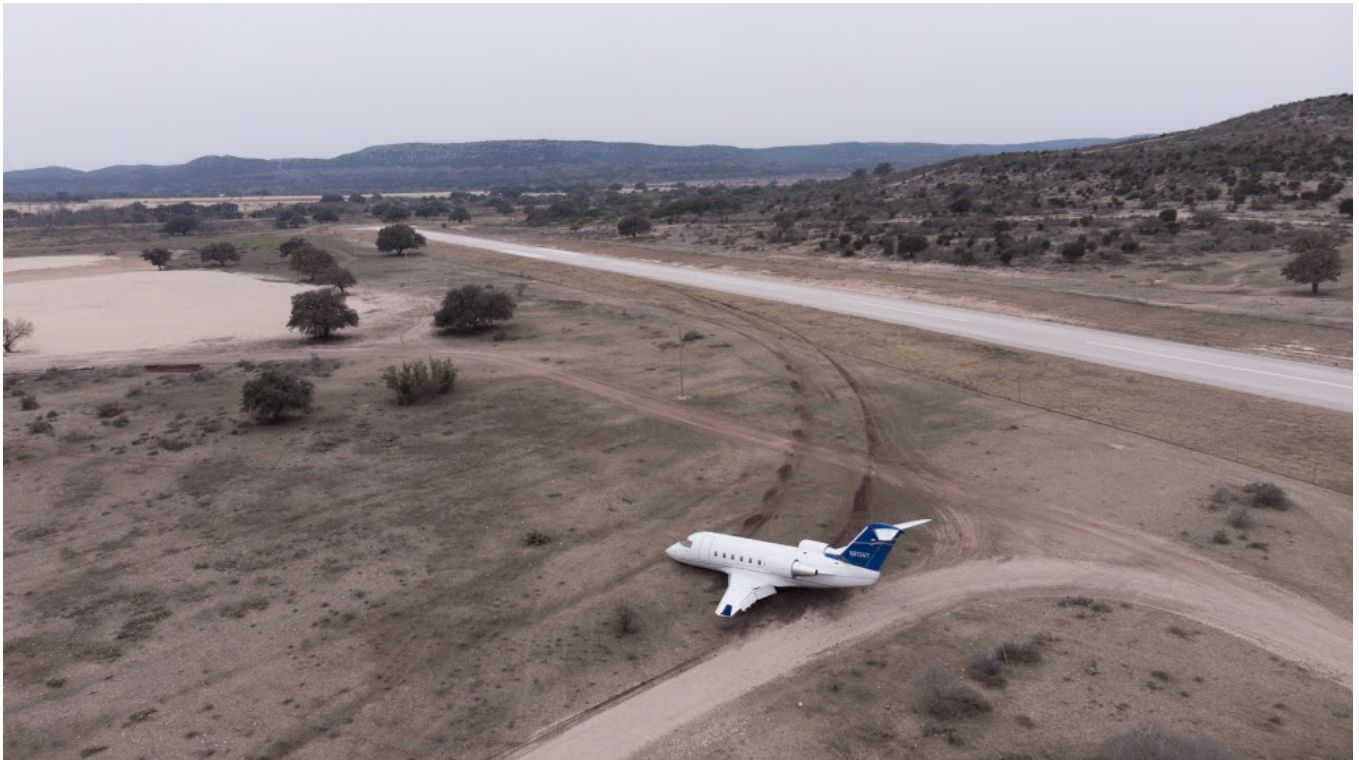
Figure 1: Accident Scene

A representative for the airport reported that the airplane on landing hit hard. About two-thirds of the way down runway 35, the airplane slid off the right side of the runway. The airplane proceeded through a ditch and struck a perimeter fence before coming to a stop.

The airplane wreckage was in a field near a dirt service road on airport property, about 2,100 ft. east of runway 35. The airplane was upright and oriented on a 170° heading. Preceding the airplane were two sets of parallel skid marks in the dirt that began about 1,600 ft from the runway threshold and curved along the ground ending at the airplane. Also preceding the airplane was a three inch wide, 2 inch deep, and 1,500 ft long gouge in the runway asphalt that began 53 ft from the runway threshold and ran parallel to the right side of the runway to where it ended, the point where the airplane departed the right side of the runway.

The airplane was intact and rested on the right wing, left main landing gear, and the nose section beneath the flight deck. A portion of the airport perimeter fence was found embedded in the vertical fin leading to the vertical stabilizer. The right main landing gear was broken aft and collapsed under the right wing. It remained attached to the airplane at the main gear side strut retraction actuator. The right winglet and leading edge of the right wing showed impact damage along their spans. The trailing edge of the right wing and spar structure at the right main landing gear wheel well were bent and broken upward. The inboard portion of the right inboard flap was broken upward at the wing root. A black rubber mark corresponding to the
