**AIRCRAFT ACCIDENT REPORT AND EXECUTIVE SUMMARY**

<b>Reference:</b>	CA18/2/3/9767	
<b>Aircraft Registration</b>	ZS-OOB	<b>Date of Accident</b>	29 January 2019		<b>Time of Accident</b>	0552Z
<b>Type of Aircraft</b>	Pitts Special S-2B		<b>Type of Operation</b>	Private (Part 91)		
<b>Pilot-in-Command Licence Type</b>	Commercial Pilot Licence		<b>Age</b>	71	<b>Licence Valid</b>	Yes
<b>Pilot-in-Command Flying Experience</b>	<b>Total Flying Hours</b>		6497.7	<b>Hours on Type</b>	1012.8	
<b>Last Point of Departure</b>	Rand Aerodrome (FAGM), Gauteng Province					
<b>Next Point of Intended Landing</b>	Rand Aerodrome (FAGM), Gauteng Province					
<b>Location of the accident site with reference to easily defined geographical points (GPS readings if possible)</b>						
Kliprivier area in Gauteng Province at GPS co-ordinates: 26° 26' 12.50" South 028° 7' 16.31" East and at a field elevation of 4922ft AMSL						
<b>Meteorological Information</b>	Wind: 326° at 14kts, Temperature: 27 °C, Dew Point: 12 °C, Visibility: 9999m and QNH: 1027 hPa.

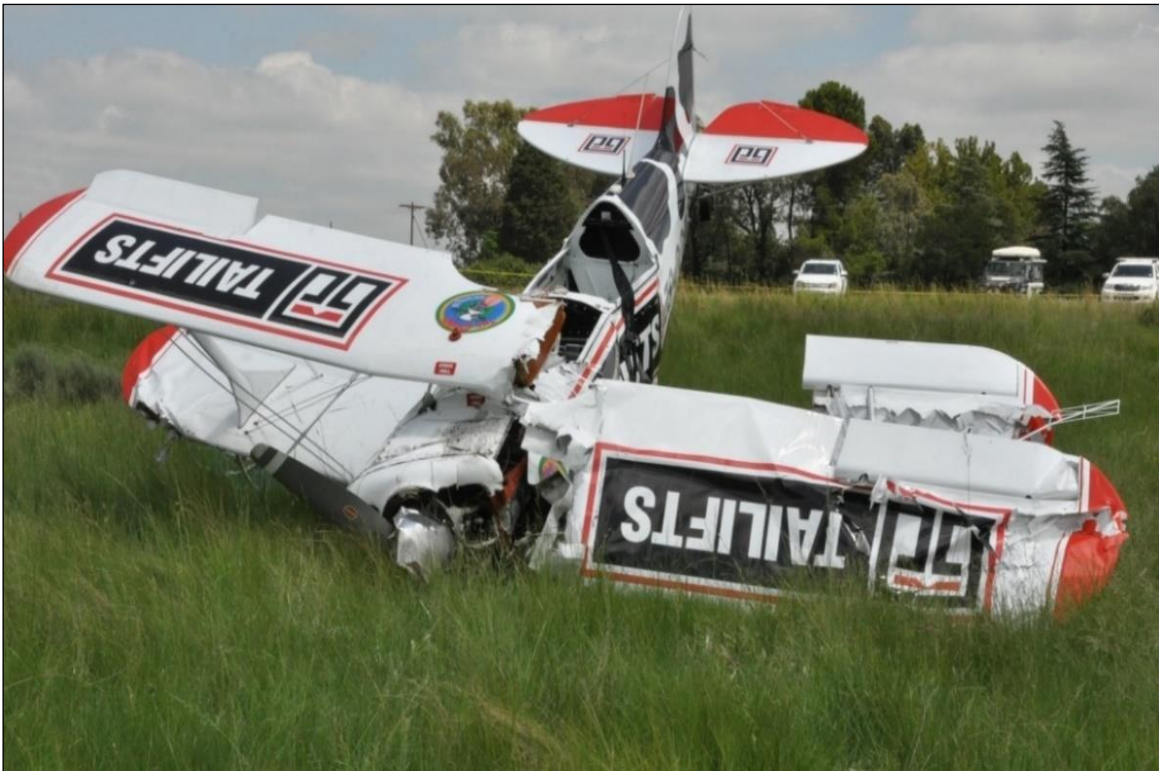
1.3.1. The aircraft was destroyed during the accident sequence.

**Figure 2:** The damaged aircraft post-accident.

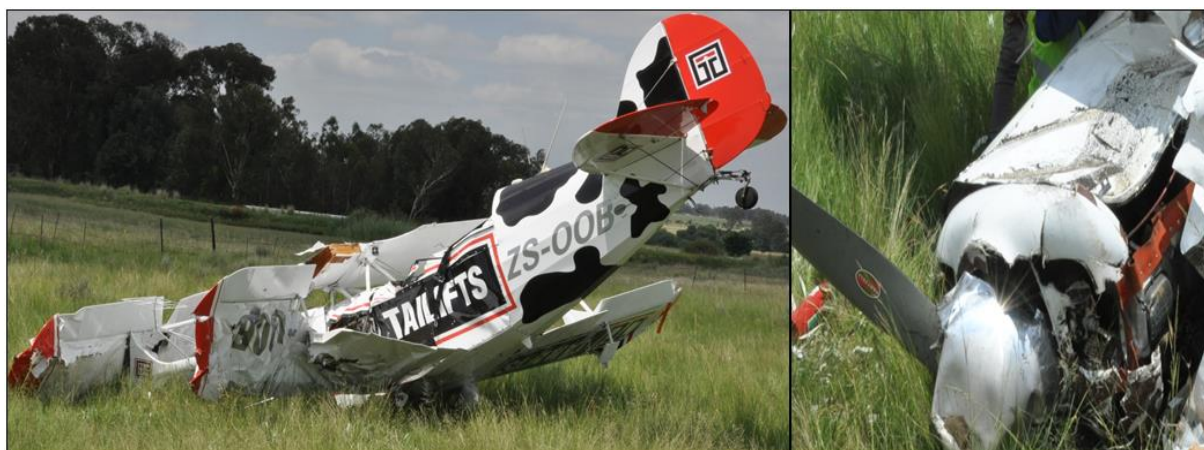
**Figure 3:** Damages on the aircraft's left side, engine compartment and propeller spinner.

- 1.12.2. Wreckage observation revealed that the aircraft impacted the ground in a left-wing attitude, consistent with a left-wing sideslip, followed by the engine and the right wing. The aircraft debris at the accident site was consistent with the described accident sequence.
- 1.12.3. Both the left-side wings and the right-side bottom wing were destroyed during the accident sequence. The engine propeller and nacelle sustained substantial damages. The propeller sustained damage on one of its blades, which is an indication that the engine was not under power prior to impact. The propeller spinner was damaged during the accident sequence. The aircraft's canopy was found on the right-side of the aircraft near the tail, with the Perspex damaged.
- 1.12.4. The aircraft was flown from the rear seat (this was indicated by evidence of the front cockpit being configured for rear flight control).

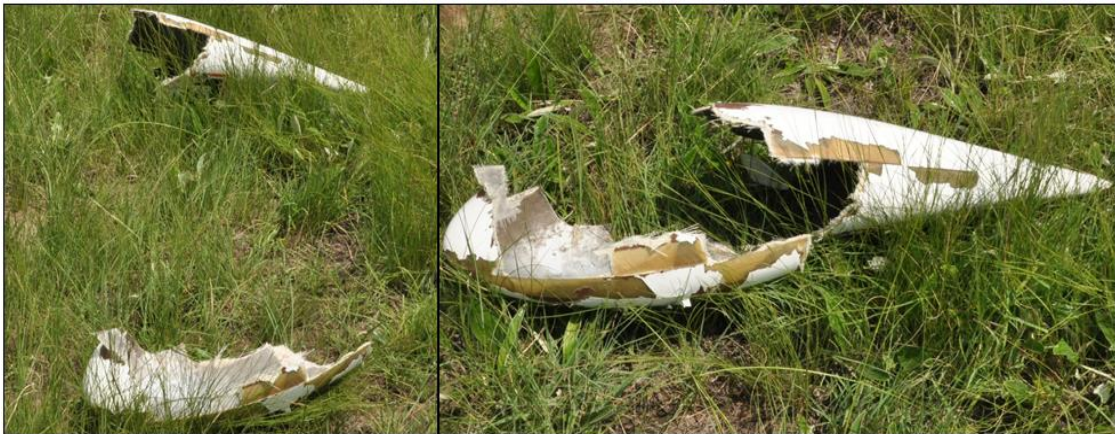
**Figure 4:** The detached left main landing gear wheel fairings covers.

- 1.12.5. The main landing gears were damaged, and the left main wheel fairing detached.
- 1.12.6. The engine had two holes on the top cover near cylinder No.3 and No.6 assembly positions, with the connecting rods protruding.

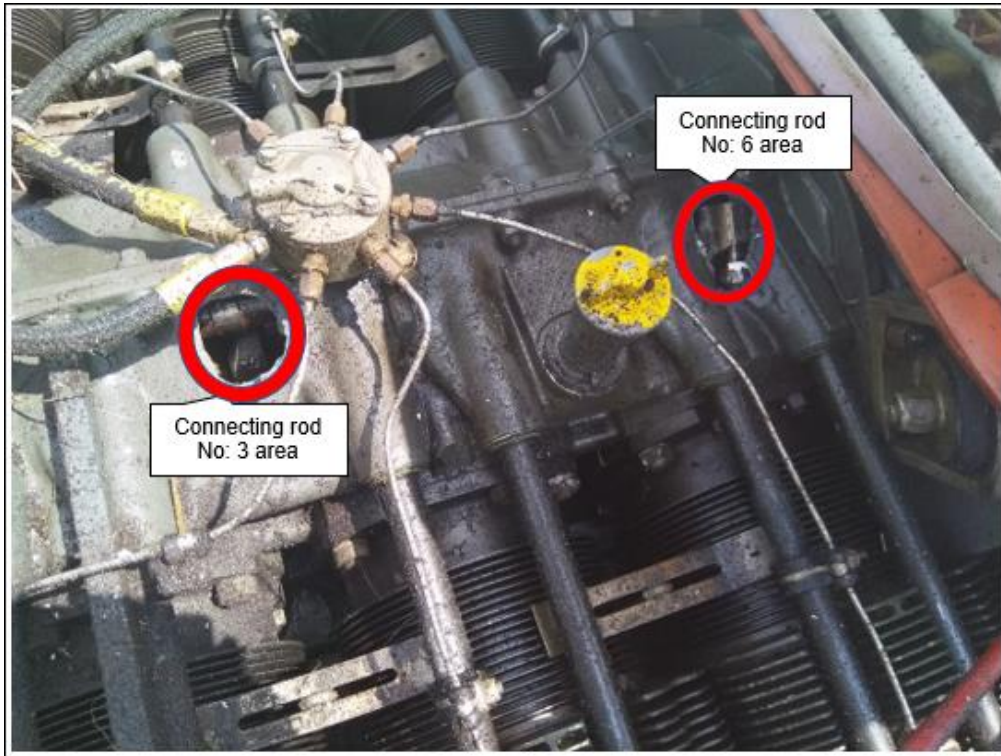
**Figure 5:** Orange circles show holes in the engine crankcase in the No.3 and No.6 cylinders.

1.12.7. Although the pilot had stated that oil had splashed on the windshield, there was no evidence of oil at the accident site and on the aircraft's windshield during the on-site investigation. Oil residue was confined to the engine compartment as shown in Figure 5.

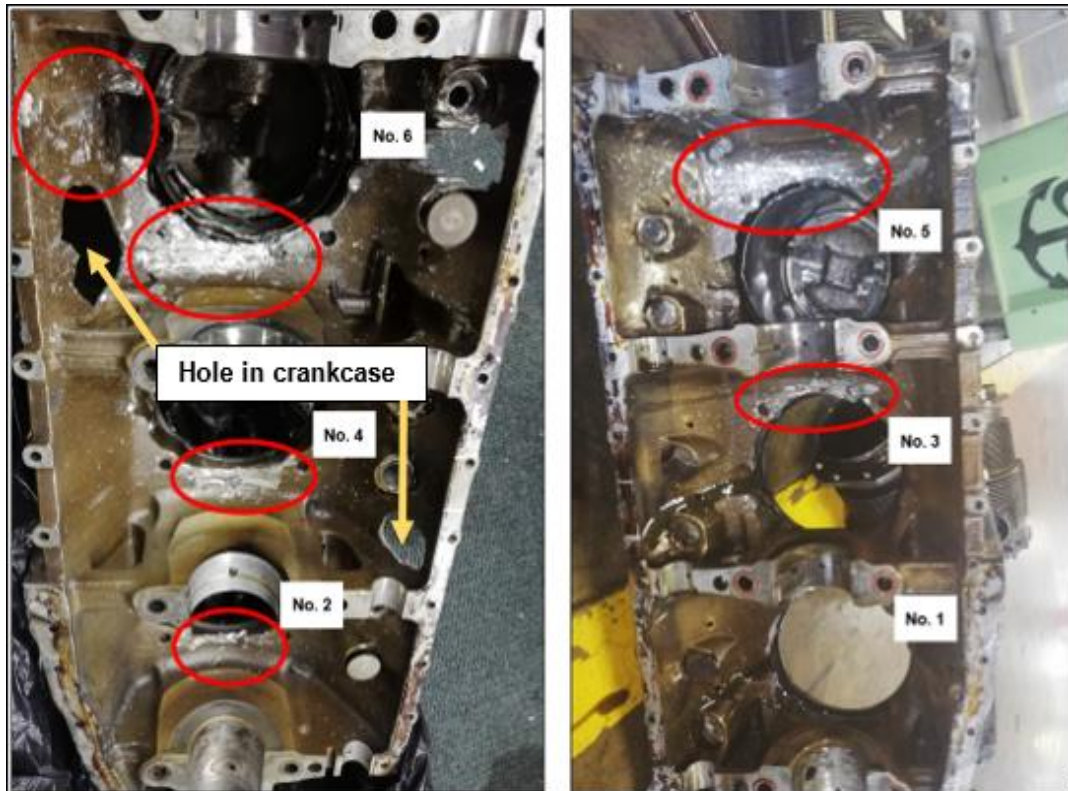
**Figure 6:** Severe impact marks and dents (circled in red) inside the crankcase from ricocheting debris from the No.6 connecting rod after failure. The yellow arrows show the holes in the crankcase caused by the No.3 and No.6 connecting rods.

- After separating the crankcase, severe multiple sites of impact marks and dents were observed throughout the internal crankcase and other components caused by ricocheting

debris of the No.6 connecting rod following its fracture while the crankshaft was still rotating. The marks and dents were more pronounced around the No.6 and No.5 piston areas, while the severity of the marks decreases around the No.4, No.3, No.2 and No.1 piston areas, respectively (see Figure 7). This was an indication that the No.6 connecting rod had failed first, followed by the No.3 connecting rod.

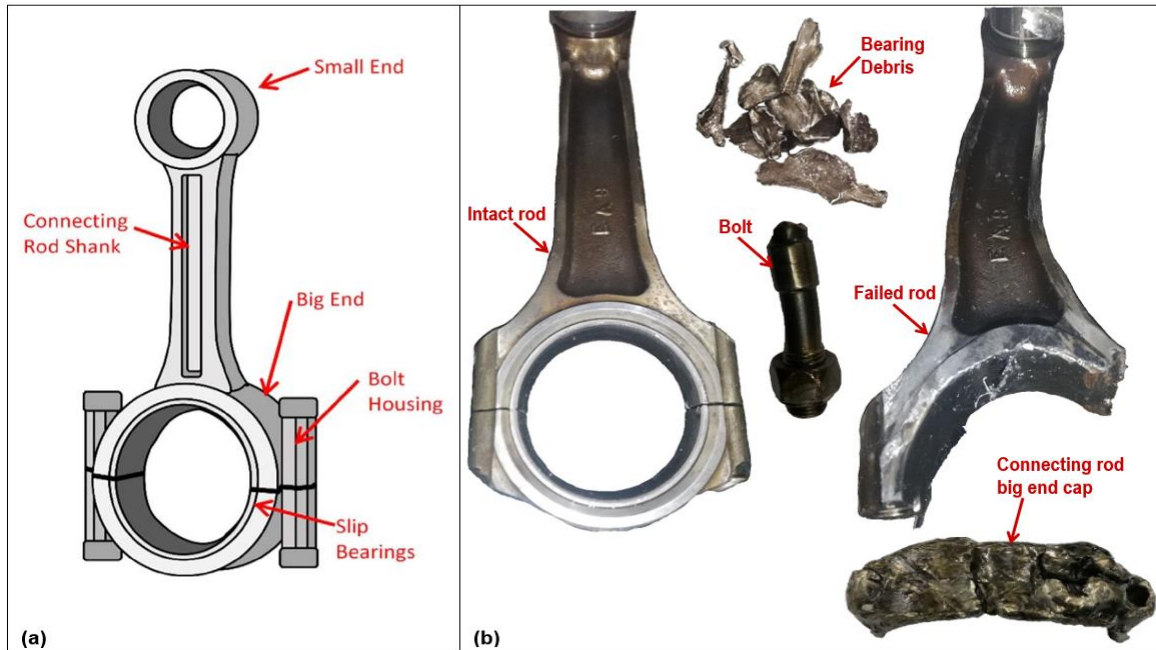
- Figure 7 shows that the No.5 and No.6 piston cylinders were jammed in the crankcase; these could not be removed due to distortion from impact, making it difficult for the dismantling team to separate the two halves of the crankcase. A destructive method was used to separate the crankcase.
- There was evidence of oil in the engine. Also, debris from the crankcase was found in the oil sump.

- The No.6 connecting rod was jammed in the crankcase. Remnants of the No.6 piston connecting rod big-end housing were damaged extensively, and the rest of the housing was recovered from the oil sump.

- The nature of the failure of the No.6 connecting rod indicated that the big-end housing had been destroyed during operation before disintegrating due to the impact forces and before it got stuck in the crankcase hole.

- The No.6 connecting rod was discoloured, which indicated a prevalence of heat build-up during operation prior to its failure. The presence of excessive heat in the region had caused a drop in the yield strength, ultimately leading to micro crack formation that spread rapidly through the big-end housing.

- The bearing material had been forced out of the bearing caps, leaving the connecting rod running on the steel housing. This was indicated by the reduced thickness of the bearing inserts. (Figure 7 shows an illustration and a picture of the intact connecting rod compared to the failed connecting rod from the failed engine.)

- The No.6 connecting rod and bearing cap had broken into four parts and the remnants of the recovered bolt exhibited failure on overload, which is characterised by necking (elongation).

**Figure 7:** (a) For reference, the key parts of a generic connecting rod assembly; (b) the intact No.5 connecting rod and the failed No.6 connecting rod with failed components.

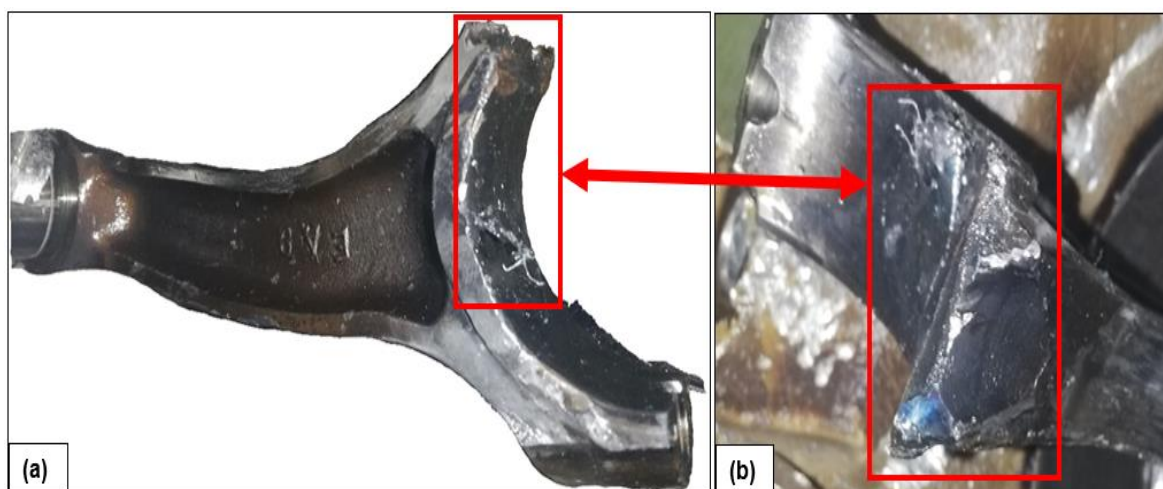
Evidence of heat tinting was observed, suggesting the existence of thermal hotspots in the material which contributed to the connecting rod failure. (Figure 8b shows the fractured surface; the red block indicates the suggested region of crack initiation.)

- Sections of the slip bearing had melted onto the inner control rod big-end of the connecting rod (all referred to as galling) because of substantial amount of heat that was generated by friction between the bearing and the connecting rod big-end, primarily due to oil starvation.

**Figure 8:** The failed connecting rod; (a) fractured and blackened big-end rod and melted bearing; (b) a closer view of the fractured point showing heat tinting.

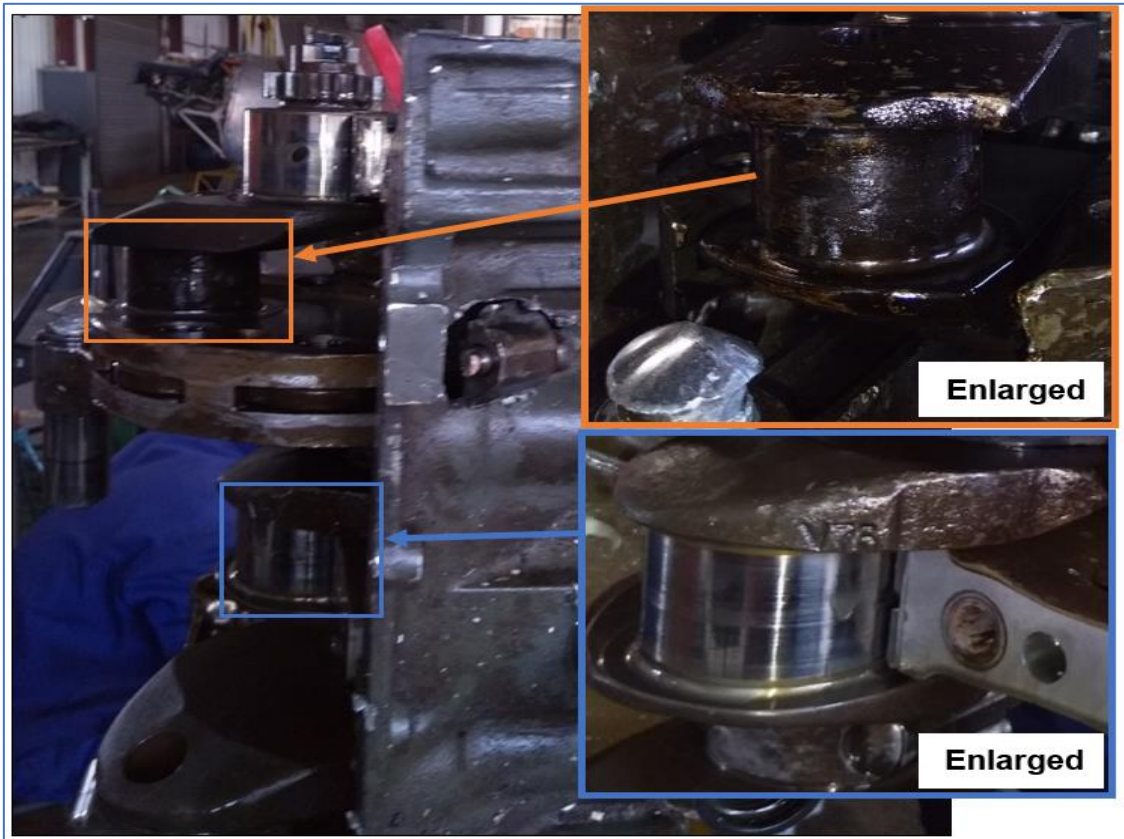
- The crankshaft counterweights were intact. The No.6 crankshaft journal was discoloured, an evidence of overheating.

**Figure 9:** The orange block and arrow show the discoloured No.6 crankshaft journal. The blue block and arrow show the No.5 crankshaft journal without discolouration.
