AIRCRAFT ACCIDENT SHORT REPORT

CA18/2/3/9768: ZU-INH: During a low-level aerial flight in the Kruger National Park the engine stopped, and the pilot executed a forced landing.

Aircraft registration : ZU-INH

Aircraft manufacturer and model : Aeroprakt Ltd, A22-LS

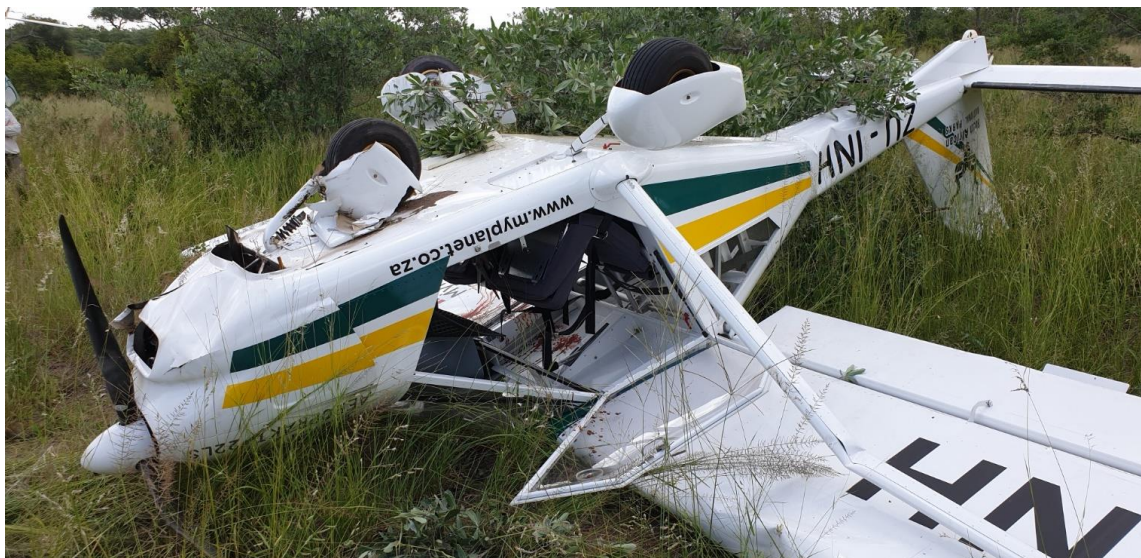
- 2.1.5 From this point on, the pilot focused outside in an attempt to find a place where he could execute a forced landing. He stated that the area straight ahead of him was densely vegetated with high trees. The area 45° to his left appeared to be slightly more open, and he turned in that direction and lined up the aircraft; he called Mayday three times. He stated that he brought the speed down to almost stall speed before touching down. Approximately 5 to 10 metres after touchdown, the nose wheel dug into the soft soil and the aircraft nosed over, coming to rest in an inverted attitude.

Figure 1: The aircraft as it came to rest in an inverted position.

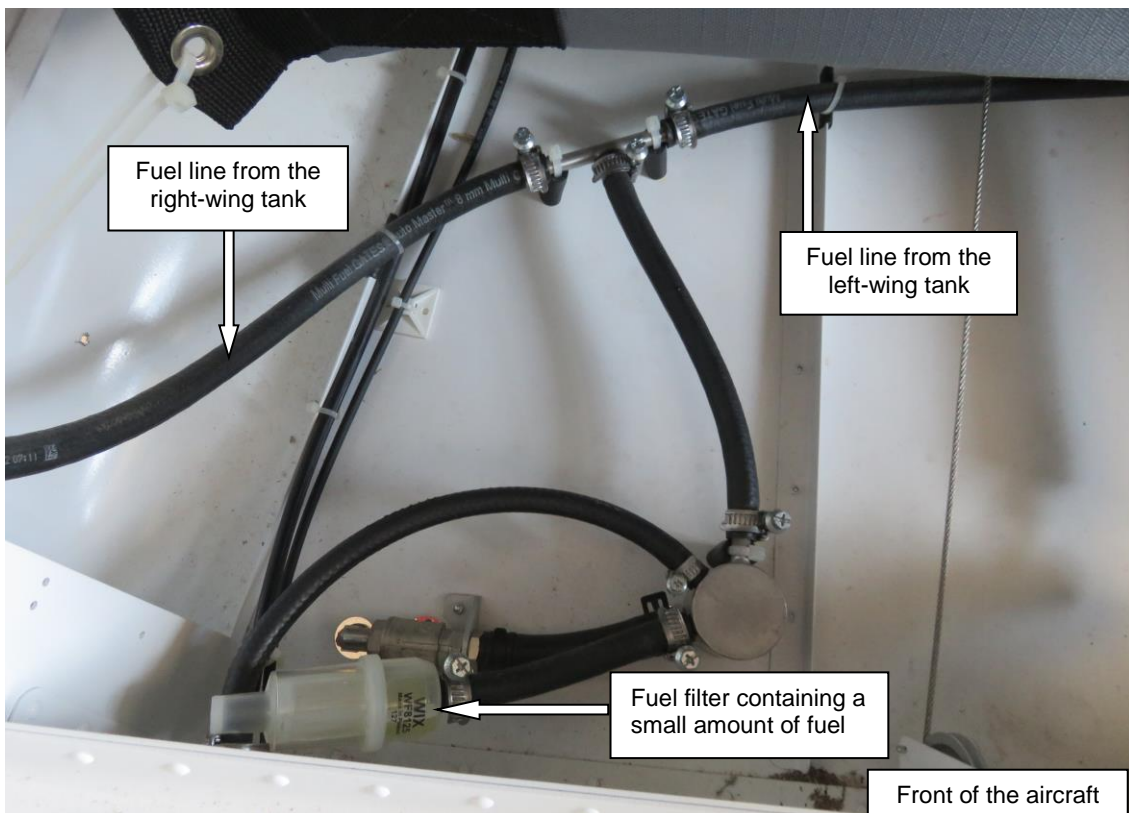
Figure 4: Fuel lines from the left- and right-wing tanks feeding under gravity into a T-fitting (this fuel plumbing is installed behind the two seats)

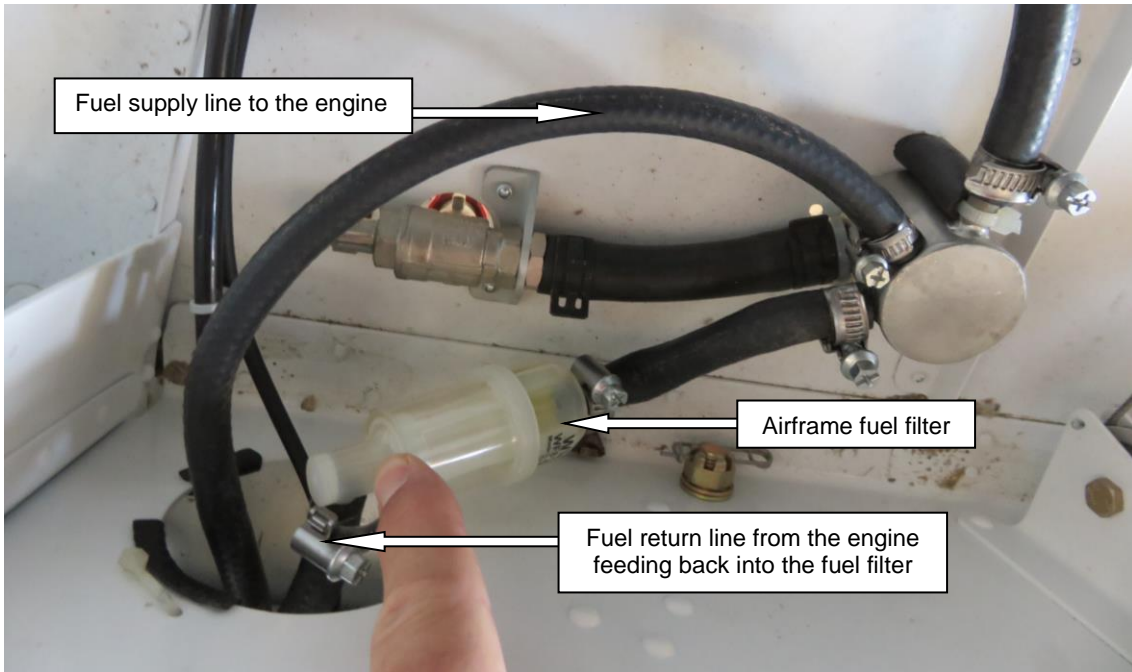
Figure 5: The airframe fuel filter located behind the right seat

- 3.15 The fuel return line (airframe fuel system) was installed on the accident aircraft but did not route back to the fuel tank (suction side of the fuel system) as discussed in sub-paragraph 2.1.14 of this report and also as per the official Rotax fuel system as contained in the Installation Manual (Annexure B). Instead, it was connected to the airframe fuel filter as depicted in Figure 5.

- 9.2 The fuel return line from the engine to the airframe should meet the prescribed guidelines as called for by the Rotax Information Safety Notice: 912 Series Fuel Return Line (Mandatory) whereby the fuel return line should root back to the fuel tank(s), which would include the fuel suction system.

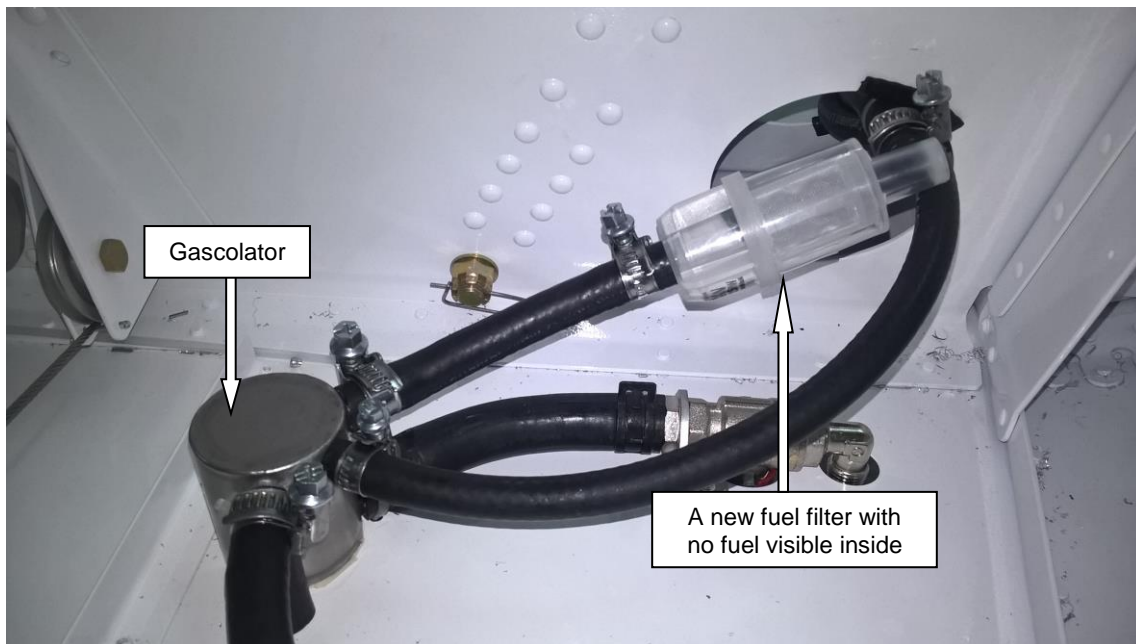
Figure 6: Fuel plumbing installation behind the right seat (photograph courtesy of Aeroprakt Ltd)

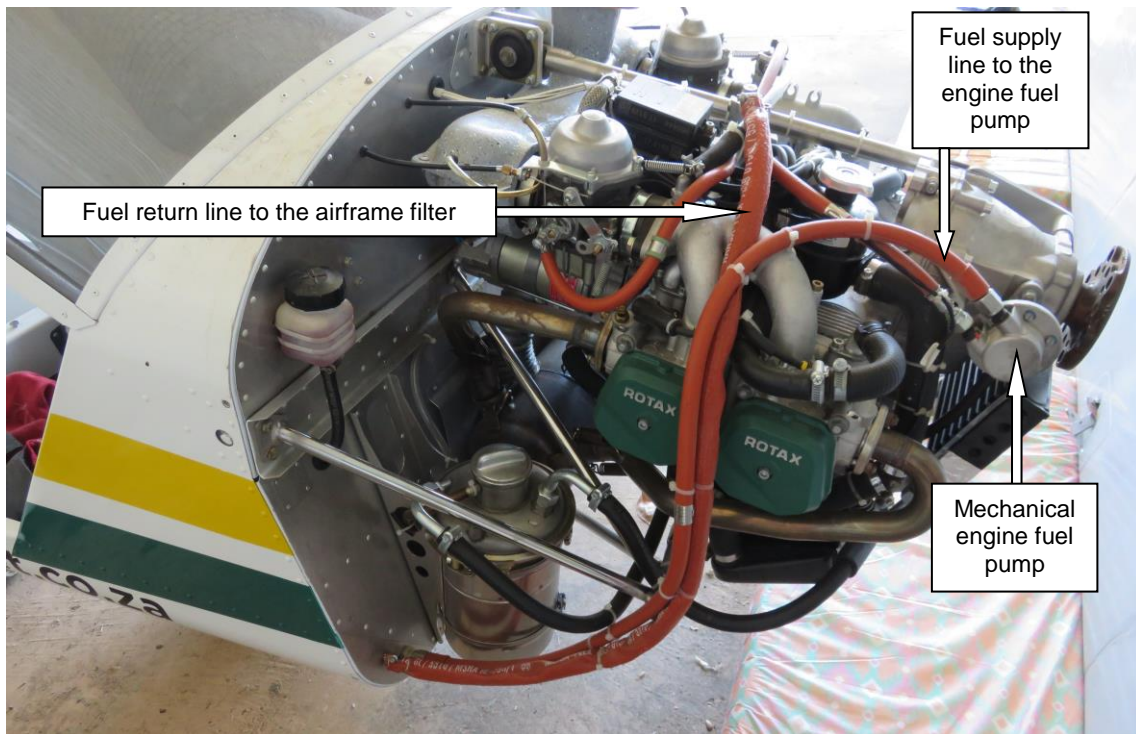
Figure 7: A view of the right side of the engine still within the airframe of ZU-INH

- 3.18 In Figures 7, 10 and 11 in this report, the same type of engine was installed in the same type of aircraft but different airframes. Neither of these three engine installations were consistent with one another, especially with regards to the fuel return line.

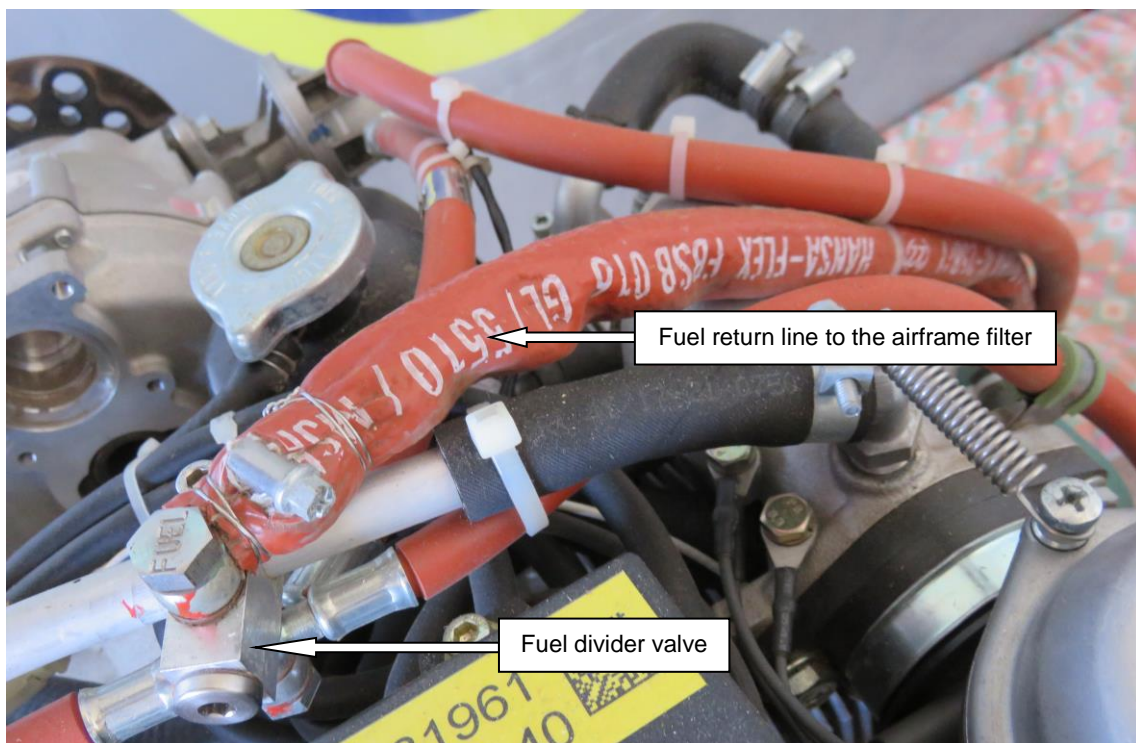
Figure 8: The fuel divider valve (spider valve) located on top of the engine (ZU-INH)

- 3.14 There was no fuel pressure gauge installed on this aircraft, nor was the aircraft equipped with an electrical auxiliary fuel pump as recommended by the engine manufacturer.

- 9.1 It is recommended that all Aeroprakt A22LS aircraft registered in South Africa be equipped with a (i) fuel pressure gauge as well as (ii) an electrical auxiliary fuel pump as standard equipment. The Rotax Installation Manual extract attached as Annexure B emphasise that these requirements should be met.

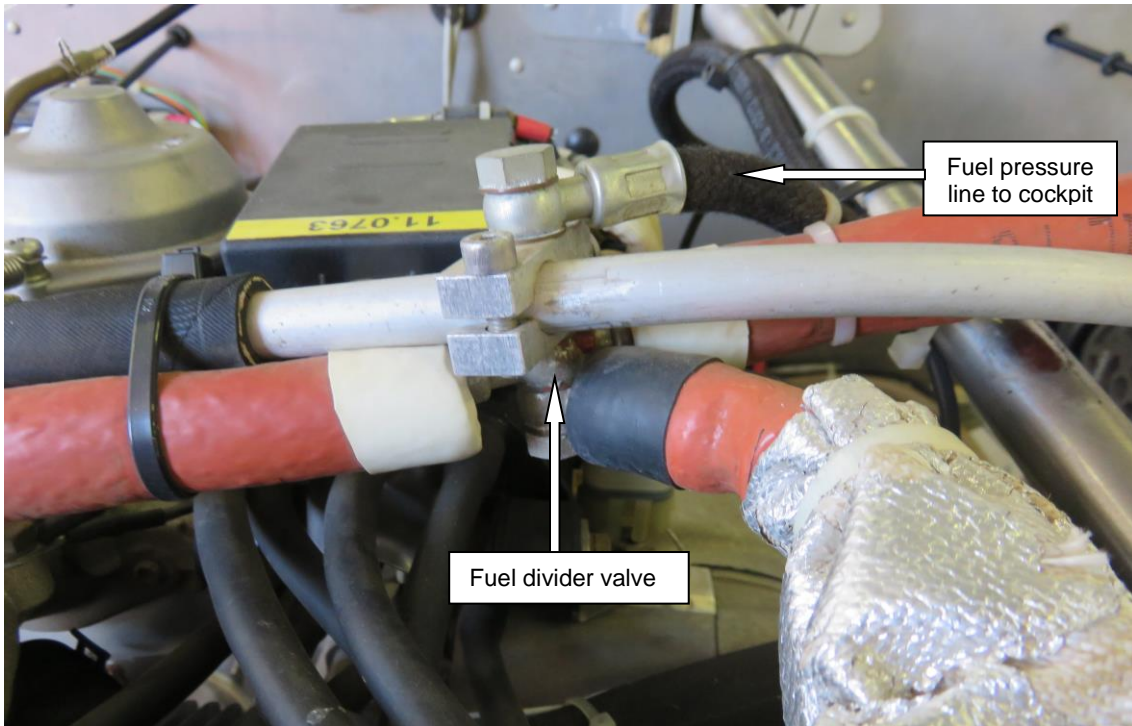
Figure 9: The fuel divider valve from another similar type of aircraft, with a fuel pressure line to the cockpit

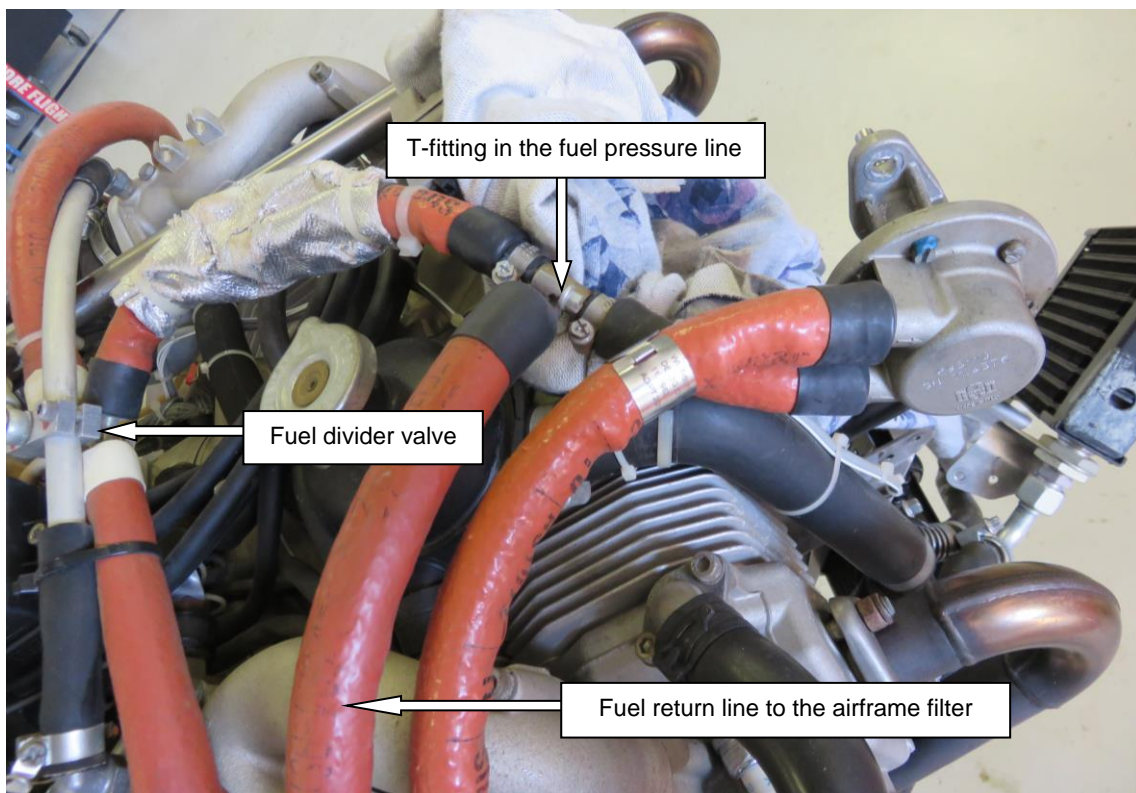
Figure 10: The fuel return line bleeding off from a T-fitting located within the fuel supply line from the engine driven fuel pump to the fuel divider valve (From a similar type of engine and aircraft)
