AIRCRAFT ACCIDENT INVESTIGATION BUREAU

INVESTIGATION REPORT ON

ACCIDENT TO THE B737-MAX8 REG. ET-AVJ OPERATED

Report No. AI-01/19

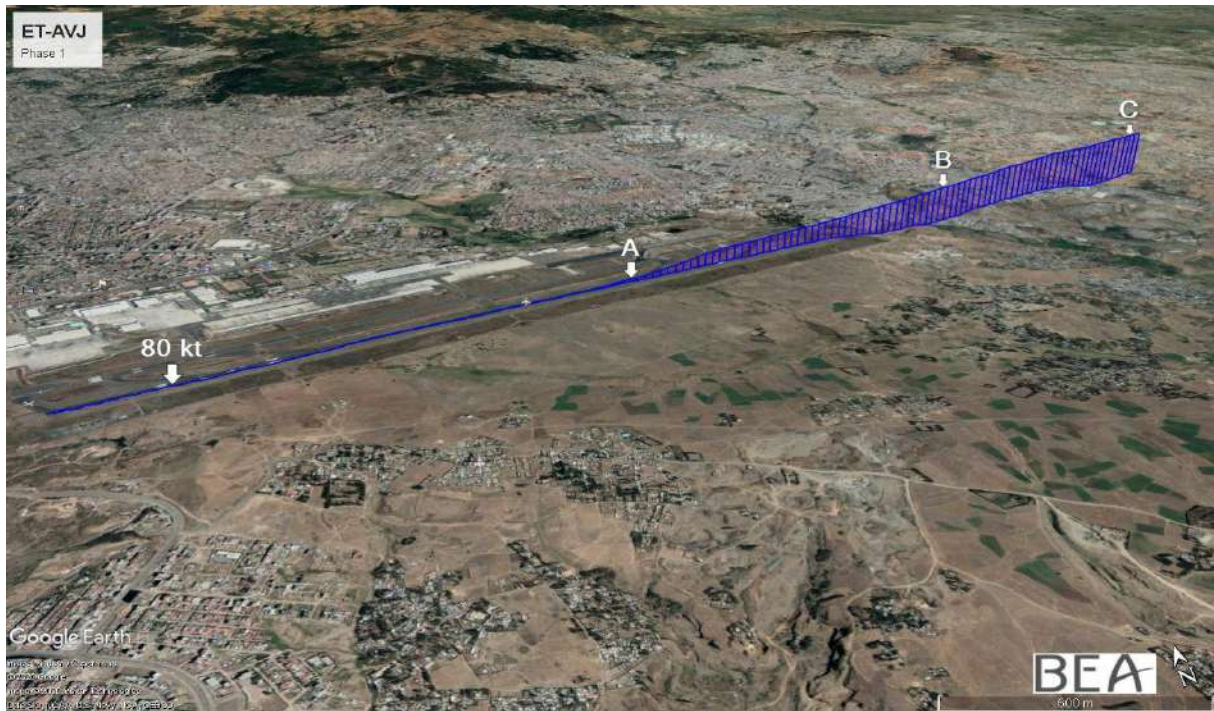
FIGURE 1: PHASE1 FROM TAKEOFF TO AUTOPILOT ENGAGEMENT

Before CMD A engaged, the stabilizer trim position was around 5.6 units, with elevator positions around 4° (consistent with the elevator neutral position for the stabilized flight condition).

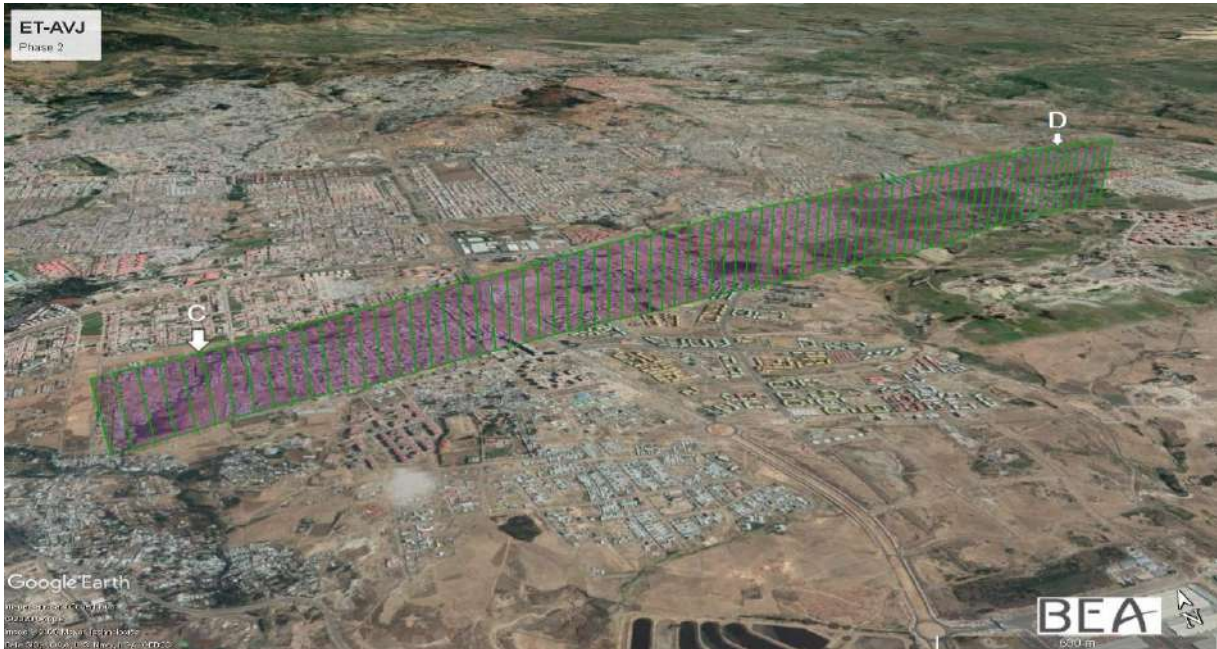
FIGURE 2: PHASE 2 DURING AUTOPILOT CONTROL

At the end of this phase, the pitch angle was around 1°, the stabilizer was at 4.6 units and the vertical speed was around -1,400 ft/min Flaps were still moving up.

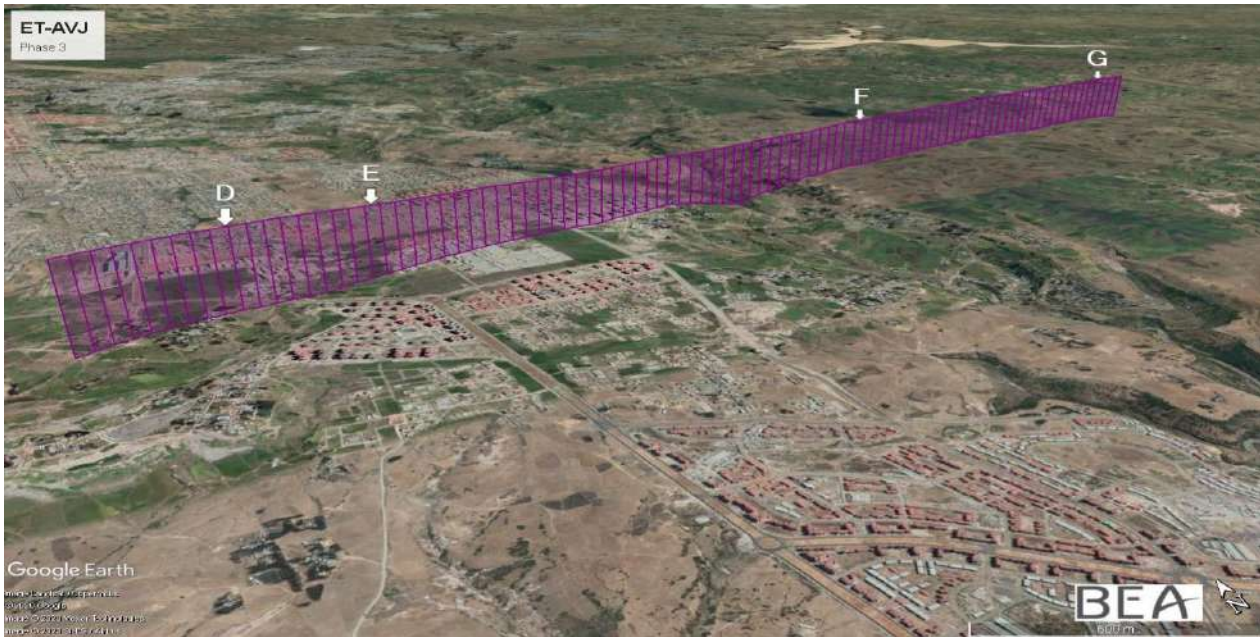
FIGURE3: PHASE 3 FROM A/P DISCONNECT TO STABILIZER TRIM CUTOUT

As a result of the erroneous LH AOA value and the increasing airspeed, SMYDC 1 computed LH minimum operational speed and LH stick shaker speed greater than VMO (340Kt) without any alert or invalidity detection.

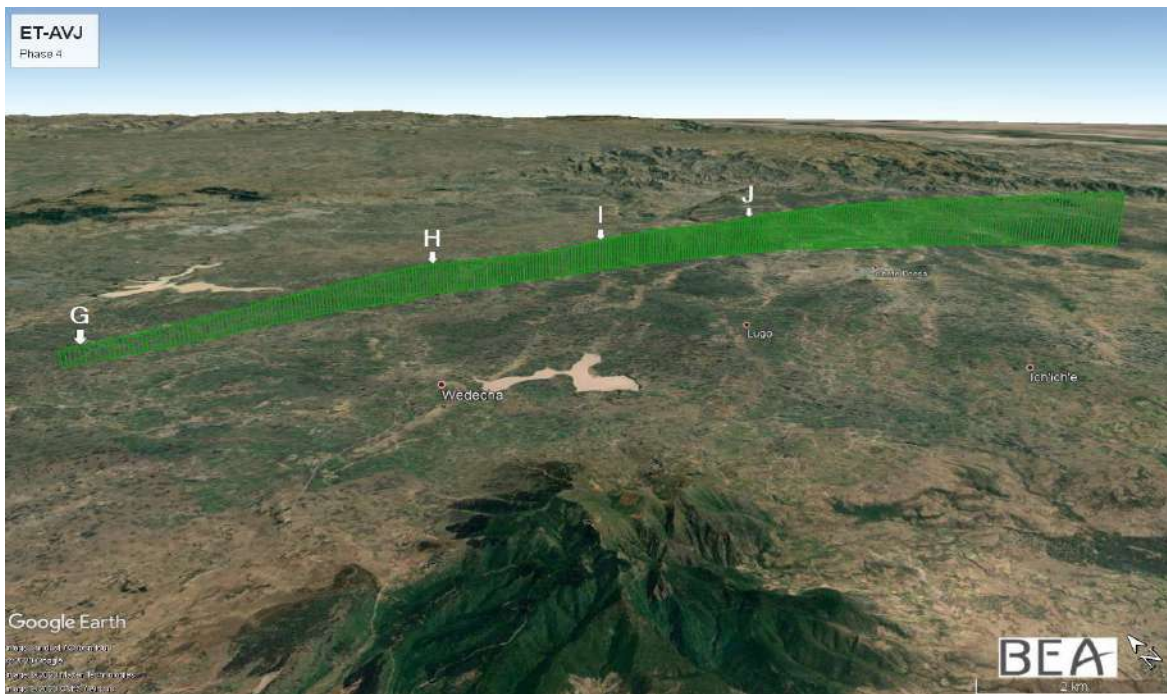
FIGURE 4: PHASE 4 FLIGHT WHILE THE STAB TRIM CUTOUT SWITCHES WERE IN THE CUTOUT POSITION

- The Airplane was at an altitude of 6,200 ft above the airfield elevation (computed from the RH pressure altitude). LH altitude values were 1,250 ft lower.
- Computed airspeed was around 367Kt (RH value), LH erroneous value was 344 Kt.
- The pitch angle of the Airplane was lower than 1°
- The vertical speed was around + 125 ft/min and decreasing
- The bank angle was around 21° right, with a slight trend to increase.

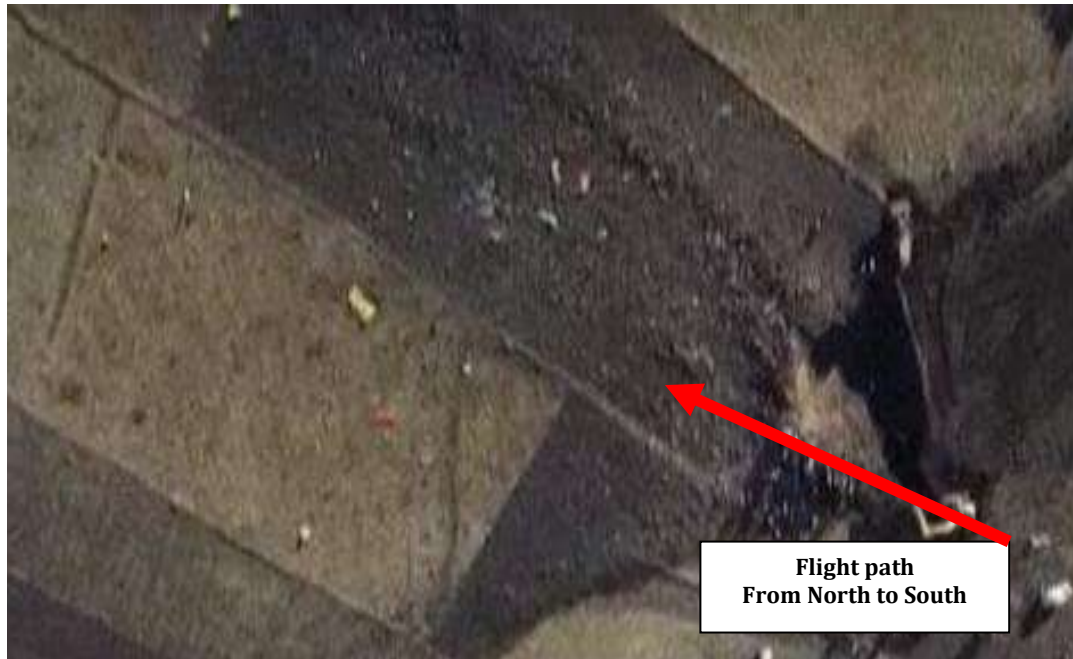
FIGURE 40: TOP VIEW OF THE CRATER

The Airplane impacted terrain at a farm field and created a crater approximately 10 meters deep (last Airplane part found) with a hole of about 28 meters width and 40 meters length. Most of the wreckage was found buried in the ground; small fragments of the Airplane were found scattered around the site in an area about 200 meters wide and 300 meters long. Damages to the Airplane were consistent with a high energy impact.

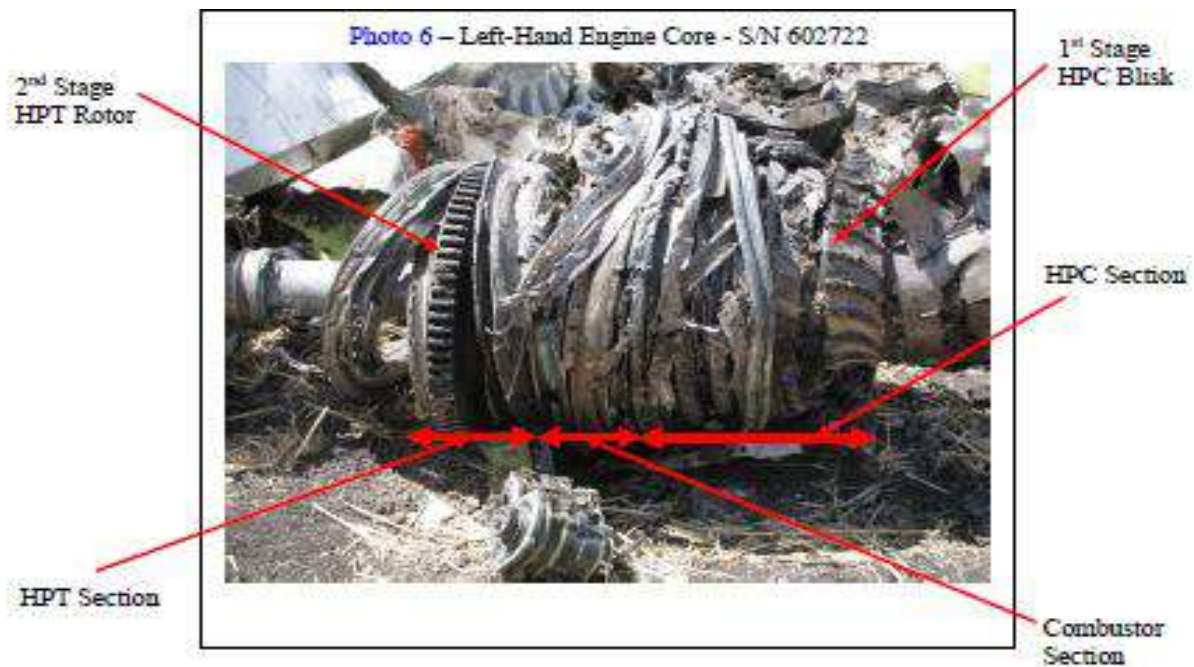
FIGURE 43: LEFT HAND ENGINE SECTION

The left engine core was recovered from the site and examined by the group. The engine was reportedly recovered at a depth of approximately 10 to 15 meters depth on the left side of the excavation site. The predominant feature of the deformation of the entire remaining core was axial deformation.

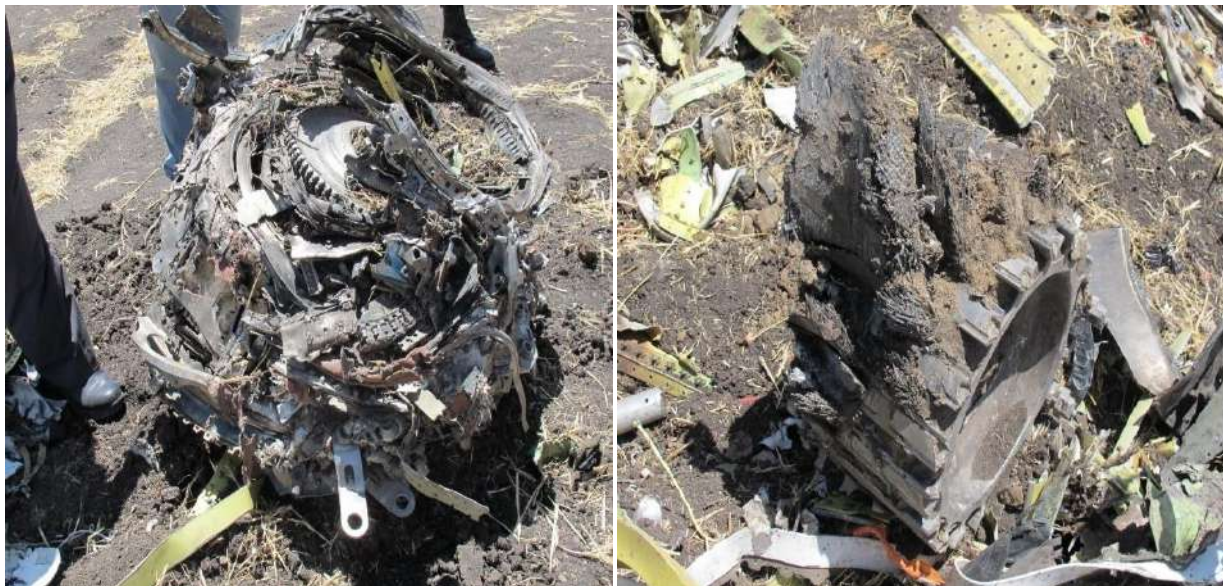
FIGURE 44: R/H ENGINE - S/N 602695 - CORE FIGURE 45: - R/H ENGINE - S/N 602695 - FAN DISK

The predominant feature of the deformation of the entire remaining core was axial deformation.

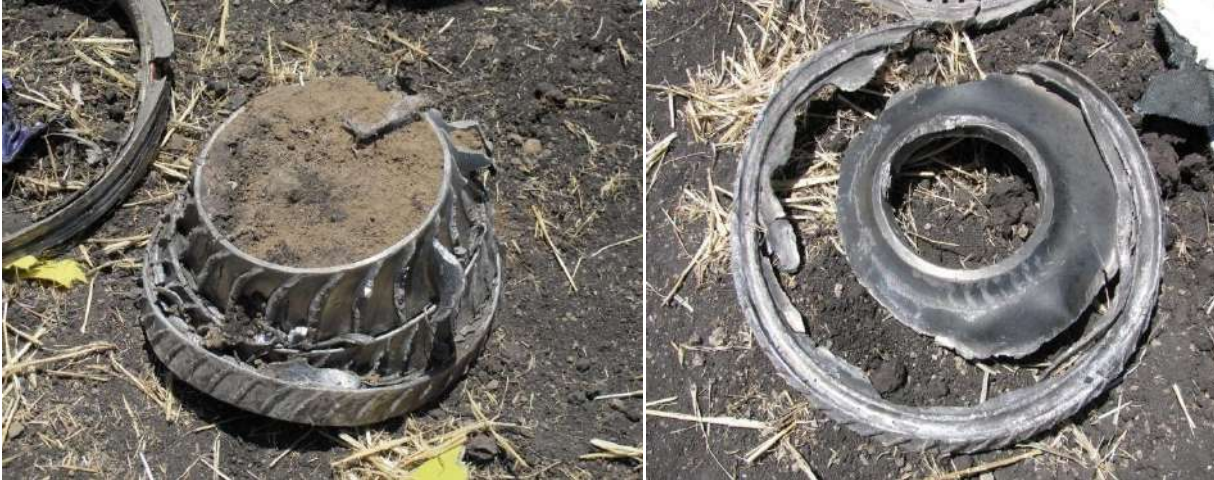
FIGURE 48: - R/H ENGINE - S/N 602695 - HPC STAGES 1 TO 3 FIGURES 49:- R/H ENGINE - S/N 602695 - HPC STAGE 7

6th, and the 8th to 10th stages were not found. The 5th stage was found separately, and it was also missing its airfoils. The 7th stage web was fractured circumferentially. The stator sections could not be identified.

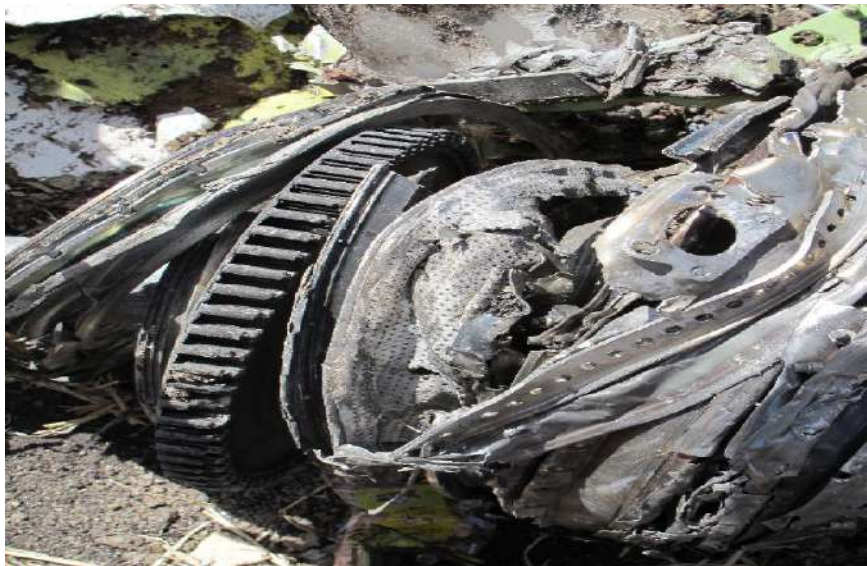
FIGURE 50: COMBUSTOR CRASHED

The combustor was severely crushed and most of it was missing into pieces.

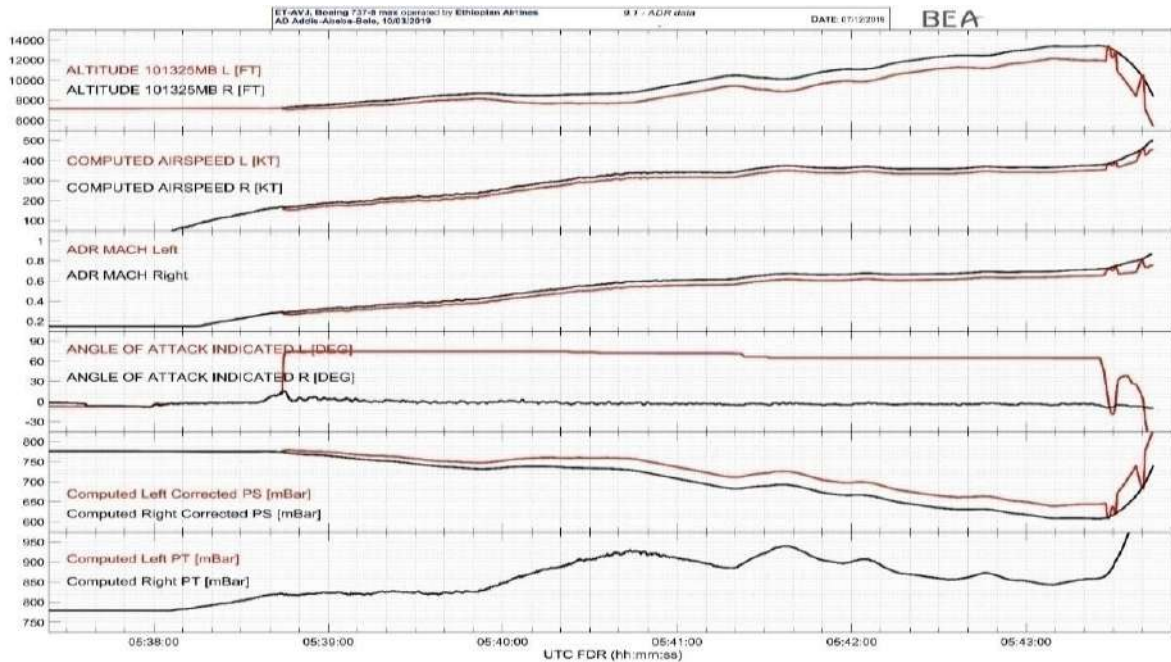
FIGURE 68: AIR DATA PARAMETERS

During the flight of the event, the left and right recorded altitude values, the recorded CAS values and the recorded Mach numbers diverged after LH and RH AOA values divergence.

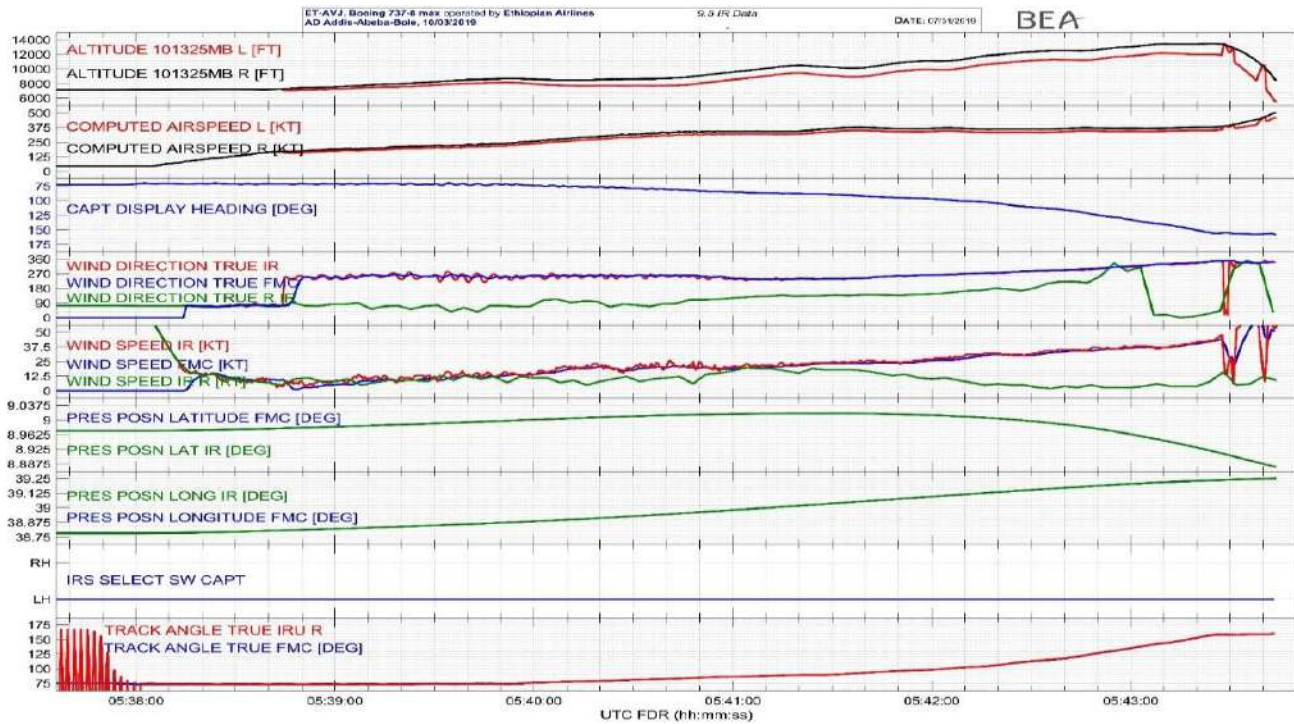
FIGURE70: IMPACT OF AOA FAILURE ON THE WIND COMPUTED VALUES

Most of the recorded IRS parameters did not show any variation following the AOA failure. On the contrary, the computed wind, on the left side, was clearly affected by that failure.

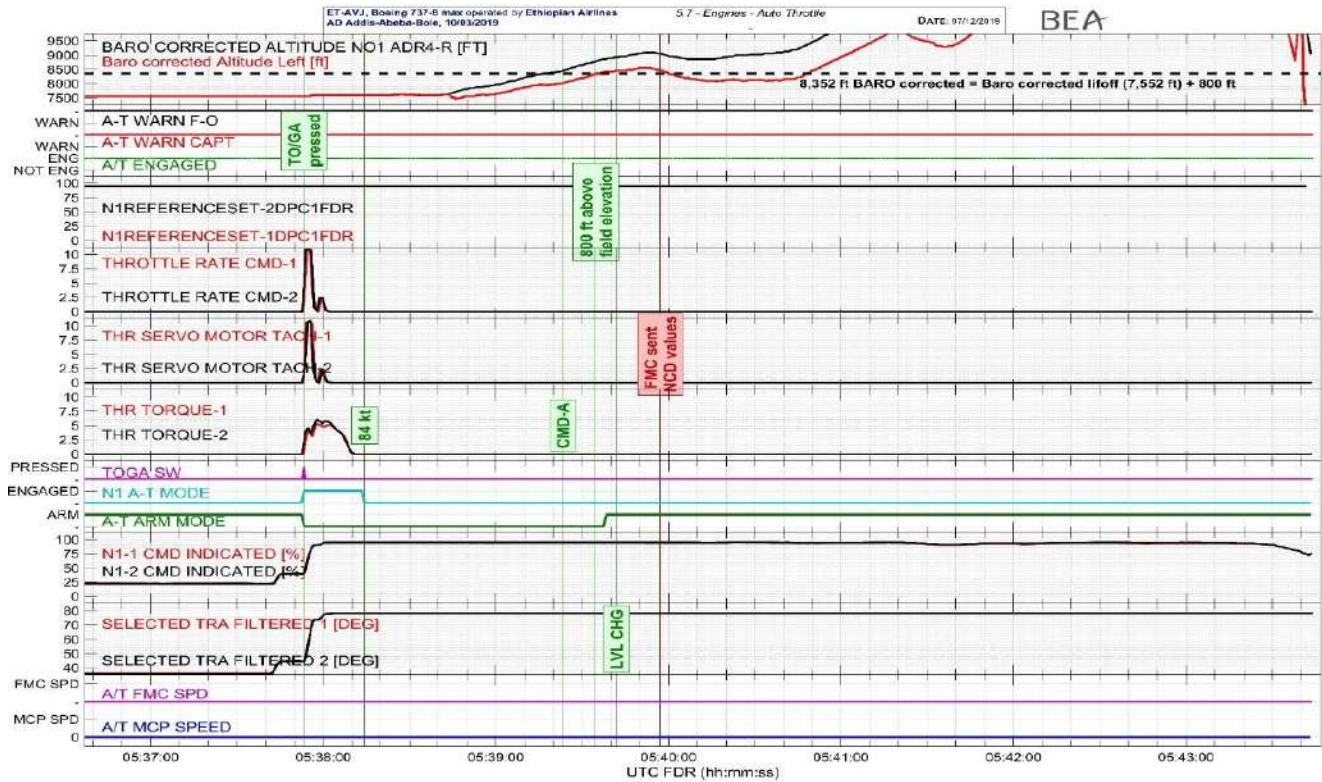
FIGURE 73: AUTO THROTTLE BEHAVIOR DURING THE FLIGHT OF THE EVENT

automatic reduction to climb thrust did not occur because the LH and RH TAS diverged by more than 25Kt before the FMC sensed that the Airplane had reached the thrust reduction altitude.

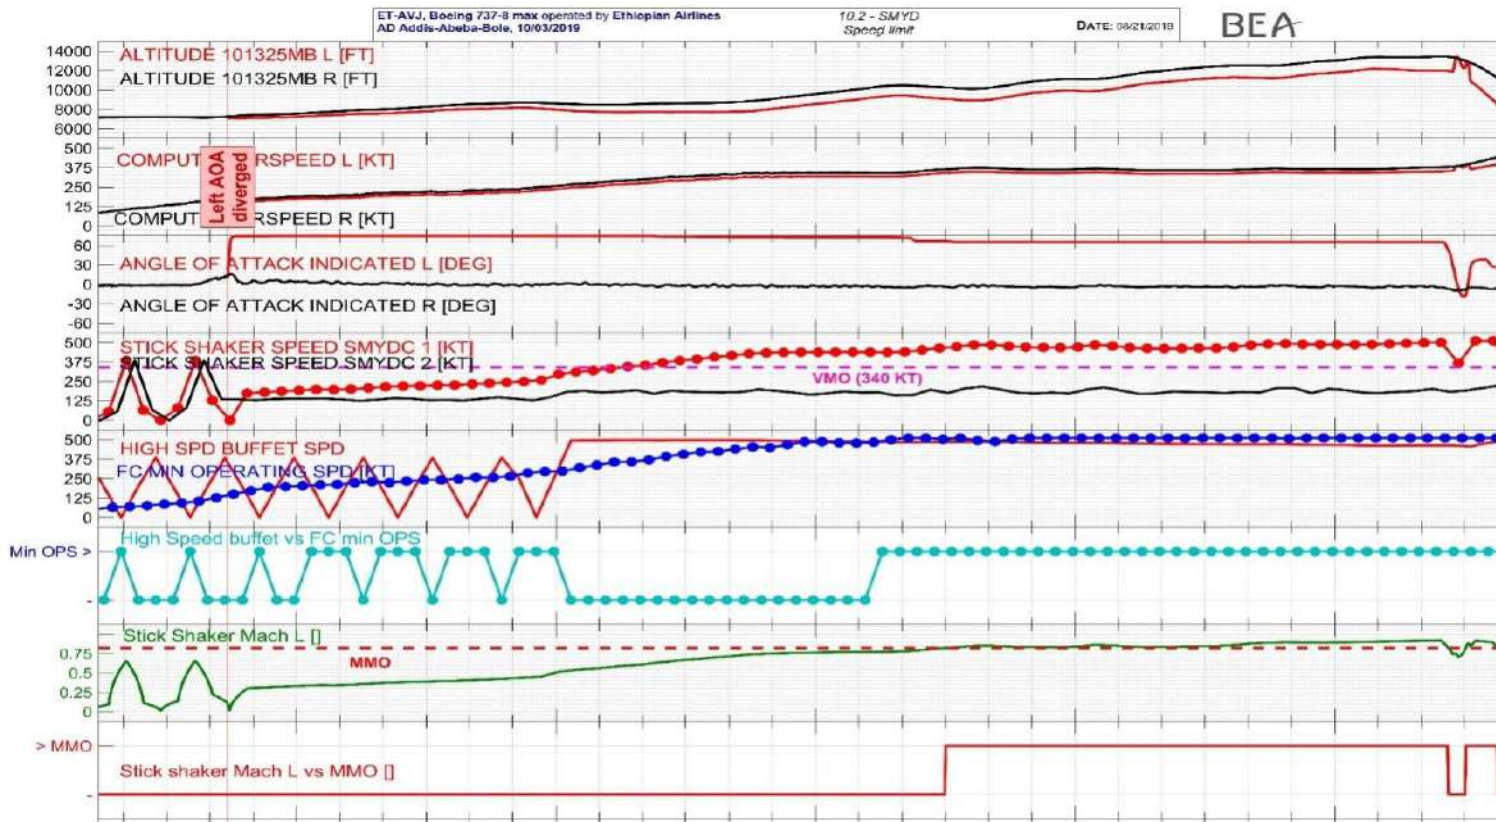
FIGURE 75: SMYD COMPUTED SPEEDS LIMITS

At 5 h 41 min 17 s, SMYDC1 computed FC minimum operational speed values greater than High speed buffet speed values. Both values were computed by the same computer SMYDC 1.

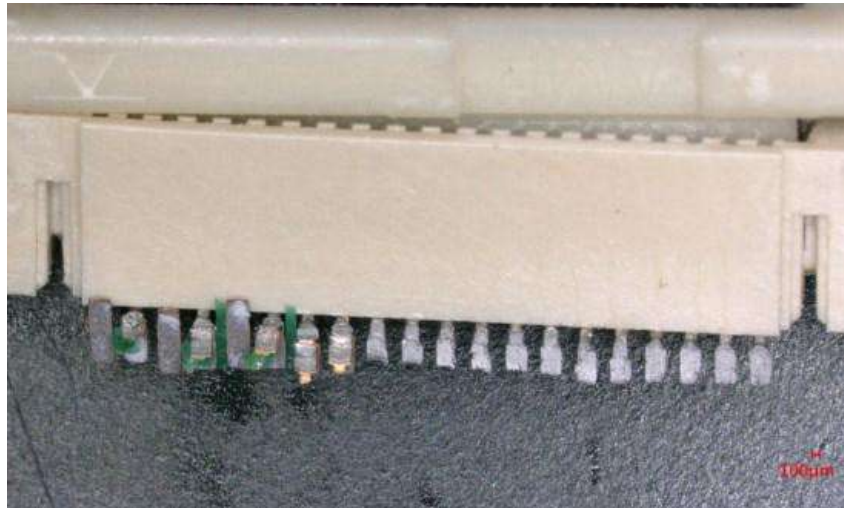
Figure5: Pads and pieces of PCB material on the connector pins

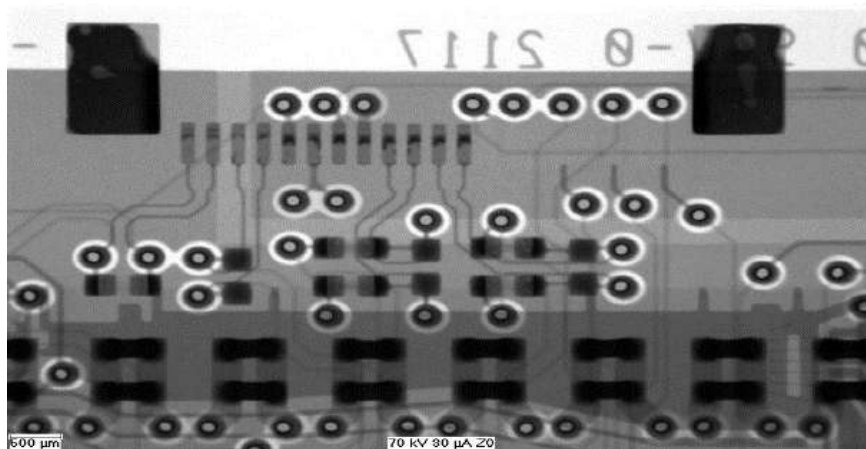
FIGURE 6: X-RAY EXAMINATION OF THE FDR MEMORY BOARD SHOWING THE 8 MISSING PADS
