The Islamic Republic of Iran
Civil Aviation Organization
Aircraft Accident Investigation Board

Final Report

File Number: S980102 ATG

Type of Aircraft: Fokker 100

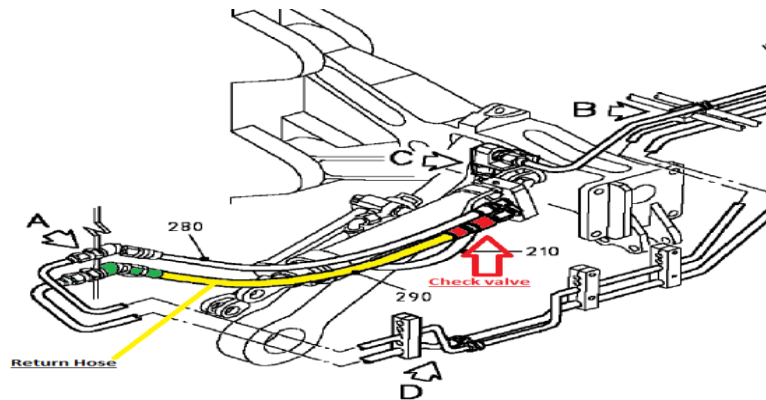
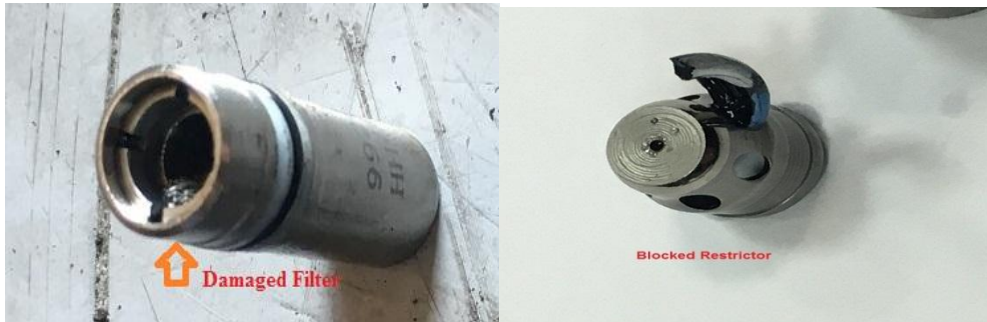
- The aircraft was jacked up, and the operational tests of landing gear both on normal and alternate condition were made, but the right main landing gear was not extended.
- The restrictor check valve near RH main landing gear actuator was opened and some parts of Cut O-ring were found on the orifices of the restrictor valve and related screen filter was cut.
- The main LG selector valve and its filter were checked with normal condition.

Failed Check Valve

During landing gear operation, the O-ring parts had been displaced between LG selector valve and RH main landing actuator in the hydraulic system. The displacement of the parts as contamination of hydraulic fluid incorporating high-pressure operation caused damage/rupture to screen filter of check valve and contaminated parts entered the orifice of restrictor and blocked return line of actuator to extend right main LG.

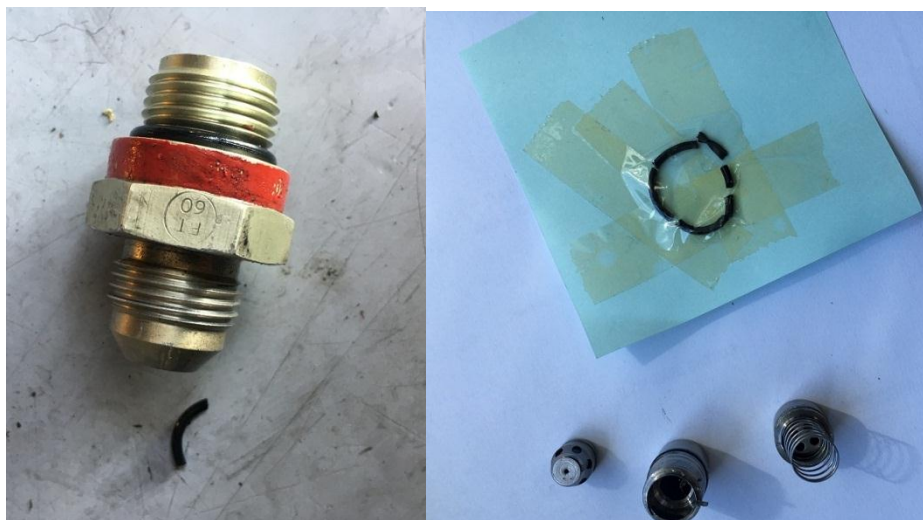
All parts of O-ring were collected from the system and sent to Fokker Service in the Netherlands for analysis.

The investigation at Fokker Service has been finalized with the following conclusions:

- The origin and part number of the O-ring cannot be positively defined.
- Most probably, the O-ring entered the hydraulic system during a maintenance activity.
